## REMOTE AIR BAG DEPLOYMENT REPORT

CASE NUMBER - IN01-001  
LOCATION - Texas  
VEHICLE - 1991 FORD LTD CROWN VICTORIA  
CRASH DATE - November 1998

1. Report No. IN01-001		2. Government Accession No.		3. Recipient's Catalog No.	
4. Title and Subtitle Remote Air Bag Fatality Investigation Vehicle - 1991 Ford LTD Crown Victoria Location - Texas			5. Report Date: August 12, 2002

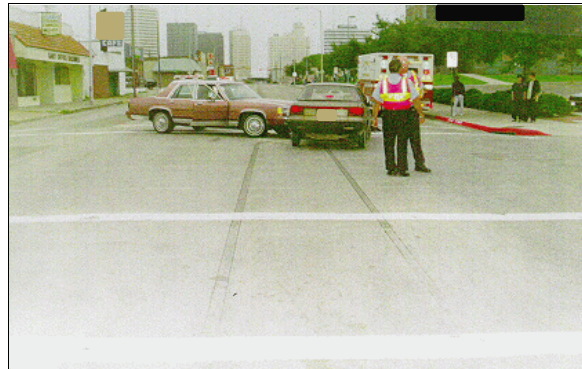
The case vehicle had been traveling west in the inside westbound lane of a four-lane, undivided city street and was entering a partially controlled four-leg intersection, intending to turn left and travel in a southerly direction (there were two lanes in both the east and westbound directions; there was no traffic control for east-west traffic and there were STOP signs for the intersecting north-south roadway). The Mitsubishi was traveling east in the inside lane of the same city street and was entering the intersection, intending to continue traveling in a easterly direction. The case vehicle's driver made no known avoidance maneuvers prior to the crash. The driver of the Mitsubishi locked-up her brakes and tried to steer to the right in an attempt to avoid the crash. The Mitsubishi deposited 11.6 meters [38 feet] of straight-line skid marks prior to impact (**Figure 1**). The crash occurred within the intersection of the two roadways (**Figure 2**).

**Figure 1:** On-scene view looking east at case vehicle's (left) and Mitsubishi's (right) final rest positions and braking skid marks from Mitsubishi; Note: Mitsubishi deflected slightly southward while rotating slightly clockwise (case photo #01)

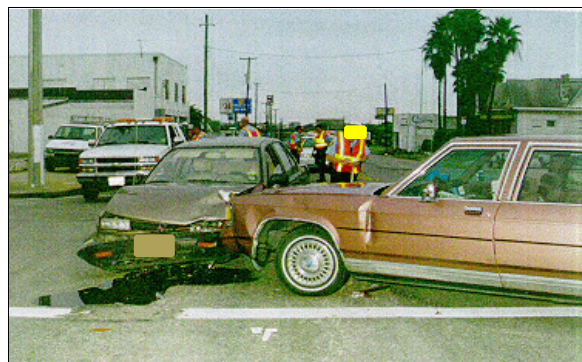
**Figure 2:** On-scene view looking west at case vehicle's (right) and Mitsubishi's (left) final rest positions; Note: case vehicle rotated counterclockwise post-impact (case photo #03)

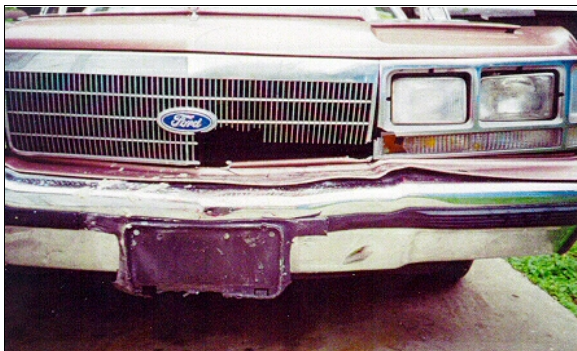
The front left half of the case vehicle (**Figures 3 and 4**) impacted the front left of the Mitsubishi (**Figure 5**), causing the case vehicle driver's air bag to deploy. The case vehicle rotated approximately 10 degrees counterclockwise and came to rest heading in a south-southwesterly direction. The Mitsubishi was deflected southward and was pushed approximately 10 degrees clockwise prior to coming to rest heading east-southeastward. The vehicles remained in contact with each other at final rest (**Figure 6**).

Based on the available photographs, the case vehicle's contact with the Mitsubishi involved the left half of the case vehicle's front plane. Direct damage extended approximately from the center to the front left corner on the bumper and grille, with induced damage extending across the entire front. Portions of the grille were broken away, but the headlight and turn signal assemblies were intact (**Figure 3**). The case vehicle's left front fender sustained induced damage as it was pushed rearward (**Figure 5**). All glazing appears to have remained intact and no doors came open.

**Figure 3:** Case vehicle's damaged front bumper and grille (case photo #07)

Based on the available photographs, the CDC for the case vehicle was estimated as: **01-FYEW-1 (30)**. Maximum crush was estimated at 8 centimeters [3 inches]. The WinSMASH reconstruction program, CDC-only algorithm based on photographs of both vehicles, was used. The Total, Longitudinal, and Lateral Delta Vs are, respectively: 14 km.p.h. [8.7 m.p.h.], -12 km.p.h. [-7.5 m.p.h.], and -7 km.p.h. [-4.3 m.p.h.]. This is a borderline reconstruction, but the results appear reasonable.

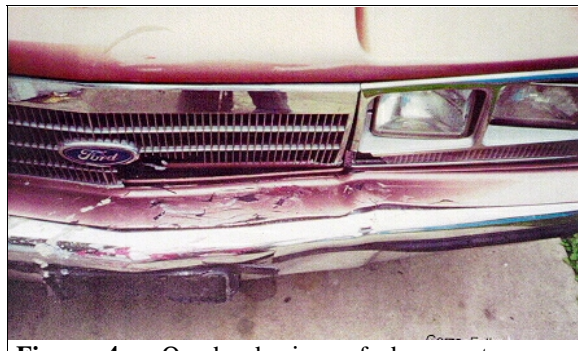
**Figure 4:** Overhead view of damage to case vehicle's front bumper and grille (case photo #08)

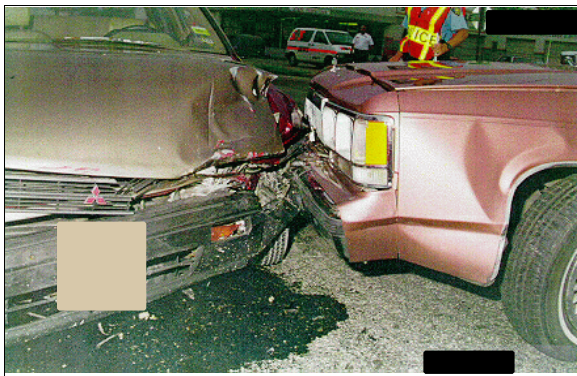
**Figure 5:** On-scene at final rest, looking across the case vehicle's front from the left and showing the Mitsubishi's front left area (case photo #05)

The Mitsubishi's contact with the case vehicle involved approximately the left half of the front plane, with light contact at the center and heavy contact at the front left corner (**Figure 5**). As the vehicles reached maximum engagement and rotated, the contact extended around to the left front fender and the left front wheel area (**Figure 6**). The leading edge of the hood was pushed rearward and downward with the middle of the hood buckling upward. The leading edge of the left front fender was pushed rearward and inward, restricting the left front tire. The left headlight assembly was shattered and the left portions of the grille were broken away. The left end of bumper was pushed rearward, causing the right end to be levered forward and apparently separated from its mounting.

Based on the available photographs, the CDC for the Mitsubishi was estimated as: **11-FYEW-2 (340)**. Maximum crush was estimated as 30 centimeters [11.8 inches]. The WinSMASH reconstruction program, CDC-only algorithm based on photographs of both vehicles, was used. The Total, Longitudinal and Lateral Delta Vs are, respectively: 24 km.p.h. [14.9 m.p.h.], -23 km.p.h. [-14.3 m.p.h.] and +8 km.p.h. [+5.0 m.p.h.]. This is a borderline reconstruction, but the results appear reasonable.

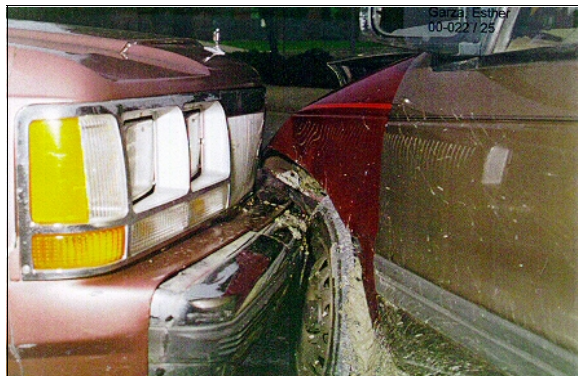
**Figure 6:** On-scene at final rest, looking across the case vehicle's front from the right and showing the Mitsubishi's left front wheel (case photo #04)

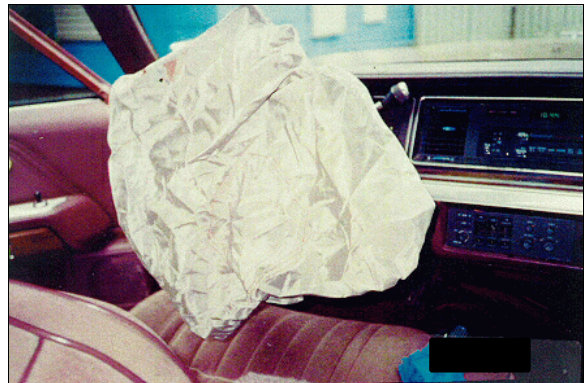
The case vehicle was equipped with a single air bag for the driver's seat position. The air bag was located in the steering wheel hub. Police photographs of the case vehicle indicate that the driver air bag module's cover flaps appear to have opened at the designated tear points and also that there was no visible

evidence of damage during the deployment to the air bag's fabric. There are no clear pictures of the air bag module's cover flaps. Because this case is a remote investigation, it is unknown if the driver's air bag was designed with tethers and/or vent ports, and the air bag's dimensions are also unknown. However, the photographs do show faint blood smears to the driver's air bag (**Figure 7**), but there is no other obvious evidence of occupant contact to the case vehicle's interior surfaces.

**Figure 7:** Case vehicle's deployed driver air bag showing blood spots on fabric (case photo #15)

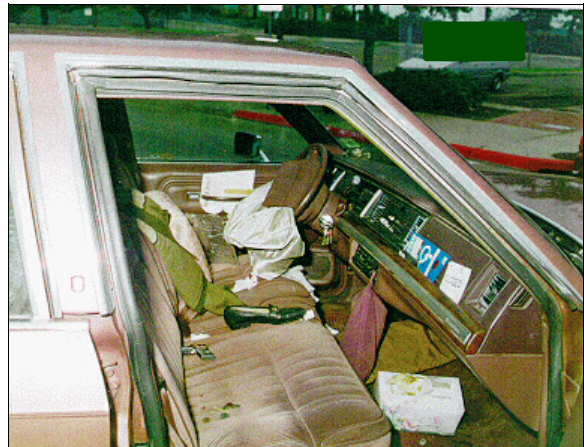
The driver's exact posture immediately prior to the crash is unknown, but she was probably seated in an upright posture with her back against the seat back, her left foot on the floor, her right on the accelerator, and both of her hands on the steering wheel (i.e., driver was turning left at the intersection). Based on the available photographs, her seat track appears to have been adjusted close to its forward-most position (**Figure 8**), the seat back was upright and the tilt steering wheel appears to have been adjusted at its middle position.

**Figure 8:** On-scene view looking across case vehicle's front seating area; Note: close proximity of bench seat to instrument panel (case photo #14)
