ON-SITE ADVANCED OCCUPANT PROTECTION SYSTEM INVESTIGATION

CASE NUMBER - IN01-003
LOCATION - MISSISSIPPI
VEHICLE - 2001 LEXUS GS300
CRASH DATE - February, 2001

February 13, 2003

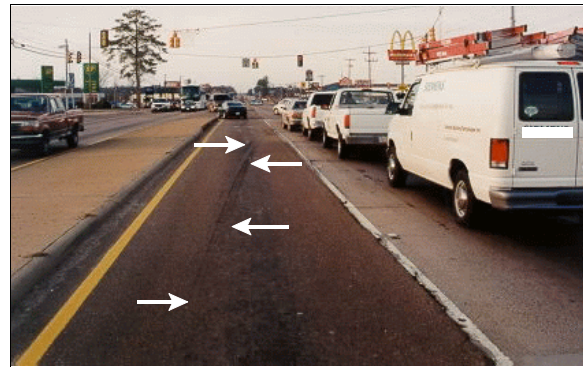
Figure 1: On-scene view showing critical curve scuff deposited in left-hand turn lane as case vehicle's driver swerved rightward, attempting to re-enter the roadway's through lanes during vehicle's attempt to flee from pursuing police vehicles (case photo #66)

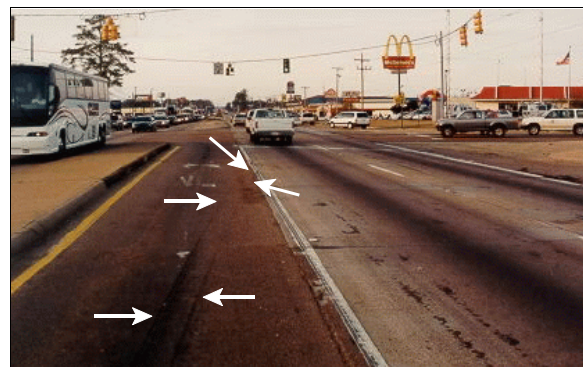
Figure 2: On-site view showing sharply turning critical curve scuff deposited in left-hand turn lane as case vehicle's driver swerved rightward into through lanes and began traveling northbound across roadway (case photo #67)

The northbound roadway of the U.S. highway was straight and level at the area of impact (**Figure 2** above). The pavement was concrete for the through lanes and bituminous for the right and left-hand turn lanes. The width of the northbound, left-hand, turn lane was approximately 2.7 meters (9 feet). The width of the outside, northbound, through lane—prior to departing the roadway, was approximately 4.0 meters (13 feet). The northbound left-hand turn lane was bordered on the west side by a short shoulder which was adjacent to a 3.6 meter (11.8 foot) wide raised, paved median. At the mouth of the intersection, the outside, northbound, through lane was bordered on the east side by a short shoulder which was adjacent to a raised, paved gore. The shoulders were improved (i.e., bituminous), and the roadway was bordered by barrier curbs. Pavement markings consisted of a single solid yellow “no passing” line for northbound traffic, boarding the left-hand turn lane, and a solid white edge line which was adjacent to the outside through lane. The through lanes were divided by a dashed white line, and single, solid, white lane lines separated the through lanes from the turn lanes. The estimated coefficient of friction was 0.70. Traffic controls consisted of two on-colors, pre-timed, vertically mounted traffic control signals. The signals were located between the left-hand turn lane the inside through lane and between the two through lanes. The legal speed limit was 72 km.p.h. (45 m.p.h.). No regulatory speed limit sign was posted near the crash site. At the time of the crash the light condition was daylight, the atmospheric condition was partially cloudy, and the road pavement was

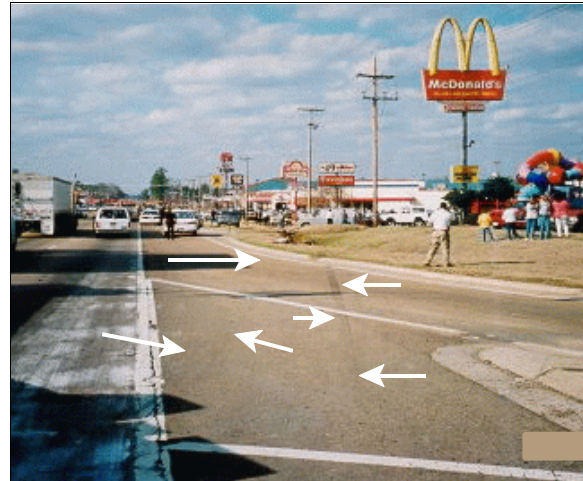
Figure 3: On-scene view of case vehicle's northward travel path from inside through lane onto eastern shoulder prior to departing road; Note: tire yaw marks leading off road toward curb indicate driver's attempt to steer leftward back toward roadway (case photo #69)

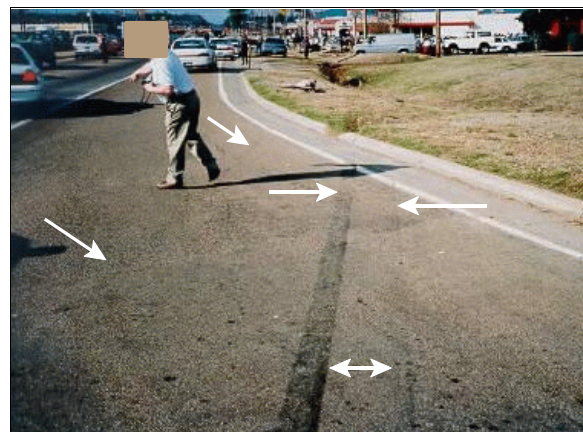
Figure 4: On-scene view of case vehicle's yaw marks leading off road and into curb impact (case photo #71)

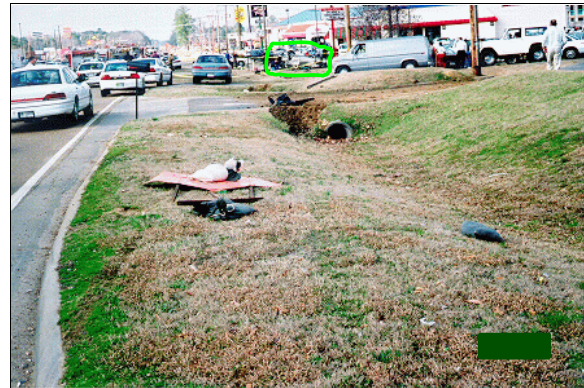
Figure 5: On-scene view looking in a northerly direction at case vehicle's path of travel through warning sign (2nd impact) and into culvert's embankment (3rd impact); Note: ground dugout during embankment impact and final rest position (highlighted) of case vehicle (case photo #74)

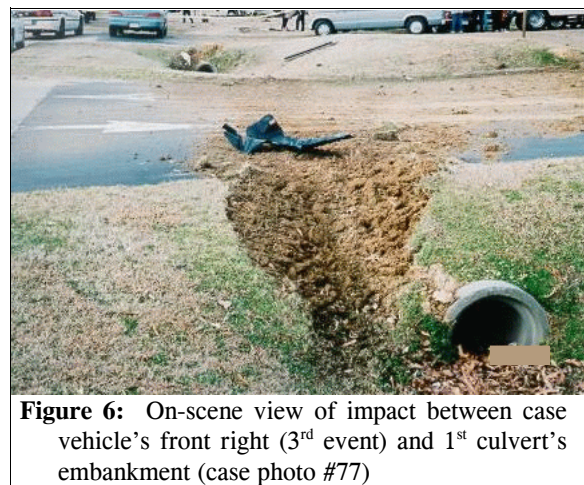
Figure 6: On-scene view of impact between case vehicle's front right (3rd event) and 1st culvert's embankment (case photo #77)

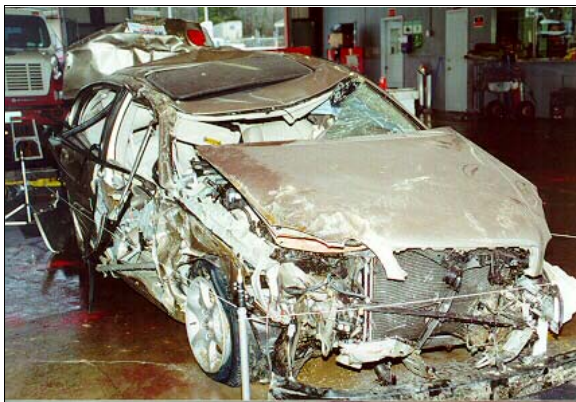
Figure 7: Deformation to case vehicle's front from impacts with sign, 1st culvert's embankment, and subsequent rollover impacts, viewed from right of front (case photo #23)

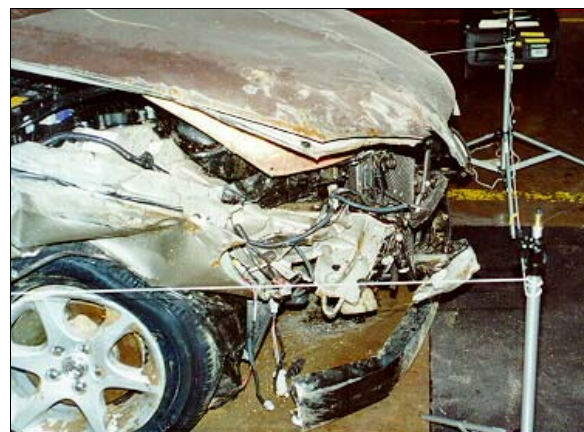
Figure 8: Reference line view from right of deformation to case vehicle's front right corner as a result of impact with 1st culvert's embankment (case photo #22)

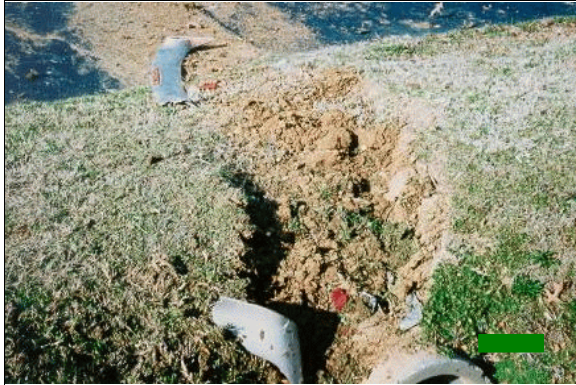
Figure 9: On-scene view of non-horizontal impact between case vehicle's back left (4th event) and 2nd culvert's embankment; this impact most likely caused the ejection of the case vehicle's front right and back left passengers (case photo #80)

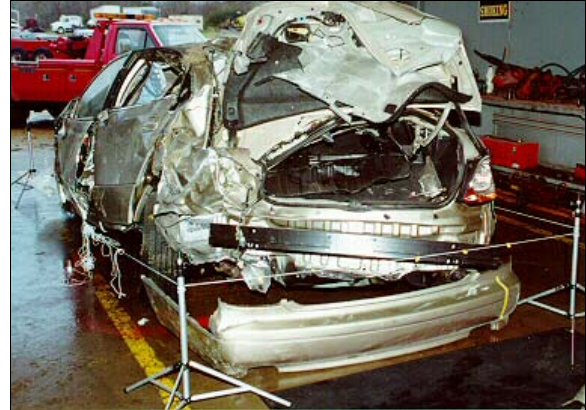
Figure 10: Deformation to case vehicle's back left corner viewed from left of back; Note: mud and grass stuck in left "C"-pillar (case photo #09)

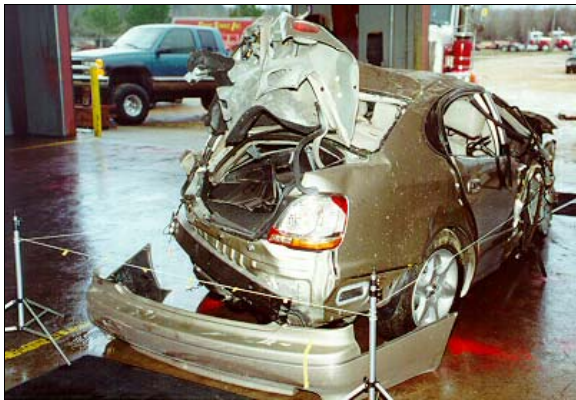
Figure 11: Deformation to case vehicle's back viewed from right of back; Note: damage occurred during vehicle's end-over-end rollover impact with 2nd culvert's embankment (case photo #14)

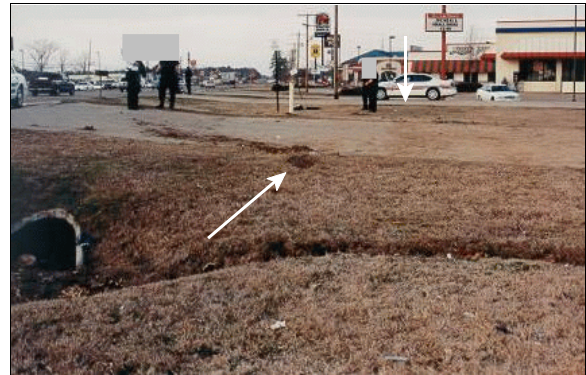
Figure 12: On-scene view of area where case vehicle landed after rolling over (i.e., rotation about both longitudinal and lateral axes) following its impact with the 2nd culvert's embankment (closest arrow); case vehicle continued to roll about its longitudinal axis, coming to rest on the north side (farthest arrow) of the 3rd driveway (case photo #86)

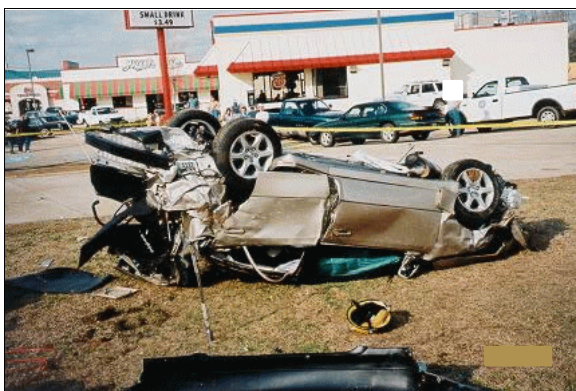
Figure 13: Northward on-scene view of case vehicle's final rest position on its roof, heading in an easterly direction, between the 3rd and 4th driveways north of the four-leg intersection (case photo #90)

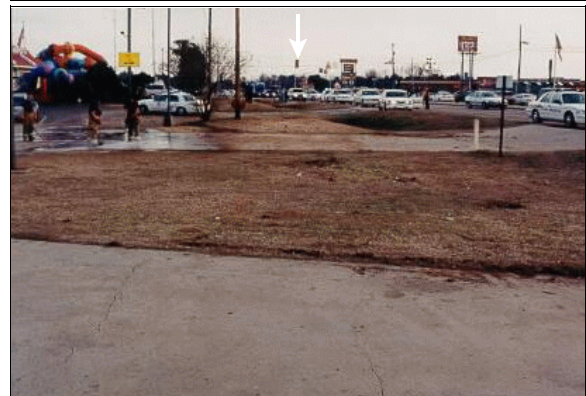
Figure 14: On-scene view just prior to completion of crash scene clean-up from north of case vehicle's final rest position looking southwards along case vehicle's off-road travel path; Note: arrow indicates traffic signal light at intersection where off road travel began (case photo #106)

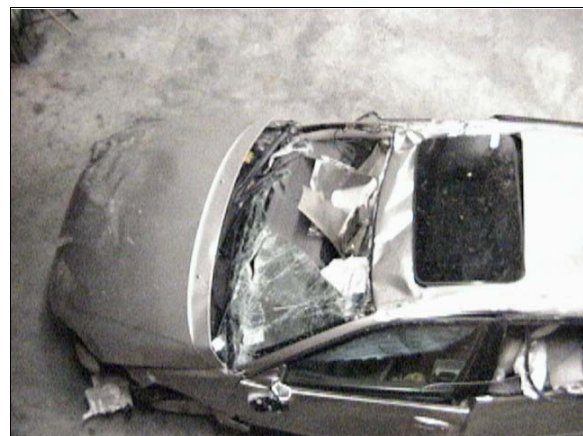
The case vehicle's impact with the curb most likely involved the right front wheel but, because of the masking damage, the exact nature of the damage was not determinable (**Figure 8** above). The case vehicle's impact with the metal temporary warning sign most likely involved the left two-thirds of the case vehicle's front. Once again, because of the masking damage, the exact location was not determinable (**Figure 7** above). The case vehicle's horizontal impact with the 1st culvert's embankment (3rd event) involved the front right half of the bumper and its front undercarriage (**Figure 15**). Direct damage began 21 centimeters (8.3 inches) right of the vehicle's center and extended to the front right bumper corner, a measured distance of 61 centimeters (24.0 inches) along the front bumper. Maximum

Figure 15: Overhead view of deformation to case vehicle's front; Note: rightward shift of hood in response to impact with 1st culvert's embankment (case photo #107)

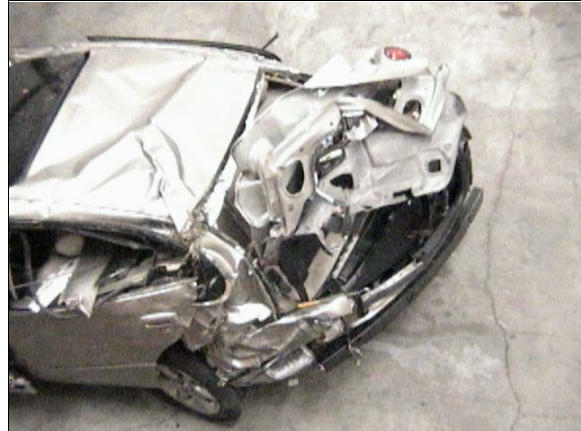
crush was measured as 31 centimeters (19.3 inches) at the front right bumper corner. The case vehicle's most severe impact, a non-horizontal impact with the 2nd culvert's embankment (4th event) involved its back left half (**Figure 16**). Direct damage began at the back left bumper corner and extended, a measured distance of 144 centimeters (56.7 inches), along the back bumper (**Figure 10** above). The direct damage also extended down the left side and included the left "C"-pillar. Residual maximum crush was measured as 66 centimeters (26.0 inches) at C₁. The wheelbase on the case vehicle's left side was shortened 54 centimeters (21.3 inches) while the right side was shortened 16 centimeters (6.3 inches). As a result of this crash the case vehicle's front and back bumpers, front and back bumper fasciae, grille, hood, radiator, truck, roof, front headlight and turn signal assemblies, back left taillight and turn signal assemblies, both fenders, left quarter panel, and all four doors were directly damaged and crushed inward. Furthermore, all four of the case vehicle's tires were physically restricted, and both of the front tires were deflated from damage. The right taillight and turn signal assemblies sustained induced damage as well as the right quarter panel and both left side doors. The windshield was cracked and holed. The right front, right rear, backlite, and left rear window glazings were all disintegrated; however, the left front (**Figure 17**) and roof glazings remained intact (**Figure 15** above).

Figure 16: Overhead view of deformation to case vehicle's back showing non-horizontal impact direction to back left corner from impact with 2nd culvert's embankment (case photo #108)

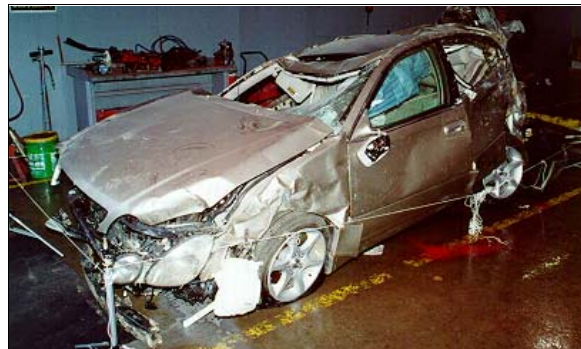
Figure 17: Deformation to case vehicle from frontal and multiple rollover impacts viewed from front portion of left side (case photo #05)

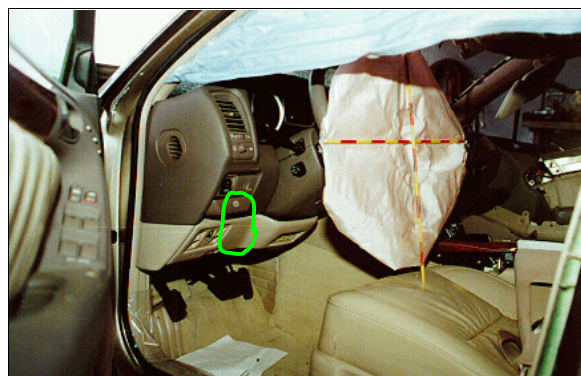
Inspection of the case vehicle's interior revealed contact evidence on both the driver's (**Figure 18**) and front right passenger's knee bolsters (**Figure 19** below). The latter was found just below the glove box door. Furthermore, there was obvious contact evidence on the back surface of the front right passenger's seat back (**Figure 20** below), and the turn signal/windshield wiper stalk was broken off the steering column. Finally, there was intrusion to the driver's toe pan area, to all occupant seating positions from the roof being crush downward, and to the back left passenger's seating area (**Figure 21** below).

Figure 18: Case vehicle's driver seating area showing driver's deployed front air bag and side inflatable curtain; Note: minimal floor pan intrusion and left knee contact to driver's knee bolster (case photo #28)

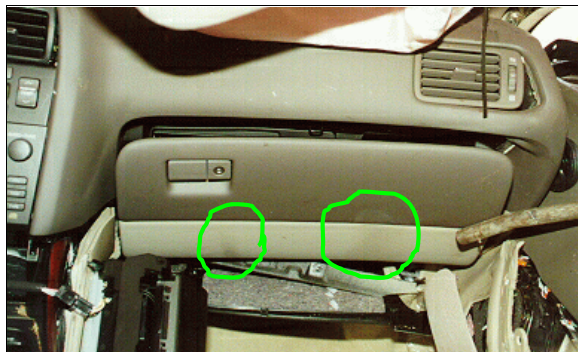
Figure 19: Contact evidence (highlighted) on case vehicle's front right knee bolster, just below glove box door from front right passenger's knees (case photo #46)

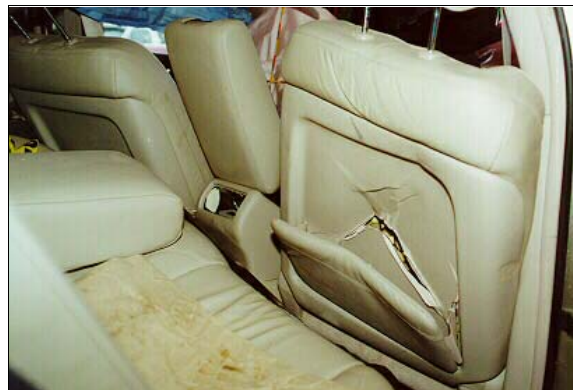
Figure 20: Damage to back surface of case vehicle's front right seat back from loading by back right passenger (case photo #58)

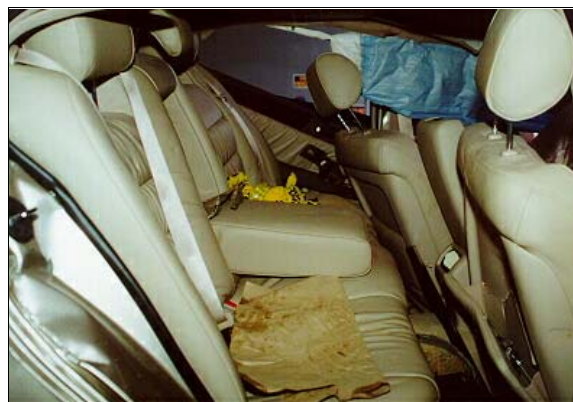
Figure 21: Case vehicle's back seats viewed from right rear door showing intrusion to back left seating position; Note: deployed driver side inflatable curtain (case photo #61)

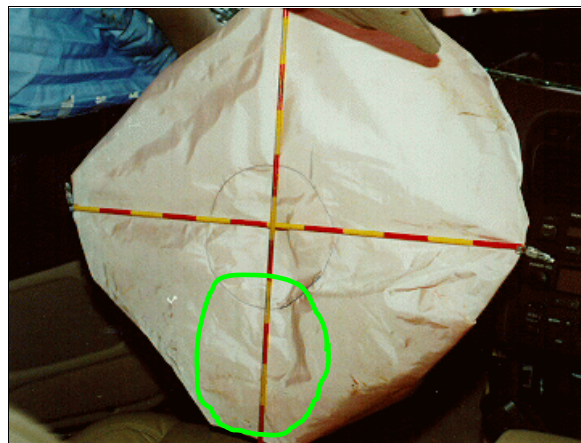
The case vehicle's driver air bag was located in the steering wheel hub. The module cover consisted of three asymmetrical cover flaps made of thick vinyl. The top and largest flap was somewhat semicircular in design while the left and right lower flaps were hexagonal and obliquely oriented. The top cover flap had overall dimensions of 17 centimeters (6.7 inches) horizontally and 12 centimeters (4.7 inches) vertically at their widest points. The two bottom flaps were mirror imaged and each measured 7 centimeters (2.8 inches) horizontally and had an overall height of 10 centimeters (3.9 inches) vertically. An inspection of the air bag module's cover flaps and air bag fabric revealed that the cover flaps opened at the designated tear points, and there was no evidence of damage during the deployment to the air bag or the cover flaps. The driver's air bag was designed with two tethers, each 11 centimeters (4.3 inches) wide. The driver's air bag had two vent ports, approximately 1.5 centimeters (0.6 inches) in diameter, located at the 11 and 1 o'clock positions. The deployed driver's air bag was round with diameter 57 centimeters (22.4 inches). An inspection of the driver's air bag fabric revealed obvious contact evidence (i.e., two areas of bloody and oily smears) on the lower half of the air bag's fabric between the 6:30 and 7:30 o'clock positions (**Figure 22**).

Figure 22: Case vehicle's deployed driver air bag showing area (highlighted) of bloody and oily smears (case photo #33)

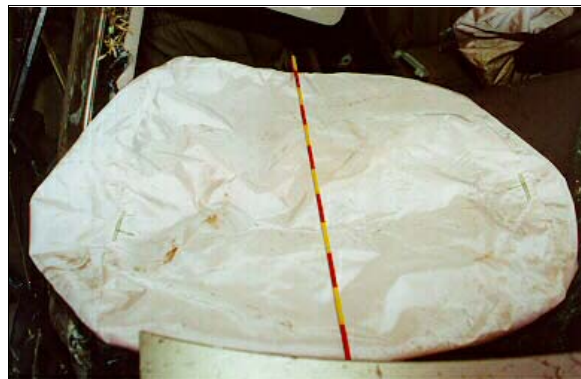
Figure 23: Overhead view looking down at front surface of case vehicle's deployed front right passenger air bag; Note: air bag module's cover flap is visible in bottom of photo and bottom of front surface of air bag is located towards top of photo (case photo #49)

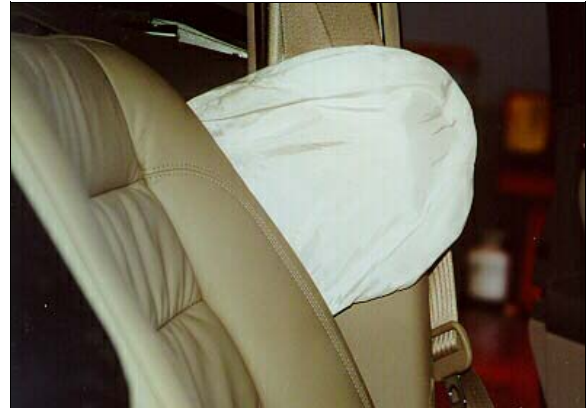
Figure 24: Close-up of interior portion of case vehicle's deployed, driver seat back-mounted, side air bag showing no visible contact evidence (case photo #39)

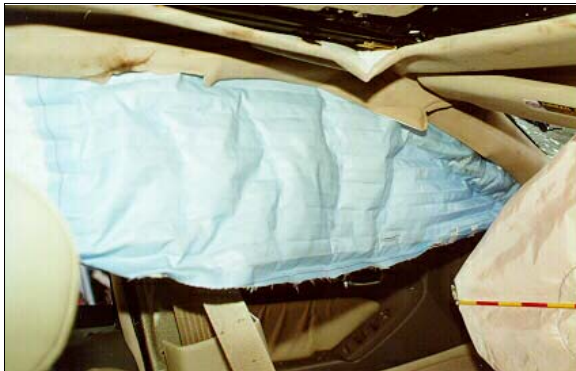
Figure 25: Case vehicle's deployed driver side inflatable curtain viewed from back right seat; Note: collapsed roof and left "A"-pillar (case photo #31)

The case vehicle's driver side inflatable curtain was located along the seam between the roof and left side roof rail, and the curtain was located from the left "A"-pillar rearwards to just beyond the left "B"-pillar (**Figure 25**). An inspection of the driver's side inflatable curtain revealed that there was no evidence of damage during the deployment to the curtain. The driver's inflatable curtain was designed with one tether, 30 centimeter (11.8 inches) in length, that connected between the rear of the curtain and the left "C"-pillar. The inflatable curtain was not designed with vent ports, but there were six baffles spread across the width of the curtain that acted as a type of tether. The deployed inflatable curtain measured 158 centimeters (62.2 inches)

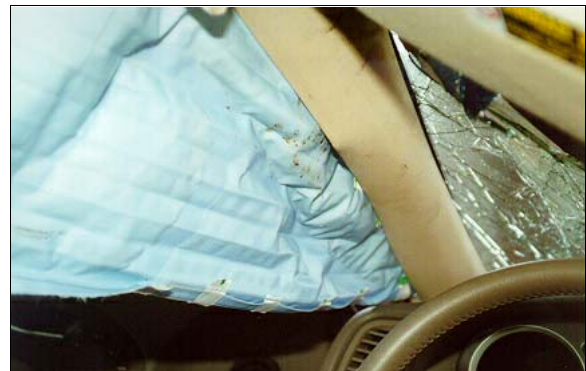
Figure 26: Close-up of front interior portion of case vehicle's deployed driver side inflatable curtain showing blood evidence (case photo #32)

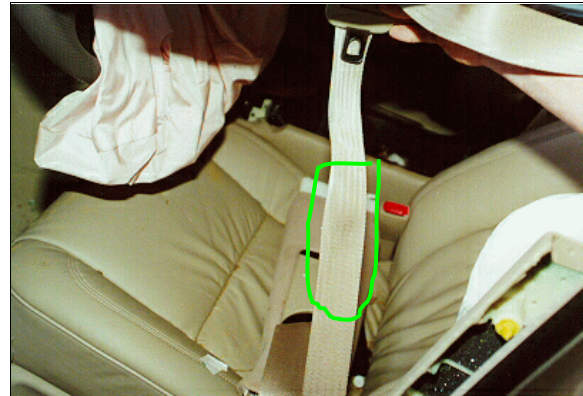
Figure 27: Loading evidence on webbing of case vehicle's driver seat belt (case photo #41)

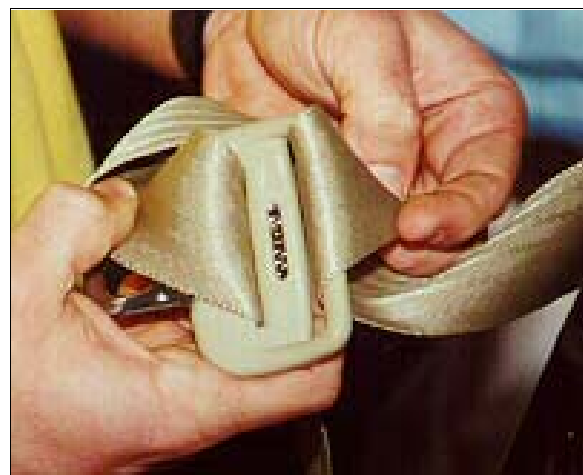
The case vehicle's driver was restrained by his available, active, three-point, lap-and-shoulder, safety belt system which was equipped with a pretensioner. The inspection of the driver's seat belt webbing, "D"-ring, and latch plate showed significant visible evidence of loading. Photographs taken by this contractor showed stretching to the belt webbing near the "D"-ring and the latch portion (**Figure 27**), and their were heat abrasions to the "D"-ring and belt latch (**Figure 28**).

Figure 28: Close-up of heavy friction mark on plastic latch of case vehicle's driver seat belt (case photo #44)

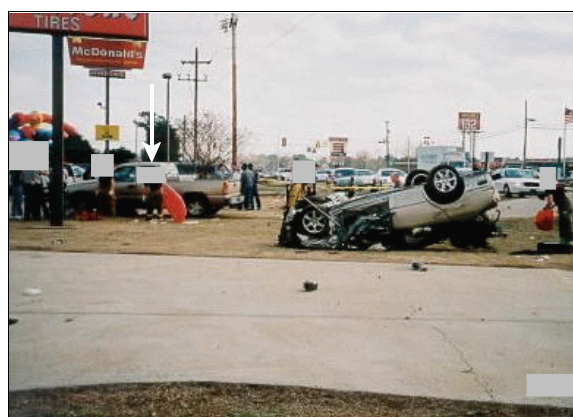
Figure 29: Southward on-scene view of case vehicle's final rest position on ground between the 3rd and 4th driveways, heading east; Note: shoes on 4th driveway are most likely from back right passenger who came to rest on driveway and pickup truck at left (arrow) which was contacted (i.e., front right passenger came to rest south of pickup and back left passenger came to rest north of pickup) by ejected occupants (case photo #96)

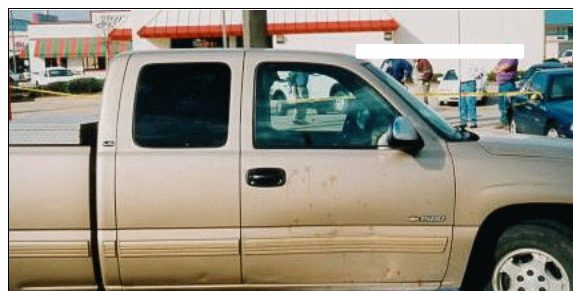
Figure 30: Northward on-scene view of parked pickup truck that was struck by case vehicle's ejected occupants; front right passenger came to rest near right front door (case photo #97)

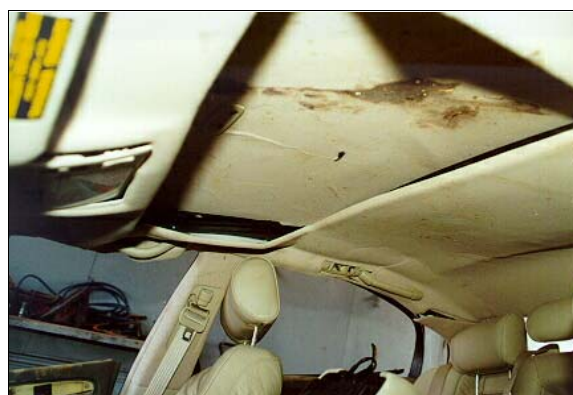
Figure 31: Case vehicle's roof viewed from driver's seating position showing numerous marks and blood stains; Note: adjustable head restraints and front upper anchorages (case photo #64)

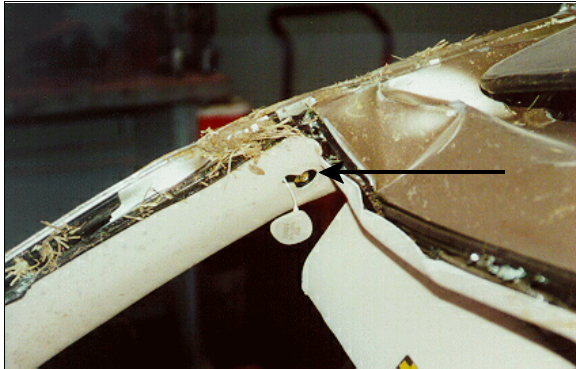
Figure 32: Close-up of open tether hole for case vehicle's, non-deployed, right side inflatable curtain, which was located in right "A"-pillar (case photo #53)

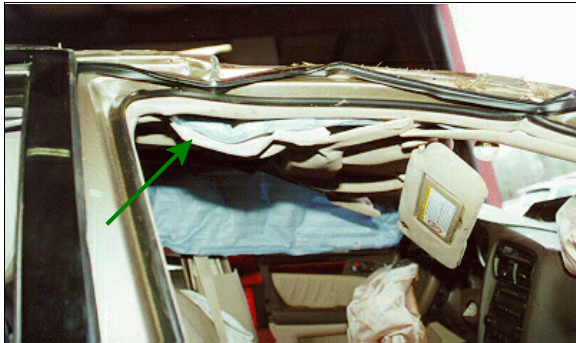
Figure 34: Case vehicle's exposed, non-deployed, right side inflatable curtain which was stored between right side rail and roof (case photo #54)

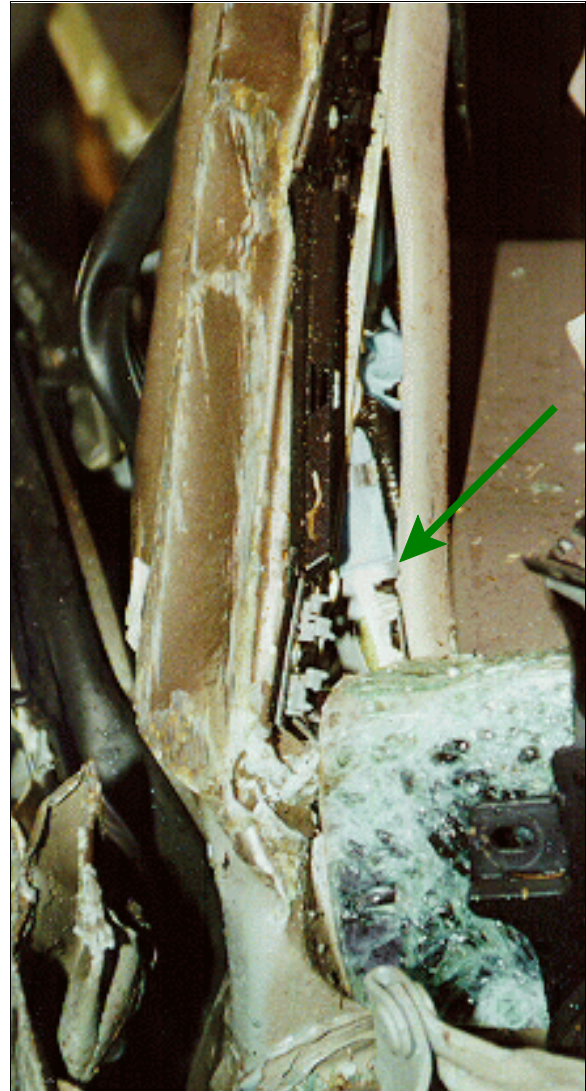
Figure 33: Close-up of exposed exhaust cannister stored in base of right "A"-pillar for case vehicle's non-deployed, right side inflatable curtain (case photo #52)
