TRANSPORTATION RESEARCH CENTER

REMOTE REDESIGNED AIR BAG REPORT

CASE NUMBER - IN01-005
LOCATION - ARIZONA
VEHICLE - 1999 CHEVROLET BLAZER
CRASH DATE - September, 2000

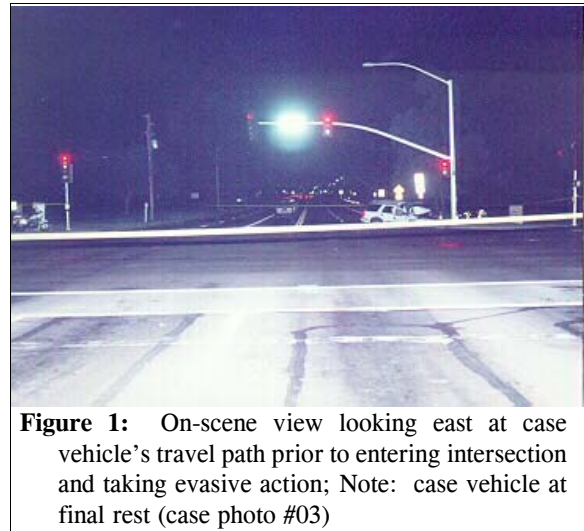
The case vehicle was traveling east, approaching a controlled intersection, in the inside eastbound lane of a five-lane, undivided, city street (**Figure 1**) and intended to continue traveling eastward (i.e., there were two through lanes in both the east and westbound directions and an opposing left-hand turn lane on both the east and west legs of the four-leg intersection). A noncontact vehicle (i.e., a Geo Metro, according to eyewitnesses), traveling westbound in the left-hand turn lane of the same five-lane, undivided, city street, began to turn left at the intersection, in front of the case vehicle. But, the noncontact saw the on-coming case vehicle and braked, coming to a stop "midway" through the intersection. The case vehicle's driver steered to the right, depositing a critical curve scuff, while attempting to avoid the noncontact vehicle (**Figure 2** and **Figure 3** below) The driver's avoidance maneuver enabled case vehicle to successfully evade the noncontact vehicle, but the case vehicle was now headed toward the southeast corner of the intersection. Based on the available evidence, the case vehicle's driver braked, depositing skid marks (**Figure 4** below), and most likely attempted to steer to the left to avoid traveling off the southeast corner of the intersection. The crash occurred within the intersection of the two

Figure 1: On-scene view looking east at case vehicle's travel path prior to entering intersection and taking evasive action; Note: case vehicle at final rest (case photo #03)

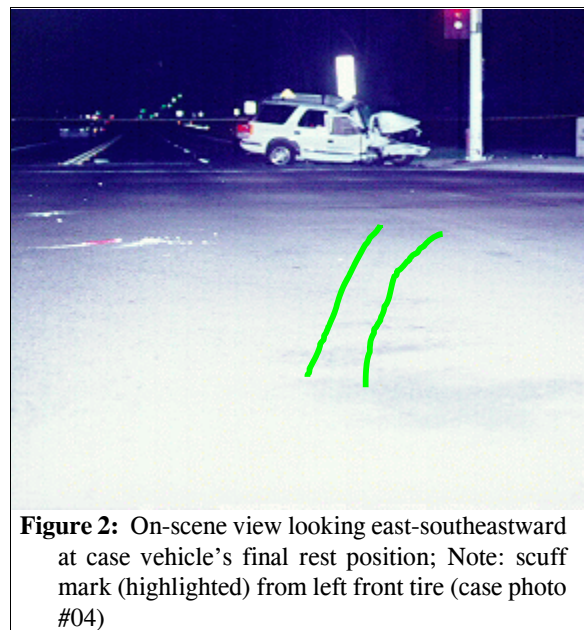
Figure 2: On-scene view looking east-southeastward at case vehicle's final rest position; Note: scuff mark (highlighted) from left front tire (case photo #04)

trafficways but on their south and east roadsides, respectively (**Figure 2** above and **Figure 4**).

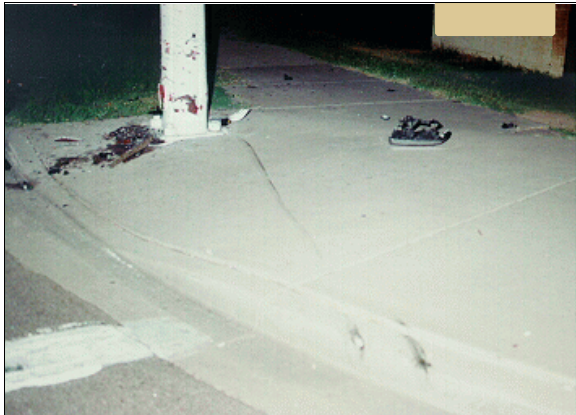
Figure 4: On-scene view of skid mark from case vehicle's right front tire leading into struck pole (case photo #09)

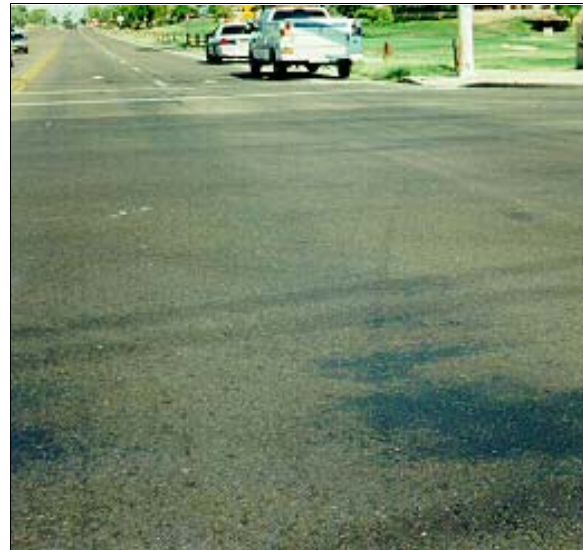
Figure 3: Police photo, taken next day, looking east-southeastward, clearly showing scuff mark from case vehicle's left front tire (case photo #06)

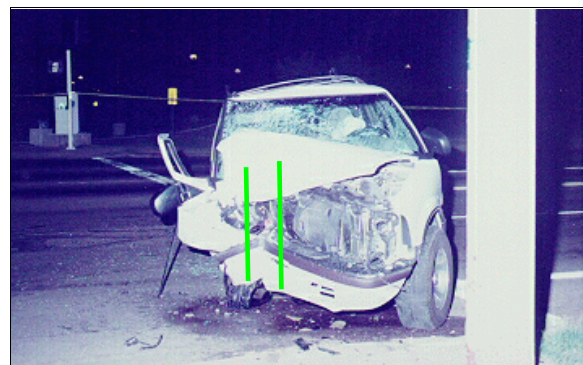
The front right (**Figure 5**) of the case vehicle impacted a metal traffic signal/light pole (**Figures 6** and **7** below), causing the case vehicle's driver and front right passenger supplemental restraints (air bags) to deploy. As a result of the front right impact, the case vehicle rotated approximately 45 degrees clockwise around the pole and rebounded northward, coming to rest straddling the inside eastbound travel lane and a bicycle lane and heading, primarily, in a southern direction (**Figure 8** below). The engine compartment of the case vehicle was off the south edge of the roadway.

Figure 5: On-scene view looking north-northeast at case vehicle's final rest position; Note: pole impact (highlighted) location (case photo #14)

Based on the police photographs, the case vehicle's initial contact with the metal traffic signal/light pole involved the front right portion (**Figure 5** above). Maximum crush measured by the investigating officer was 134.6 centimeters (53 inches) at the front right corner (**Figure 9** below). According to the police, the wheelbase on the case vehicle's right side was shortened 48

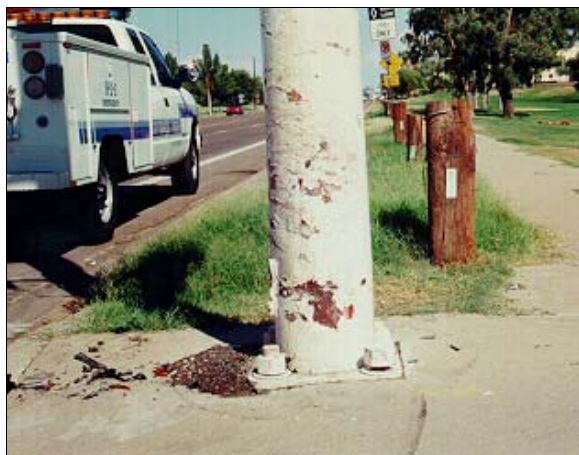
Figure 6: Close-up police photo, taken next day, looking east at metal pole struck by case vehicle (case photo #10)

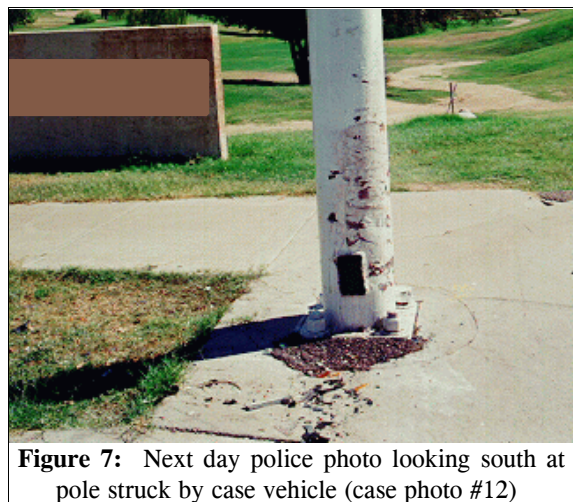
Figure 7: Next day police photo looking south at pole struck by case vehicle (case photo #12)

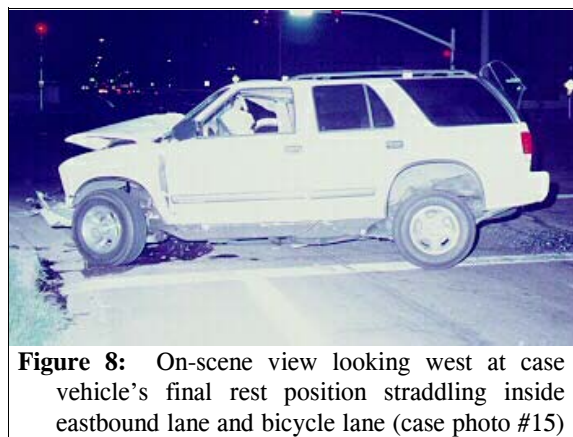
Figure 8: On-scene view looking west at case vehicle's final rest position straddling inside eastbound lane and bicycle lane (case photo #15)

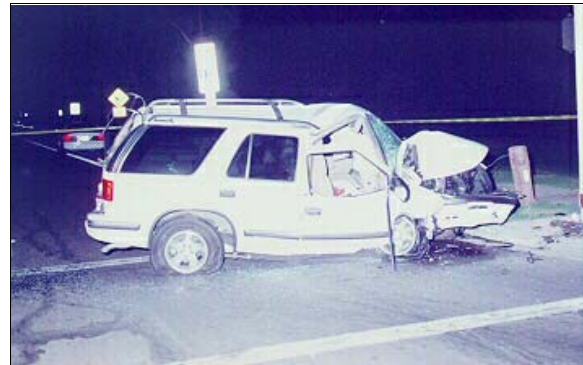
centimeters (19 inches) while the left side was extended 25 centimeters (10 inches). Based on the available photographs, the case vehicle's front bumper, bumper fascia, grille, hood, radiator, right and left headlight and turn signal assemblies, and right fender were directly damaged and crushed rearward (Figure 5 above). The case vehicle's front right tire was shoved rearward into the cowl area and front right passenger toe pan. The case vehicle's right front tire was physically restricted, and both right side tires were deflated. The right "A"-pillar was bent backwards with the roof buckled upwards (Figure 9). The front right door glazing and back light (Figure 10) were disintegrated from the shear force of the frontal impact. There appears to be a significant amount of intrusion to the passenger compartment primarily to the right side (Figure 11).

Figure 9: On-scene view looking east-southeast at case vehicle's final rest position; Note: extent of deformation (case photo #13)

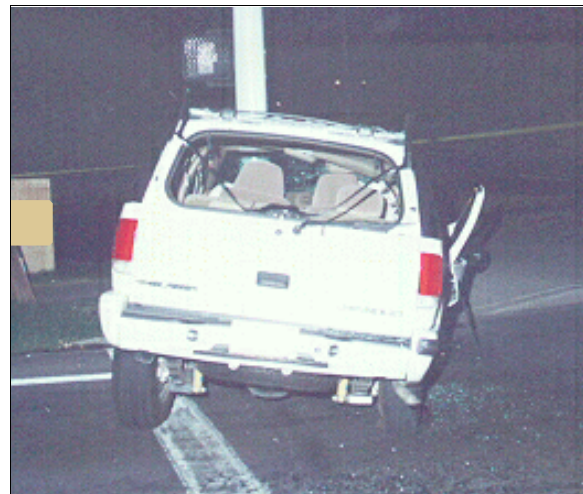
Figure 10: On-scene view looking south at case vehicle's final rest position (case photo #16)

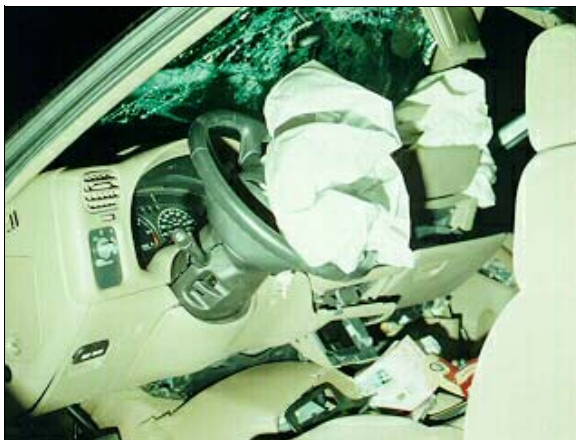
Figure 11: On-scene view of case vehicle's driver seating area showing deployed air bags and intrusion to right instrument panel (case photo #17)

The available photographs document damage to the windshield's glazing (Figure 11) and blood on the back left passenger's seat (Figure 12).

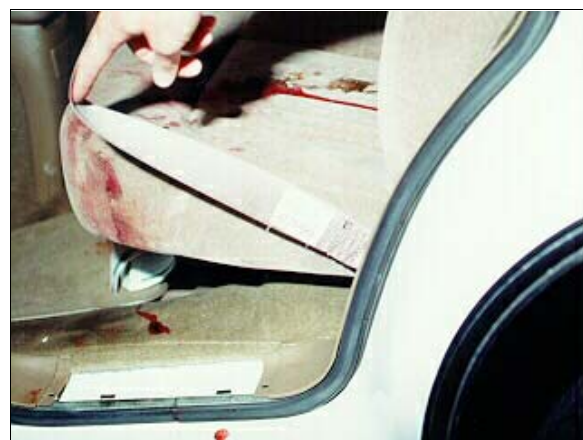
Figure 12: On-scene view of case vehicle's back left safety belt showing no blood or loading evidence on belt; Note: copious amount of blood on back left seat's cushion (case photo #18)

The case vehicle's back left passenger was not using his available, active, three-point, lap-and-shoulder, safety belt system (**Figure 12** above). In addition, there was no mention in the obtained, one page of partial medical, of any belt pattern bruising and/or abrasions to the back left passenger's body.

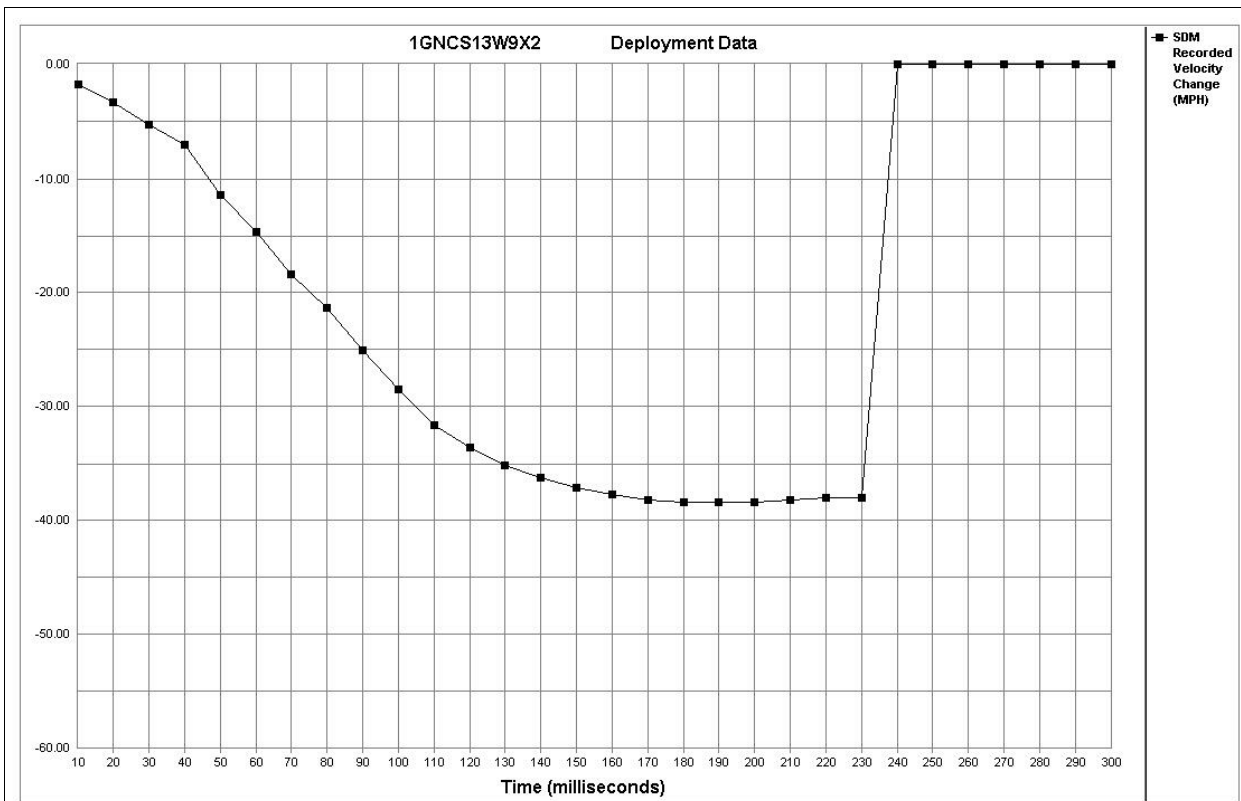
The data downloaded from the case vehicle's **EDR** showed the vehicle's SIR warning lamp status, driver's seat belt buckle status, ignition cycles at deployment, time from algorithm enable to deployment (i.e., air bag deployments) and velocity change (i.e., Delta V). Downloaded data of interest indicated the following. The case vehicle's driver seat belt status showed it was not buckled, and the Delta V was 61.80 km.p.h. (38.40 m.p.h.); see **EVENT DATA RECORDER GRAPHS (Figures 13 and 14)** below. This investigator feels the recorded Delta V seems reasonable considering the amount of deformation to the case vehicle's front.

Figure 14: The case vehicle sustained a velocity change of approximately 61 km.p.h. (38 m.p.h.) during the first 180 milliseconds after deployment
