### **ON-SITE CHILD AIR BAG-RELATED FATALITY INVESTIGATION**

CASE NUMBER - IN01-008  
LOCATION - TEXAS  
VEHICLE - 1995 PLYMOUTH NEON  
CRASH DATE - April, 2001

1. <i>Report No.</i> IN01-008		2. <i>Government Accession No.</i>		3. <i>Recipient's Catalog No.</i>	
4. <i>Title and Subtitle</i> On-Site Child Air Bag-Related Fatality Investigation Vehicle - 1995 Plymouth Neon Location - Texas			5. <i>Report Date:</i> September 13, 2002

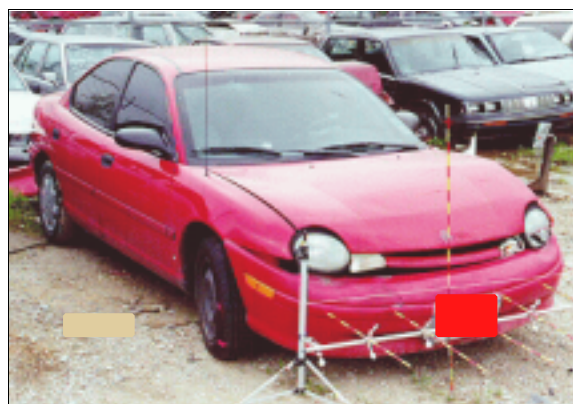
**Figure 3:** Case vehicle's damaged front with contour gauge present (case photo #24)

The front of the case vehicle (**Figures 3 and 4** above) impacted the left side of the Chevrolet (**Figure 5**), causing the case vehicle's driver and front right passenger supplemental restraints (air bags) to deploy. The case vehicle continued northward a short distance while rotating approximately 20 degrees counterclockwise and came to rest in the intersection heading east-northeast (**Figure 6**). The Chevrolet rotated approximately 100 degrees counterclockwise before coming to rest in the intersection heading southwest (**Figure 7**).

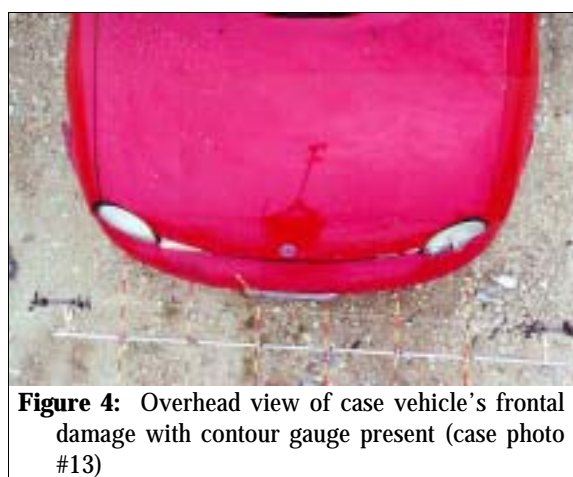
**Figure 4:** Overhead view of case vehicle's frontal damage with contour gauge present (case photo #13)

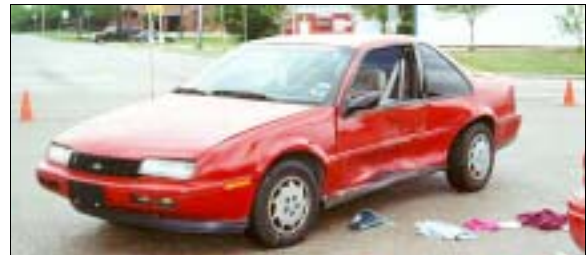
**Figure 5:** On-scene view of Chevrolet's left side damage; Note: Chevrolet is heading southwest (case photo #70)

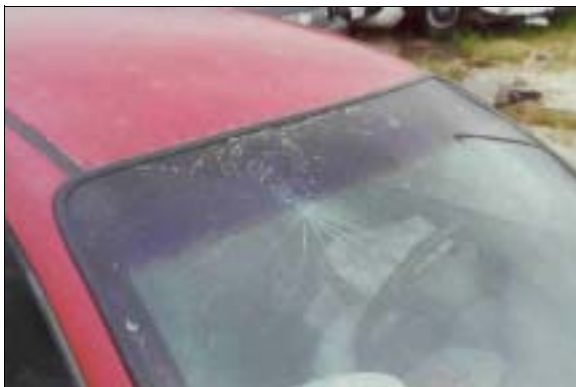
**Figure 9:** Exterior view of impacts to case vehicle's right front windshield glazing (case photo #25)

Inspection of the case vehicle's interior revealed two spider web contacts to the windshield's glazing (**Figure 9**), one from the front right passenger's head located underneath the front right sun visor (**Figure 10** and **Figure 11** below) and the other from the left corner of the rearview mirror, which was rotated into the glazing, possibly by the front right passenger. Furthermore, hair was present in the windshield's header on the right side and on the right sun visor

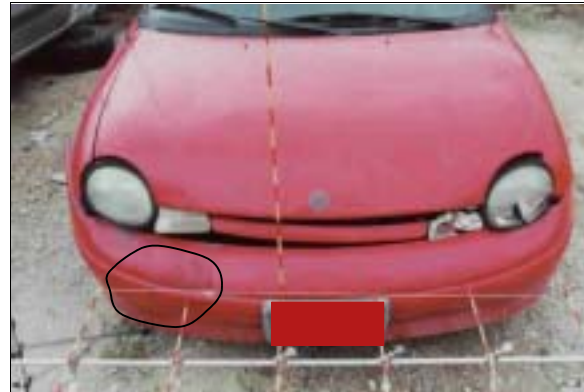
The case vehicle's contact with the Chevrolet involved the entire front. Direct damage began at the right bumper corner and extended to the left bumper corner, a measured distance of 130 centimeters (51.2 inches). In fact, the Chevrolet's left rear wheel made an imprint on the front right of the case vehicle's front bumper, depositing a tire scuff on the bumper and a slight tear in the bumper fascia from the Chevrolet's left rear wheel well (**Figure 8**). Maximum crush was measured as 7 centimeters (2.8 inches) at  $C_1$  (**Figure 4** above). The case vehicle's wheelbase was unaltered from the crash. The case vehicle's front bumper fascia, grille, and front left headlight and turn signal assemblies were directly damaged and crushed rearward. The case vehicle's left front tire was physically restricted by the left fender; none of the tires were deflated. In addition, the hood and both fenders sustained induced damage. No obvious induced damage or remote buckling was noted to the remainder of the case vehicle's exterior.

**Figure 8:** Elevated view of case vehicle's frontal damage with contour gauge present on bumper; Note: black scuffs toward front right corner are from Chevrolet's left rear tire (case photo #12)

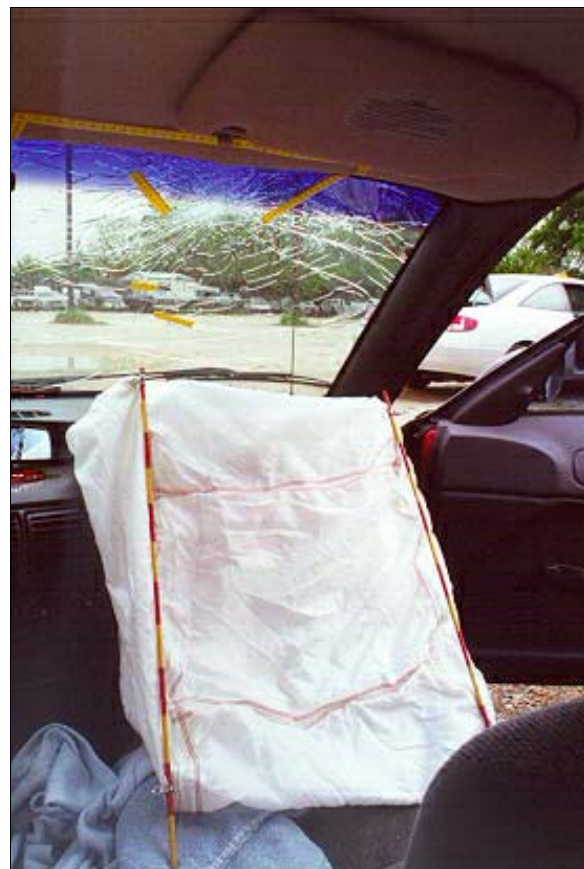
**Figure 10:** Vertical view of case vehicle's deployed front right passenger air bag; Note: pink cloth transfer to air bag's front surface and contacts to windshield's glazing and header, and sun visor (case photo #37)

vent port, some black scuffs on the top surface to the left of the vent port, and finally, an obliquely oriented area containing both skin and pink cloth transfers on the air bag's front surface, left of the midline, and located between the middle and top of the front surface (**Figure 10** above).

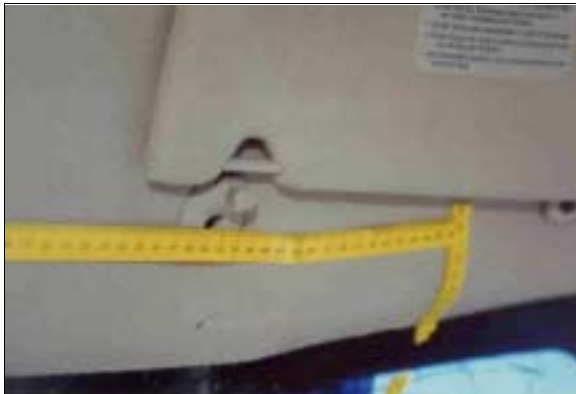
(**Figure 12**). The windshield's header was indented from the impact of the front right passenger's head. In addition there were two knees scuffs to the glove box (**Figure 13**) from contact by the unrestrained front right passenger. There was no evidence of intrusion to the case vehicle's interior, no evidence of compression to the energy absorbing shear capsules in the steering column, and no deformation to the steering wheel rim.

**Figure 12:** Case vehicle's contacted front right windshield header toward left side of front right sun visor showing hair and indentation in header (case photo #38)

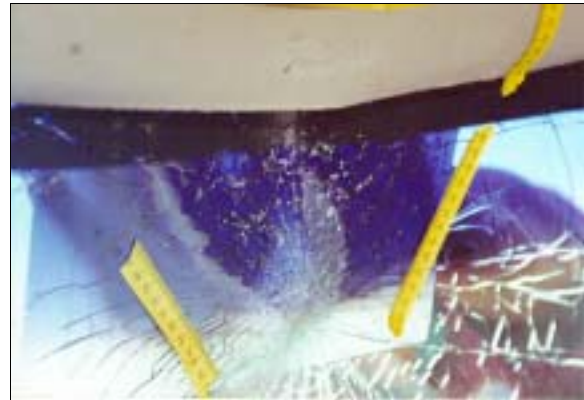
**Figure 11:** Close-up of front right passenger's head contact to case vehicle's right windshield, header, and sun visor (case photo #39)

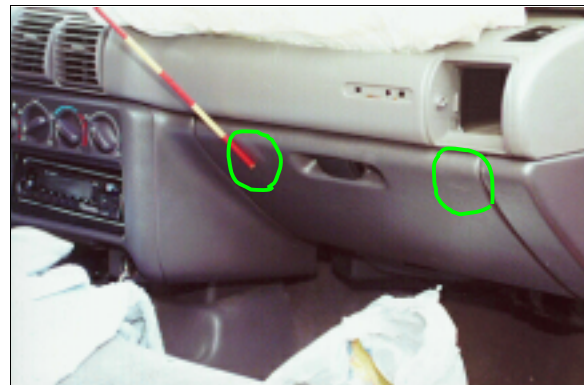
**Figure 13:** Contacts to case vehicle's glove box by front right passenger's thighs (case photo #35)

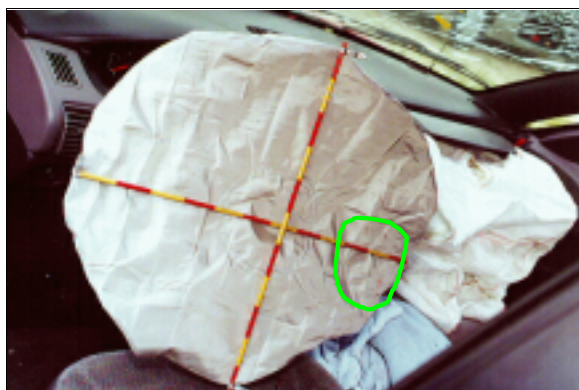
during the deployment to the air bag or the cover flap. The driver's air bag was designed with three tethers, each approximately 6 centimeters in width. The driver's air bag had one vent port, approximately 3 centimeters (1.2 inches) in diameter, located at the 12 o'clock position. The deployed driver's air bag was round with diameter 62 centimeters (24.4 inches). An inspection of the driver's air bag fabric revealed that there was contact evidence (i.e., mascara, skin, and blood) readily apparent to the front right half of the air bag's fabric toward the 3 o'clock position (Figures 14 and 15).

**Figure 14:** Case vehicle's driver air bag showing area of contact evidence (skin, mascara, and blood) highlighted (case photo #29)

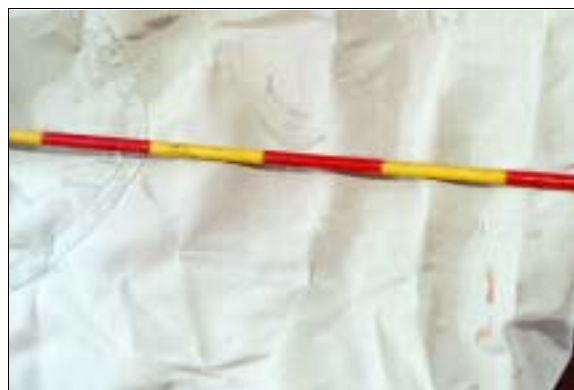
**Figure 15:** Close-up of contact evidence (i.e., skin, mascara, and blood) on case vehicle's driver air bag (case photo #30a)

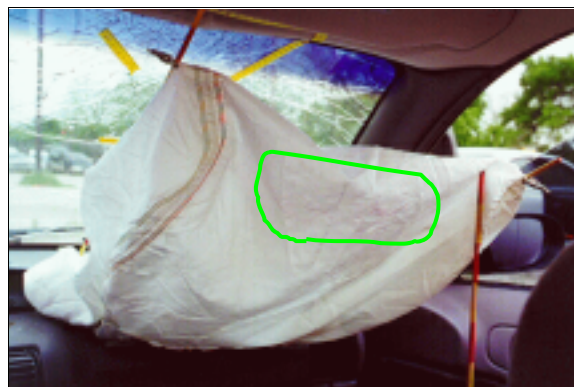
**Figure 16:** Case vehicle's deployed front right passenger air bag showing more pink cloth transfers on bottom surface (case photo #37a)

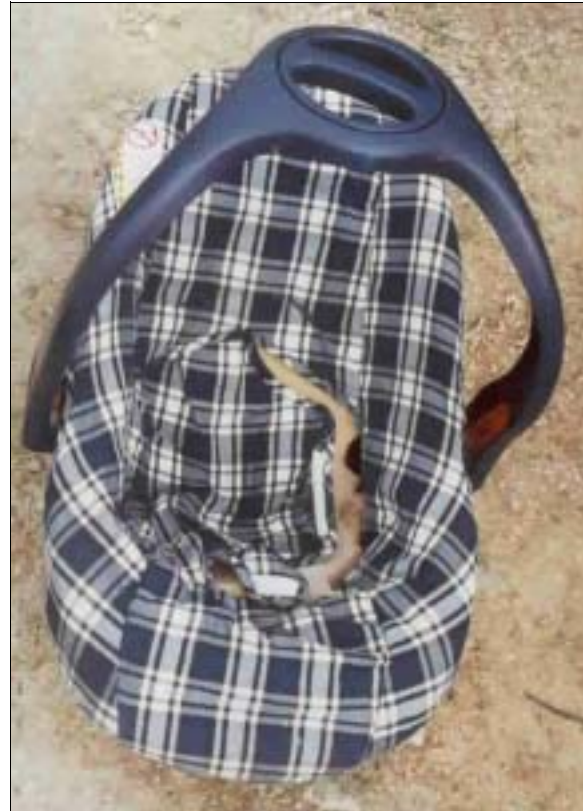
**Figure 17:** Overhead view of Cosco Arriva infant carrier seat that contained case vehicle's back left passenger; Note: absence of five-point harness (case photo #46)

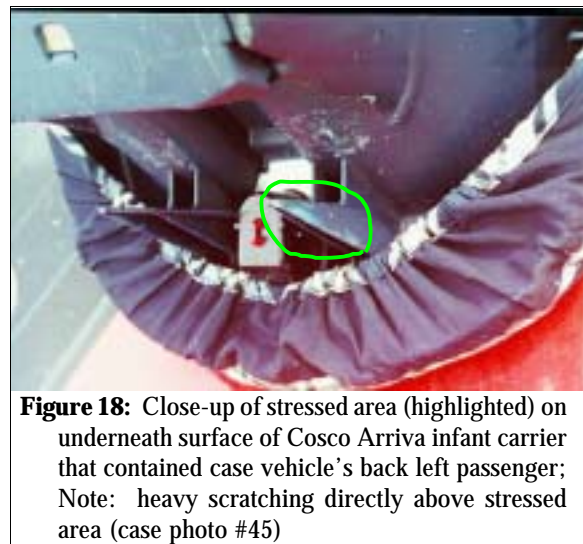
**Figure 18:** Close-up of stressed area (highlighted) on underneath surface of Cosco Arriva infant carrier that contained case vehicle's back left passenger; Note: heavy scratching directly above stressed area (case photo #45)

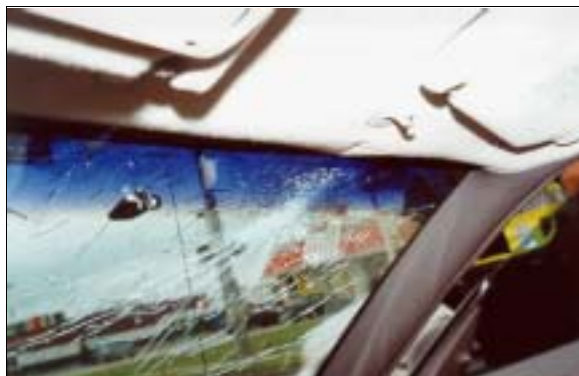
**Figure 20:** On-scene view from driver’s seat showing dislodged rear view mirror and contacts to right windshield’s glazing and header (case photo #69)

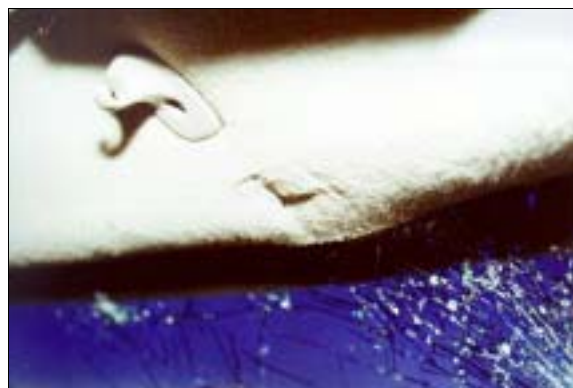
**Figure 21:** On-scene close-up of evidence (i.e., hair and indentation) on case vehicle’s right windshield header from contact by front right passenger (case photo #68)

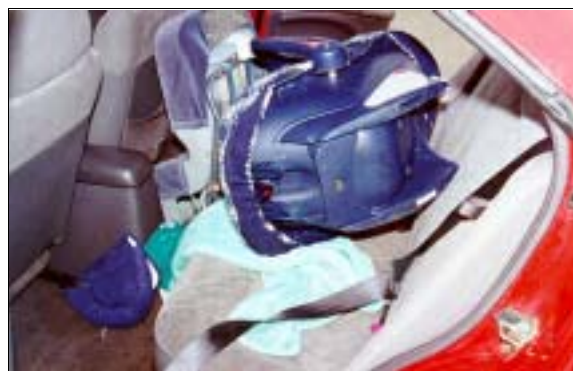
**Figure 22** On-scene view from left of case vehicle's back seat showing unsecured child safety seats (case photo #66)

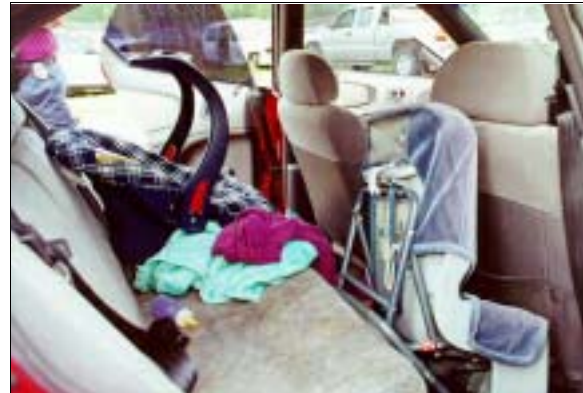
convertible child safety seat, along with the unrestrained child, were found pinned between the back of the front right seat back and the back seat's right seat cushion (**Figure 23**).

**Figure 23:** Case vehicle's back seat viewed from right showing unsecured child safety seats; Note: Fischer-Price seat contacted front right seat back (case photo #49)

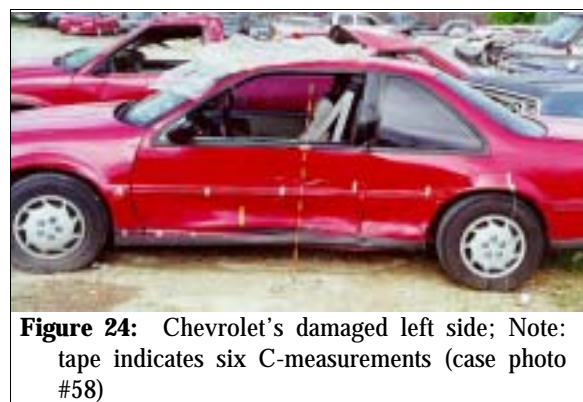
**Figure 24:** Chevrolet's damaged left side; Note: tape indicates six C-measurements (case photo #58)

Based on the vehicle inspection the CDC for the Chevrolet was determined to be: **10-LZEW-2 (290)** [maximum crush was measured as 22 centimeters (8.7 inches) between C<sub>3</sub> and C<sub>4</sub>-**Figure 24** above and **Figures 25** and **26**]. The WinSMASH reconstruction program, damage only algorithm, was used on the Chevrolet's highest severity impact. The Total, Longitudinal, and Lateral Delta Vs are, respectively: 18.0 km.p.h. (11.2 m.p.h.), -9.0 km.p.h. (-5.6 m.p.h.), and + 15.6 km.p.h. (+ 9.7 m.p.h.). These results appear reasonable to this contractor. The Chevrolet was towed due to damage.

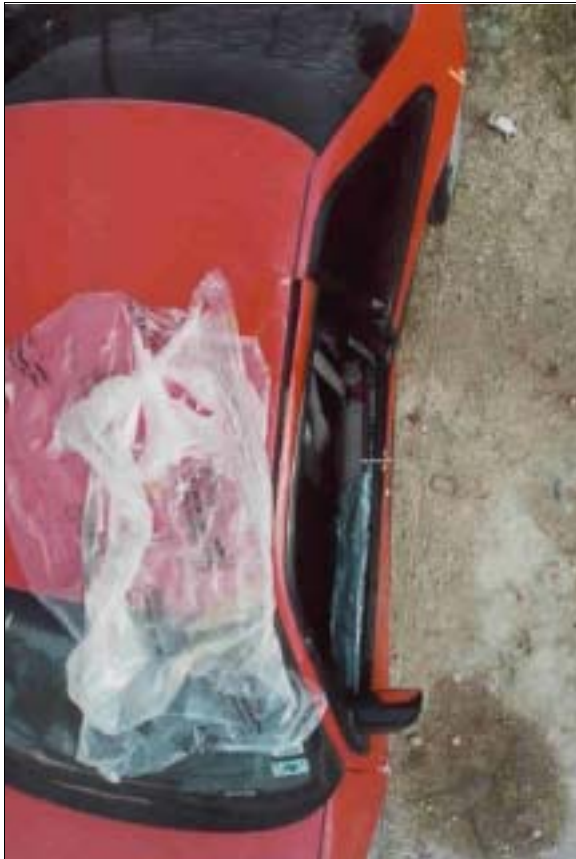
**Figure 25:** Overhead view of Chevrolet's left side damage and stringline placement case photo #61)

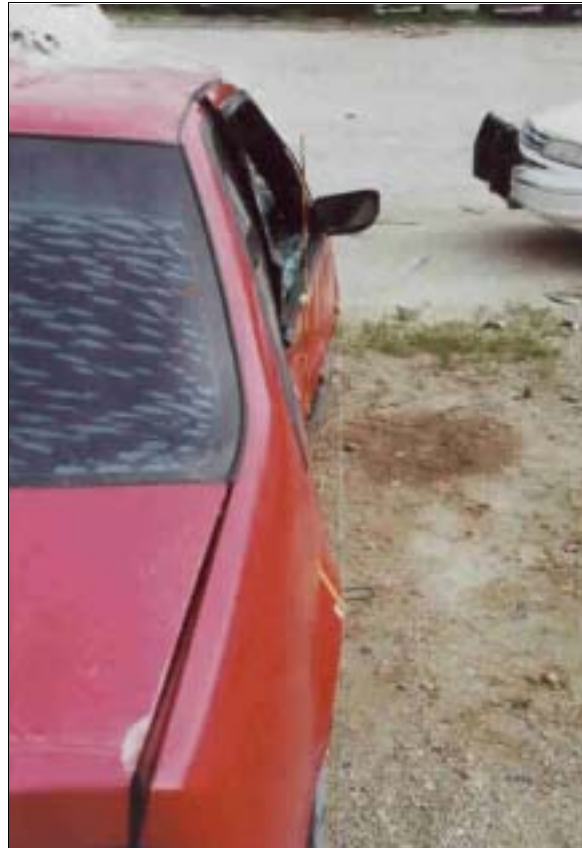
**Figure 26:** Chevrolet's left side damage viewed from front along stringline (case photo #62)
