**ON-SITE ADVANCED OCCUPANT PROTECTION SYSTEM INVESTIGATION**

**VERIDIAN CASE NO. CA01-011**

**VEHICLE: 2001 CHRYSLER TOWN & COUNTRY MINIVAN**

**CRASH DATE: DECEMBER 2000**

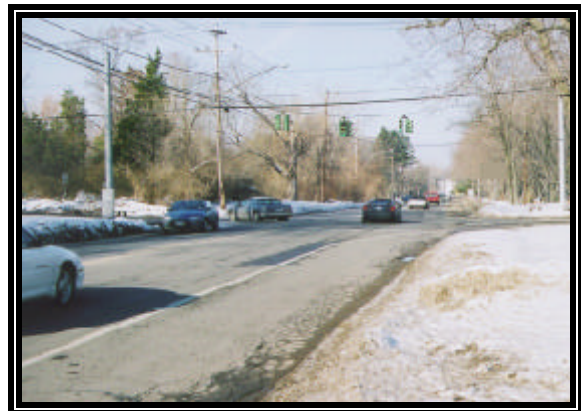
**Figure 1:** Northbound view of the crash scene.

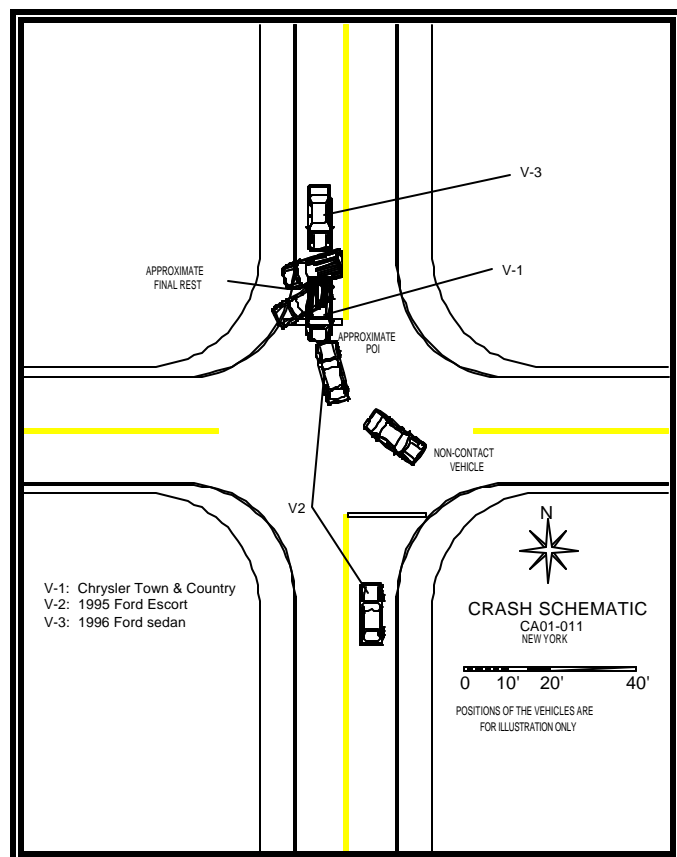
The crash occurred when the center and right aspects of the Ford Escort impacted the front of the Chrysler. The force of the crash caused the left buckle pretensioner to fire and the frontal air bags in the Chrysler to deploy. The barrier equivalent delta V experienced by the Chrysler was approximately 19.6 km/h (12.2 mph). The northbound momentum of the Ford displaced the Chrysler rearward and caused it rotate clockwise. The vehicles then contacted again in a minor secondary side slap with the right front side of the Ford contacting the left side of the Chrysler. The rearward displacement of the Chrysler from the initial impact caused a minor secondary contact with the 1996 Ford sedan. The 1985 Ford and the Chrysler Town & Country came to rest adjacent to each other facing westward. A schematic of the crash is depicted in **Figure 2**.

**Figure 2:** Crash schematic.

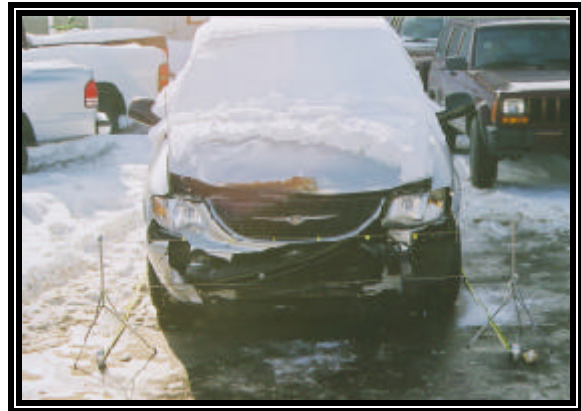
**Figures 3 and 4** are the front and left right lateral views of the frontal damaged Chrysler, respectively. The Chrysler sustained 158 cm (62 in) of direct contact damage that extended across the entire frontal end width of the vehicle. The residual crush measured along the bumper reinforcement bar was as follows: C1=2.0 cm (0.8 in), C2=15.0 cm (5.9 in), C3=18.0 cm (7.1 in), C4=11.0 cm (4.3 in), C5=1.0 cm (0.4 in), C6=0. The maximum crush was located 33.5 cm (13.2 in) left of center (between C2 and C3) and measured 24.1 cm (9.5 in). The principle direction of force was within the 12 o'clock sector and was an estimated 350 degrees (-10 degrees). The impact energy was managed by the forward structures of the vehicle. The damaged components included the bumper fascia and reinforcement bar, upper and lower radiator supports and the hood. There was no measured change in the wheelbase dimensions. There were no glazing fractures and all the doors remained operational. The Collision deformation Classification (CDC) was 12-FDEW-1. The total velocity change calculated by the Missing Vehicle algorithm of the WINSMASH collision model was 24.3 km/h (15.1 mph). The longitudinal and lateral delta V components were -24.0 km/h (14.9 mph) and 4.2 km/h (2.6 mph), respectively.

**Figure 3:** Front view of the Chrysler.

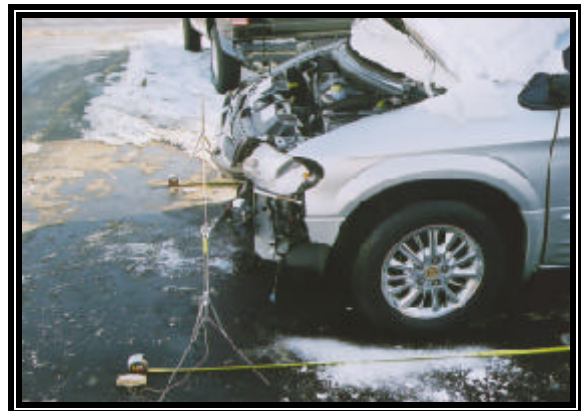
**Figure 4:** Left lateral view.

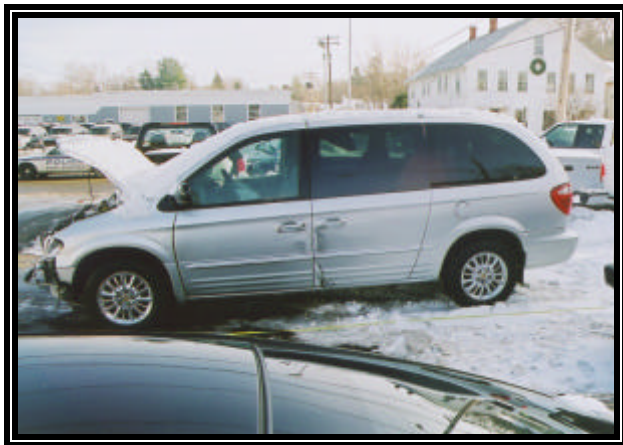
The left side of the vehicle sustained minor damage as a result of a secondary side slap, **Figure 5**. This damage pattern was centered on the trailing aspect of the driver's door 152 cm (60 in) forward of the rear axle and measured 23 cm (9 in) in length. The lateral deformation in the area was an estimated 3.8 cm (1.5 in). The CDC of this contact was 09-LPEN-1.

**Figure 5:** Left side view of the Chrysler.

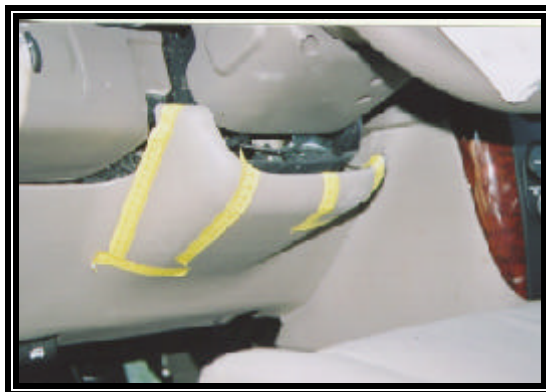
The driver's knee bolster exhibited two scuff marks from contact with the driver's lower extremities. The left lower extremity scuff measured 5 cm x 18 cm (2 in x 7 in) and was centered 10 cm (4 in) left of the steering column. A 2 cm x 3.8 cm (1 in x 1.5 in) scuff from right knee contact was located 5.3 cm (2.1 in) right of the steering column. These occupant contacts are depicted in **Figure 6**.

**Figure 6:** View of the driver's knee bolster.

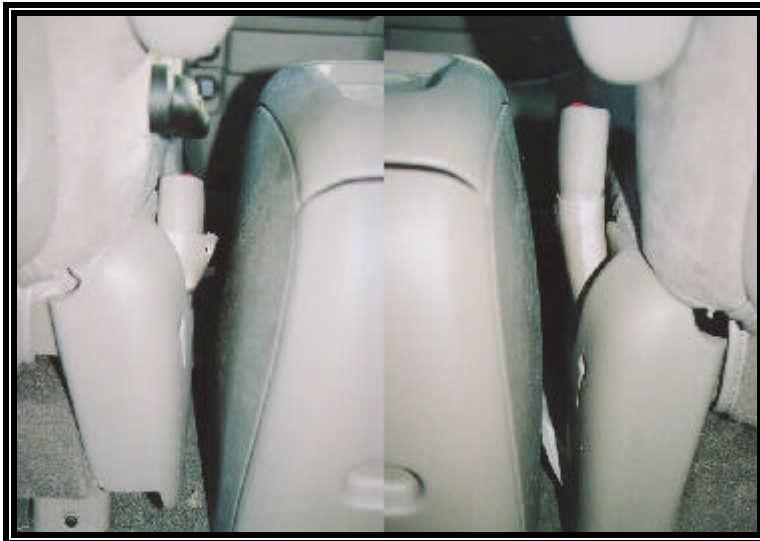
The driver's manual restraint system consisted of a continuous loop 3-point lap and shoulder belt with a sliding latch plate. The dual mode locking retractor was located in the base of the B-pillar. The seat belt buckle was mounted on a pretensioner attached to the inboard aspect of the seat. The left pretensioner had fired as a result of the impact. Comparable measurements taken from the unfired right pretensioner indicated the left pretensioner stroked approximately 6.9 cm (2.8 in). **Figure 7** is a composite photograph of the front seat pretensioners taken from the second row looking forward. The left upper adjustable D-ring was 2.5 cm (1.0 in) above the lowest adjustment. The total adjustment range was 10 cm (4 in). There was little evidence of historical usage observed on the surface of the latch plate, however, this was consistent with the age of the vehicle. There was no crash-related evidence observed on the webbing.

**Figure 7:** Composite photograph of the fired driver and unfired front right pretensioners.

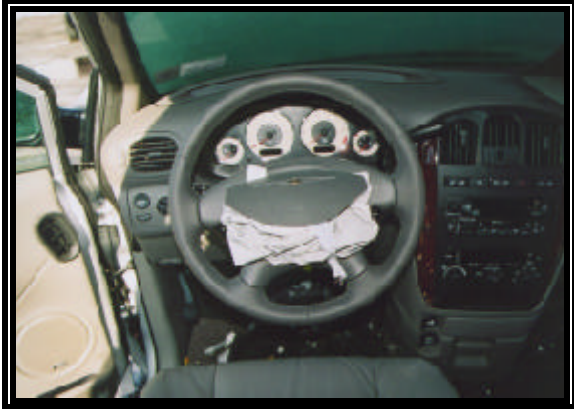
The Supplemental Restraint System in the 2001 Chrysler Town & Country consisted of driver and front right passenger air bags that deployed as a result of the crash. The driver air bag module was designed in the typical manner and located in the center hub of the steering wheel rim, **Figure 8**. The driver air bag module had a single semi-circular flap that hinged on top. The vinyl cover flap measured 20 cm (8 in) in diameter. There was no contact evidence on the cover flap. The diameter of the deployed driver air bag, **Figure 9**, measured 66 cm (26 in) in its deflated state. It was tethered by four internal straps sewn to the face of the bag and vented internally. There was no contact evidence on the face of the bag. The following nomenclature was affixed to the cover flap:

**Figure 8:** Driver air bag module.

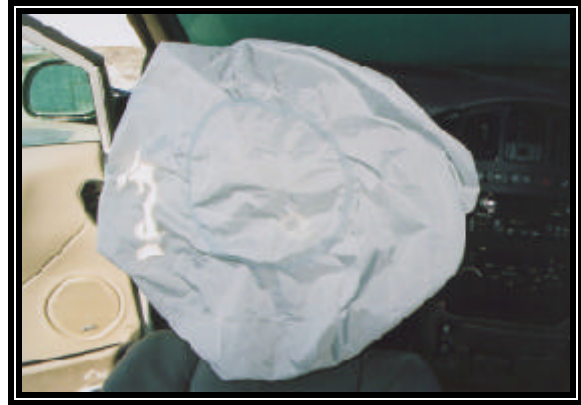
**Figure 9:** Deployed driver air bag.
