SIDE IMPACT OCCUPANT PROTECTION INVESTIGATION

VERIDIAN CASE NO. CA01-012

VEHICLE - 2000 INFINITY I30

CRASH DATE - JANUARY, 2001

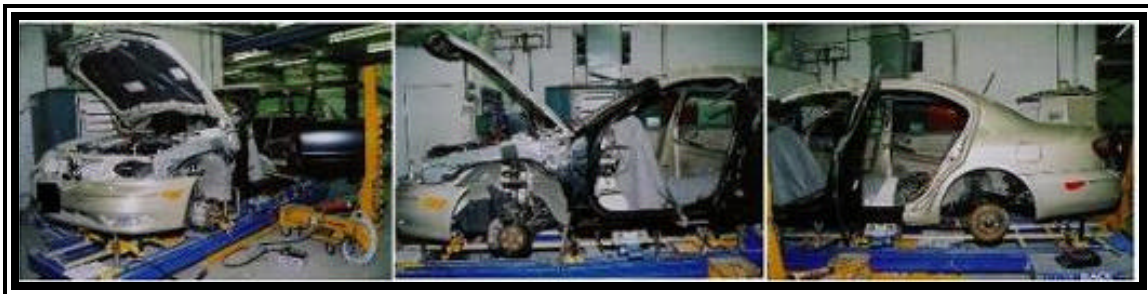
The 2000 Infinity I30 sustained minor left side surface damage as a result of the impact with the Ford Focus (**Figures 3 & 4**). Although the vehicle was under repair at the time of the SCI inspection, all damaged parts were immediately available for meticulous documentation. The direct contact damage began 43.0 cm (16.9 in) aft of the left front axle and extended 138.0 cm (54.3 in) rearward. The combined direct and induced damage length (Field L) began 38.0 cm (15.0 in) aft of the left front axle and extended 171.0 cm (67.3 in) rearward. Six crush measurements were approximated at the level of the mid-door: C1= 0 cm, C2= 3.0 cm (1.2 in), C3= 5.0 cm (2.0 in), C4= 10.0 cm (3.9 in), C5= 7.0 cm (2.8 in), C6= 0 cm. The Collision Deformation Classification (CDC) for this impact to the Infinity was 09-LYEW-1 with a principal direction of force of (-) 80 degrees. The left side tempered glazings were undamaged. Induced contact damage produced minor buckling along the leading edge of the A-pillar. The windshield was fractured at the lower left A-pillar from the impact force. Abrading was noted to the right front rim and attributed to pavement scrubbing during post-impact vehicle rotation.

Figure 3. Left side surface damage to the 2000 Infinity I30 4-door sedan.

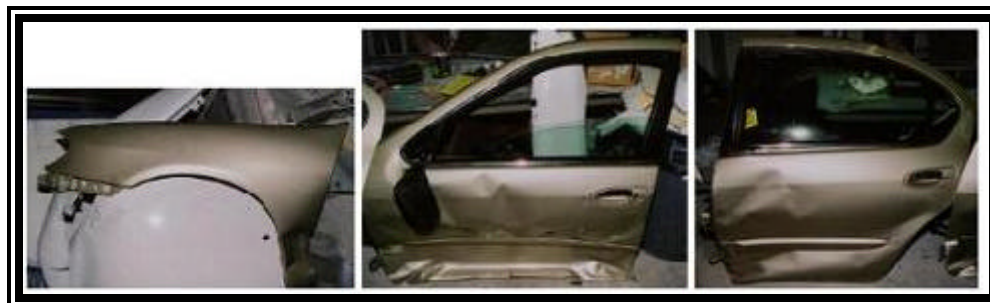
Figure 4. Infinity damaged components.

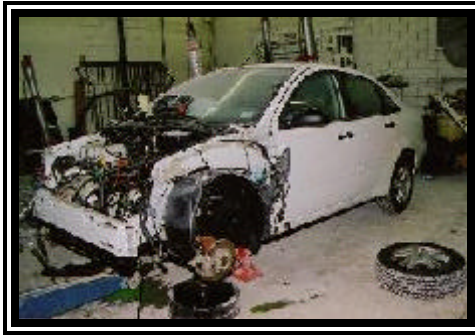
The 2000 Ford Focus SE 4-door sedan sustained minor frontal damage as a result of the impact with the Infinity I30 (**Figures 5 & 6**). Although the vehicle was under repair at the time of the SCI inspection, all damaged parts were immediately available for meticulous documentation. The direct contact damage began at the front right bumper corner and extended 72.0 cm (28.3 in) inboard. Maximum crush was approximated to be 15.0 cm (5.9 in) at the front right bumper corner area. The Collision Deformation Classification (CDC) for this impact to the Ford was 01-FZEW-1 with a principal direction of force of (+) 20 degrees. Bumper (only) shift to the left measured 11.5 cm (4.5 in). The windshield was fractured at the lower left A-pillar from exterior impact forces and the (interior) right mid-windshield area from the passenger air bag flap. All tempered glazings were undamaged.

Figure 5. Frontal damage to the 2000 Ford Focus SE 4-door sedan.

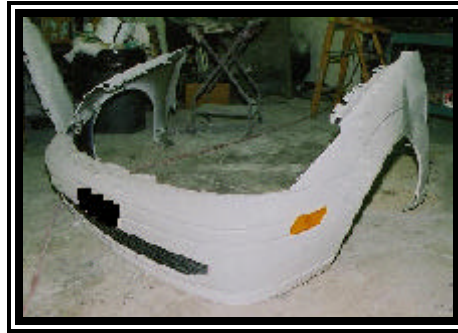
Figure 6. Ford Focus damaged bumper cover and fenders.

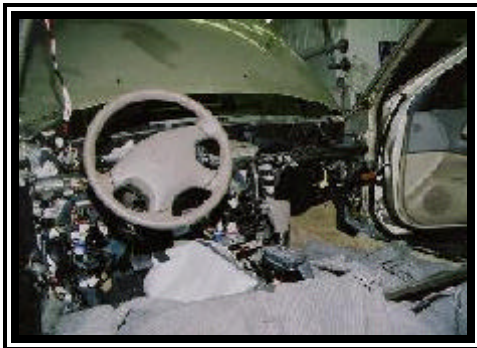
Interior damage to the Infinity identified through the vehicle inspection was minimal and attributed to occupant contact (**Figures 7 & 8**). Scuff marks were documented on the right aspect of the center armrest and left front door armrest. Scuff marks were also noted to the upper left front door panel area from the side impact air bag deployment. No intrusions were found in the vehicle.

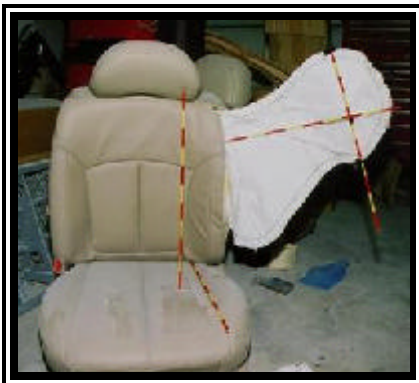
The Infinity was also equipped with side impact air bags for the front seated positions. The air bag modules were housed in the outboard side aspect of the front seat backs with a vertically oriented tear seam integrated into the seat back stitching (**Figures 9 & 10**). The left front side impact air bag deployed as a result of the crash and was identified by the following bar coded lot number: *PL3Y0005190484*. The air bag membrane inflated vertically to offer head and thoracic protection. The “elbow” shaped air bag measured 47.0 cm (18.5 in) in width and 40.8 cm (16.1 in) in height in its deflated state (**Figure 11**). The bag was tethered by two vertical stitch patterns along the membrane. No vent ports were present. No contact evidence was identified on the side impact air bag, however, bag interaction by the driver produced the noted scuff marks to the left front door panel.

Figure 9. 2000 Infinity I30 deployed left front side impact air bag.
