On-scene Investigation / Vehicle to Vehicle  
Dynamic Science, Inc. / Case Number: DS01-013  
1997 Nissan Quest  
North Carolina  
May, 2001

1. Report No. DS01-013		2. Government Accession No.		3. Recipient Catalog No.	
4. Title and Subtitle In-Depth Accident Investigation				5. Report Date	
				6. Performing Organization Report No.

**Dynamic Science, Inc.**  
**Accident Investigation**  
**Case Number: DS01-013**

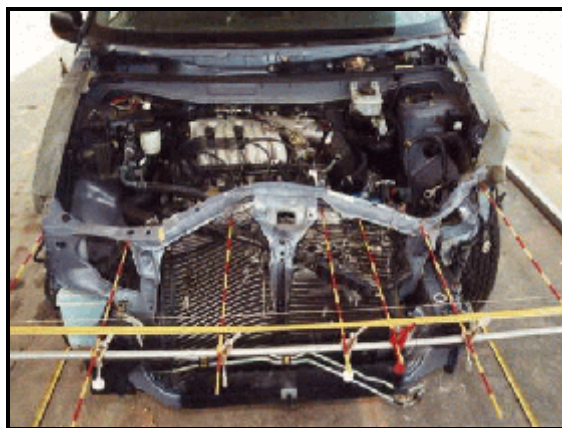
**Figure 2.** Frontal overhead view showing frontal deformation to case vehicle

At the time that the case vehicle was inspected, the front bumper, fascia, hood and front fenders were removed. The upper radiator support had been manipulated from its post-crash position so a crush profile was derived by measuring to areas of the upper radiator support that had not been altered and direct measurements to the radiator. This crush profile was averaged with the front bumper damage which was described as none. Although the SAE Vehicle Measurement protocol was closely followed, the crush profile and WinSmash results should be utilized as a marginal guideline for determining energy calculations.

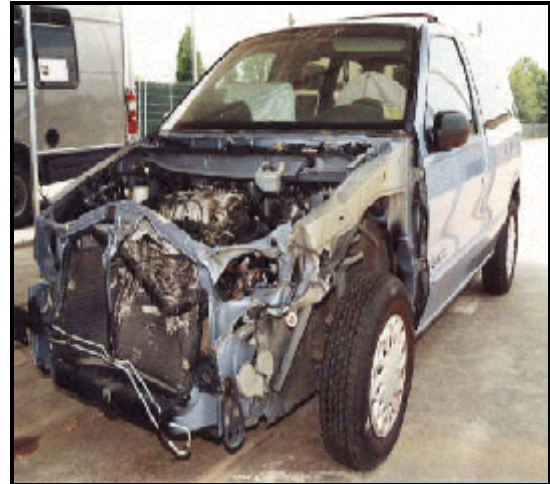
**Figure 1.** Front, left three-quarter view of case vehicle

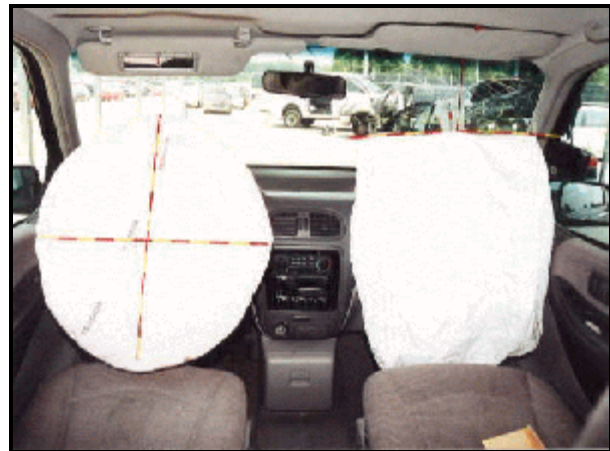
The case vehicle sustained a longitudinal delta v of -14.3 km/h (-8.9 mph)<sup>1</sup>. This frontal collision appeared to be at the low end of the threshold necessary for air bag deployment. Both the driver's steering wheel mounted air bag and the front right passenger's top mounted air bag deployed as a result of the frontal impact. The involved vehicles came to rest in lane two of the four-lane roadway and were facing west. The case vehicle was towed from the crash location and was subsequently determined to be a total loss by the insurance company. The damage to the other vehicle was described as light and the vehicle was subsequently driven from the crash location.

**Figure 4.** Full frontal view of case vehicle interior showing deployed air bags

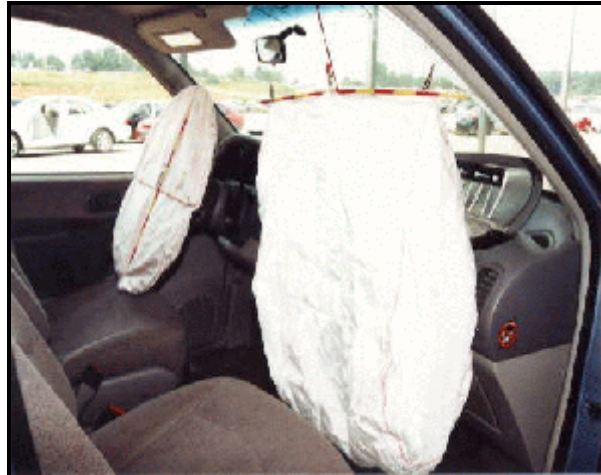
The unrestrained 9-year-old male who occupied the front right seated position initially responded to the braking forces by pitching forward. He likely raised his arms in a protective gesture. At impact he responded to the 12 o'clock impact force by moving directly forward. His right arm was above the air bag module cover and likely contacted the windshield. There was no contact to the module cover itself. There was damage noted to the glove box door which was the result of knee loading from this occupant. While his arm was in contact with the windshield, the air bag deployed upward and rearward. The air bag struck his right arm, near the elbow. With his arm pinned by the windshield, the force was directed upward through the joint. This occupant sustained the following injuries to the right arm: burns/abrasions, and a distal humerus lateral condyle fracture. He sustained a complete avulsion of the brachial plexus, complete avulsion of the sub-clavian artery, complete avulsion of the lower brachial nerve roots from the spinal cord, and a complete avulsion of the upper brachial nerve roots. He also sustained contusions to the right side of the face.

**Figure 6.** Front, right view showing deployed frontal air bags.

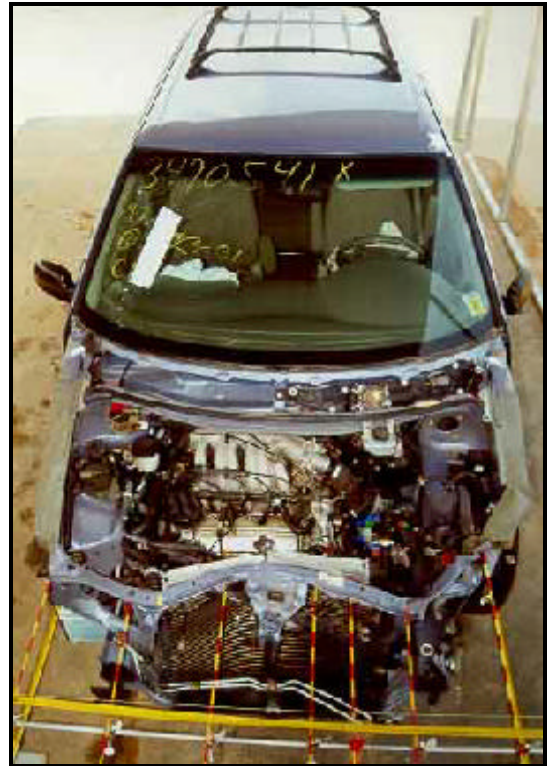
Description:	1997 Nissan Quest minivan	
VIN:	4N2DN1111VDxxxxxx	
Odometer:	67,379 km (41,869 miles)	
Engine:	3.0 L V6	
Reported Defects:	None	
Cargo:	None	
Damage Description:	Moderate frontal damage. Bumper override. There was 3 cm (1.2 in.) of stroke to the right EAD. Police indicate a TAD of FD-6 with a damage estimate of \$8,000. There was intrusion into the second seat row by the second seat seatback caused by the rear third row seat occupant. All the doors remained functional.	
CDC:	12FDEW1	
Delta V:	Total	14.3 km/h (8.9 mph)
	Longitudinal	-14.3 km/h (-8.9 mph)
	Latitudinal	0 km/h (0 mph)
	Energy	6,850 joules (5,053 ft-lbs)

**Figure 8.** Overview of frontal damage

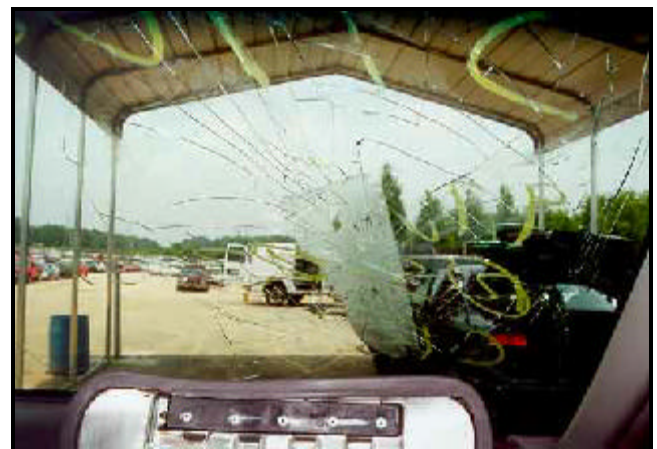
Figure 12. Windshield contact

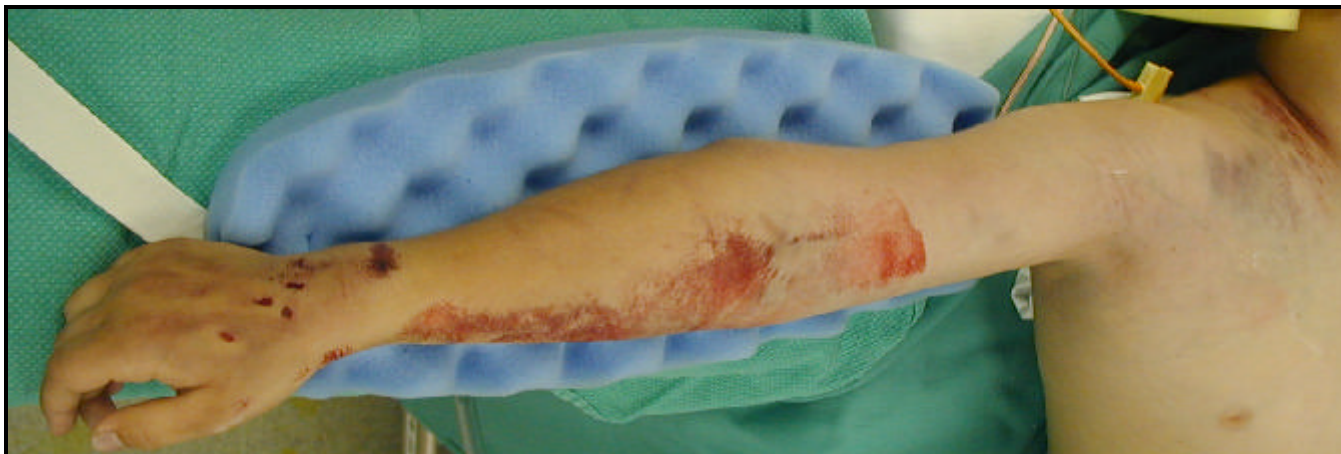
<u>INJURY</u>	<u>OIC CODE</u>	<u>ICD-9</u>	<u>SOURCE</u>
Driver:	Not injured			
Front right	Distal humerus lateral condyle fracture, right	752604.3,1	812.42	Air bag
	Complete avulsion of the brachial plexus	630226.3,6	953.4	Air bag
	Complete avulsion of the sub-clavian artery, right	721008.3,1	901.1	Air bag
	Complete avulsion of the upper and lower brachial nerve roots from the spinal cord	630266.3,0	953.4	Air bag
	Contusion, right side of face	290402.1,1	920.0	Air bag
	Abrasions, right forearm	790602.1,1	913.0	Air bag
	Abrasions, right upper arm	790602.1,1	912.0	Air bag
	Abrasions, right hand	790602.1,1	913.0	Windshield
	Abrasion, right side of neck	390202.1,1	910.0	Air bag
Second seat left	Not injured			
Second seat right	Type "C" (possible injuries) were reported			
Third seat middle	Not injured

**Figure 13.** Front right occupant injuries

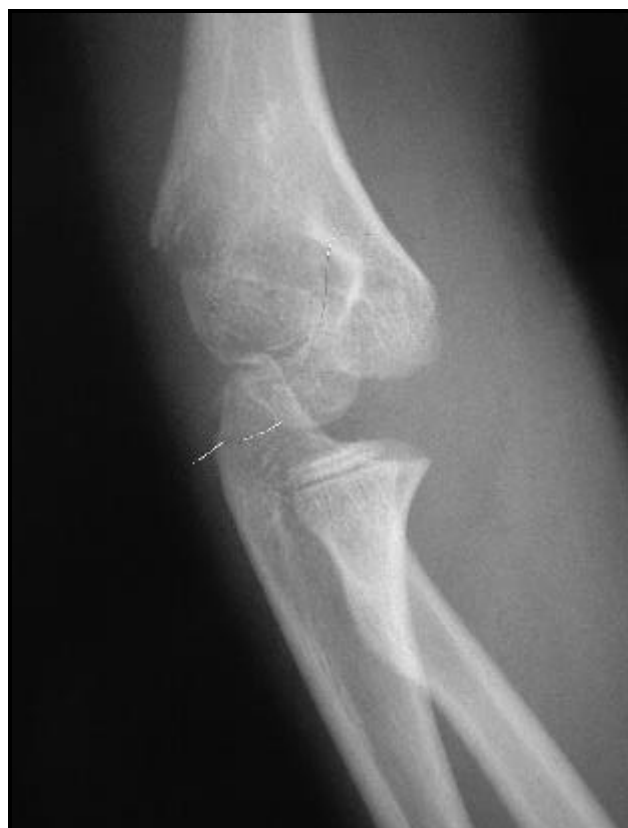
**Figure 14.** Right arm fracture

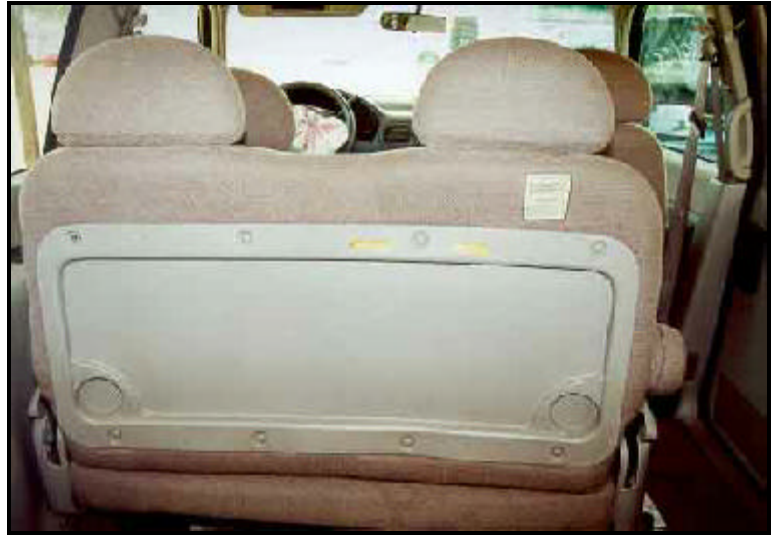
The 9-year-old female third seat middle seat occupant was seated in the cloth-covered bench seat (with folding back) in what is presumed to be a normal upright fashion. She was not wearing the available manual lap belt. During braking and the subsequent impact, this occupant pitched forward and struck the rear of the second seat—deforming it forward. There were no injuries reported.

**Figure 15.** Rear of second seat - contact from rear middle seat occupant
