**VERIDIAN REMOTE AIR BAG RELATED CHILD SAFETY SEAT FATALITY
INVESTIGATION
SCI TECHNICAL SUMMARY REPORT**

VERIDIAN CASE NO. CA01-014

VEHICLE - 1996 TOYOTA COROLLA

CRASH DATE - OCTOBER 1998

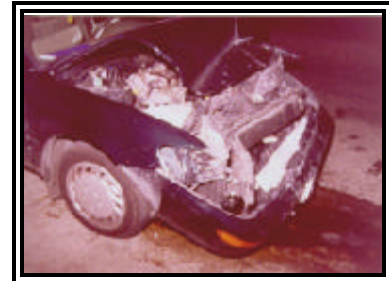
Figure 1. Frontal damage to the 1996 Toyota Corolla

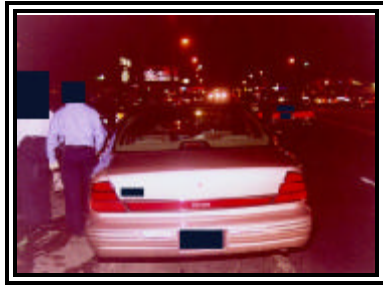
The Delta 88 came to rest adjacent to the curb facing south on the outboard northbound lane (**Figure 2**). The Corolla came to rest facing north on the outboard northbound lane (**Figure 3**).

Figure 2. Final rest position for the Delta 88

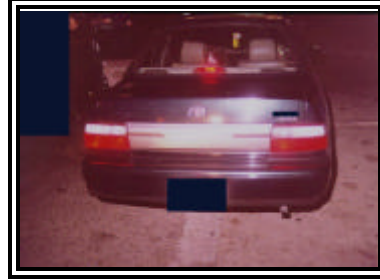
Figure 3. Final rest position for the Corolla

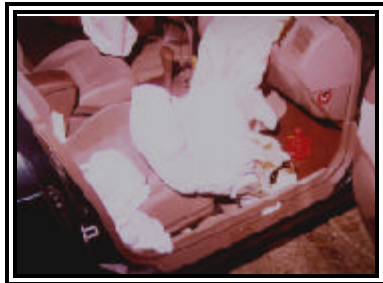
Damage to the child safety seat was based on the on-scene police photographs. Due to the overexposed nature of the photographs, the exact extent of the damage could not be identified. The child safety seat was found in the front right floor pan area and was upside down in the photographs (**Figure 4**). The top aspect was on the floor pan and the bottom aspect was resting against the front right seat cushion. The rigid plastic on the outboard areas of the child safety seat was fractured, and plastic fragments were noted on the floor pan and interior sill area (**Figure 5**). It appeared that the plastic carrying handle had fractured on the top aspect, and the left arm was displaced upward. There also appeared to be a fracture line on the lower right aspect of the base.

Figure 4. Damaged child safety seat in the Corolla

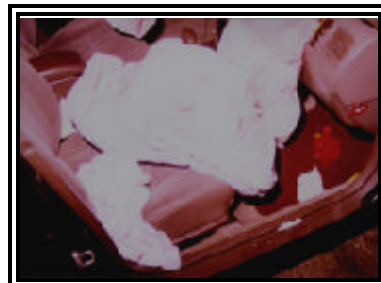
Figure 5. Closer view of the damaged child safety seat

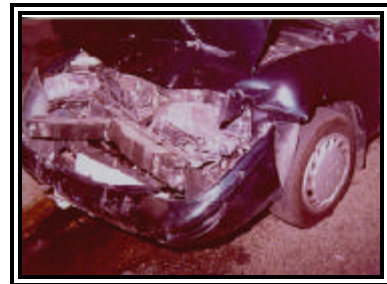
The 1996 Toyota Corolla sustained moderate frontal damage as a result of the impact with the Oldsmobile Delta 88. The direct contact damage began at the front left bumper corner and extended approximately 115 cm (45") laterally across the frontal plane. The combined direct and induced damage involved the entire frontal width of the vehicle (**Figure 6**). The bumper fascia was displaced downward and was partially separated from the vehicle. It was also abraded on the top aspect. The bumper beam was crushed rearward and fractured approximately 15 cm (6") to the left of the centerline at C4. The maximum crush was also located 15 cm (6") to the left of the centerline at C4 and was estimated to be 30 cm (12"). The radiator core was crushed as well as the upper and lower radiator supports. Both headlamp assemblies were displaced and the grille fascia was separated from the vehicle. The hood was buckled rearward at the designated fold points and the leading edge was abraded from contact with the Delta 88. The left fender was crushed rearward and buckled. The left front wheel appeared to be restricted from the rearward displacement of the frontal components. The Collision Deformation Classification (CDC) for the impact with the Delta 88 was 12-FDEW-2. Six crush measurements were estimated along the bumper beam

Figure 6. Frontal damage to the Toyota Corolla

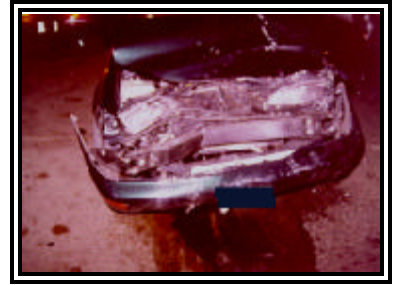
(Figure 7) and were as follows: C1 = 15 cm (6"), C2 = 20 cm (8"), C3 = 25 cm (10"), C4 = 30 cm (12"), C5 = 15 cm (6"), C6 = 5 cm (2").

Figure 7. Frontal damage along the bumper beam

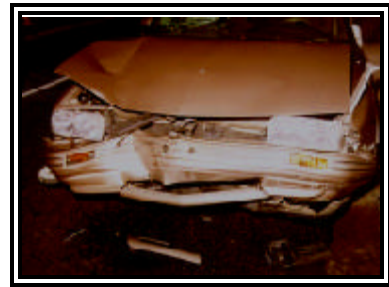
The 1995 Oldsmobile Delta 88 sustained moderate frontal damage as a result of the impact with the Toyota Corolla. The direct damage began at the front left bumper corner and extended laterally approximately 115 cm (45") across the frontal plane. The combined direct and induced damage involved the entire frontal width of the vehicle (Figure 8). The maximum crush was located at C4, approximately 17 cm (7") to the right of the centerline and was estimated to be 15 cm (6"). The bumper fascia was crushed and displaced upward on the left and center aspects. Abrasions were noted on the front aspect of the bumper fascia on the left and center aspects, as well. The bumper fascia was fractured approximately 50 cm (20") to the left of the centerline on the bottom aspect. The left side aspect of the bumper fascia was crushed against the left front wheel, which appeared to be restricted. The grille was separated from the vehicle. There was no direct contact evidence on the leading edge of the hood, but the hood was buckled rearward at the designated fold points. Both headlamps were displaced. The CDC for this impact with the Corolla was 12-FDEW-1. Six crush measurements were estimated along the bumper and were as follows: C1 = 13 cm (5"), C2 = 13 cm (5"), C3 = 13 cm (5"), C4 = 15 cm (6"), C5 = 8 cm (3"), C6 = 3 cm (1").

Figure 8. Frontal damage to the Delta 88

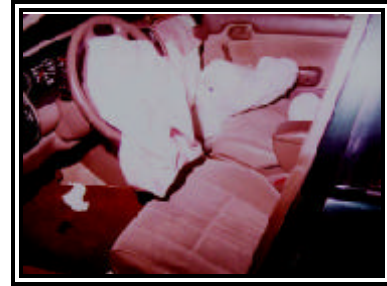
The 1996 Toyota Corolla was equipped with frontal air bags for the driver and front right passenger positions (**Figure 9**) that deployed as a result of the impact with the Delta 88. The driver's air bag was housed in the center of the steering wheel with symmetrical H-configuration module cover flaps.

Figure 9. Deployed frontal air bag system in the Toyota Corolla
