INDIANA UNIVERSITY

ON-SITE CHILD AIR BAG-RELATED FATALITY INVESTIGATION

CASE NUMBER - IN01-015
LOCATION - TEXAS
VEHICLE - 2001 FORD F150 XLT
CRASH DATE - May, 2001

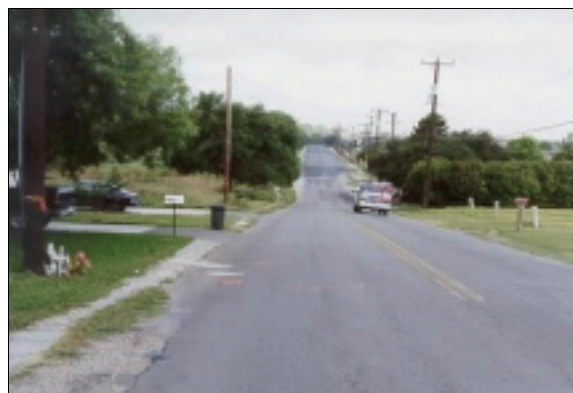
Figure 1: Northwesterly view of case vehicle's and Crown Victoria's uphill pre-crash travel path; Note: flowers by reference point mark approximate point of impact (case photo #04)

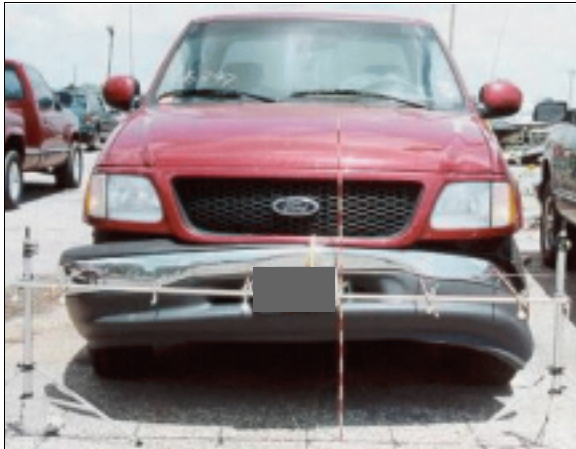
Figure 2: Case vehicle's frontal damage with contour gauge present; Note: bumper rotated upward (case photo #08)

The front (**Figure 2**) of the case vehicle impacted the back (**Figure 3**) of the Crown Victoria, causing the case vehicle's driver and front right passenger supplemental restraints (air bags) to deploy. The case vehicle came to rest heading southeast in the southeastbound lane (**Figure 4**) less than a meter (less than 3.3 feet) past the point-of-impact. The impact to the back of the Crown Victoria nudged it forward, but the Crown Victoria continued its left turn and parked along the southeast edge of the street heading northeast (**Figure 5**).

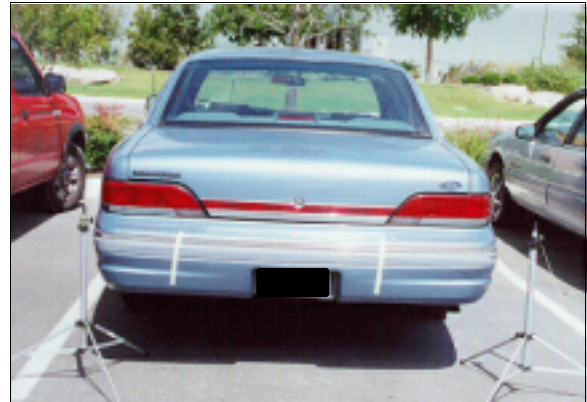
Figure 3: Ford Crown Victoria's impacted back bumper showing outline (between tape) of direct damage (case photo #31)

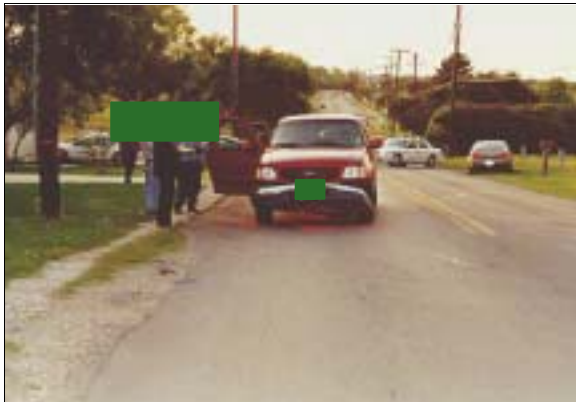
Figure 4: On-scene photo looking northwestward in the southeastbound lane showing case vehicle at final rest (case photo #45)

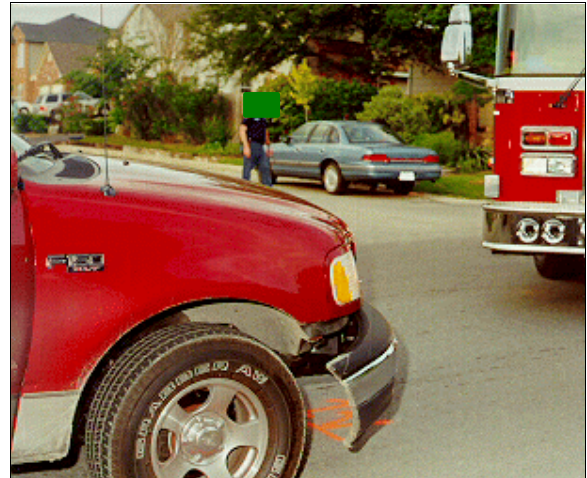
Figure 5: On-scene photo showing final rest position of case vehicle (foreground) and parked position (background) of Crown Victoria (case photo #41)

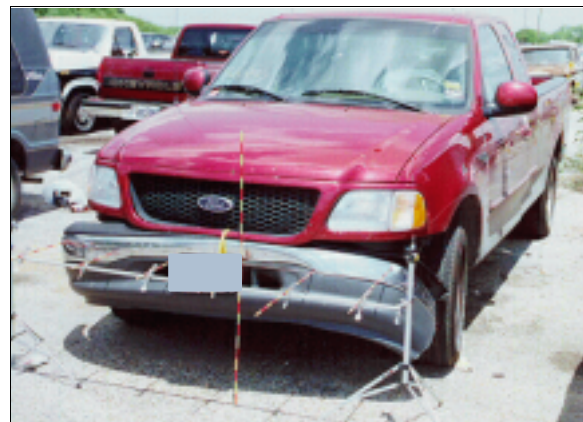
The case vehicle's contact with the Crown Victoria involved the front left half of its bumper (**Figure 7**). Direct damage began 7.5 centimeters (3.0 inches) left of the case vehicle's center (toward the driver's side) and extended, a measured distance of 71 centimeters (28.0 inches), toward the front left bumper corner. The Field "L" was 160 centimeters (63.0 inches) and extended from bumper corner to bumper corner. Residual maximum crush was measured as 13 centimeters (5.1 inches) at C₁. The case vehicle's wheelbase was unaltered from the crash. The front of the case vehicle's front bumper was rotated upward causing the left front corner of the front bumper to be pushed into and restrict the left front tire (**Figure 8** below). None of the case vehicle's other tires were damaged, deflated, or physically restricted. No obvious induced damage or remote buckling was noted to the remainder of the case vehicle's exterior.

Figure 7: Case vehicle's damaged front viewed from left of front with contour gauge present showing direct damage width between tape and front left bumper corner (case photo #07)

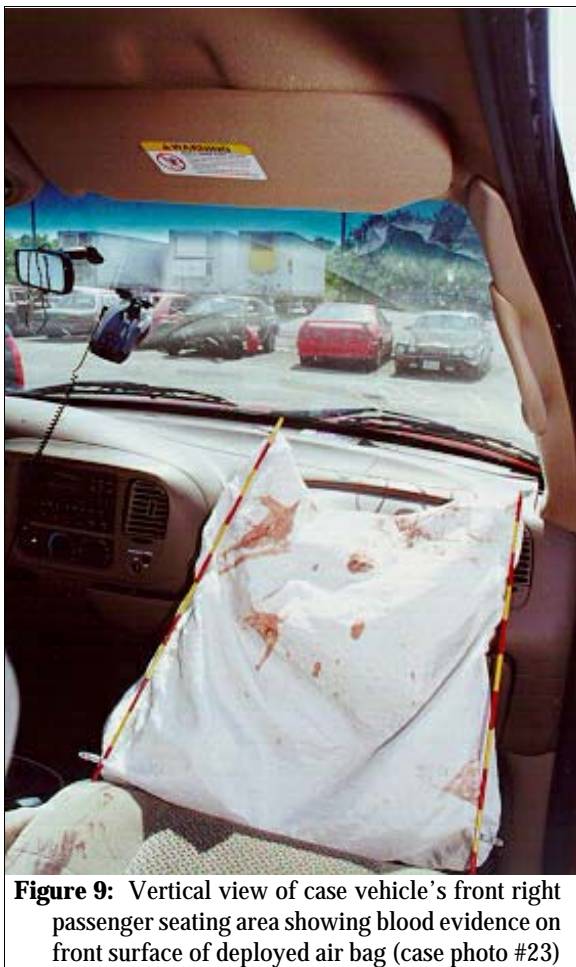
fabric (**Figure 9**). Specifically, there were blood spots on the windshield, right instrument panel, right window sill, and front right seat's back support. Furthermore, there was a large amount of blood on the driver's seat cushion and center floor-mounted console (**Figure 10**), and a little on the vertical, outside surface of the driver's seat cushion (**Figure 11** below). In addition, there were scuffs on the right instrument panel and center instrument panel near the front right air bag's On/Off switch, and the air vent in the center instrument panel had been pushed inward (**Figure 12** below). Finally, there was no evidence of intrusion to the case vehicle's interior, no evidence of compression to the energy absorbing sheer capsules in the steering column, and no deformation to the steering wheel rim.

Figure 9: Vertical view of case vehicle's front right passenger seating area showing blood evidence on front surface of deployed air bag (case photo #23)

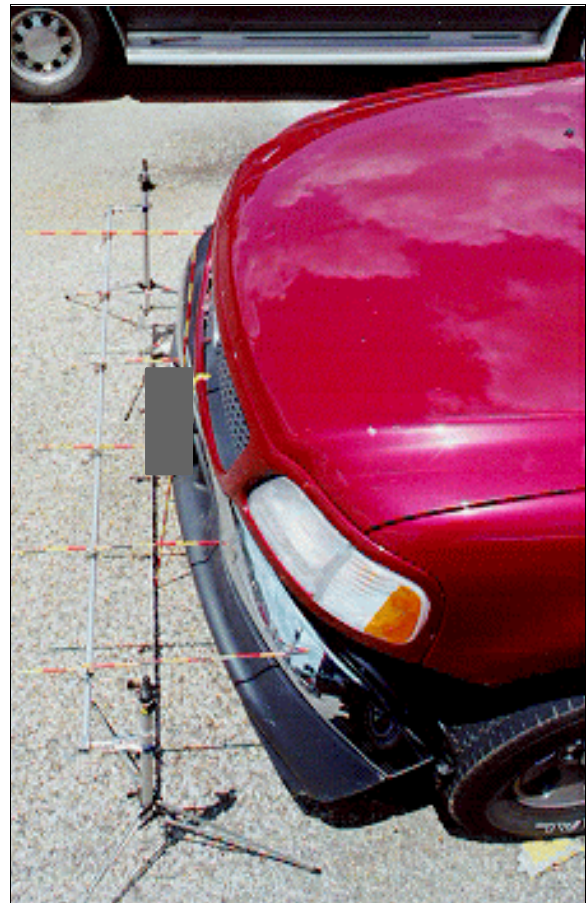
Figure 8: Reference line view of minor deformation to case vehicle's front bumper (case photo #09)

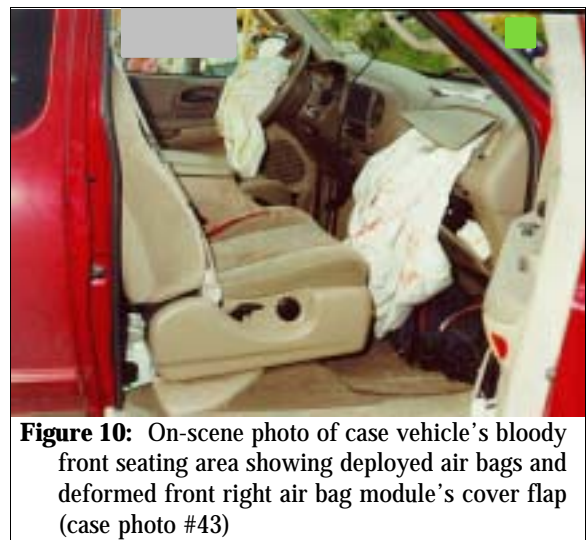
Figure 10: On-scene photo of case vehicle's bloody front seating area showing deployed air bags and deformed front right air bag module's cover flap (case photo #43)

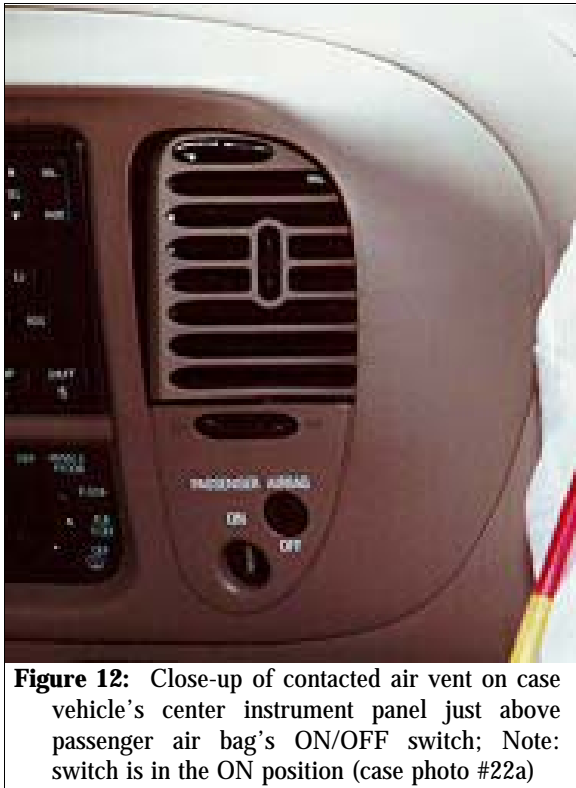
Figure 12: Close-up of contacted air vent on case vehicle's center instrument panel just above passenger air bag's ON/OFF switch; Note: switch is in the ON position (case photo #22a)

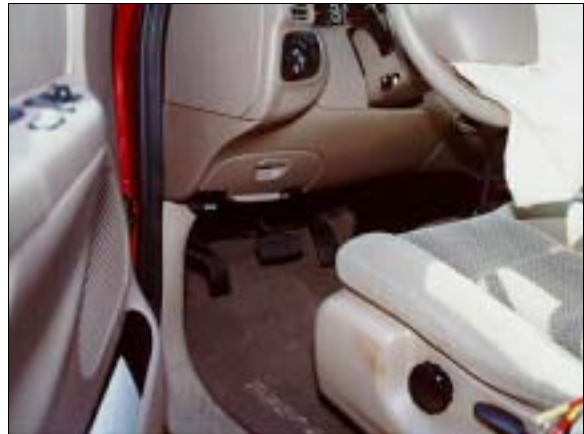
Figure 11: Case vehicle's driver knee bolster; Note: blood smear to side of driver's seat cushion (case photo #19)

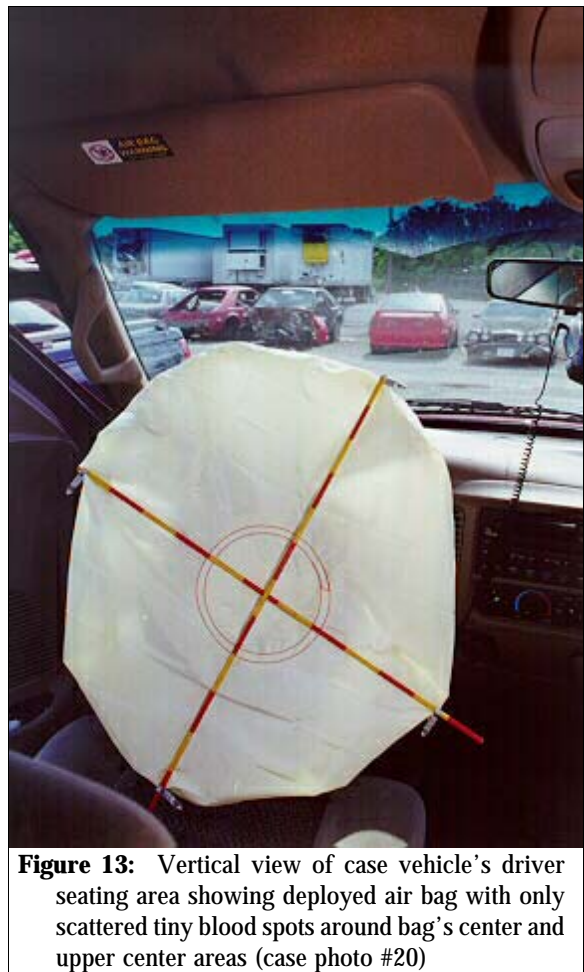
Figure 13: Vertical view of case vehicle's driver seating area showing deployed air bag with only scattered tiny blood spots around bag's center and upper center areas (case photo #20)

vertically for the lower flap. An inspection of the air bag module's cover flaps and the air bag fabric revealed that the cover flaps opened at the designated tear points, and there was no evidence of damage during the deployment to the air bag or the cover flaps. The driver's air bag was designed with two wide tethers, each approximately 14 centimeters (5.5 inches) in width. The driver's air bag had two vent ports, approximately 2.5 centimeters (1.0 inches) in diameter, located at the 11 and 1 o'clock positions. The deployed driver's air bag was round with diameter 63 centimeters (24.8 inches). An inspection of the driver's air bag fabric revealed only the presence of blood spots on the air bag's fabric. These blood spots were scattered around the center and upper center of the air bag's fabric (**Figure 13** above).

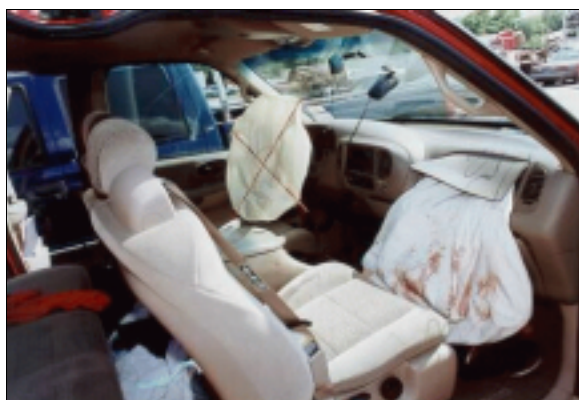
Figure 14: Case vehicle's front seating area showing deployed air bags, deformed front right passenger air bag module's cover flap, and cell phone on windshield (case photo #17)

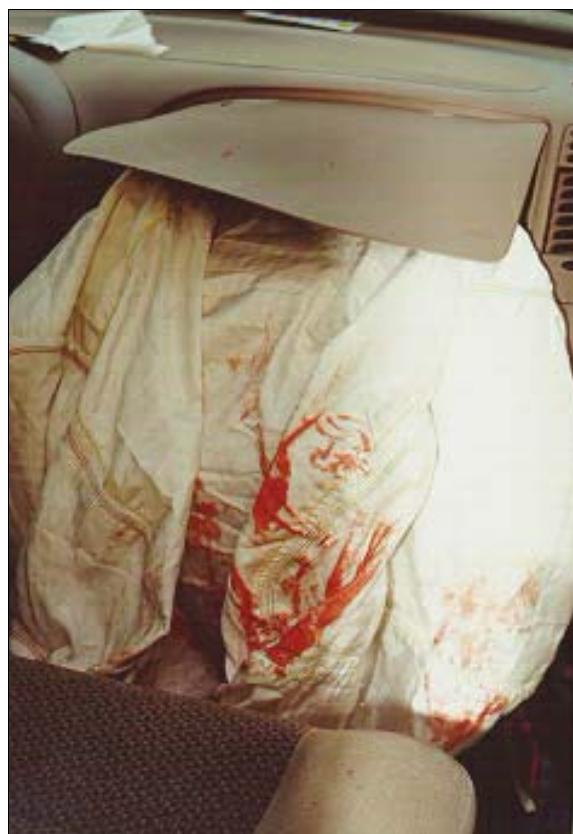
Figure 15: On-scene photo of case vehicle's bloodied front right passenger air bag and contacted air bag module's cover flap (case photo #38)

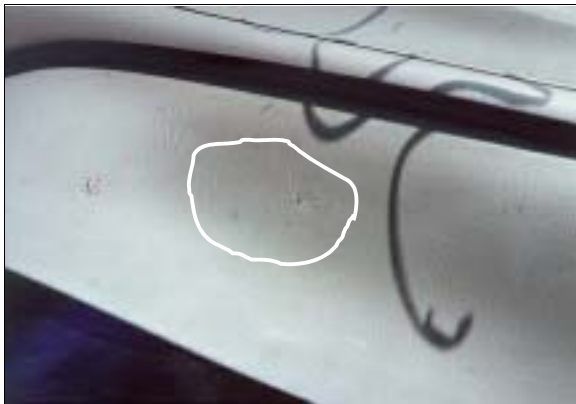
Figure 16: Close-up of contact evidence (tooth mark and saliva area) on case vehicle's front right air bag module's cover flap (case photo #27)

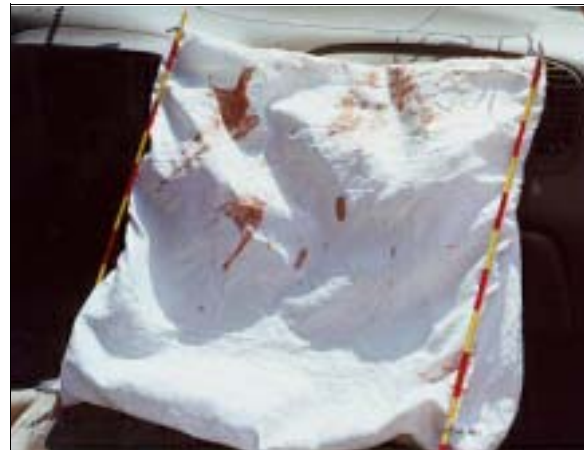
Figure 17: Front surface of case vehicle's deployed front right passenger air bag showing copious blood splatter evidence (case photo #24)

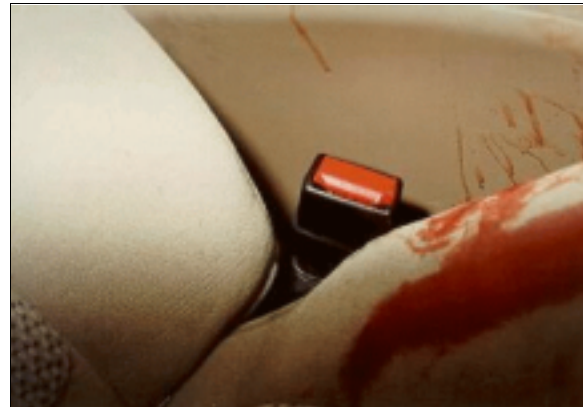
This particular system does not record seat belt status; however, an examination of the front right passenger’s buckle-mounted pretensioner indicates that the pretensioner did not retract (**Figure 18**).

Figure 18: On-scene close-up photo of case vehicle’s bloody front right seat showing safety belt system’s buckle with pretensioner not retracted, indicating non-usage (case photo #40)

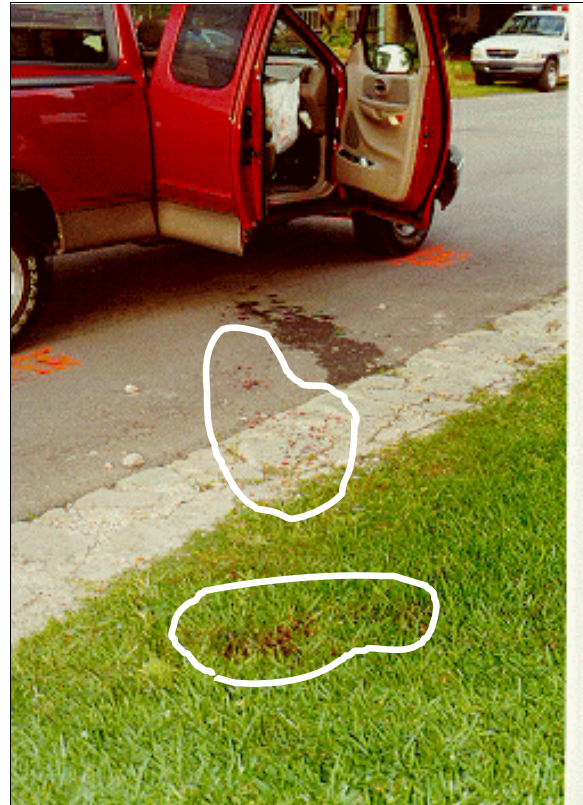
Figure 19: On-scene photo looking east showing blood evidence trail (highlighted) dripped by case vehicle's front right passenger when her body was removed from vehicle and placed on grass (case photo #39)

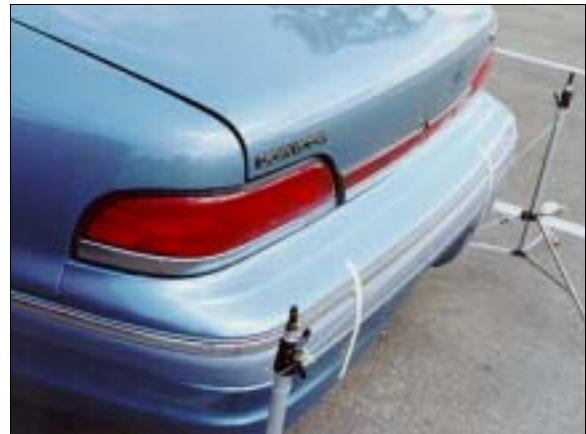
Figure 20: Ford Crown Victoria's back showing width of direct contact on bumper and slight separation of trunk lid as only visible deformation (case photo #46)

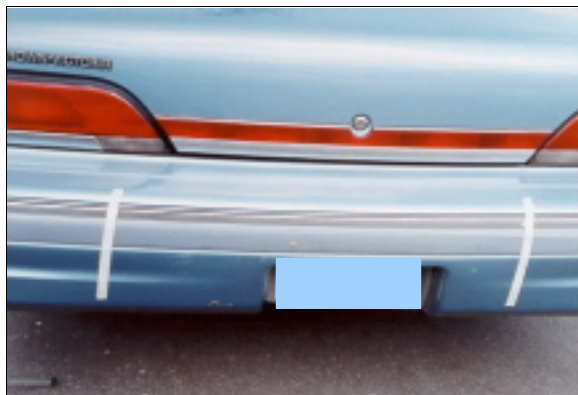
Figure 21: Ford Crown Victoria's back bumper damage with tape indicating length of direct contact; Note: only very minor damage was found (case photo #47)

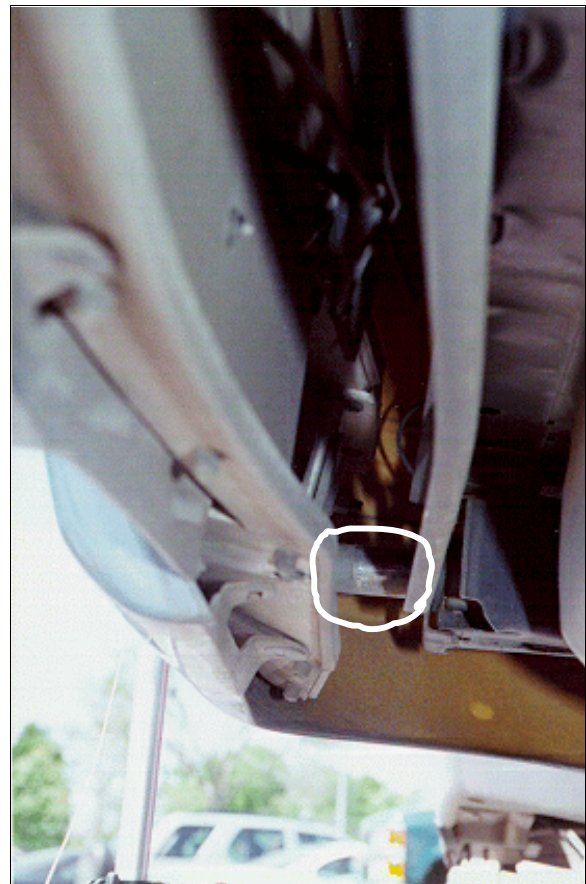
Figure 22: Undercarriage view of Ford Crown Victoria's back bumper reinforcement bar and left EAD stroke (case photo #51)

The Crown Victoria's contact with the case vehicle involved its back bumper. Direct damage began 49 centimeters (19.3 inches) left of the vehicle's center and extended, a measured distance of 84 centimeters (33.1 inches), along the back bumper toward the back right bumper corner (**Figures 20** and **21** above). Field "L" involved the entire back bumper and was measured as 170 centimeters (66.9 inches). There was no detectable crush at the bumper, but maximum crush was measured as 6 centimeters (2.4 inches)–left EAD stroke measurement (**Figure 22** above).
