On-scene Investigation / Vehicle to object
Dynamic Science, Inc. / Case Number: DS01-016
1998 Chevrolet K-2500 pickup
Oregon
November, 2001

1. Report No. DS01-016		2. Government Accession No.		3. Recipient Catalog No.	
4. Title and Subtitle In-Depth Accident Investigation				5. Report Date	
				6. Performing Organization Report No.

Dynamic Science, Inc.
Accident Investigation
Case Number: DS01-016

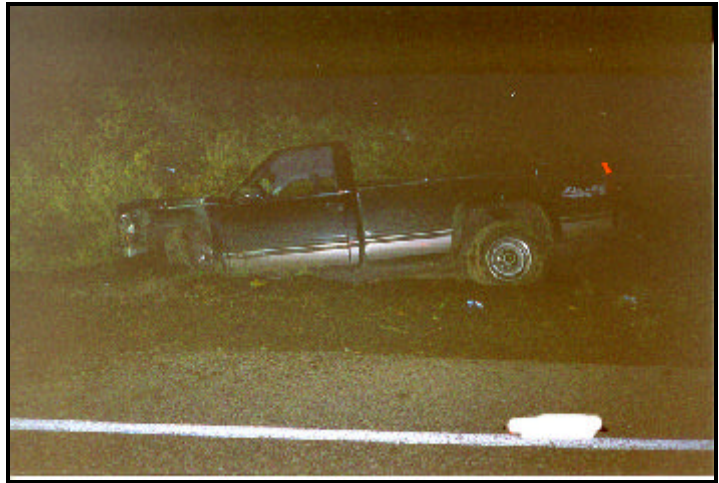
Figure 1. Final rest—south

Approximately 91.4 m (300 ft) before the impact, the driver corrected his vehicle and brought it back into the eastbound lanes. Approximately 60.9 m (200 ft) before impact, the case vehicle's right side departed the roadway. After traveling another 30.4 m (100 ft), the front of the case vehicle struck the embankment—possibly several times. The right front tire was knocked off. The case vehicle continued on for another 30.4 m (100 ft) before the front left tire and bumper dug into the ground and the vehicle came to rest.

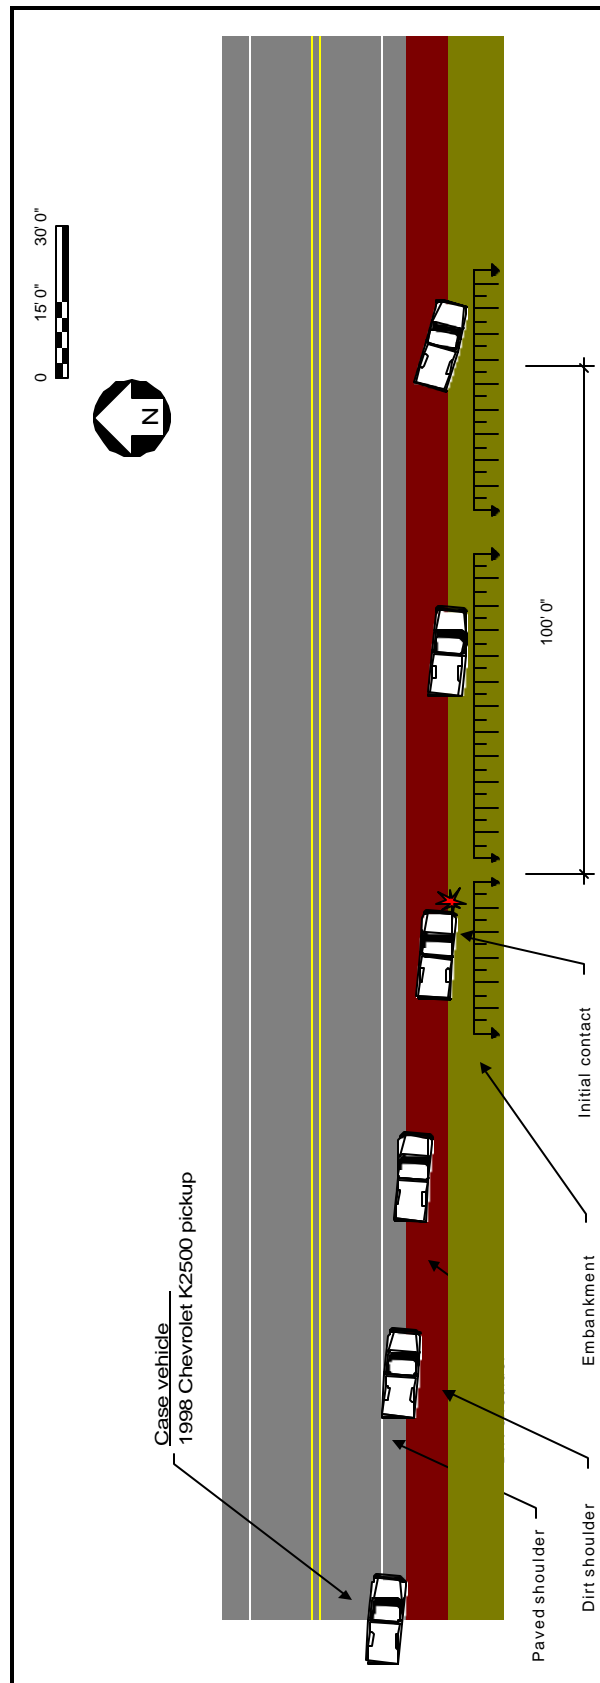
Figure 3. Scene diagram

COLLISION MEASUREMENTS						
Reference point:	Cross street					
Reference line:	South edge of roadway at edge of paved shoulder					
Data Point	Distance and Direction from RP			Distance and Direction from RL		
	ft	m	d	ft	m	d
LF corner of vehicle	106	32.3	E		0	
LF axle	102.9	31.4	E	8.8	2.7	S
LR axle	93.2	28.4	E	7.4	2.3	S
Width of eastbound paved shoulder	93.0	28.3	E	4.0	1.2	N
Width of eastbound travel lane	93.0	28.3	E	24.0	7.3	N
Width of westbound paved shoulder	93.0	28.3	E	35.6	10.9	N
LR tire mark leaves paved shoulder to dirt shoulder	94.4	28.8	W			
Right tire mark leaves paved shoulder to dirt shoulder	148.9	45.4	W			
Tire mark on centerline coming from westbound lane	311.9	95.1	W			
East edge of cross street from highway	411.9	125.5	W

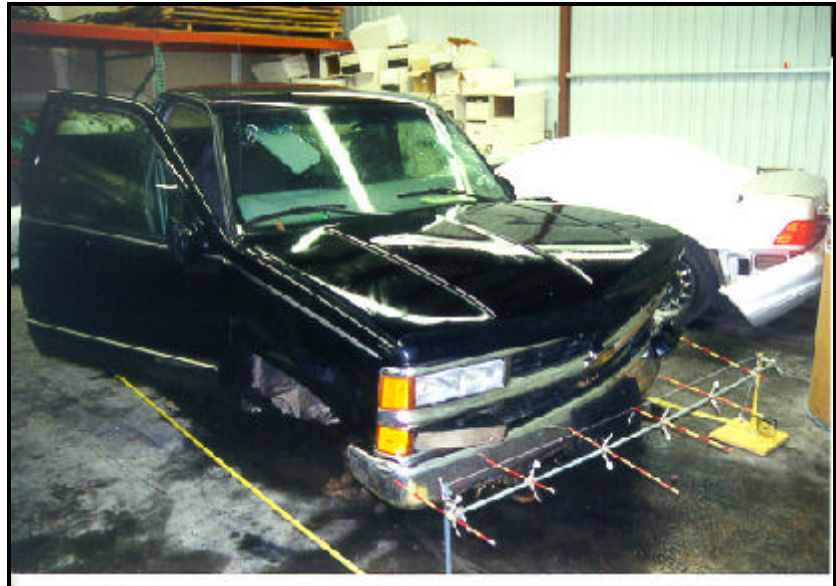
Figure 4. Front right, case vehicle

The case vehicle sustained moderate frontal damage (12FDEW1). The front right wheel was knocked

off. The wheelbase on the left side was shortened by 16 cm (6.2 in). There was 173 cm (68.1 in) of direct contact along the bumper—mostly dirt and grass. The maximum crush of 9 cm (3.5 in) was found at C₁. There was direct contact damage to the left front fender that may have happened at some earlier time. The case vehicle sustained a longitudinal delta v of -12.1 km/h (-7.5 mph)³. The results are low and the damage to the wheels is not accounted for in any fashion. The case vehicle was towed from the scene and later declared a total loss by the insurance company.

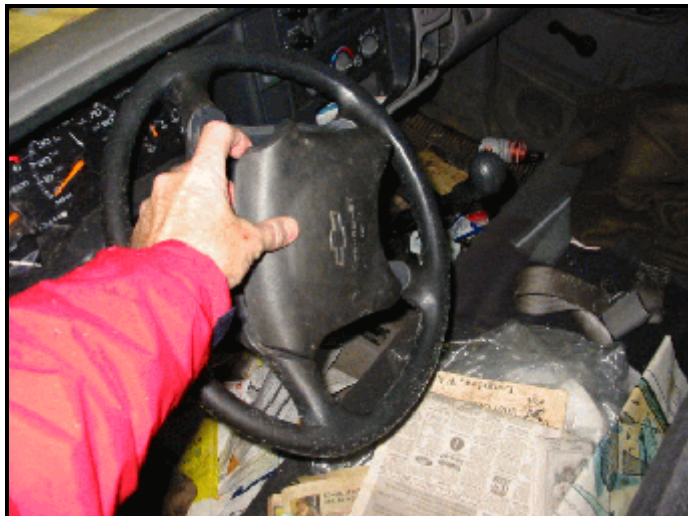
Figure 6. Horn button

As stated earlier, this case was originally initiated in response to a report of a fatality involving a non-deployed air bag. The report of a non-deployed air bag was incorrect. The case vehicle was not equipped with air bags because it met the >3856 kg (8500 lbs) GVW cutoff as described in the Federal Motor Vehicle Safety Standard, Standard No. 208 -- Occupant Crash Protection shown below:

The case continued to be investigated because of its borderline nature and to determine if the existence of the air bag might have mitigated the resulting fatal injuries. It is this investigator's opinion that the existence of a steering wheel mounted air bag would have greatly reduced the number of injuries sustained by the driver as well as their severity. In particular, the air bag might have prevented the driver's head from ever reaching the windshield thus mitigating the inevitable fatal injuries. The air bag would also have likely eliminated the chest and abdomen injuries.

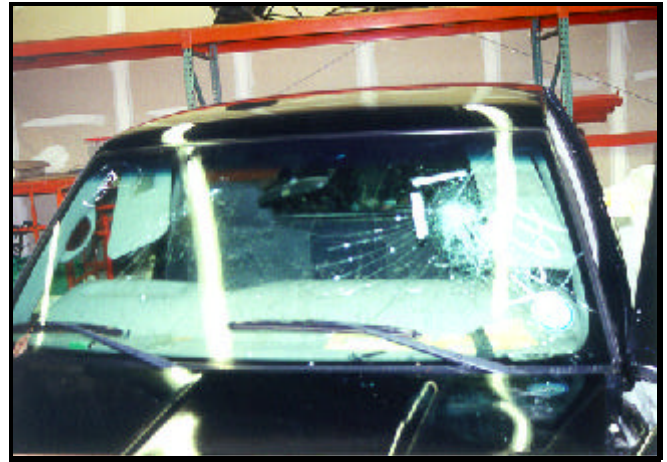
<u>INJURY</u>	<u>OIC CODE</u>	<u>ICD-9</u>	<u>SOURCE</u>
	<i>Based on information found in CT scan report</i>			
Driver:	Comminuted fracture, nasal bone	251004.2,4	802.0	Windshield
	Fracture at the region of the left zygomaticoaxillart suture	251800.2,2	802.4	Windshield
	Bilateral frontal lobe contusions	140620.3,3	851.06	Windshield
	Interparechymal hemorrhage, bilateral subarachnoid hemorrhage	140684.3,1 140684.3,2	800.2	Windshield
	Soft tissue swelling, left frontal area of head (coded as contusion)	290402.1,7	920.0	Windshield
	Unconscious upon arrival	Not codeable	NA	NA
	<i>Based on information reported in medical examiner report</i>			
	Cervical fracture	650216.2,6	805.00	Windshield
	Liver laceration	541820.2,1	864.02	Steering wheel
	Multiple rib fractures	450210.2,9	807.09	Steering wheel
	Lacerations to nasal bridge	290600.1,4	873.20	Windshield

Figure 9. Exterior view of windshield contact

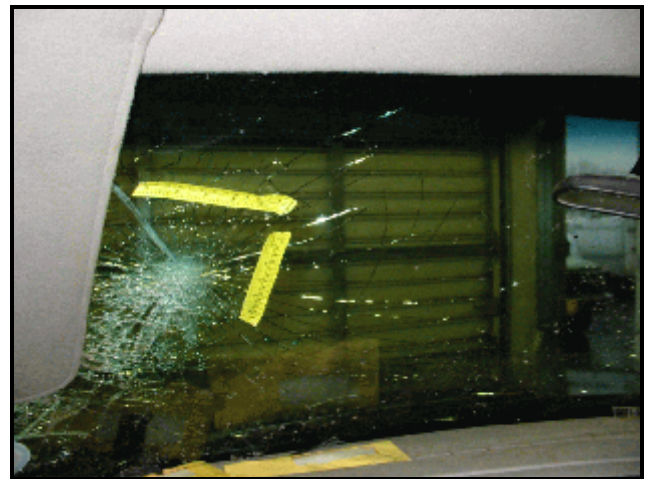
Figure 10. Head contact to windshield

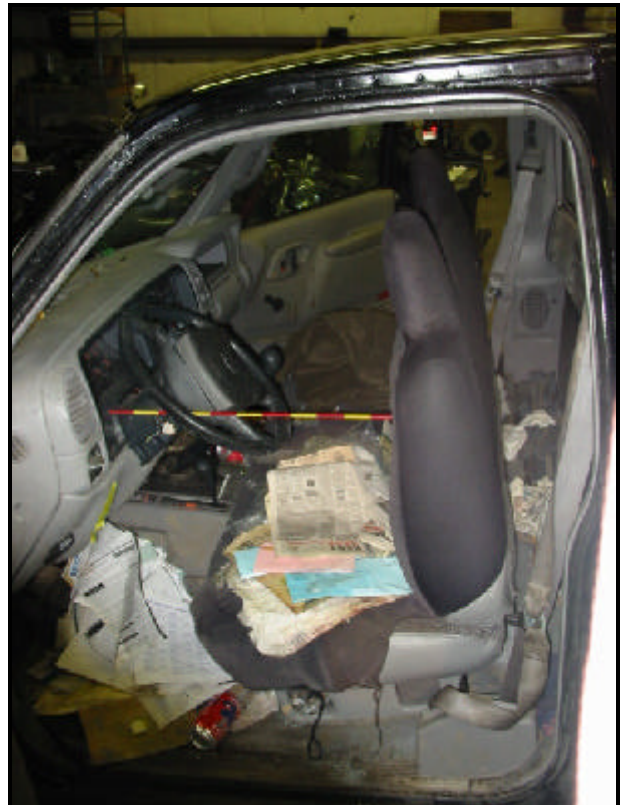
The seat back appears to have failed during the crash. In police photos it can be seen that the seat is no longer in its locked position. At the time of the inspection the investigator was unable to put the seat back into the latched position. The reason for the failure may have been inertial forces. There was no indication of loading from the rear.

Figure 12. Driver's seated position—note seat back and deformed steering wheel

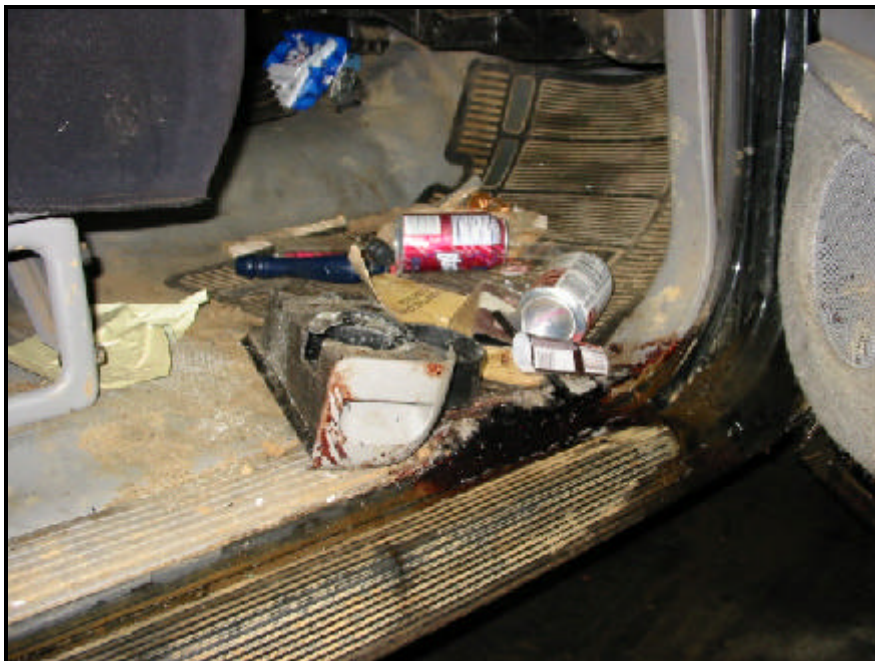
It appears that the driver was seated in a normal, upright fashion prior to the crash. He was not wearing the available lap and shoulder belt. The driver was likely conscious. As the vehicle negotiated the right hand curve, he made a steering maneuver to the right and lost control of the vehicle. The vehicle departed the roadway on the right, went down into a ditch, and impacted an embankment. The driver was in a higher than normal—as compared to the position the driver would be on a level surface. The driver responded to the 12 o'clock direction of force by moving forward. He loaded and collapsed the steering wheel with his torso—causing the rib fractures and the liver laceration. As his body wrapped around the wheel, his head struck the windshield—causing the fatal head injuries. Strands of hair and small pieces of tissue were embedded in the windshield at the impact point. As the vehicle came to rest, the driver fell to the right. He struck and dislodged the center cup holder. He was found lying face down on the passenger side floor by the investigating officer.

Figure 13. Center cup holder—dislodged by driver
