INDIANA UNIVERSITY

TRANSPORTATION RESEARCH CENTER

ON-SITE AOPS INVESTIGATION

CASE NUMBER - IN01-017
LOCATION - Indiana
VEHICLE - 2000 FORD TAURUS SE
CRASH DATE - June 2001

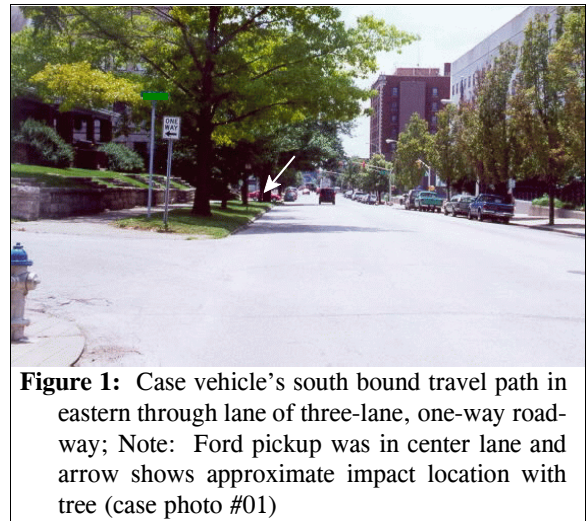
Figure 1: Case vehicle's south bound travel path in eastern through lane of three-lane, one-way roadway; Note: Ford pickup was in center lane and arrow shows approximate impact location with tree (case photo #01)

The southbound city roadway was straight with a positive 2.1% slope at the area of the initial impact. The pavement was bituminous, and the width of the inside southbound lane was 3.3 meters [10.9 feet]. The width of the center southbound lane was 3.6 meters [11.9 feet]. The southbound roadway was bordered by 7.5 centimeter [3.0 inch] curb. Beyond the curb on the east side was a grass tree lawn with the west side having a concrete sidewalk. Pavement markings consisted of a painted, broken white, lane lines separating the three southbound through lanes. The estimated coefficient of friction was 0.70. Traffic controls consisted of several regulatory signs, including NO PARKING, ONE-WAY and an information sign. The posted speed limit was 56 km.p.h. [35 m.p.h.].

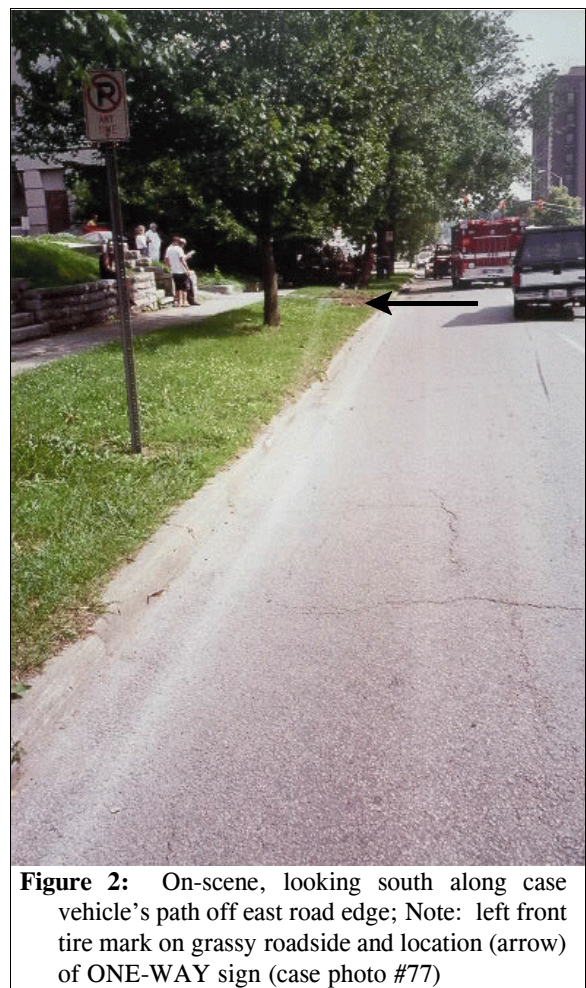
Figure 2: On-scene, looking south along case vehicle's path off east road edge; Note: left front tire mark on grassy roadside and location (arrow) of ONE-WAY sign (case photo #77)

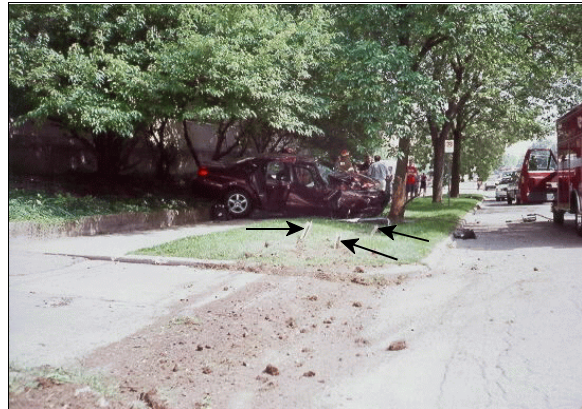
Figure 3: On-scene, case vehicle's path, showing soil thrown by undercarriage impact, sign posts (arrows), and final rest (case photo #72)

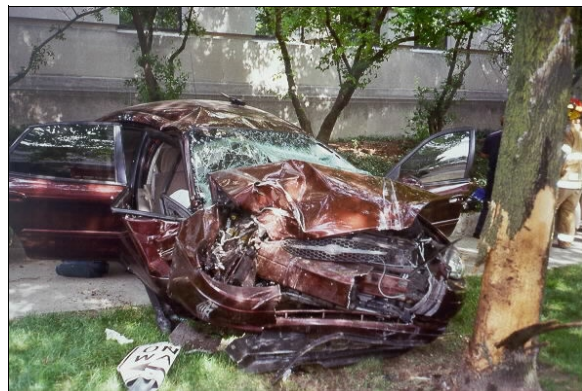
As a result of the case vehicle's impact with the tree, the case vehicle pitched upwards while rotating approximately 80 degrees clockwise (**Figure 4**). The case vehicle's left rear tire struck and went over a concrete knee wall that separated the outside edge of the sidewalk and a landscape area (event 7). The case vehicle came to rest straddling the sidewalk with its front pointing downward and its rear tires on and over the knee wall. At final rest, the case vehicle was heading west-southwest (**Figure 5**).

Figure 4: On-scene, looking east at case vehicle's final rest position (case photo #78)

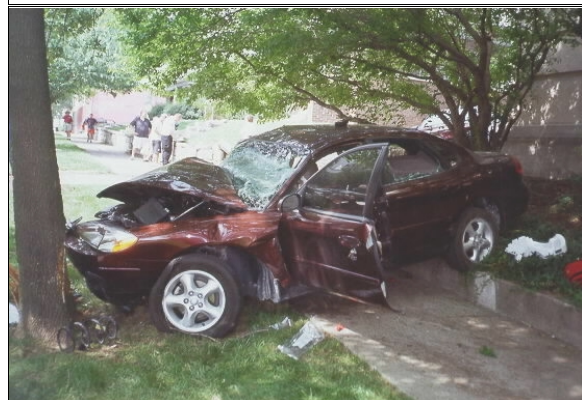
Figure 5: On-scene view of case vehicle's final rest position, straddling sidewalk with rear tires up over concrete knee wall (case photo #75)

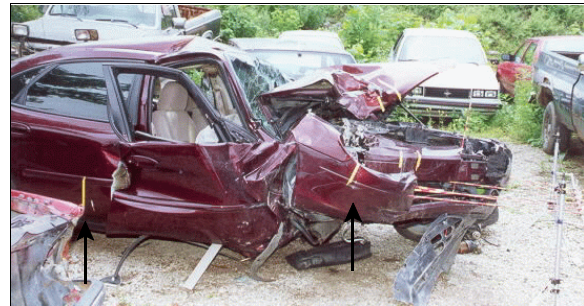
Figure 6: Case vehicle's right side showing front deformation, right front wheel off, and side swipe damage (tape) (case photo #25)

The case vehicle's initial contact with the Ford pickup involved the right fender. Direct damage began at the right front bumper corner and extended rearward to the right B-pillar. The exact direct damage width and maximum crush, although minimal, could not be determined because the damage was masked by the severe frontal impact with the tree (**Figure 6**). The case vehicle's curb impact blew out the front left tire (**Figure 7**). The case vehicle's third impact with the ONE-WAY regulatory sign involved the front right. The sign, which was located on the north side of the alleyway and faced east (i.e., for traffic exiting the alleyway), was supported by a U-channel steel post which, when struck, was uprooted and wrapped over the bumper and onto the hood. The case vehicle's undercarriage impact (4th impact) with the ground showed direct damage extending between the front wheels (**Figure 8**) a measured distance of 121 centimeters [47.6 inches]. The fifth impact involved an information sign that had two U-channel steel sign posts sunk in the ground with two U-channel extensions holding the sign and bolted to the anchored posts. The two upper posts and the sign broke away from the two lower posts. The case vehicle ran over the two lower posts while the upper posts and sign contacted the hood and

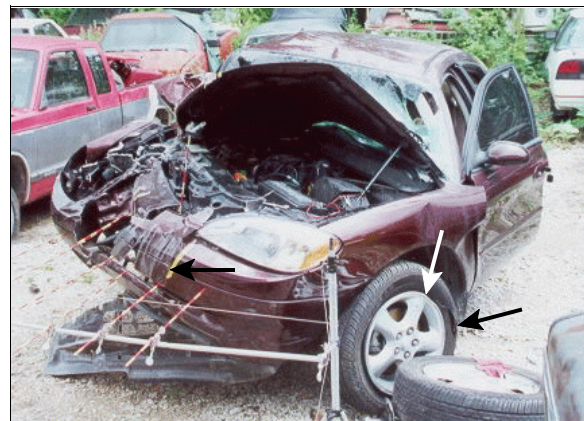
Figure 7: Front left view of case vehicle's damage; Note: tape on bumper (arrow) indicates 2nd sign post impact; damaged left front wheel/tire; right front wheel/tire broken off (case photo #17)

windshield. It appears the sign pierced and holed the windshield near the left A-pillar. The direct damage width was 86 centimeters [33.9 inches] and started 20 centimeters [7.9 inches] left of center.

The case vehicle's most severe impact involved the front right (**Figures 7 and 9**). The field L went from bumper corner to bumper corner a measured distance of 97 centimeters [38.2 inches]. Direct damage began 36 centimeters [14.2 inches] right of center and extended rightward 26 centimeters [10.2 inches]. Maximum crush was measured as 111 centimeters [43.7 inches] between C₄ and C₅. The wheelbase on the case vehicle's left side was extended 21 centimeters [8.3 inches] while the right side was shortened 61 centimeters [24.0 inches]. The case vehicle's front bumper, bumper fascia, grille, hood, radiator, front right headlight and turn signal assemblies, and right fender were directly damaged and crushed rearward. The case vehicle's left front tire was restricted, deflated, and punctured from the curb impact (**Figure 7**), the left rear tire was punctured and deflated from its impact with the concrete border (7th impact), and the right front tire was torn off during the case vehicle's tree impact. Remote buckling was also found on the case vehicle's right front roof and right and left quarter panels.

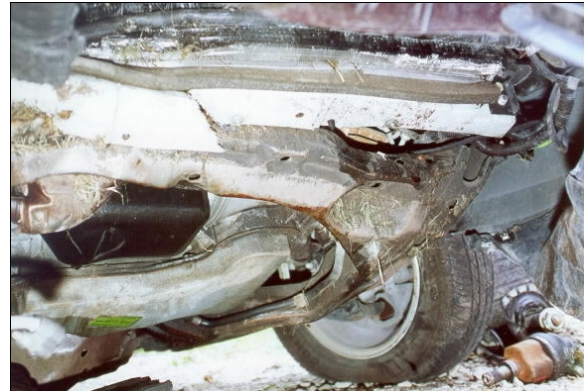
Figure 8: Undercarriage view from front of direct contact to case vehicle's front frame members with embedded grass (case photo #30)

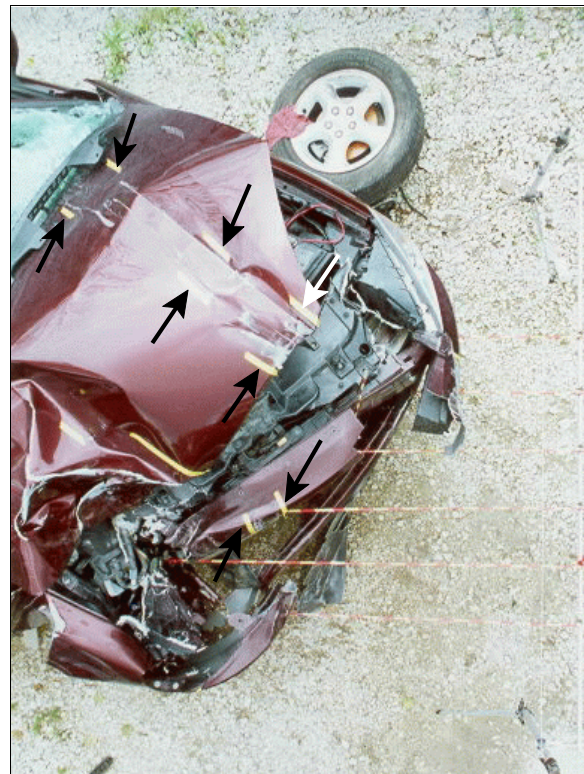
Figure 9: Overhead view of deformation to case vehicle's front; Note: imprint from informational sign's west post on left-center hood, imprint from ONE WAY sign post on right bumper, and right front wheel on ground (case photo #14)

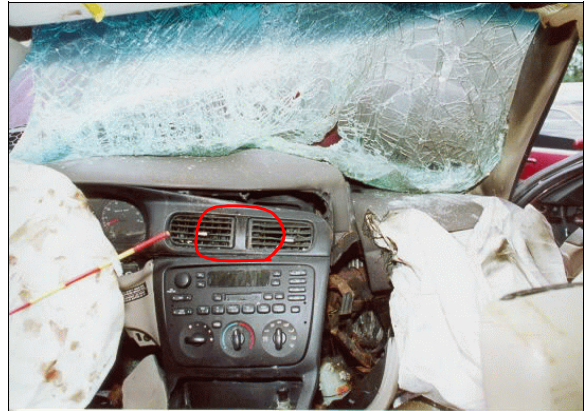
Inspection of the case vehicle's interior revealed evidence of occupant contact on the driver's knee bolster, to the right of the steering column, and to the center instrument panel (**Figure 10**). There was blood on the driver's sun visor, the webbing of the driver's safety belt, and on the headrest of the driver's seat back, towards the outside. The shear capsule was completely separated and the steering column's breakaway coupling was separated. A post-crash fire in the area of the lower front right instrument panel occurred to the case vehicle's interior (**Figure 10**). The fire was noticed by passing motorists as the tow truck operator was hauling the case vehicle to the tow yard. The fire was extinguished by the tow operator soon after his arrival at the tow yard. The fire resulted in a melting to the left side surface of the air bag (13 x 12 centimeters [5.1 x 4.7 inches] area) as well as the lower portion of the right instrument panel. In addition, there was smoke residue to the bottom and right side of the front right air bag and smoke and heat residue on the windshield. There was melting residue on the right sun visor.

Figure 10: Case vehicle's center and front right area showing intrusion, driver contact evidence on center instrument panel, cracked and holed windshield glazing, deployed front right air bag, and fire damage to right instrument panel area and below (case photo #46)

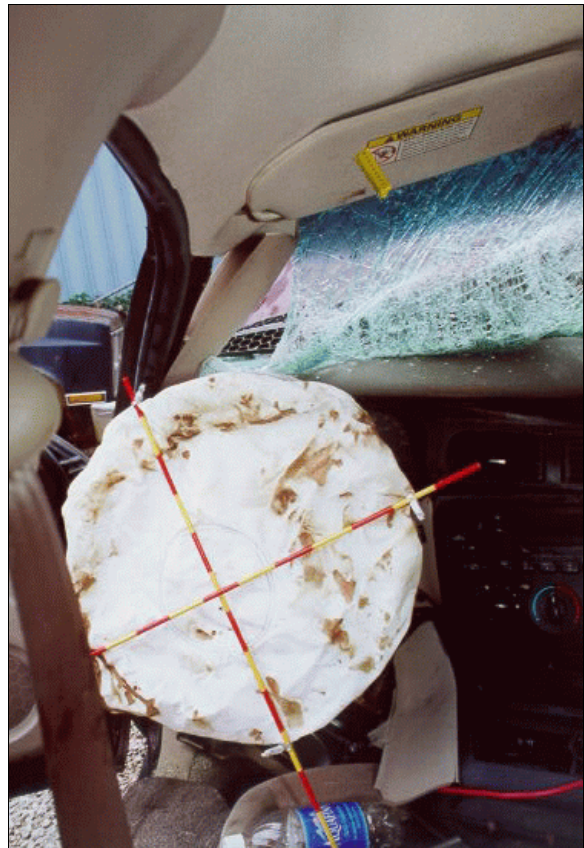
Figure 11: Case vehicle's driver seating area showing driver's deployed bloodstained air bag, cracked windshield glazing, and blood evidence on driver's sun visor (case photo #40)

was round with a diameter of 56 centimeters [22.0 inches]. There was no contact evidence readily apparent on the air bag's surface; although, the driver's air bag had a significant amount of blood covering the majority of the outer edges with a small amount to the center surface.

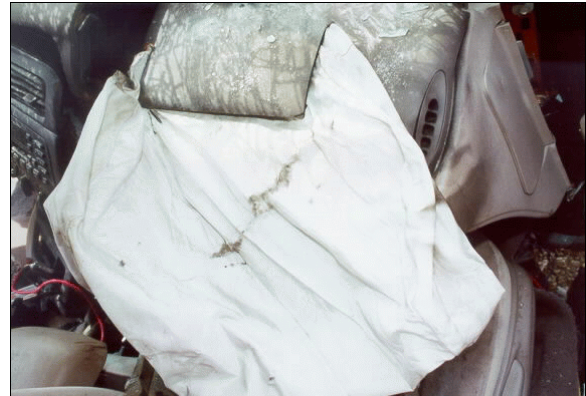
The front right passenger's air bag was located in the top of the instrument panel (**Figure 12**). An inspection of the front right air bag module's cover flap and air bag revealed that the cover flap opened at the designated tear points, and there was no evidence of damage during the deployment to the cover flap. There was however a 34 centimeter [13.4 inches] snag with tearing to the top surface of the air bag from the intruding and holed windshield. This line of tearing ran in an 8 o'clock to 2 o'clock direction. Furthermore, there were scattered glass punctures to the front surface, also from the cracked windshield's glazing. The front right passenger's air bag was designed without any tethers. The front right air bag had two vent ports, approximately 5 centimeters [2.0 inches] in diameter, located at the 10 and 2 o'clock positions. The deployed front right air bag was rectangular with a height of approximately 30 centimeters [11.8 inches] and a width of approximately 60 centimeters [23.6 inches]. There was no contact evidence readily apparent on the front right air bag.

Figure 12: Case vehicle's front right module cover flap and deployed air bag showing snagging and tears to top surface (case photo #55)

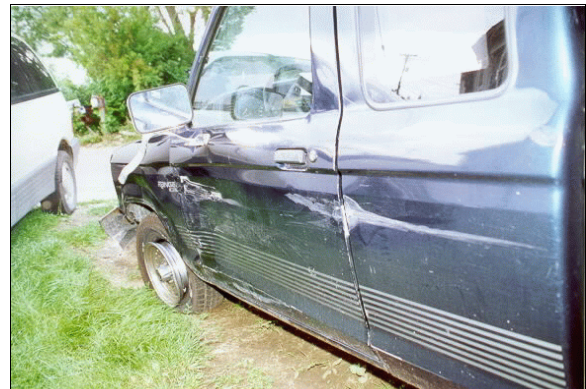
The 1992 Ford Ranger XLT was a rear wheel drive, 4x2, two-door, super cab pickup truck (VIN: 1F7CR14UXNP-----). Based on the vehicle inspection, the CDC was determined to be: **06-LYES-2 (190)** (maximum crush was 12 centimeters [4.7 inches]). No reconstruction program was used on the Ranger's left side sideswipe type impact (**Figure 13**) because the impact was out-of-scope. The Ford pickup was towed due to damage.

Figure 13: Sideswipe damage to Ford Ranger pickup's left side (case photo #65)

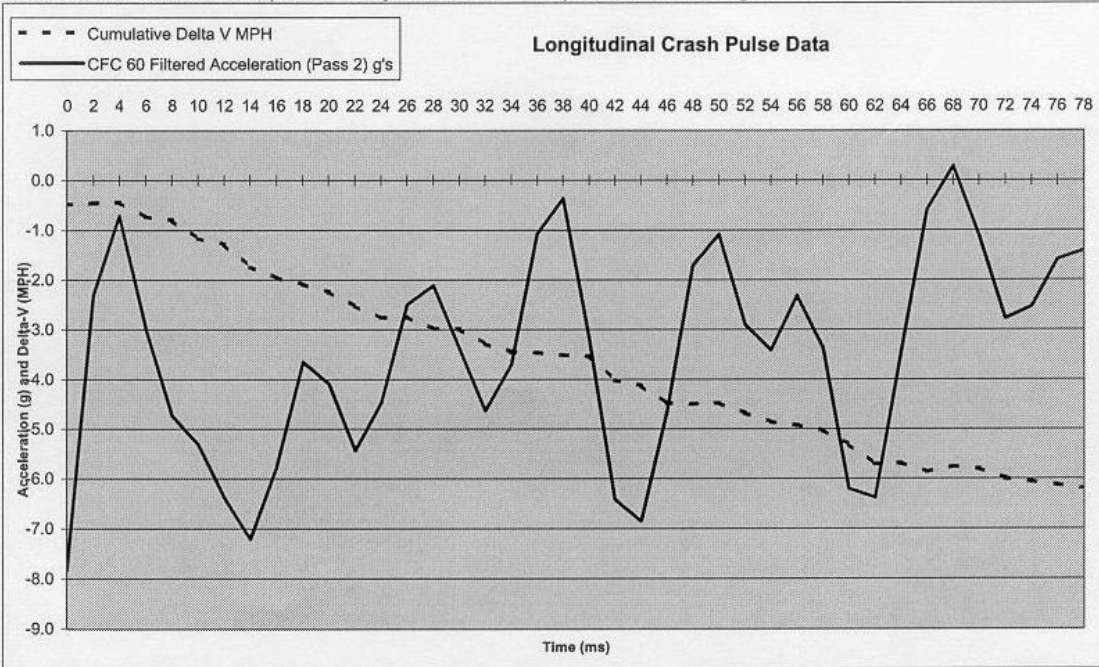
Longitudinal Cumulative Delta-V

Time (ms)	0	10	20	30	40	50	60	70	78
Delta-V (MPH)	-0.5	-1.2	-2.2	-3.0	-3.5	-4.5	-5.3	-5.8	-6.2

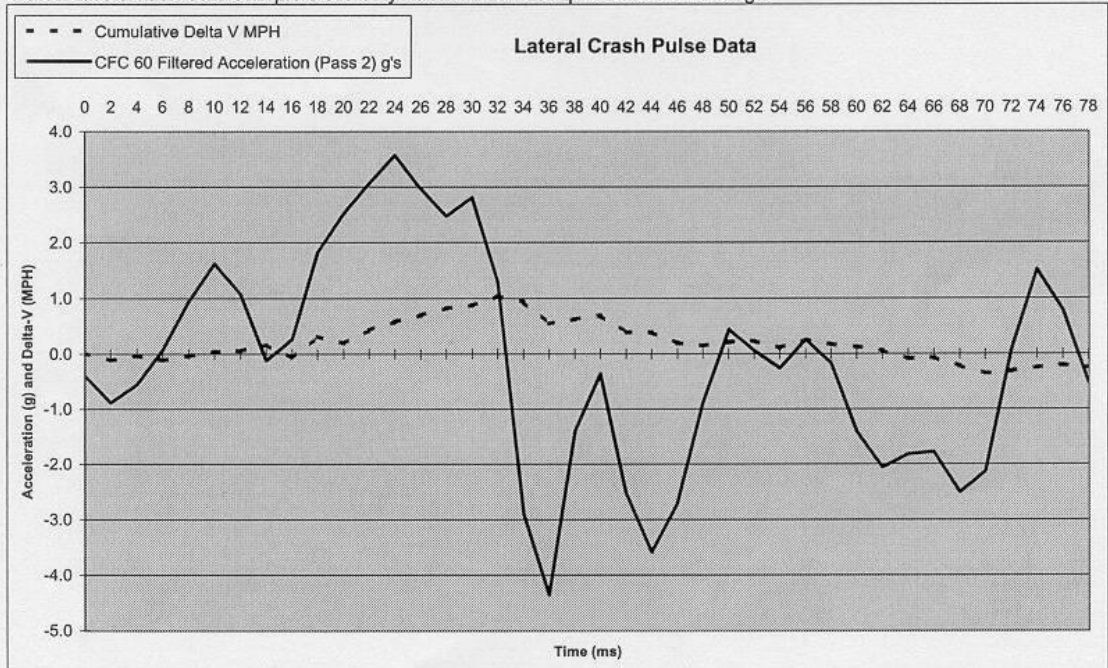
Lateral Cumulative Delta-V

Time (ms)	0	10	20	30	40	50	60	70	78
Delta-V (MPH)	0.0	0.0	0.2	0.9	0.7	0.2	0.1	-0.4	-0.2
