Remote Investigation/ Vehicle to Vehicle  
Dynamic Science, Inc. / Case Number: DS01018  
2001 Chrysler Town and Country Minivan  
Arizona  
November 2001

1. Report No. DS01018		2. Government Accession No.		3. Recipient Catalog No.	
4. Title and Subtitle  In-Depth Accident Investigation				5. Report Date	
				6. Performing Organization Report No.

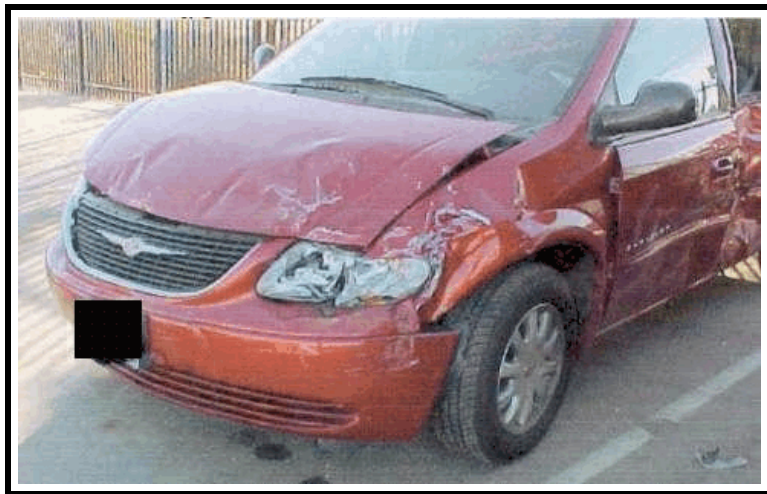
**Figure 1.** Front left, case vehicle, impact 1

The two vehicles impacted corner to corner. The front of the case vehicle (12FYEW1) struck the right front side of the other vehicle. The case vehicle had 106.0 cm (42.0 in) of direct contact damage<sup>1</sup> on the front end beginning at the left bumper corner. The case vehicle sustained a longitudinal delta V of -15.1 km/h (-9.4 mph) and a lateral delta V of 2.7 km/h (1.7 mph)<sup>2</sup>. Both front air bags deployed at this time. Given the relatively low speed and the restraint status of the

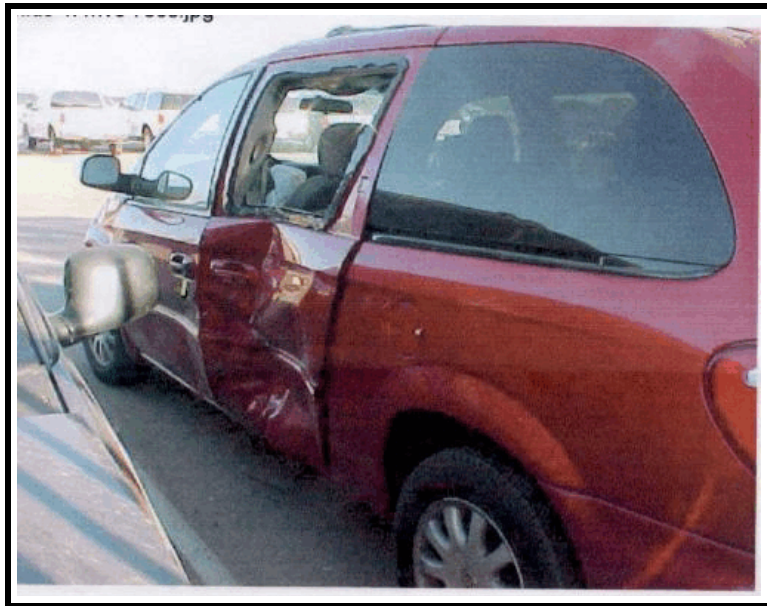
**Figure 2.** Left side, impact 2, case vehicle

The case vehicle was redirected to the right slightly. The other vehicle was pushed sharply in a counterclockwise direction. There was a second, side-slap type impact between the left rear door of the case vehicle (09LPEW2) and the right side of the other vehicle. The case vehicle sustained a lateral delta V of 16.8 km/h (10.4 mph)<sup>1</sup>. The other vehicle was redirected backwards and to the north where it departed the roadway and struck a fire hydrant. The fire hydrant was damaged and was leaking. The driver of the case vehicle reported that she sustained bruising to her left breast. The police indicated that she also had contusions to her arms, but she stated in the interview that it was her passenger who sustained those injuries. The police coded her injuries as “1–No Injury”. She was able to exit the vehicle on her own. She did not receive any medical treatment.

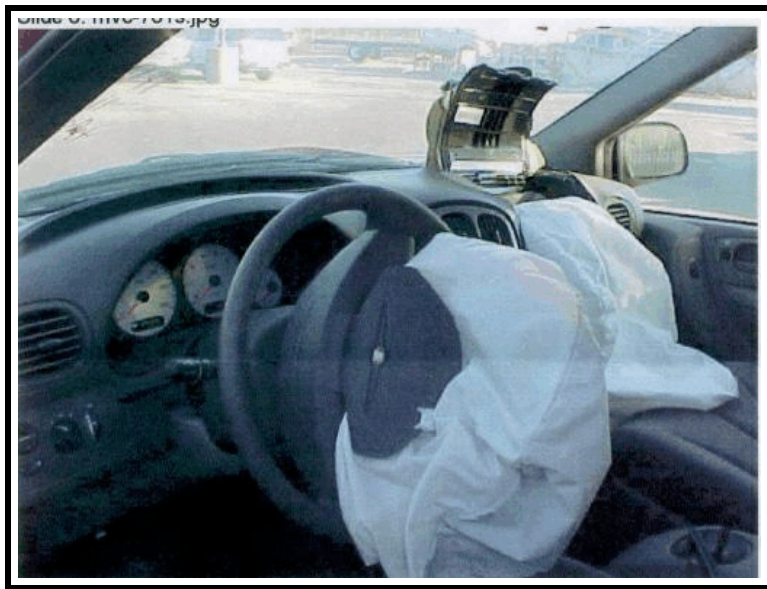
**Figure 3.** Driver and front right passenger air bags

occupants, this was likely a stage 1 deployment.

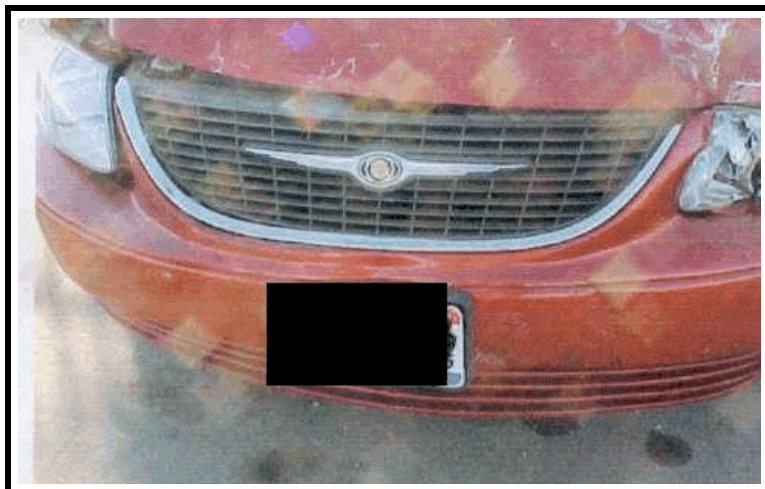
Description:	2001 Chrysler Town and Country van	
VIN:	2C8GP74L21Rxxxxxx	
Odometer:	Unknown	
Engine:	3.8L, 6 cylinder	
Reported Defects:	None	
Cargo:	None	
Damage Description:	Front bumper, hood, grille damaged. Some shifting to the right. Left door damaged. Left rear window disintegrated.	
CDC:	Impact 1: 12FDEW1 Impact 2: 09LPEW2	
Delta V (Impact 1):	Total	15.4 km/h (9.5 mph)
	Longitudinal	-15.3 km/h (-9.4 mph)
	Latitudinal	2.7 km/h (1.7 mph)
	Energy	10,935 joules (8,068 ft-lbs)

**Figure 5.** Front, case vehicle, impact 1

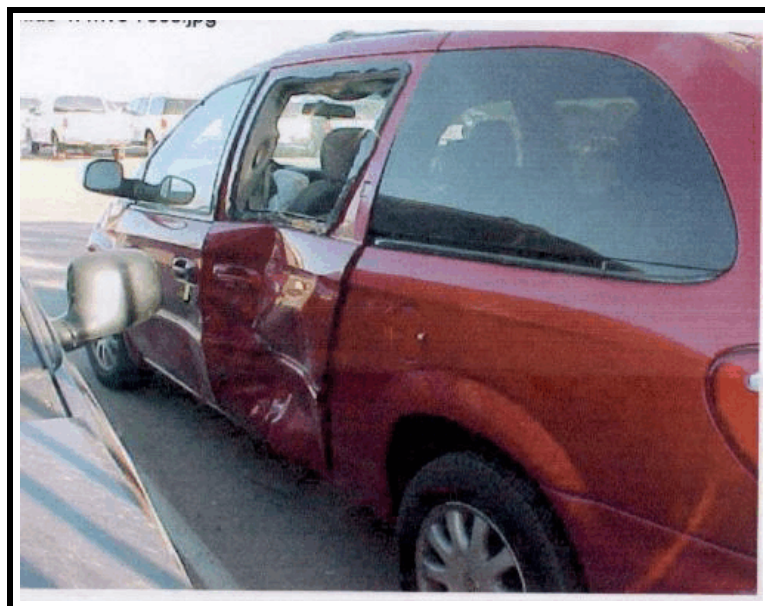
**Figure 6.** Left side, case vehicle, impact 2

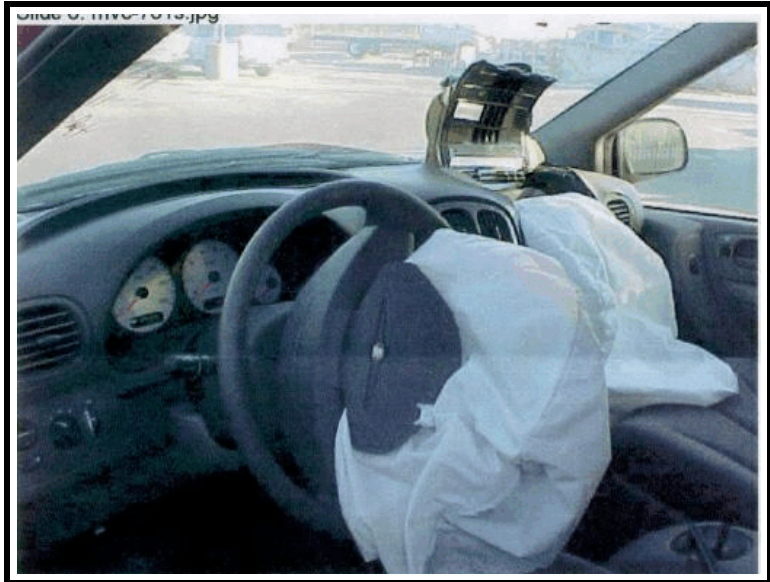
**Figure 7.** Deployed air bags
