ON-SITE AIR BAG INVESTIGATION

CASE NUMBER - IN01-019

VEHICLE - 2001 FORD CROWN VICTORIA "POLICE INTERCEPTOR"

CRASH DATE - July 2001

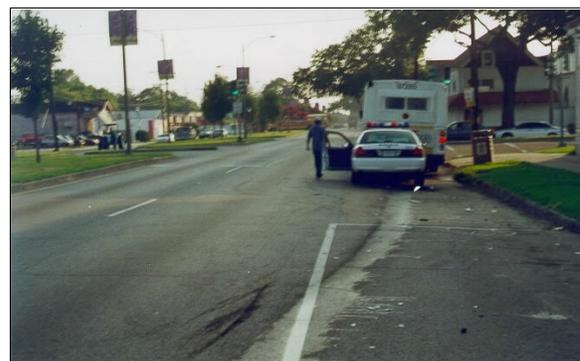
Figure 1: On-scene view looking northeast at final rest positions of case vehicle and transit bus; Note: radiator fluid trail from case vehicle leading to final rest (case photo #39)

The northeastbound roadway was straight and level at the area of impact (**Figure 1**). The pavement was bituminous, and the width of the inside through lane was approximately 3.4 meters [11.1 feet]. The northeastbound inside lane was bordered on the northwest side by a painted solid yellow line adjacent to a raised grassy median that was 8.1 meters [26.6 feet] wide. Pavement markings consisted of a painted dashed white line separating the two travel lanes and a painted solid white line separating the outside lane and a parking lane along the curb. The parking lane was 3.7 meters [12.2 feet] wide and was bordered by a mountable curb which protected the concrete sidewalk. The parking lane ended 25.3 meters [83.5 feet] southwest of an intersection, allowing for buses to pick up and drop off passengers at a designated bus stop. The estimated coefficient of friction was 0.70. Traffic controls at the intersection consisted of three vertically mounted on-colors traffic signals. The legal speed limit was 56 km.p.h. [35 m.p.h.].

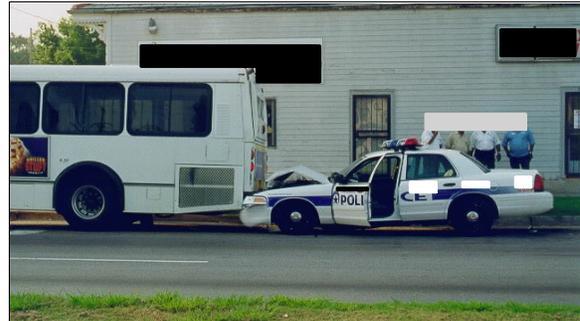
Figure 2: On-scene view looking southeast at final rest positions of case vehicle and transit bus; Note: case vehicle lodged underneath bus (case photo #40)

The front of the case vehicle (**Figure 2** and **Figure 3**) impacted and underrode the back left of the transit bus, causing the case vehicle's front right passenger air bag to deploy. Specifically, the top half of the case vehicle's bumper impacted the back bumper of the bus and, as a result, the case vehicle's bumper rotated backwards, allowing the case vehicle to underride the back of the bus and, subsequently, become stuck underneath it (**Figure 3**). After the impact, both vehicles continued traveling northeastward, while linked together, a distance of approximately 15.6 meters [52 feet] before coming to a stop at the bus stop (**Figure 1**).

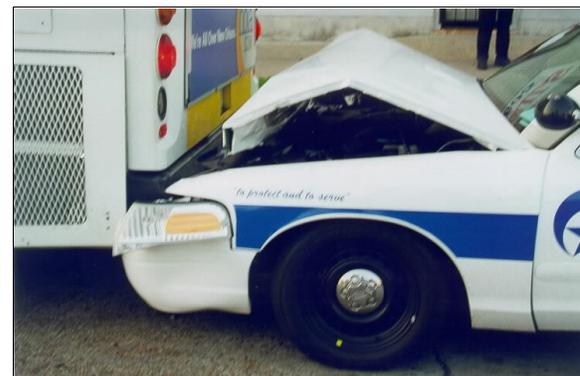
Figure 3: On-scene view looking southeast at case vehicle and transit bus stuck together at final rest (case photo #41)

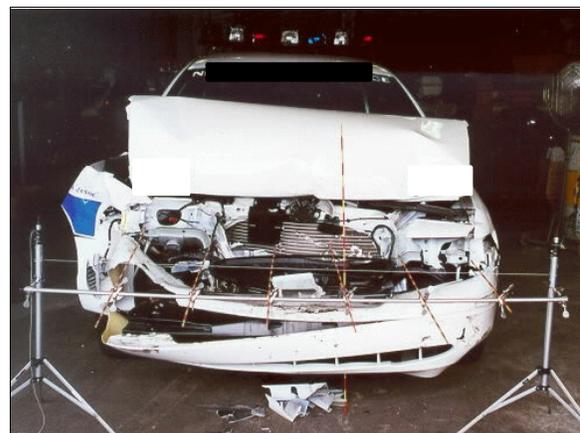
The case vehicle's contact with the Orion transit bus involved the entire front (**Figures 2 and 3** above) with the majority of damage being above bumper (**Figures 4 and 5**). Direct damage extended from bumper corner to front bumper, a measured distance of 150 centimeters [59.1 inches]. Maximum crush at the bumper level was measured as 11 centimeters [4.3 inches] at C6. Maximum crush above the bumper was measured as 53 centimeters [20.9 inches] at C3. The wheelbase on the case vehicle's left side was extended 2 centimeters [0.8 inches] while the right side remained unchanged. The case vehicle's front bumper, bumper fascia, grille, hood, right fender, radiator, and right and left headlight and right turn signal assemblies were directly damaged and crushed rearward. The left turn signal assembly sustained induced damage as well as both the right and left fenders. The right corner of the windshield's glazing, near the base, was cracked from contact by the corner of the hood.

Figure 4: Case vehicle's frontal damage with contour gauge in place for above bumper measurements (case photo #07)

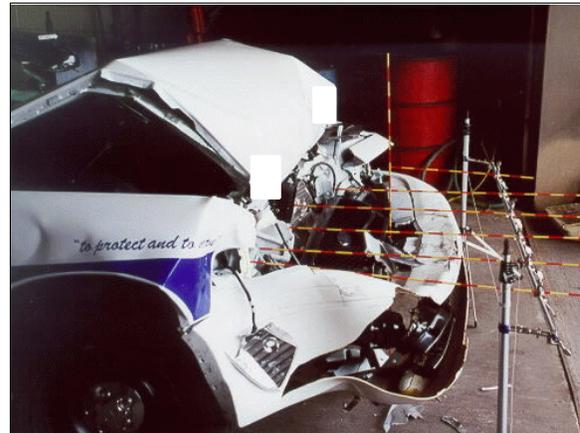
Figure 5: Reference line view from right showing above-bumper crush to case vehicle's front from underride impact with transit bus (case photo #14)

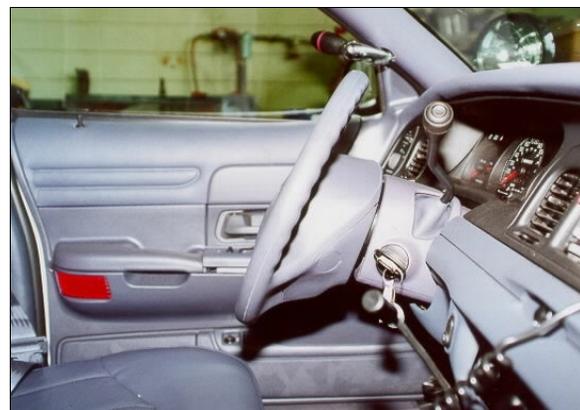
Inspection of the case vehicle's interior revealed evidence of occupant contact on: the windshield glazing; the brake release handle; the knee bolster; the left instrument panel; and the steering wheel rim, which was bent forward 3 centimeters [1.2 inches]. The steering column's shear capsule also showed movement with 1.5 centimeters [0.6 inches] of separation on the left and 0.5 centimeters [0.2 inches] on the right (**Figure 6**).

The case vehicle driver's air bag, which did not deploy, was located in the steering wheel hub. The existence, number, and size of tethers or vent ports could not be assessed nor could the shape or size of the driver's air bag be described. There was a 9 centimeter [3.5 inch] area of separation readily apparent along the left side of the driver's air bag module between the module's cover flap and steering wheel (**Figure 7**), which was a result of the steering wheel rim and spokes being deformed from the driver's contact.

Figure 6: Side view of case vehicle's deformed steering wheel rim; Note: shear capsule movement also occurred (case photo #29)

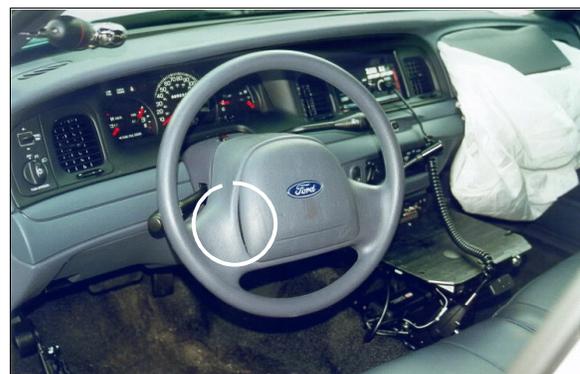
Figure 7: On-scene view of case vehicle's asymmetrical air bag deployment; Note: separation (highlighted) between steering wheel hub and air bag module (case photo #44)

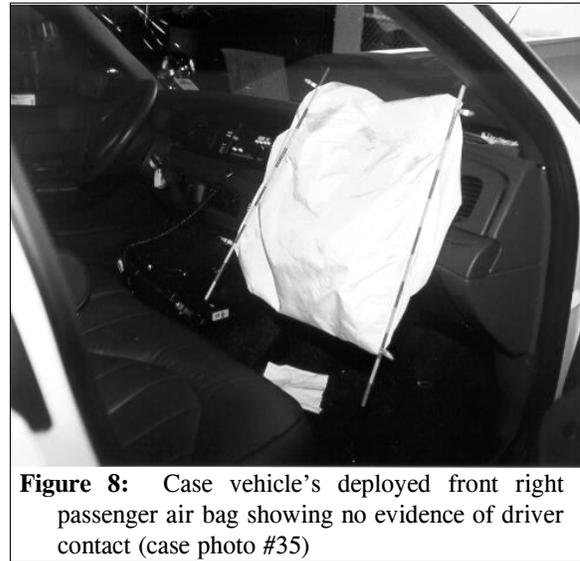
deployment to the air bag or the cover flap. The front right passenger's air bag was designed without any tethers. The front right air bag had one vent port, approximately 7 centimeters [2.8 inches] in diameter, located at the 10 o'clock position. The deployed front right air bag was rectangular with a height of approximately 42 centimeters [16.5 inches] and a width of approximately 52 centimeters [20.5 inches]. There was no contact evidence on the front right air bag (**Figure 8**).

Figure 8: Case vehicle's deployed front right passenger air bag showing no evidence of driver contact (case photo #35)

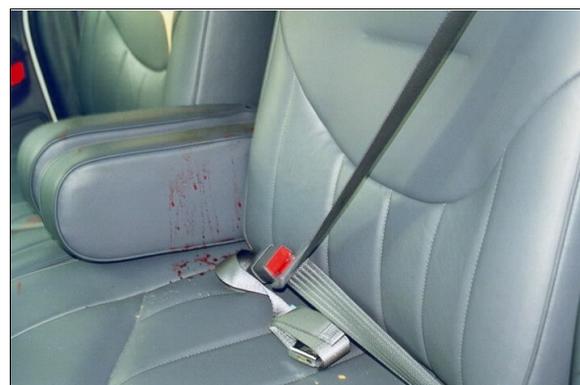
The case vehicle's driver was not using his available, active, three-point, lap-and-shoulder, safety belt system (i.e., it was buckled behind his back—**Figure 9**). The inspection of the driver's D-ring showed friction abrasions, but only because the pretensioner in the retractor actuated, which tugged the belt slack across the D-ring.

Figure 9: On-scene view of case vehicle's buckled, driver seat belt, which was behind driver's back; Note: blood on center arm rest (case photo #45)

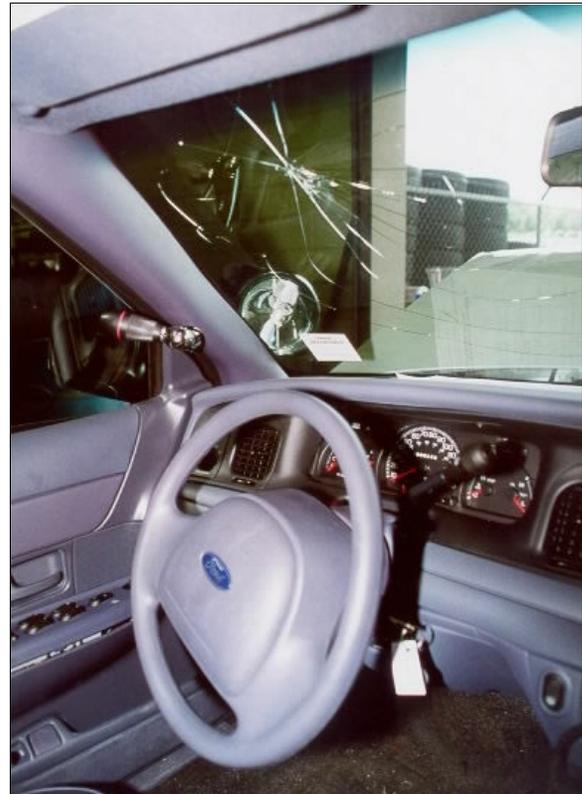
Figure 10: Vertical view of case vehicle’s driver seating area showing contacted steering wheel rim, non-deployed driver’s air bag, and “spider web” crack on windshield from driver’s head contact (case photo #30)

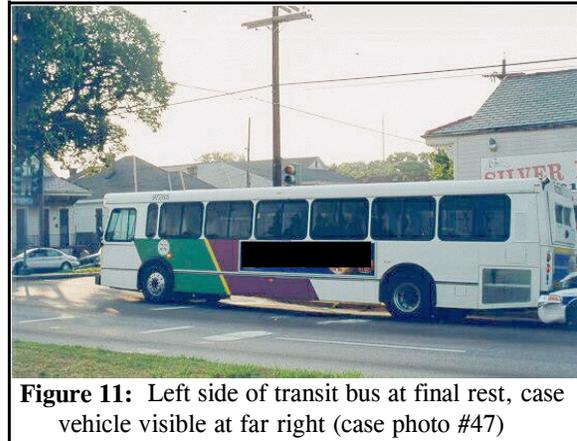
The other vehicle was a 1997 Orion V rear engine, two axle transit bus (VIN: 2B1569P78V6-----) (**Figure 11**). The maximum crush could not be estimated because the only available photographs show the two vehicles still lodged together with the case vehicle obscuring the damage on the bus. It appears that the damage to the bus was limited to minor deformation on the back bumper (**Figures 2 & 3**). The transit bus was taken out of service and was driven away from the scene.

Figure 11: Left side of transit bus at final rest, case vehicle visible at far right (case photo #47)

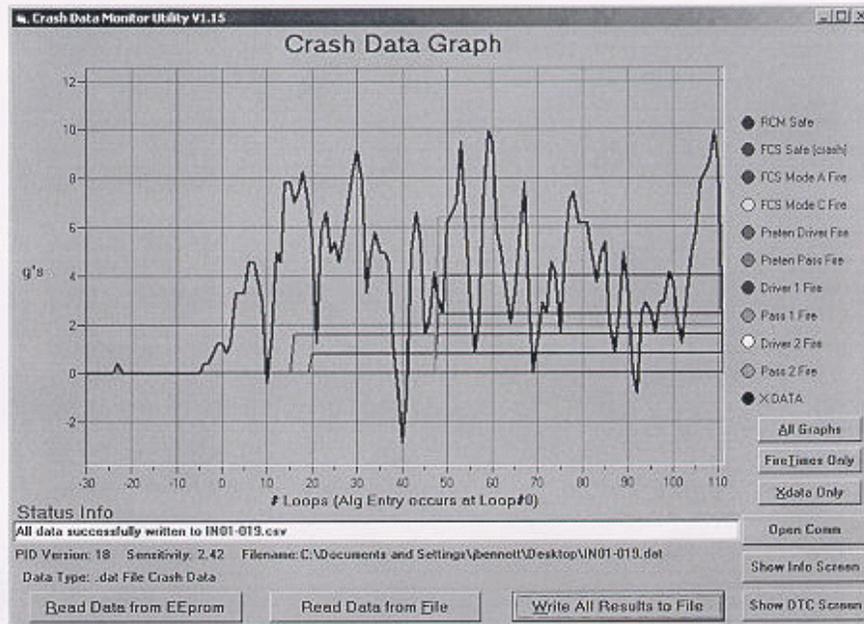
Figure 1.0: Acceleration data (at RCM) overlaid with severity logic & pyro deployment

The Front Crash Sensor (FCS) located on the radiator support realized a significant impact given the "FCS Mode A Fire" command illustrated in figure 1.0. The acceleration seen at the RCM, although relatively small is sufficient to "SAFE" the FCS decision thus an unbelted 1st stage airbag deploy results.

- Pretensioner: 38.4ms
- First (1st) Stage Unbelted: 38.4ms
- First (1st) Stage Belted: NONE -> Did NOT exceed threshold
- Second (2nd) Stage Unbelted: NONE -> Did NOT exceed threshold within Ford predefined window of opportunity following Unbelted 1st stage (10ms - 20ms)
- Second (2nd) Stage Belted: NONE -> Did NOT exceed threshold within Ford predefined window of opportunity following Belted 1st stage (10ms - 20ms)
