TRANSPORTATION RESEARCH CENTER

ON-SITE CHILD SAFETY SEAT INVESTIGATION

CASE NUMBER - IN01-023
LOCATION - ILLINOIS
VEHICLE - 1996 CHRYSLER CONCORDE LX
CRASH DATE - August, 2001

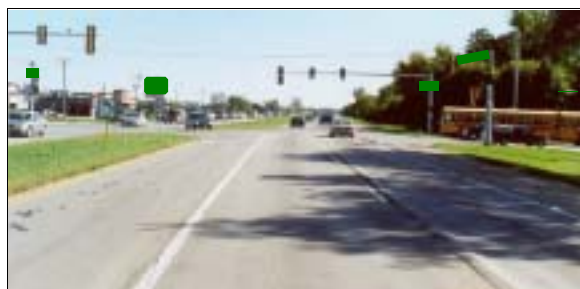
Figure 1: Case vehicle's southward travel path in inside through lane of southbound roadway (case photo #01)

The case vehicle was traveling south in the inside southbound through lane of a five-lane, divided, U.S. highway (**Figure 1**) and was approaching a four-leg intersection, intending to continue southward through the intersection (i.e., both the north and southbound roadways had two through lanes and a left-hand, turn lane). The Pontiac had been traveling north in the northbound, left-hand, turn lane of the same, five-lane, divided, U.S. trafficway and was turning

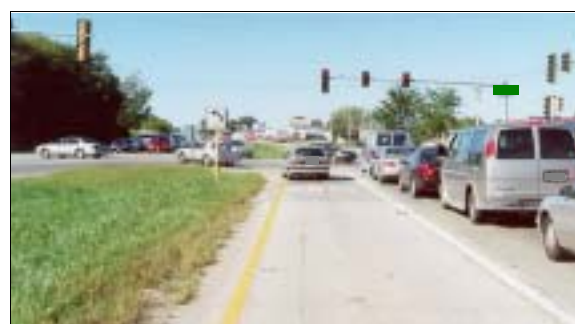
Figure 2: Pontiac's northward travel path in left-hand turn lane and likely converging trajectory (case photo #11)

left at the intersection (**Figure 2** above), attempting to travel westward on the intersecting roadway. The Chevrolet was stopped at the four-leg intersection, waiting for the traffic signal light to change. The Chevrolet was heading east in the eastbound through lane of a three-lane, undivided, city street, and intended to continue eastward (there was one through lane in both the east and westbound directions and an opposing, left-hand, turn lane in each direction). The case vehicle's driver steered to the right and was attempting to brake, trying to avoid the crash. The crash occurred in the inside, southbound through lane of the four-leg intersection; see **CRASH DIAGRAM** at end.

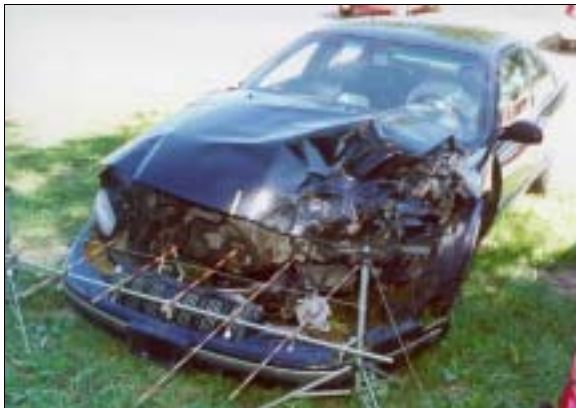
Figure 3: Elevated view from left of front of case vehicle's frontal deformation with contour gauge present showing damage from impact with Pontiac and traffic signal pole (case photo #18)

The front left half of the case vehicle (**Figure 3**) impacted the front right of the Pontiac (**Figure 4**), causing the case vehicle's driver and front right passenger supplemental restraints (air bags) to deploy. Next, the two vehicles side slapped with the case vehicle's left quarter panel (**Figure 5**) contacting the right quarter panel of the Pontiac (**Figure 4**). As a result of their converging trajectories and relative momentum, the case vehicle was redirected in a southwesterly direction and endswiped the stopped Chevrolet with

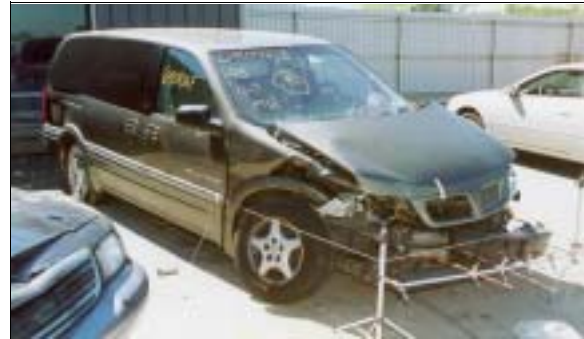
Figure 4: Pontiac's front right deformation viewed from right of front with contour gauge present showing impact from case vehicle; Note: side slap damage to right rear (case photo #73)

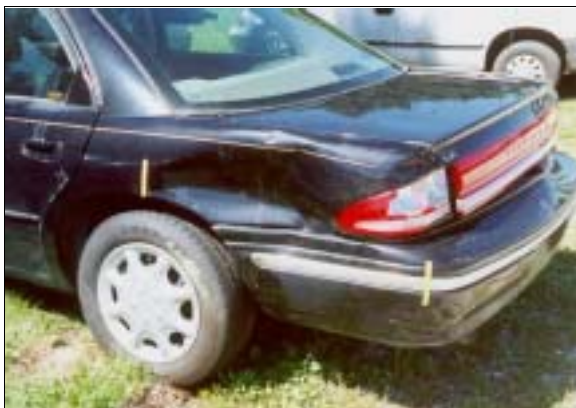
Figure 5: Case vehicle damaged left quarter panel from side slap impact with Pontiac; Note: yellow tape marks direct contact width (case photo #25)

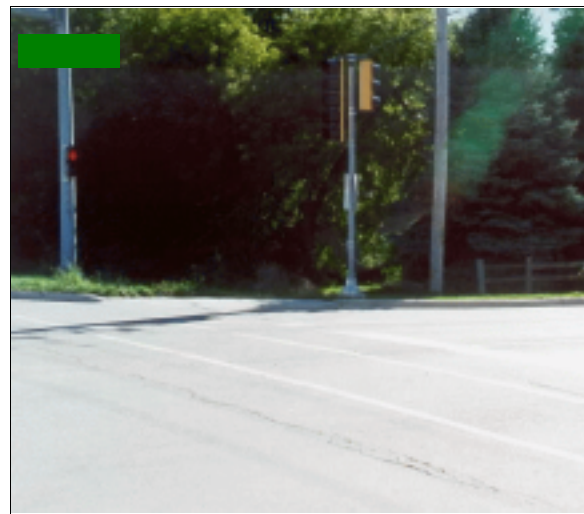
Figure 6: Case vehicle's redirected travel path toward Chevrolet which was stopped in eastbound through lane of intersecting roadway **and** toward southwest corner of four-leg intersection as a result of impacts with Pontiac (case photo #03)

its front right (**Figure 6** above). The case vehicle continued in a southwesterly direction and impacted the curb as it went off the southwest corner of the intersection. Almost immediately, the case vehicle impacted a traffic signal light control pole with its front left (**Figure 7**), whereupon it rotated slightly counterclockwise before continuing in a southerly direction. Next, the case vehicle sideswiped a wooden utility pole with its right side (**Figure 8**) prior to impacting and coming to rest against a wood pile, on the west side of the north-south trafficway, heading in a southerly direction (**Figure 9**). The Pontiac came to rest in the intersection heading in a south-southwesterly direction. The Chevrolet came to rest near its point of impact in the eastbound lane, still heading primarily in a easterly direction.

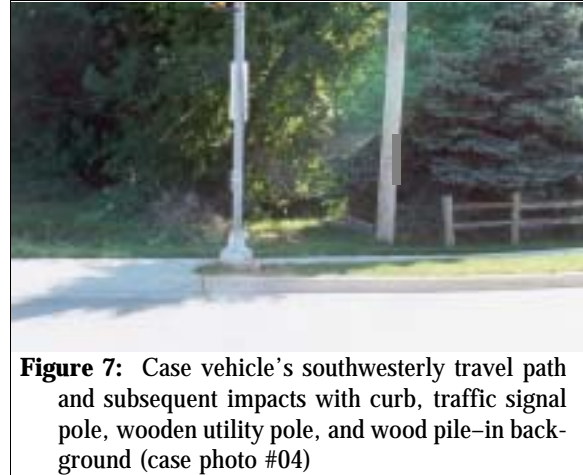
Figure 7: Case vehicle's southwesterly travel path and subsequent impacts with curb, traffic signal pole, wooden utility pole, and wood pile—in background (case photo #04)

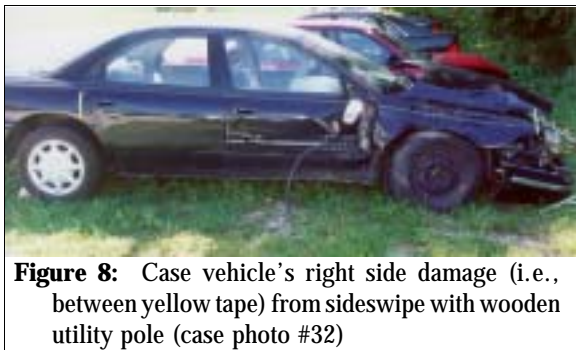
Figure 8: Case vehicle's right side damage (i.e., between yellow tape) from sideswipe with wooden utility pole (case photo #32)

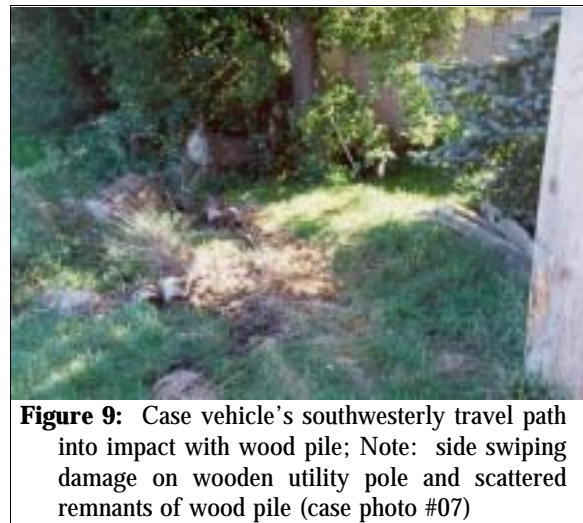
Figure 9: Case vehicle's southwesterly travel path into impact with wood pile; Note: side swiping damage on wooden utility pole and scattered remnants of wood pile (case photo #07)

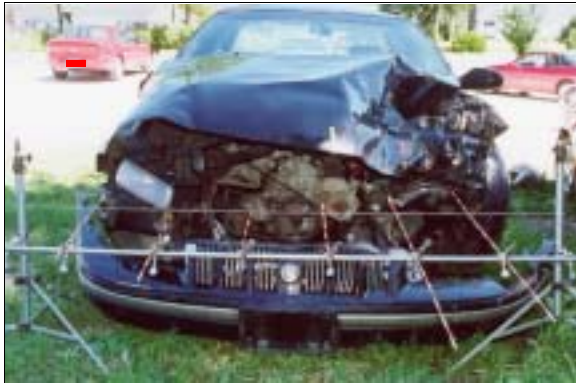
Figure 10: Case vehicle's overlapping frontal damage from four frontal impacts—Pontiac, Chevrolet, traffic signal pole, and wood pile (case photo #17)

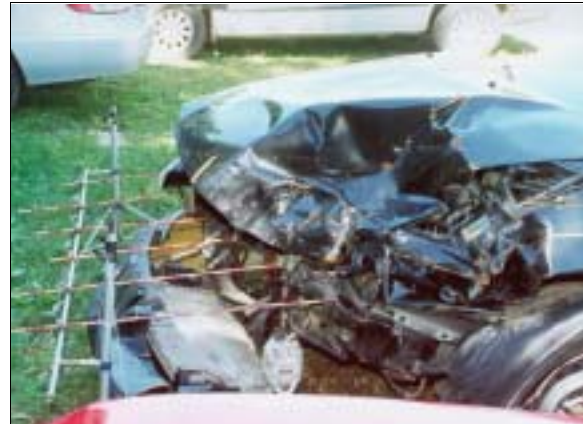
Figure 11: Reference line view from left showing case vehicle's damage from Pontiac and traffic signal pole (case photo #21)

The case vehicle's initial contact with the Pontiac involved its front left half. Direct damage appears to begin 1 centimeter (0.4 inches) to the left of center and extends to the right (towards the driver's side) a measured distance of 73 centimeters (28.7 inches) along the front bumper (**Figure 10**). The total residual maximum crush was approximately 37 centimeters (14.6 inches) at C₁ (**Figure 11**). The case vehicle's side slap impact with the Pontiac involved the case vehicle's left quarter panel (**Figure 5** above). The direct damage began 3 centimeters (1.2 inches) behind the left rear axle and extended rearwards a measured distance of 95 centimeters (37.4 inches). The maximum crush for the side slap was measured as 10 centimeters (3.9 inches). The direct damage and field L for the case vehicle's end swipe impact with the Chevrolet could not be determined. The direct damage location for the case vehicle's front left impact with the traffic signal pole was masked by its initial impact with the Pontiac (**Figure 11**). Direct and induced damage for the case vehicle's right sideswipe impact with the wooden utility pole (**Figure 6** above) began 29 centimeters (11.4 inches) forward of the right front axle and extended rearwards a measured distance of 231 centimeters (90.9 inches). Maximum crush for the sideswipe impact was measured as 14 centimeters (5.5 inches). As a result of the impacts, the wheelbase on the case vehicle's left side was shortened 6 centimeters (2.4 inches) while the right side remained unchanged. The case vehicle's front bumper, bumper fascia, grille, hood, radiator, left headlight assembly, right and left turn signal assemblies, and right and left fenders were directly damaged and crushed rearward. The case vehicle's right fender, right front door, right

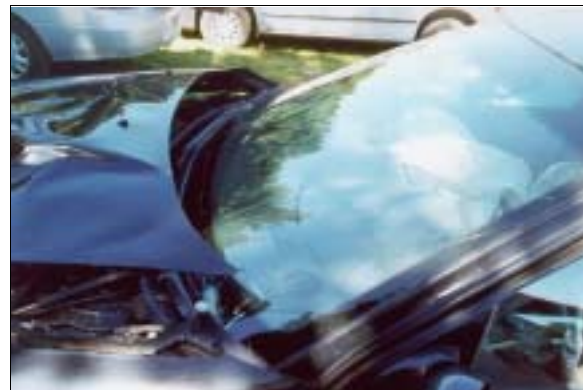
Figure 12: Stress fracture to case vehicle's windshield caused by back left tip of hood (case photo #24)

outside rear view mirror, right rear door, left quarter panel, and left back bumper were directly damaged and crushed inward. The case vehicle's left front tire was physically restricted, deflated, and dented from both the traffic signal and curb impacts. The case vehicle's right front tire was also deflated. The right headlight assembly, hood, and back bumper sustained induced damage. In addition, the left side of the windshield's glazing was cracked when the back left portion of the hood was pushed into it (**Figure 12** above).

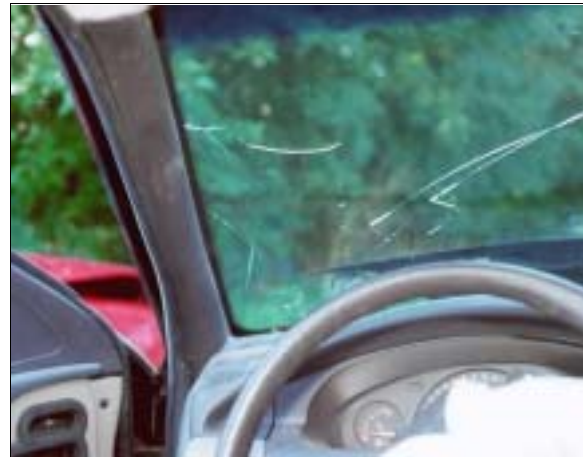
Figure 13: Case vehicle's left "A"-pillar and windshield's glazing showing scratches on "A"-pillar from rings on driver's left hand and stress fracture of windshield's glazing (case photo #38)

Inspection of the case vehicle's interior revealed occupant contact evidence on the left "A"-pillar (i.e., scratches—**Figure 13**) and driver's knee bolster (i.e., scuffs), both left (**Figure 14**) and right of the steering column. Finally, there was no evidence of intrusion to the case vehicle's interior, no evidence of compression to the energy absorbing shear capsules in the steering column, and no deformation to the steering wheel rim.

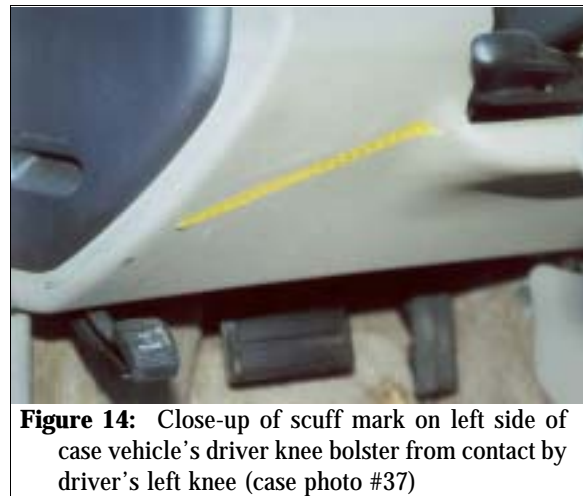
Figure 14: Close-up of scuff mark on left side of case vehicle's driver knee bolster from contact by driver's left knee (case photo #37)

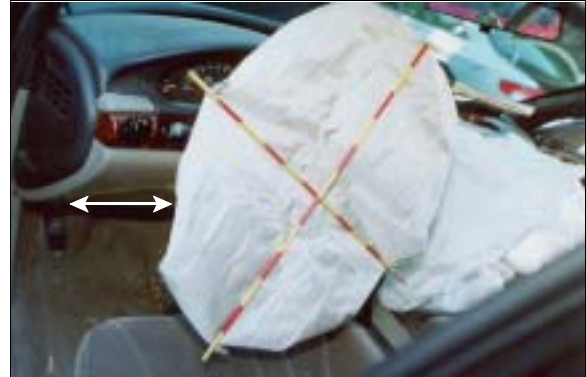
The case vehicle was equipped with a Supplemental Restraint System (SRS) that contained frontal air bags at the driver and front right passenger positions. Both frontal air bags deployed as a result of the front left corner impact with the Pontiac. The case vehicle's driver air bag was located in the steering wheel hub (**Figure 15**).

Figure 15: Case vehicle's deployed driver air bag showing small red transfer in center of air bag's stitching and contact (i.e., tape) to knee bolster (case photo #45)

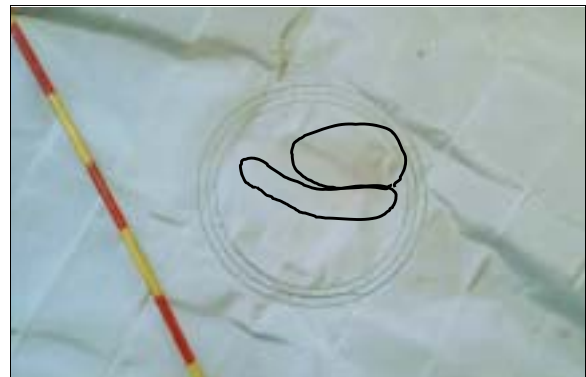
The module cover consisted of asymmetrical, essentially "H"-configuration, cover flaps made of thick vinyl with overall dimensions of 16 centimeters (6.3 inches) at the top and bottom horizontal seams and 8 centimeters (3.1 inches) vertically for the upper flap and 6 centimeters (2.4 inches) vertically for the lower flap. An inspection of the air bag module's cover flaps and the air bag's fabric revealed that the cover flaps opened at the designated tear points, and there was no evidence of damage during the deployment to the air bag or the cover flaps. The driver's air bag was designed with two tethers, each 12 centimeters (4.7 inches) in width and located vertically between the 1 and 5 o'clock and 11 and 7 o'clock positions. The driver's air bag had no vent ports. The deployed driver's air bag was round with a diameter of 63 centimeters (24.8 inches). An inspection of the driver's air bag fabric revealed a diagonally oriented, 8 centimeter (3.1 inch) red lipstick smear within the center stitching area on the driver's air bag (**Figure 16**). In addition, there was a greasy type smear located toward the 3 o'clock position.

Figure 16: Close-up of case vehicle's deployed driver air bag showing (highlighted) lipstick transfer and oily smudge on center stitching (case photo #47)

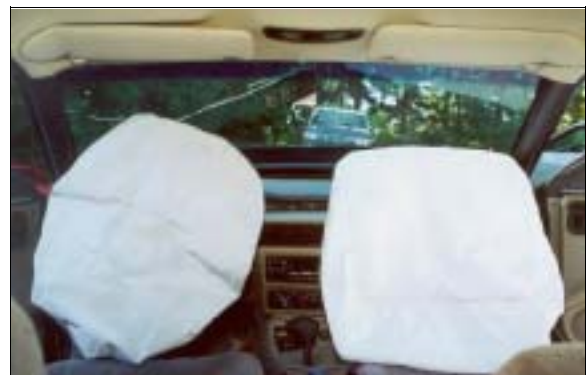
Figure 17: Case vehicle's deployed front air bags; Note: absence of contact evidence to windshield's glazing and sun visors (case photo #44)

no evidence of damage during the deployment to the air bag or the cover flap. The front right passenger's air bag was designed with one tether, 43 centimeters (16.9 inches) in width, located horizontally between the 4 and 8 o'clock positions (**Figure 17** above). The front right air bag had no vent ports. The deployed front right air bag was rectangular with a height of approximately 63 centimeters (24.8 inches) and a width of approximately 53 centimeters (20.9 inches). An inspection of the front right passenger's air bag fabric revealed that there was no contact evidence readily apparent on the front right air bag's fabric.

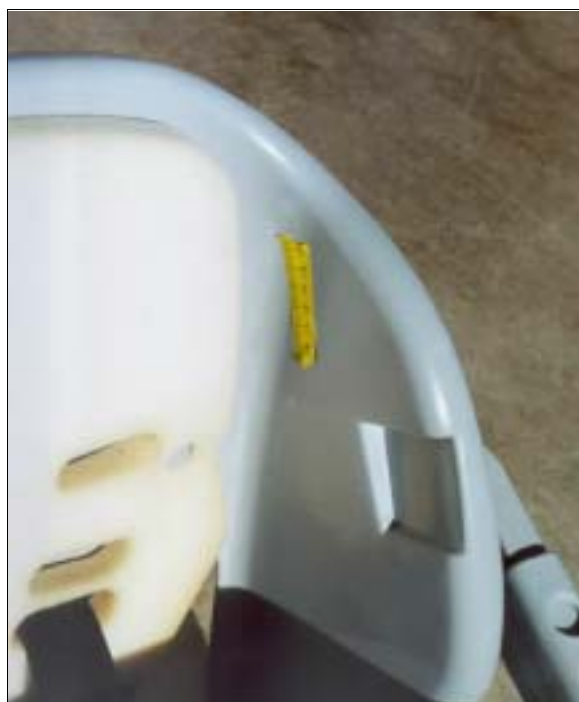
Figure 19: Close-up of child safety seat used by case vehicle's back center passenger showing small stress area to upper left corner of plastic shell (case photo #58)

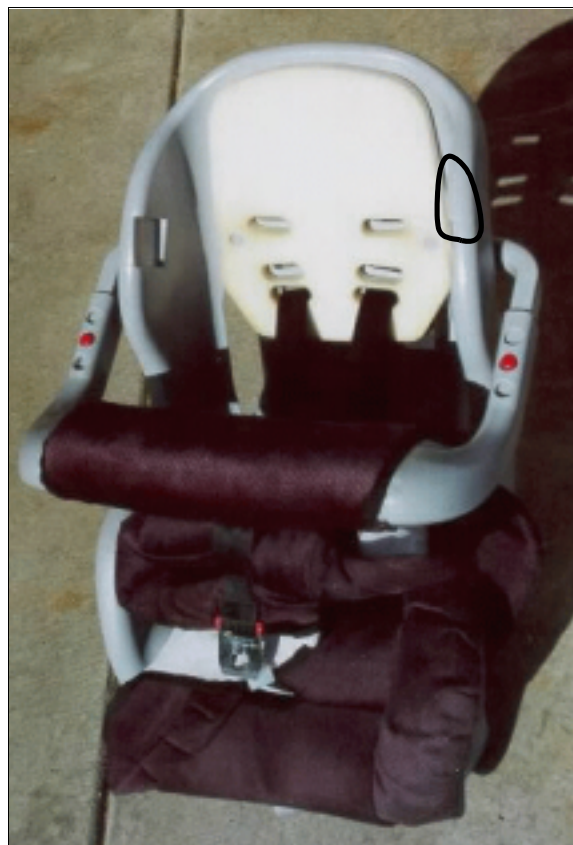
The convertible child safety seat used by the case vehicle's back center passenger was configured in the forward facing position at the time of the crash. The seat was manufactured by Evenflo on August 23, 2000 and was identified by Model name "Conquest". The seat was designed with a three-point harness connected to a pull-over shield which buckled between the child's legs (**Figure 18**). The seat also had an optional

Figure 18: Overhead view of convertible child safety seat used by back center passenger, with top half of cover pulled down, showing (highlighted) a small area of stress; Note: shield, buckle, and three upper harness slots (case photo #57)

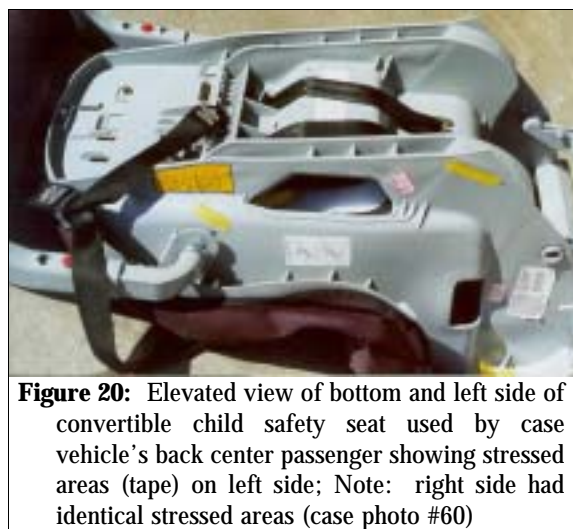
Figure 20: Elevated view of bottom and left side of convertible child safety seat used by case vehicle's back center passenger showing stressed areas (tape) on left side; Note: right side had identical stressed areas (case photo #60)

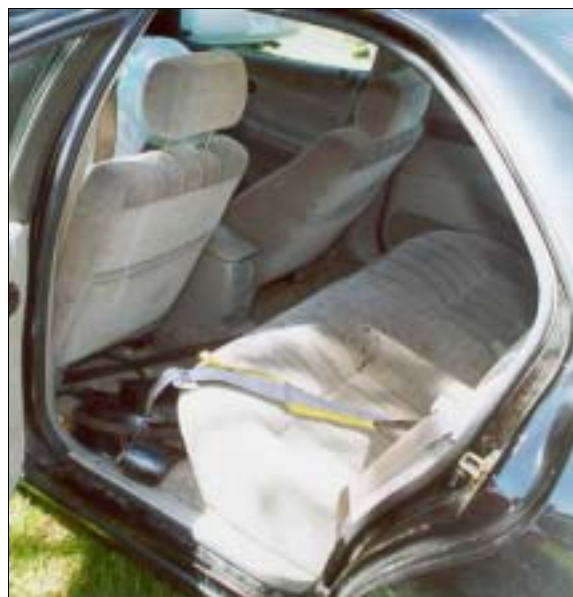
The case vehicle's back center passenger was restrained in a child safety seat which was secured by his available, active, two-point, lap belt system. The lap belt had a manual retractor with a locking teeth plate. Furthermore, there was evidence of belt pattern bruising and abrasions to his left shoulder, and the inspection of his seat belt webbing and latch plate showed evidence of loading (**Figures 21 and 22**).

Figure 21: Case vehicle's back seat showing loading evidence (yellow taped area) to center lap belt (case photo #51)

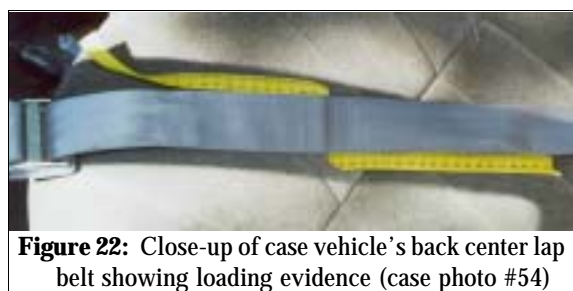
Figure 22: Close-up of case vehicle's back center lap belt showing loading evidence (case photo #54)

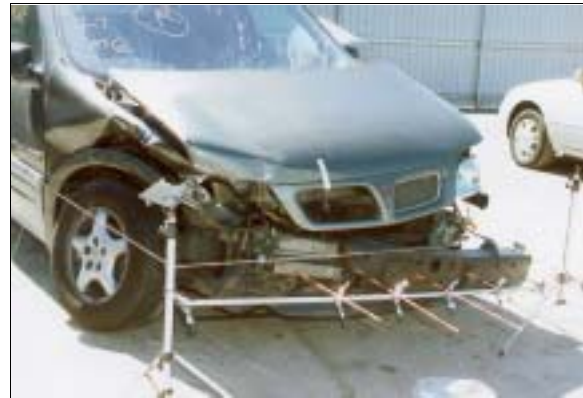
The Pontiac's initial contact with the case vehicle involved its front right corner. Direct damage began 17 centimeters (6.7 inches) right of center and extended, a measured distance of 57 centimeters (22.4 inches), along the front bumper to the front right bumper corner (**Figure 23**

Figure 23: Pontiac's front right damage viewed from right of front from impact with case vehicle; Note: left shifted front bumper and yellow tape marks width of direct contact (case photo #74)

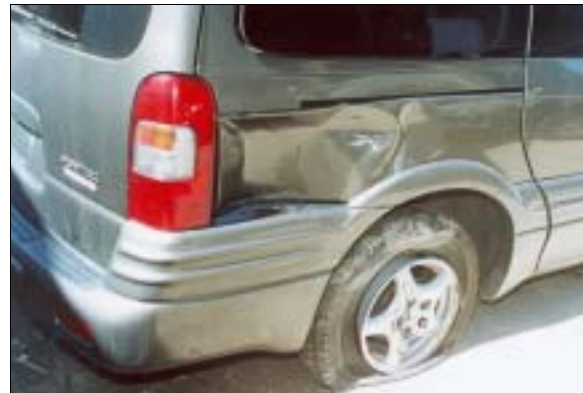
below). Residual maximum crush was measured as 16 centimeters (6.3 inches) at C₆. The Pontiac's side slap impact involved the back right (**Figure 24**). Direct damage began 14 centimeters (5.5 inches) rearward of the right rear axle and extended, a measured distance of 60 centimeters (23.6 inches), along the right side to the right back bumper. The wheelbase on the Pontiac's left side was shortened 3 centimeters (1.2 inches) while the right side was extended 2 centimeters (0.8 inches).

Figure 24: Pontiac's right back damage viewed from right of back, resulting from side slap impact with case vehicle's left back (case photo #70)
