**VERIDIAN ON-SITE CHILD SAFETY SEAT CRASH INVESTIGATION
SCI TECHNICAL SUMMARY REPORT**

VERIDIAN CASE NO. CA01-024

VEHICLE - 1996 CHEVROLET BLAZER

CRASH DATE - APRIL 2001

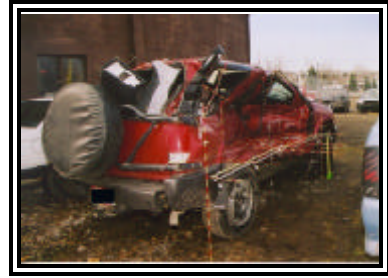
The 1996 Chevrolet Blazer sustained severe right side damage as a result of the impact with the Ford Explorer (**Figure 6**). The direct contact damage was concentrated at the passenger compartment area rearward of the right A-pillar and began 51.0 cm (20.0") aft of the front axle and extended 205.0 cm (80.7") rearward along the right side plane. The combined direct and induced damage began 32.0 cm (12.6") aft of the front axle and extended 278.0 cm (109.4") rearward along the right side. The maximum crush was located at the B-pillar, 28.0 cm (11.0") to the right of C3 and measured 63.0 cm (24.8"). The vertical location of the direct contact damage from the bumper of the Explorer was located at the mid-door level. There was no direct damage above the belt line. The right sill was crushed inward above the right frame rail and longitudinal paint transfers were noted on the right front door and right quarter panel. The right front door was crushed inward and rearward however, there were no latch or hinge failures. Induced buckling was present in each window frame and the entire right side of the Blazer. Slight separation was noted between the rear bumper and the right side panel. The Collision Deformation Classification (CDC) for this event was 02-RZEW-04. Six crush measurements spaced 55.6 cm (21.9") apart were taken at the mid-door level and were as follows: C1 = 0.0 cm, C2 = 20.0 cm (7.9"), C3 = 55.0 cm (21.7"), C4 = 61.0 cm (24.0"), C5 = 39 cm (15.4"), C6 = 0.0 cm. The window frame located between the right C-pillar and D-pillar was displaced and distorted from contact with the guardrail. The CDC for the guardrail impact was 03-RZHW-3.

Figure 6. Right side damage to Chevrolet Blazer

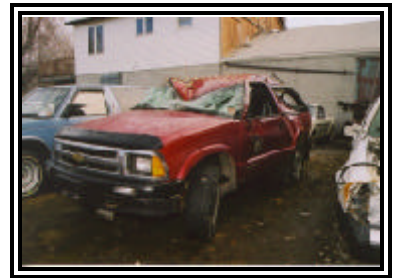
Figure 7. Trip-over damage to the Chevrolet Blazer

Both side mirrors and the rear backlight hatch were separated from the vehicle. Heavy lateral abrasions were noted on the left side rails and top aspect of the left side plane. The hood also sustained lateral abrasions on the front aspect. The roof was crushed from the trip-over and the windshield header was crushed downward approximately 30.5 cm (12.0") at the front right area (**Figure 7**). The CDC for the trip-over event was 00-TDDO-05. The plastic roof rack was separated from the vehicle, and laterally oriented abrasions were noted on the roof.

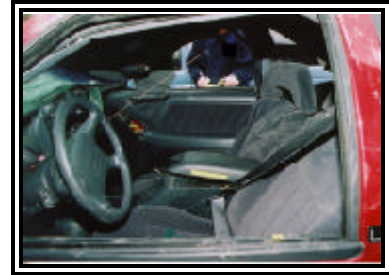
Interior damage to the 1996 Chevrolet Blazer was severe and attributed to compartment intrusion and occupant contact (**Figures 8 and 9**). Integrity was lost through all side window glazing, backlight glazing, and the windshield. All side glazing and backlight glazing was disintegrated from impact forces. The windshield glazing was cracked and holed from impact forces. The driver’s 3-point lap and shoulder belt had 10.0 cm (3.9") of fraying on the edges and had signs of loading on the lower aspect of the shoulder webbing and the right aspect of the lap webbing. Abrasions were noted on the D-ring anchor, and two small puncture marks were identified on the upper portion of the shoulder webbing below the D-ring anchor. The left front door interior surface and arm rest were scuffed and abraded from driver contact, probably when he rebounded to the left. The top aspect of the center console was displaced to the right from driver loading during the initial impact. Scuff marks were noted on the right interior side panel aft of the B-pillar from contact with the child safety seat. The retractor guide for the rear right lap and shoulder belt was fractured from loading. The retractor was found to be locked during the vehicle inspection prior to the removal of the child safety seat. After the buckle was disengaged, the retractor made a grinding sound as the webbing retracted, which indicated that it was in the automatic locking mode. After the webbing retracted, the investigator spooled out the entire length of the webbing to examine the operation of the retractor. The retractor did not switch into the ALR mode, however, the grinding sound was still present and resistance in the retractor was felt as the webbing was pulled out and retracted. Based on the inspection of the belt system, it appears the ratchet mechanism in the retractor was no longer operable, which indicates possible retractor damage. This was due to the exterior deformation and intrusion of the right C-pillar. Abrasions were noted on the plastic cover of the sliding latch plate from the webbing and the webbing showed signs of loading and exhibited a plastic transfer from the child safety seat. Multiple intrusions were documented and are listed in the following table.

Figure 8. Interior damage to Chevrolet Blazer

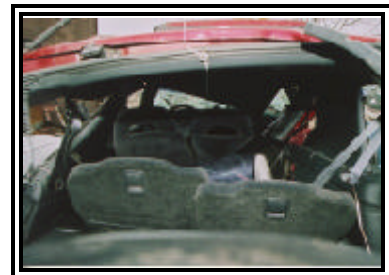
Figure 9. View from backlight of interior damage to the Chevrolet Blazer

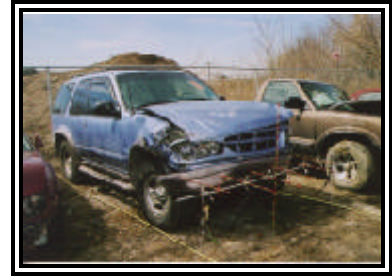
The 1997 Ford Explorer sustained moderate damage as result of the impact with the Chevrolet Blazer (**Figure 11**). The direct contact damage began at the left bumper corner and extended 146.0 cm (57.5") to the right bumper corner. The combined direct and induced damage involved the entire frontal plane and measured the same as the direct damage. The maximum crush was located at C6 at the right bumper corner and measured 27.1 cm (10.7"). The direct damage extended vertically from the bottom edge of the front bumper to the leading edge of the hood. Paint transfers from the Blazer were noted on the bumper, grille area, and leading edge of the hood. Both headlights were displaced. The front bumper was crushed rearward and shifted slightly to the right. The right aspect of the front bumper was crushed against the right front wheel, causing the wheel to be restricted. The hood was displaced slightly to the right and was buckled at the designated fold points. Both front fenders were crushed rearward and buckled outward. The Collision Deformation Classification (CDC) for this event was 11-FDEW-2. Six crush measurements were documented at the level of the front bumper and were as follows: C1 = 17.1 cm (6.7"), C2 = 10.8 cm (4.3"), C3 = 11.5 cm (4.5"), C4 = 12.5 cm (4.9"), C5 = 14.8 cm (5.8"), C6 = 27.1 cm (10.7").

Figure 11. Frontal damage to the Ford Explorer

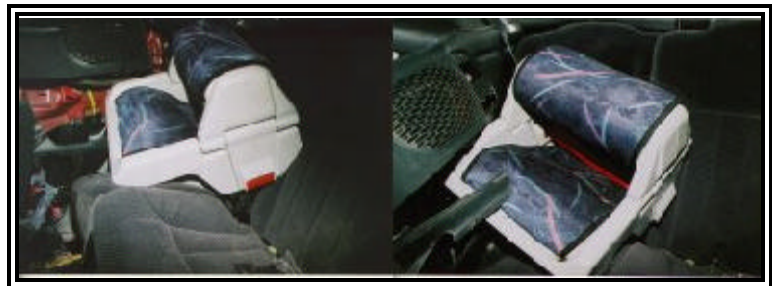
Based on the vehicle inspection and driver interview, the booster seat was used with the shield and installed with the Blazer's 3-point lap and shoulder belts routed through the belt path on the rear aspect of the seat (**Figure 14**). The driver stated that a family member had installed the seat earlier in the day prior to the crash, and engaged the switchable retractor to secure the seat. He also indicated that he had never been to a Child Safety Seat Checkpoint and did not read the owner's manual for this seat. He said that this booster seat was usually installed in a different vehicle, and was regularly switched between vehicles. Abrasions on the shield latch plate indicated frequent usage.

Figure 14. Post-crash views of seat installed in the Blazer

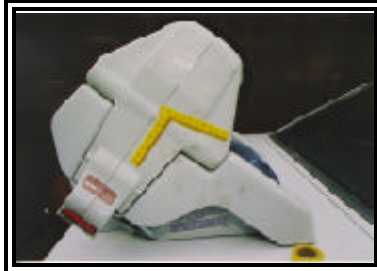
Damage to the Gerry “Double Guard” booster seat was minor, which was attributed to compartment intrusion and occupant contact. The integrated lap belt showed signs of occupant loading from the impact forces and the child being suspended upside down by the belt after the Blazer tipped onto its roof. Scuff marks were noted on the right outer aspect of the booster seat from contact with the intruded right interior side panel aft of the B-pillar (**Figures 15 and 16**). Abrasions were noted on the outboard aspects of the vehicle belt path from the lap and shoulder belt as the booster seat loaded the vehicle’s lap and shoulder belt. The rigid plastic bottom aspect of the child safety seat was scuffed from the lateral travel on the rear seat cushion.

Figure 15. Scuff marks on shield booster seat

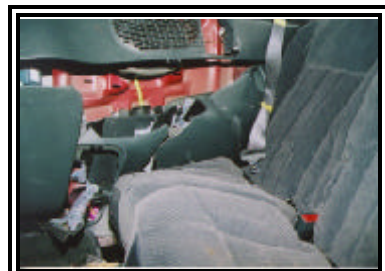
Figure 16. Scuff marks on interior trim panel from shield booster seat

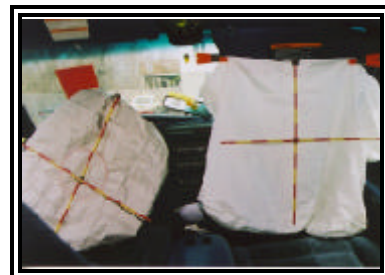
The 1997 Ford Explorer was equipped with frontal air bags for the driver and front right passenger positions (**Figure 17**). The air bags had deployed as a result of the frontal impact with the 1996 Chevrolet Blazer. The driver’s air bag was housed in the center of the steering wheel with asymmetrical H-configuration module cover flaps. The top flap measured 24.2 cm (9.5") in width across the top, 17.7 cm (7.0") in width across the bottom, and measured 6.4 cm (2.5") in height. The bottom flap measured 17.7 cm (7.0") in width and 4.2 cm (1.7") in height. The air bag was circular in shape and measured 58.0 cm (22.8") in diameter. The driver’s air bag was vented by two circular ports that measured 1.2 cm (0.5") in diameter and were located 7.0 cm (2.8") from the outer edge at the 11 and 1 o’clock positions. The air bag was tethered by two internal straps. There was no identifiable contact evidence or damage to the air bag surface or module cover flaps.

Figure 17. Frontal air bags in Ford Explorer
