# INDIANA UNIVERSITY

## ON-SITE ADVANCED OCCUPANT PROTECTION SYSTEM INVESTIGATION

CASE NUMBER - IN01-026  
LOCATION - Wisconsin  
VEHICLE - 2001 HONDA CIVIC LX  
CRASH DATE - October 2001

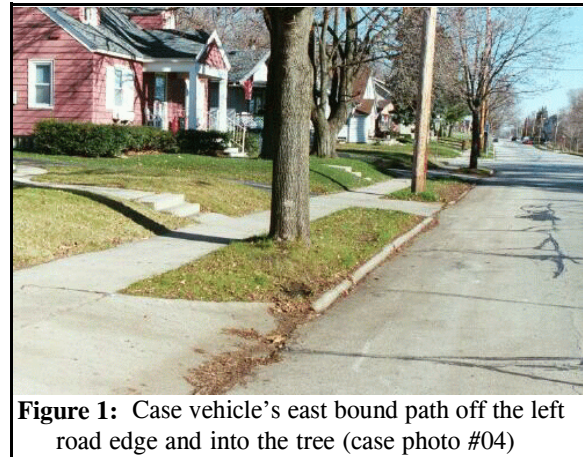
**Figure 1:** Case vehicle's east bound path off the left road edge and into the tree (case photo #04)

The crash occurred off the left (north) road edge (**Figure 1**). The front of the case vehicle impacted a large tree, causing the case vehicle's driver and front right passenger air bags to deploy and causing the safety belt pretensioners at the two front seat positions to actuate. The case vehicle rotated a few degrees counterclockwise and came to rest with its front end against the tree, its front wheels in the tree plot and its rear wheels in the roadway. The tree was approximately 41 centimeters [16 inches] in diameter. At the time of the crash, there were raked leaves piled in front of the tree such that the tree did not sustained any significant scarring or other damage.

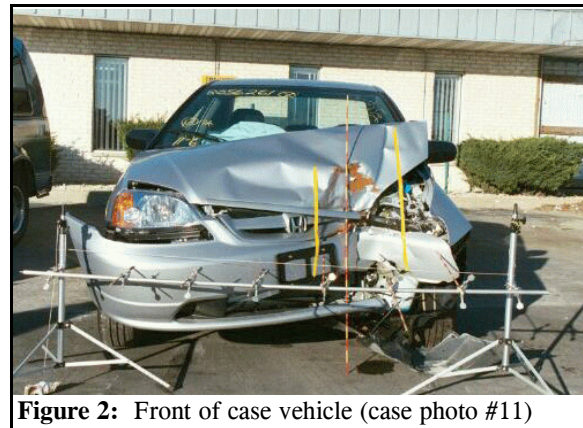
The case vehicle sustained direct damage starting 10 centimeters [3.9 inches] left of center and continuing leftward 40 centimeters, with induced damage across the entire front (**Figure 2**). The bumper cover was cracked and torn. The left headlight and turn signal assemblies were shattered and pushed rearward. The engine hood was bent down at the front, upward in the middle and was displaced rearward such that the back left corner of the hood impacted the lower left corner of the windshield, causing minor cracks. The left front wheel and tire were pushed rearward, against the trailing edge of the fender. The front edge of the left fender was bent inward, with induced buckling down the entire fender. Maximum crush was 53 centimeters [20.9 inches], in the area immediately inboard of the left headlight assembly. The wheelbase was shortened 10 centimeters [3.9 inches] on the left and lengthened 3 centimeters [1.2 inches] on the right. The CDC was determined to be **12-FYEN-3 (0)**. The WinSMASH reconstruction program, barrier algorithm, was used. Based on the case vehicle's measured crush profile, the Total, Longitudinal and Lateral Delta Vs were, respectively: 35 km.p.h [21.7 m.p.h.], -35 km.p.h. [-21.7 m.p.h.] and 0 km.p.h [0 m.p.h.]. These results appear to be reasonable. The crash severity for the case vehicle was moderate (24 to 40 km.p.h [15 to 25 m.p.h.]).

**Figure 2:** Front of case vehicle (case photo #11)

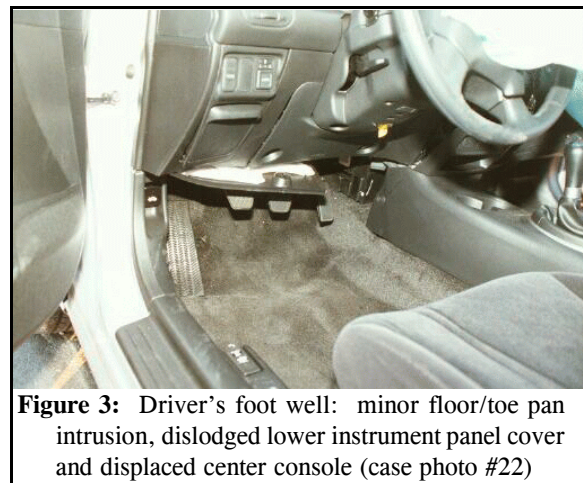
The interior of the case vehicle showed evidence of minor intrusion by the floor and toe pan in the driver's footwell and the lower portion of the left instrument panel. There was scuffing on the right side of the steering column, and the panel that enclosed the under side of the left instrument panel was cracked and displaced. The steering wheel was not deformed and the shear capsules showed no movement. The center console was cracked on both sides and along the seam where it joined the center instrument panel (**Figure 3**). Various components in the control panel in the center of the instrument panel were displaced. The glove box door showed evidence of contact by the front right passenger but did not come open (it was forced open by the police post-crash). The lower left corner of the windshield had minor cracks due to being impacted by

**Figure 3:** Driver's footwell: minor floor/toe pan intrusion, dislodged lower instrument panel cover and displaced center console (case photo #22)

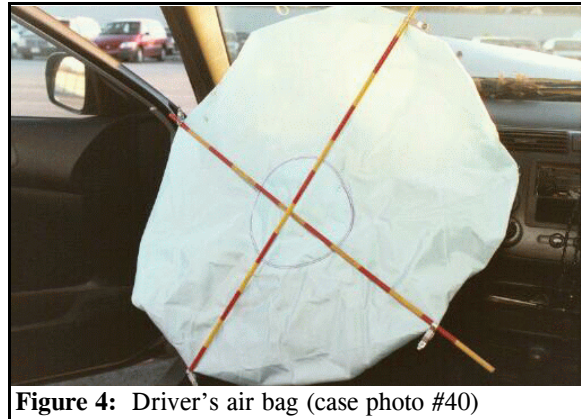
The driver's air bag was located in the steering wheel hub, with module cover flaps in the "H" configuration (**Figure 4**). The upper flap was rectangular and measured 8 centimeters [3.1 inches] vertically by 16 centimeters [6.3 inches] horizontally. The lower flap was trapezoidal, measuring 8 centimeters [3.1 inches] vertically, 16 centimeters [6.3 inches] horizontally at the top and 7 centimeters [2.8 inches] at the bottom. The driver's air bag was round, measuring 63 centimeters [24.8 inches] in diameter. It had two tether straps, and two vent ports at the 11 and 1 o'clock positions. There was no damage to the flaps nor the air bag. There was a smudge of mud in the upper right area on the front of the air bag and no other evidence of contact.

**Figure 4:** Driver's air bag (case photo #40)

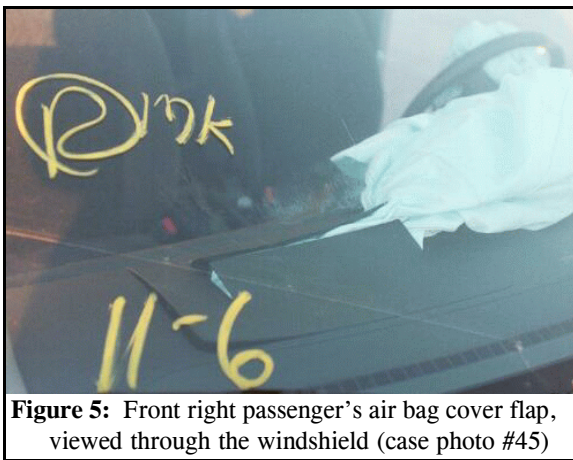
The front right passenger's air bag was located in the top of the instrument panel. The module had a large cover panel that was set into the instrument panel, with the flaps well within the margins of the larger cover panel. The upper left corner of the cover panel was slightly displaced. The flaps were approximately rectangular in the "H" configuration and opened by tearing through pre-stressed seams (**Figure 5**). The center seam measured 22 centimeters [8.7 inches]. The upper flap tore 5 centimeters [2.0 inches] on the left and 6 centimeters [2.4 inches] on the right and the lower flap tore 6 centimeters [2.4 inches] on the left and 4 centimeters [1.6 inches] on the right. The front right passenger's air bag was trapezoidal, measuring 49 centimeters [19.3 inches] vertically, 50 centimeters [19.7 inches] horizontally at the top and 46 centimeters [18.1 inches] at the bottom (**Figure 6**). It had no tether strap, and two vent ports located at the 10 and 2 o'clock positions. There were faint traces of body fluid (saliva?) in the lower right quadrant on the front of the air bag.

**Figure 5:** Front right passenger's air bag cover flap, viewed through the windshield (case photo #45)

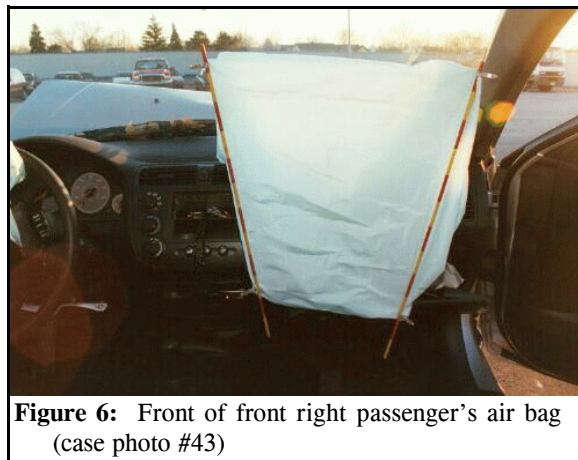
**Figure 6:** Front of front right passenger's air bag (case photo #43)

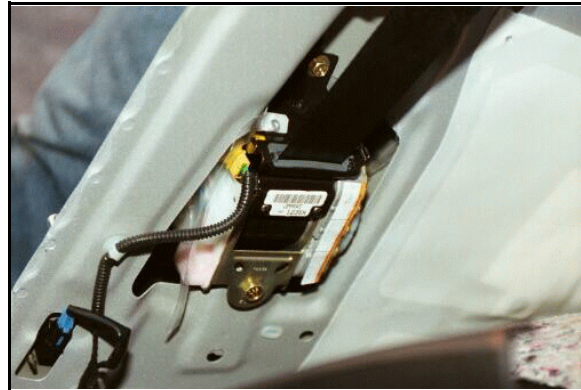
The two front seats were fitted with manual, three-point, lap-and-shoulder safety belt systems that were equipped with retractor pretensioners that did actuate. At the time of the inspection, the pretensioners were still firmly locked such that it was not possible to pull the webbing out of the spool. There was substantial slack webbing laying in the seats, indicating that the belts were in use when the pretensioners actuated. Both the left and right D-rings showed loading marks and there were stress marks and frayed edges on the webbing for both safety belts. The interior trim panel covering the right B-pillar was removed and

**Figure 7:** Front right passenger's safety belt retractor-type pretensioner (case photo #39)

the retractor mechanism was found to be mounted just below the belt line. There was no visible indication that the pretensioner had actuated other than the firmly locked webbing.

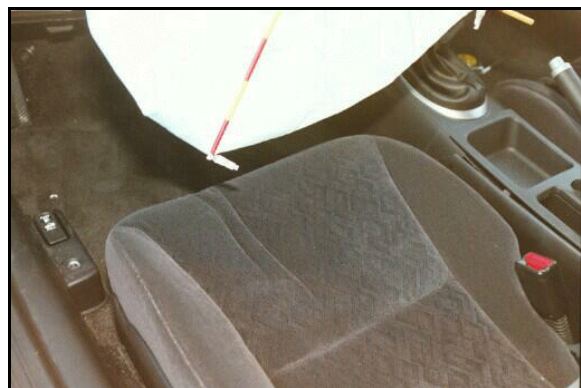
**Figure 8:** Driver's seat cushion, showing deformation of the cushion; note, there are no longitudinal creases on an undeformed seat (case photo #23)

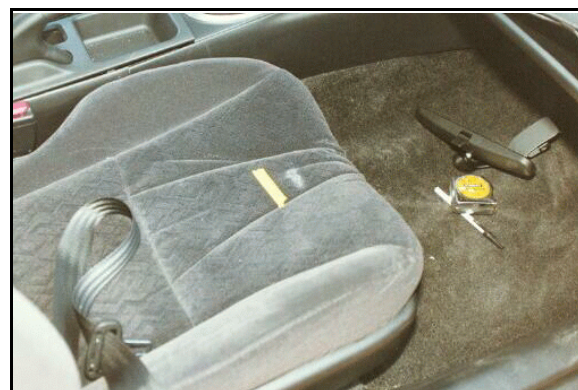
**Figure 9:** Front right passenger’s seat cushion, showing friction scrub on upholstery and bending of the cushion frame; note, there are no longitudinal creases in an undeformed cushion (case photo #33)
