**ADVANCED OCCUPANT PROTECTION SYSTEM STUDY  
2001 FORD WINDSTAR INVESTIGATION**

**VERIDIAN CASE NO. CA01-030**

**LOCATION - MARYLAND**

**CRASH DATE - MAY 2001**

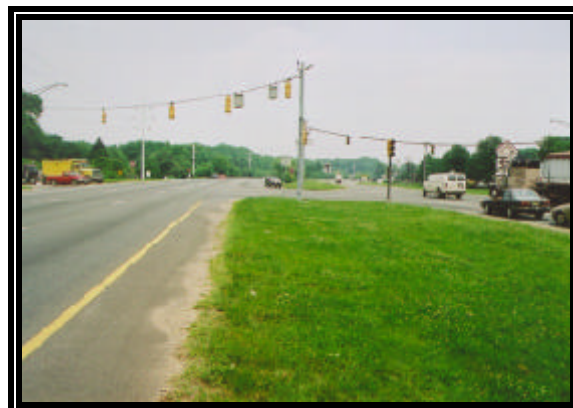
**Figure 1:** North view of the intersection.

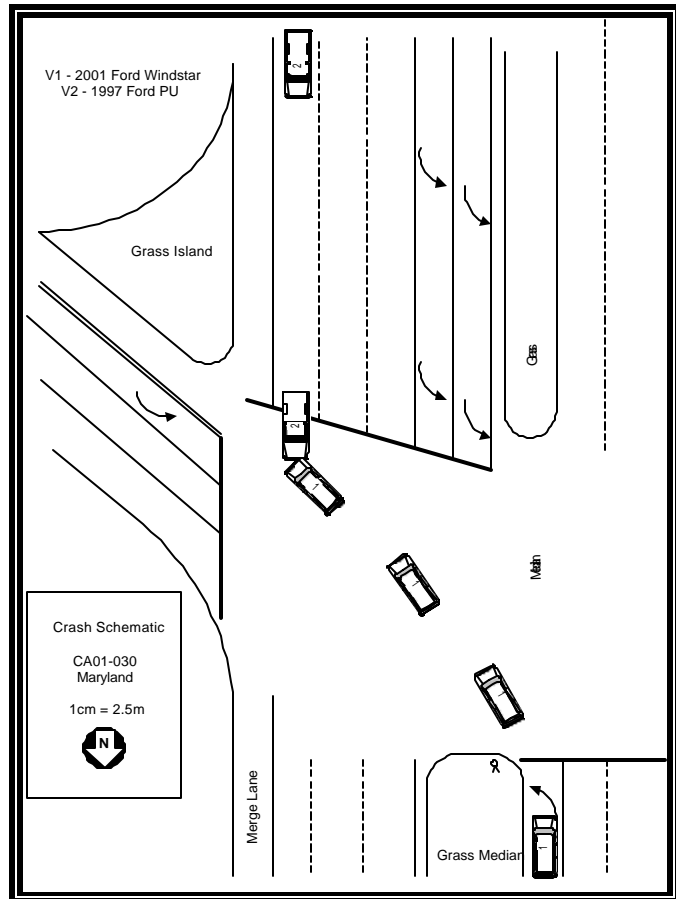
The crash occurred when the Ford Windstar turned left across the northbound travel lanes and was struck by the Ford pick-up truck. The driver of the Ford pick-up truck had entered the intersection against the red traffic signal. The left frontal region of the Ford pick-up truck impacted the right frontal region of the Windstar in an oblique angular configuration. The directions of force were 01 and 11 o'clock for the Windstar and pick-up truck, respectively. The force of the crash was below the threshold required for deployment of the Windstar's frontal occupant protection system. The barrier equivalent delta V of the Windstar calculated by the WINSMASH model was 13.1 km/h (8.1 mph). The longitudinal and lateral of the delta V were -11.5 km/h (-7.1 mph) and -6.5 km/h (-4.0 mph), respectively. This calculation appeared to underestimate the crash severity based on SCI experience. An estimated delta V in the range of 19.3 km/h (12 mph) was more consistent with the vehicle damage and crash dynamics based on SCI experience.

**Figure 2:** Crash schematic.

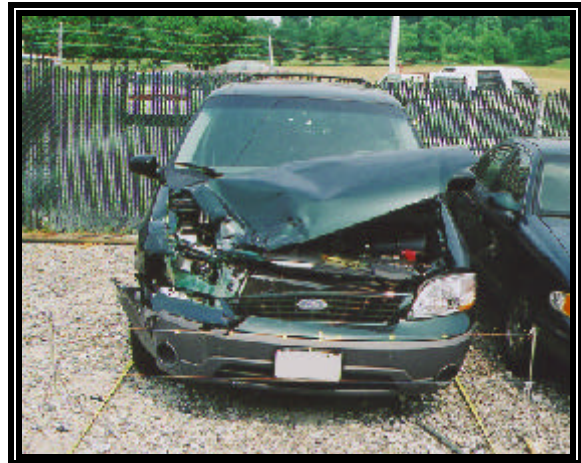
**Figures 3 and 4** are the front and left front views of the Windstar. The frontal plane of the Windstar sustained 79 cm (31 in) of direct contact damage that began 5 cm (2 in) left of center and extended to the right corner of the front bumper. The combined direct and induced damage extended across the full 147 cm (58 in) front end width. The nature of the frontal damage was consistent with an under-ride impact configuration. The maximum residual deformation of the bumper reinforcement beam measured 3.8 cm (1.5 in) at C6. The above-bumper damage at C6 was 23 cm (9.0 in) measured at the elevation of the upper radiator support. The profile representing the average residual crush was as follows: C1=0, C2=0, C3=0, C4=0, C5=8.3 cm (3.25 in), C6=13.3 cm (5.3 in). The hood buckled, and was displaced left and rearward fracturing the lower left aspect of the windshield. There was no measurable change in the wheelbase dimensions. The Collision Deformation Classification (CDC) was 01-FZEW-1. The barrier

**Figure 3:** Front view of the Ford Windstar.

algorithm of the WINSMASH collision model calculated a total delta V of 13.1 km/h (8.1 mph). The longitudinal and lateral of the delta V were -11.5 km/h (-7.1 mph) and -6.5 km/h (-4.0 mph), respectively.

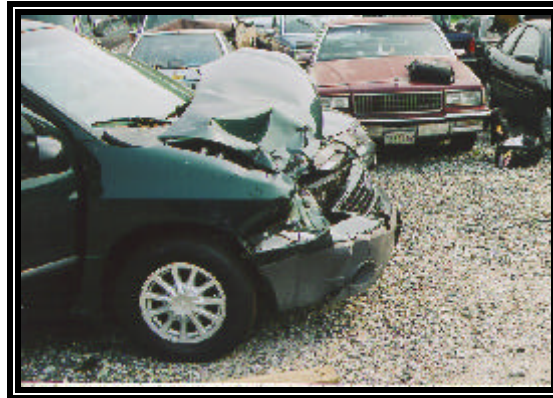
**Figure 4:** Right lateral view across the front plane.

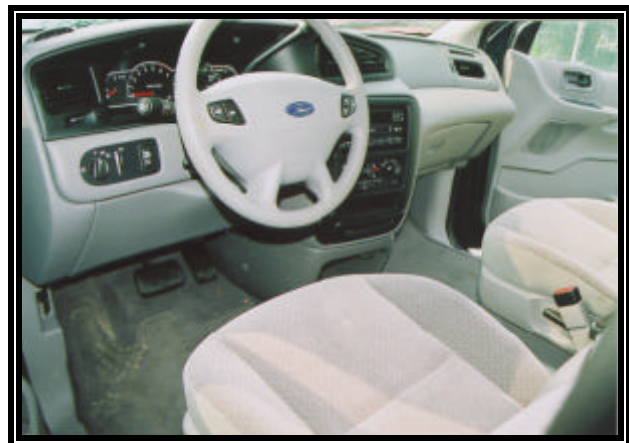
**Figure 5** is a left view of the driver's interior. There was no interior damage associated with this crash. No points of occupant contact were identified. The lack of interior damage was consistent with the minor severity of the event. The driver's seat was adjusted to a rear track position at the time of the inspection and measured 2.5 cm (1.0 in) forward of full rear. It could not be verified if this was its adjusted at-crash position.

**Figure 5:** View of the driver's interior.

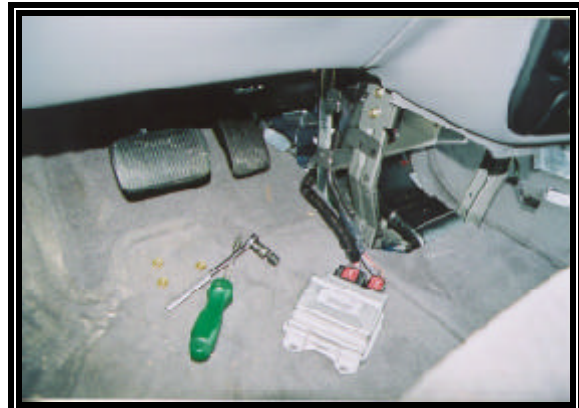
**Figure 6** is a view of the RCM taken during its removal. The module was located under the center aspect of the instrument panel, to the right of the accelerator pedal. The RCM was manufactured by the Takata Corporation and was identified by the following nomenclature:

**Figure 6:** View of the Restraint Control Module during removal.

Prior to disconnecting the wiring harness, the vehicle's ignition was cycled to read any fault codes stored within the module. The fault codes could be read via the indicator lamp in the instrument cluster. Upon cycling the key to "ON", the indicator lamp illuminated for approximately 6 seconds, as the RCM performed its diagnostic check of the air bag system. The indicator lamp then went "OFF", indicating the air bag system was operational and that there were no stored fault codes. After disconnecting the wiring harness from the RCM, cycling of the ignition key to "ON" caused the air bag indicator lamp to illuminate and remain on. (This condition was expected because the RCM had been removed from the system.)
