**TRANSPORTATION SCIENCES
CRASH DATA RESEARCH CENTER**

SEAT BACK FAILURE/CHILD FATALITY INVESTIGATION

VERIDIAN CASE NO. CA01-032

VEHICLE: 1999 TOYOTA CAMRY

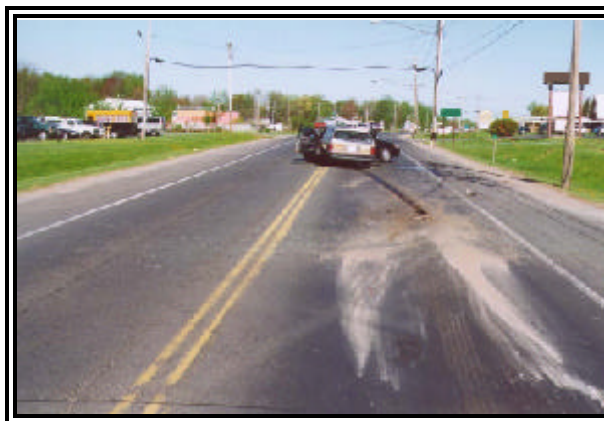
Figure 1: Trajectory view at the crash scene.

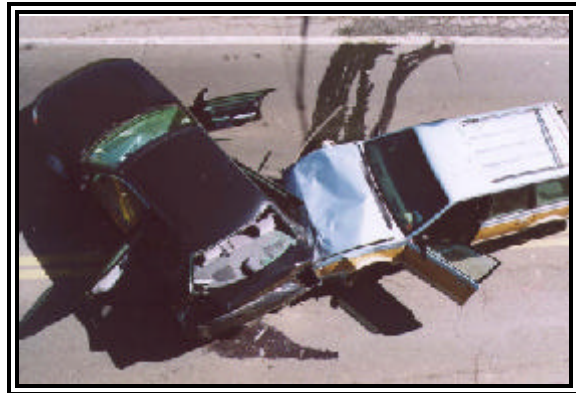
The Pontiac's momentum displaced both vehicle's 32 m (105 ft) forward, along the Pontiac's trajectory, to their final rest positions. The left offset orientation of the impact caused the Toyota to rotate 65 degrees clockwise as it slid to rest. The Toyota came to rest straddling the road's center line facing north. The Pontiac came to rest on the road's centerline, facing northwestward. The front of the Pontiac was in contact with the right rear quarterpanel of the Toyota,

Figure 2: Overhead view of the vehicles at final rest.

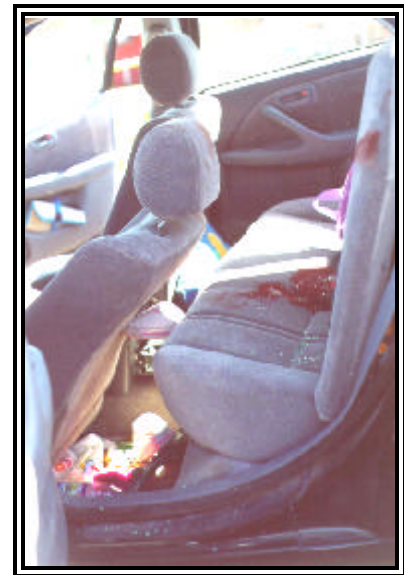
Figure 3 is an on-scene view of the left rear interior. Inspection of the vehicle revealed a significant amount of blood noted in the left rear seat position, as well as on the upper right aspect of the driver's seat back. The driver's seat back in the Toyota deformed rearward and downward as a result of the dynamic loading by the driver. The child's shoe was observed to have been wedged and suspended between the driver's seat and the rear seat.

Figure 3: On-scene police photograph of the left rear interior.

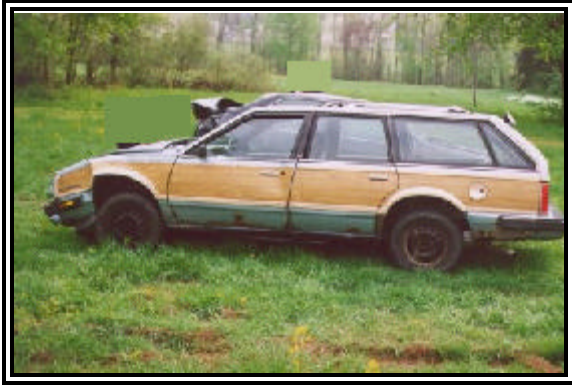
The front plane of the Pontiac sustained direct contact damage that extended across its entire 152 cm (60 in) end width. The front structures of the vehicle deformed rearward and buckled down. The buckling appeared to have occurred in the area of the left and right front suspension. The vehicle's deformation was documented during the course of the police investigation and was used in the analysis of the crash. The crush profile measured along the front bumper was as follows: C1=34.0 cm (13.4 in), C2=44.0 cm (17.3 in), C3=47.0 cm (18.5 in), C4=52.0 cm (20.4 in), C5=54.0 cm (21.2 in), C6=59.0 cm (23.2 in). The Collision Deformation Classification (CDC) was 12-FDEW-3. The total delta V of the impact calculated by Damage model of the WINSMASH program was 53.0 km/h (32.9 mph). The impact speed of the Pontiac calculated by the Trajectory model was 105.2 km/h (65.4 mph).

Figure 4: Pontiac left side view.

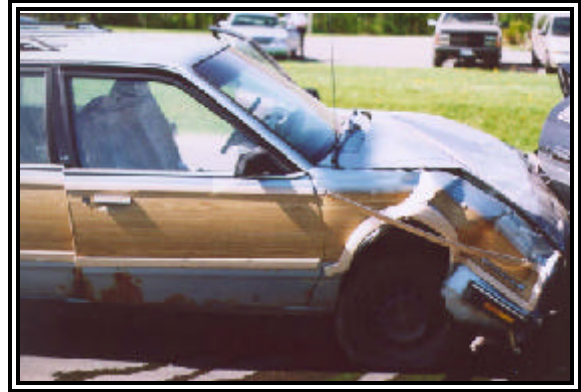
Figure 5: Pontiac right side view.

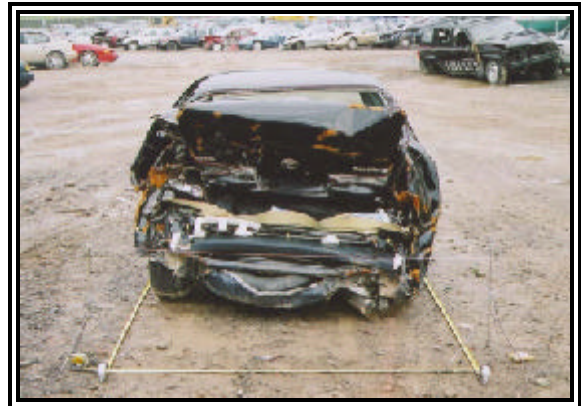
The back plane of the Toyota sustained 147 cm (58 in) of direct contact damage that extended across the vehicle's entire end width, **Figure 6**. **Figures 7 and 8** are the left side and right lateral views of the damage, respectively. The nature of the damage was indicative of a direct bumper to bumper impact with a subsequent override as the vehicles reached maximum engagement. The crush profile measured at the rear bumper reinforcement bar was as follows: C1=89.0

Figure 6: Rear view of the Toyota.

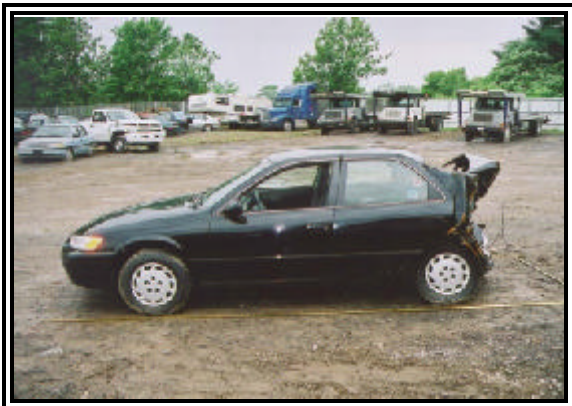
Figure 7: Left view of the Toyota.

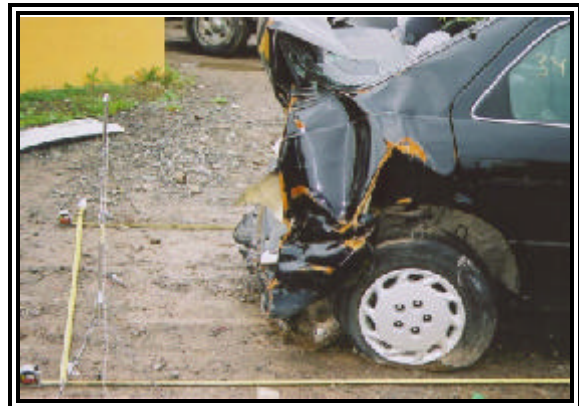
Figure 8: Right lateral view.

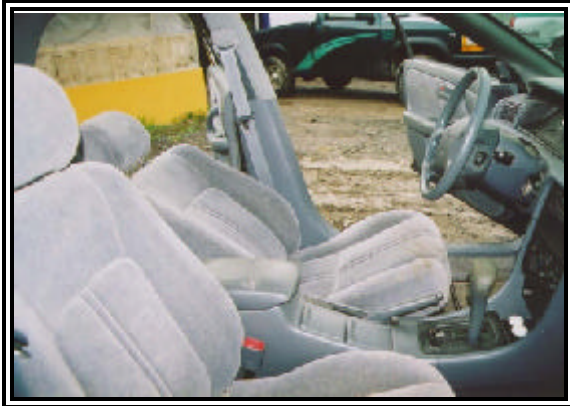
The driver seat, **Figure 9 and 10**, was adjusted to a mid to rear track position measured at 8.9 cm (3.5 in) forward of full rear. The seat was jammed in this position due to the deformation of the seat and could only be moved forward one notch (approximately 0.75 in). The total seat travel measured on the right front seat was 22.9 cm (9.0 in). The seat back was deformed to an angle of 45 to 50 degrees, referenced to vertical. The deformed seat back angle was measured 51 cm (20 in) above the seat bight. The seat back

could be reclined approximately 5 degrees further (50 to 55 degrees total) by using the recline mechanism but could not be raised to a more vertical position. The anti-submarine angle of the seat cushion measured 30 degrees. The majority of the seat back deformation occurred in the upper aspect of the seat back frame (in comparison with the right front seat back). A 5 cm (2 in) square area of blood evidence was identified on the upper rear inboard aspect of the seat back, **Figure 11**. The head restraint was raised approximately 2.5 cm (1 in). This blood evidence had deteriorated as compared to the on-scene photographs, refer to Figure 3.

Figure 9: Right interior view.

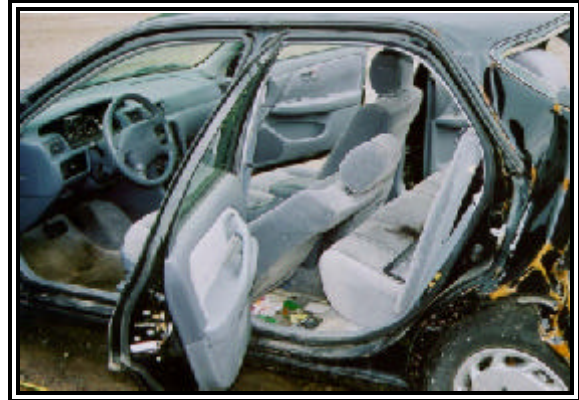
Figure 10: Left interior view.

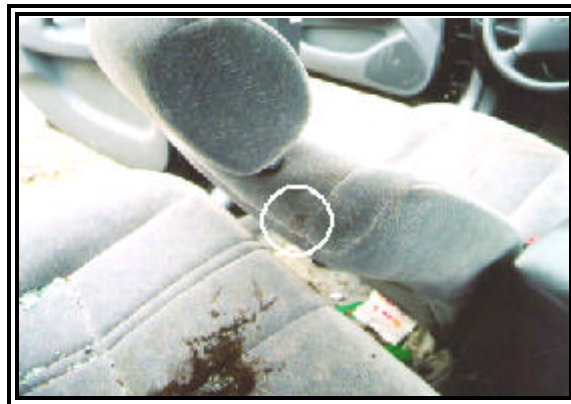
Figure 11: Blood evidence to upper seat back.

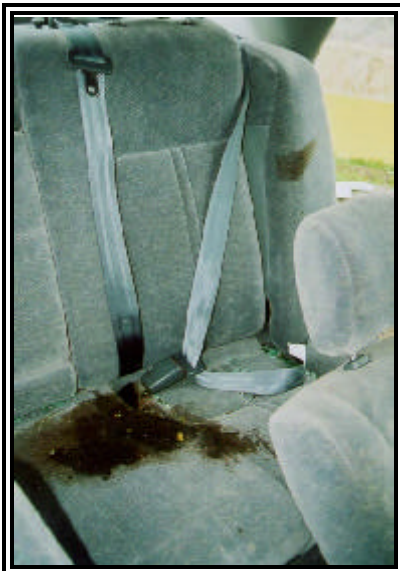
An area of dried blood evidence was located on the left central aspect of the seat cushion immediately right of the left rear seat belt buckle, **Figure 12**. This area was the final rest position of the child's head. The blood evidence measured 23 x 28 cm (9 in x 11 in) width by length. A blood smear measuring 6.4 cm x 7.6 cm (2.5 in x 3.0 in) was located on the left outboard seat back bolster and was centered 6 in above the seat bight. This contact evidence probably resulted during the removal of the child from the vehicle.

Figure 12: View of the left rear seat position.

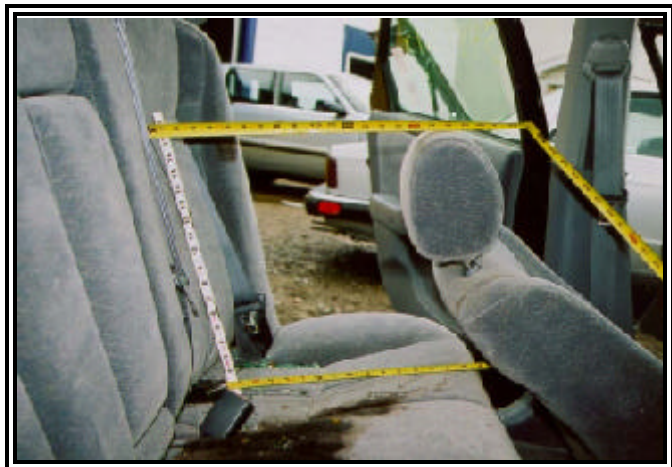
Figure 13 is a right interior views depicting the residual interior space at the left rear position.

The horizontal distance from the rear seat back to the driver's head restraint measured 39.4 cm (15.5 in). A comparison measurement taken from the right rear seat to right front seat measured 73.7 cm (29.0 in). The horizontal distance from the left rear seat bight to the deformed driver seat back measured 51 cm (20 in).

Figure 13: Measurements of the residual left rear interior space.

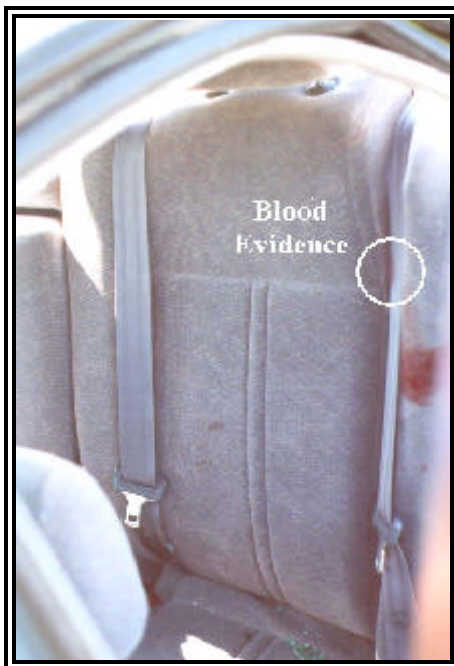
The New York State Police Collision Reconstruction Report submitted by the NYSP Fatal Investigation Unit indicated a blood transfer was noted on the webbing in the area of the buckle, when the webbing was extended to the buckled condition. **Figure 14** is the only on-scene police photograph that depicts this blood evidence. **Figure 15** is a photograph of the webbing taken at the time of the SCI inspection. The on-scene blood evidence had deteriorated between the time of the May crash date and the June SCI inspection. It should be noted that the blood evidence on the driver's seat back and head restraint had also deteriorated between the date of the crash and the SCI inspection.

Figure 14: Police photograph of the left rear restraint.

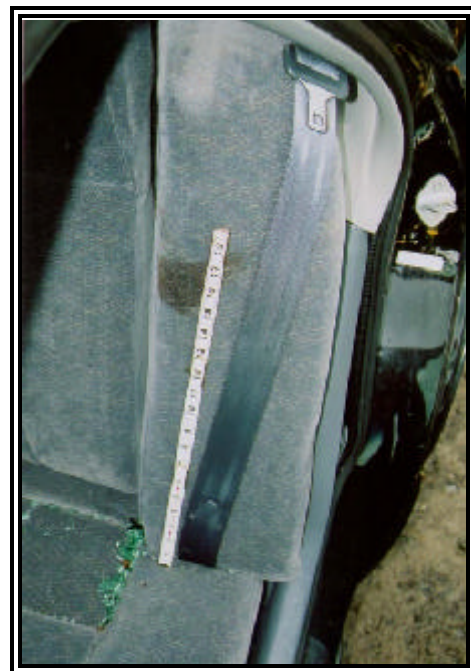
The observations of the first responders indicated the left rear child occupant was restrained by the 3-point lap and shoulder belt, as they approached the vehicle. Upon SCI inspection, the left rear restraint was in the stowed position and was operational. Examination of the latch plate revealed historical usage marks. Examination of the extended webbing and hardware was unremarkable. However, considering the initial rearward kinematics and the size of the child loading evidence would not be expected. The fabric stalk of the left rear buckle, adjacent to the blood evidence on the bench, was stained with blood.

Figure 15: Left rear restraint webbing.

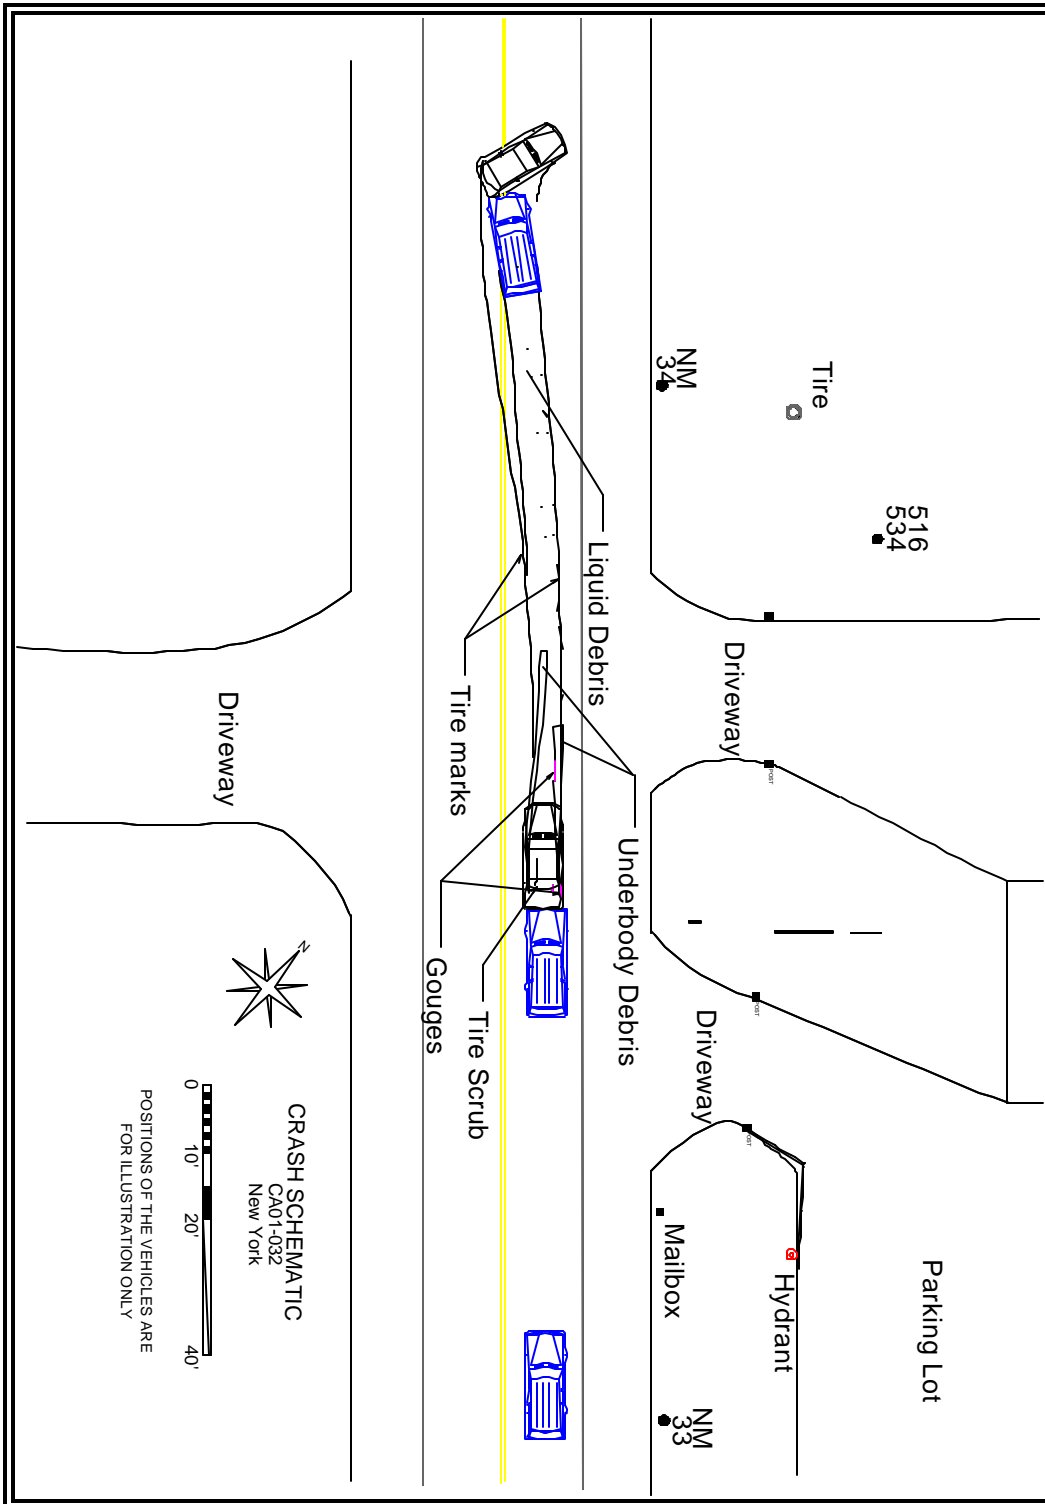
The police investigation identified tire and gouge marks that defined the point of impact. The post-crash trajectory of the vehicles was evidenced by tire marks and liquid debris. These evidences were documented by the police investigation using an electronic mapping system (i.e. a total station). That data was utilized in developing the crash schematic attached to this report, **Figure 16**, page 12. There were no pre-crash skid marks attributed to the Pontiac.

Figure 16: Crash Schematic.
