**TRANSPORTATION SCIENCES
CRASH DATA RESEARCH CENTER**

ADVANCED OCCUPANT PROTECTION SYSTEM INVESTIGATION

VERIDIAN CASE NO. CA01-034

VEHICLE: 2000 MERCURY SABLE

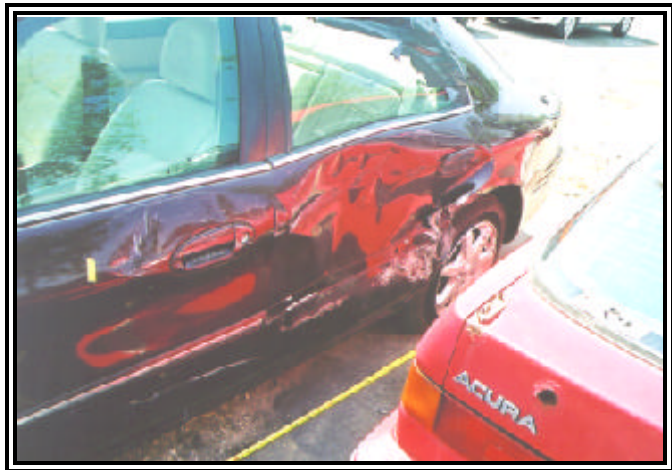
The exterior of the Mercury sustained direct contact damage to its left side resultant to its sideswiping contact with the tractor and frontal damage as a result of its impact with the concrete retaining wall. **Figure 3** is a view of the left side damage. The left side direct contact damage began on the mid aspect of the left door, 166.4 cm (65.5 in) forward of the left rear axle. The direct contact damage extended rearward 214.8 cm (84.5 in) and ended 48 cm (19 in) rear of the left rear axle. The maximum lateral deformation was located on the mid-aspect of the left rear door and measured 6.4 cm (2.5 in). Minor snagging of the left side body panel was noted immediately forward of the rear wheel opening. This damage pattern related to contact with the right side tires of the tractor. The left rear tire was cut and had debanded. The left front door remained operational. The left rear door was jammed shut. The left side window glazings were intact. The Collision Deformation Classification (CDC) was 06-LZES-1.

Figure 3: View of the left side damage.

The left side body panel was noted immediately forward of the rear wheel opening. This damage pattern related to contact with the right side tires of the tractor. The left rear tire was cut and had debanded. The left front door remained operational. The left rear door was jammed shut. The left side window glazings were intact. The Collision Deformation Classification (CDC) was 06-LZES-1.

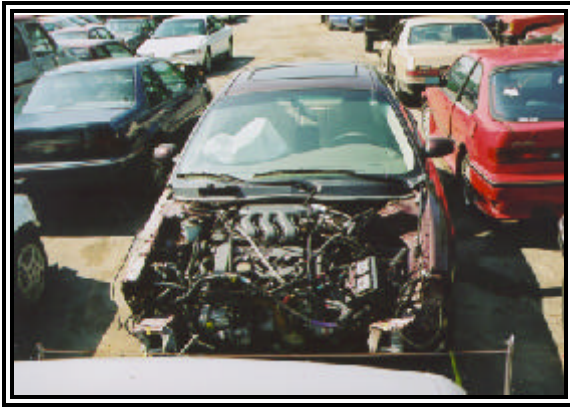
Figures 3 and 4 are the front and left lateral side views of the vehicle's frontal damage. The direct contact frontal damage extended across the vehicles's entire 137 cm (54 in) end width. The hood, right front fender and the vehicle's structures forward of the radiator support panel had been removed by the body shop during its repair estimate. The removal of these components exposed the forward uni-body sub-frame. The vehicle's deformation was estimated by measuring to the end of the sub-frame. The residual crush at the left and right sub-frame measured 8.6 cm (3.4 in) and 9.7 cm (3.8 in), respectively. There was no measurable change in the wheelbase dimensions. The windshield was not fractured. The delta V calculated by the Barrier Algorithm of the WINSMASH was 17.9 km/h (11.1 mph). The longitudinal and lateral delta V components were -17.3 km/h (-10.8 mph) and 4.6 km/h (2.9 mph), respectively. This

calculation under estimated the crash severity as compared to the RCM. The RCM recorded longitudinal delta V was 28.5 km/h (17.7 mph). The discrepancy between the WINSMASH calculation and the RCM was a result of the estimated crush profile of the vehicle. The estimated CDC of this impact was 11-FDEW-1.

Figure 4: Front view of the Mercury.

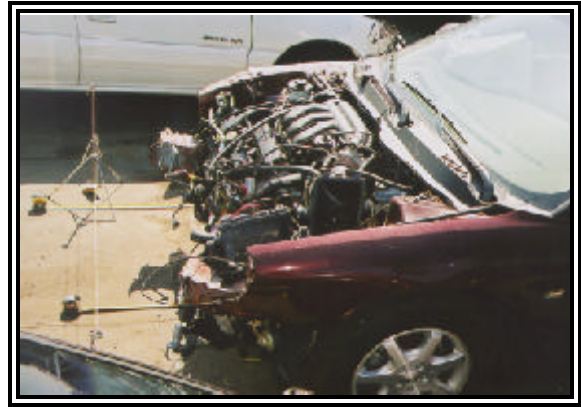
Figure 5: Left lateral view.

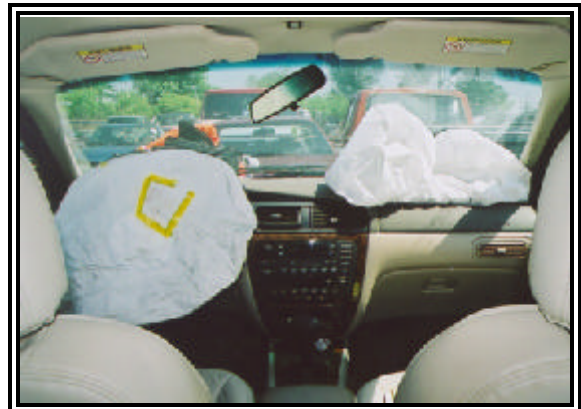
Figure 6 is a view of the Mercury's front interior. The vehicle's interior damage was only related to the deployment of the frontal air bags. There was no intrusion and no occupant contacts were noted. The use of the manual belt system and the deployment of the vehicle's safety systems mitigated significant occupant interior contact.

Figure 6: Interior view.

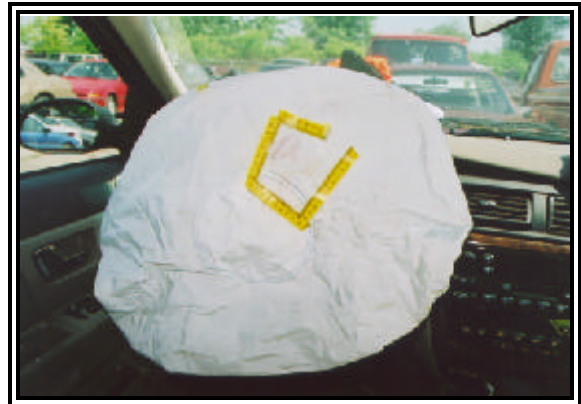
The driver air bag module was designed in the typical manner and located in the center of the steering wheel. The driver air bag had deployed from the H-configuration module cover flaps. The cover flaps opened along the designated tear seams. The height of the upper and lower flaps measured 6.4 cm (2.5 in) and 4.6 cm (1.8 in), respectively. The width of the flaps measured 17.2 cm (6.8 in). The deployed driver air bag, **Figure 7**, measured 53 cm (21 in) in diameter. It was tethered by four straps sewn to the face of the bag. The bag was vented by two 2.9 cm (1.1 in) ports located in the 10/2 o'clock position of the back side of the bag. The following nomenclature identified the air bag: P5206000-00D TXM000842132

Figure 7: Deployed driver air bag.

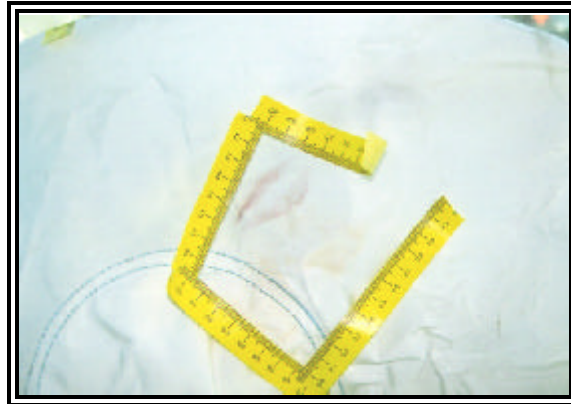
A 7.0 cm x 7.0 cm (2.8 in x 2.8 in) area of make-up transfer was located on the face of the air bag in the 2 o'clock sector, **Figure 8**. The location of the transfer measured 8 cm (3 in) right and 10 cm (4 in) above the center of the bag, respectively. The make-up consisted of a pair of lipstick imprints 3.8 cm (1.5 in) in

length and a 5 cm x 7 cm (2 in x 3 in) area of beige rouge. The orientation of the lipstick imprint indicated the steering wheel was rotated approximately 180 degrees clockwise at the time of air bag deployment and driver contact.

Figure 8: Close-up view of the make-up transfer.

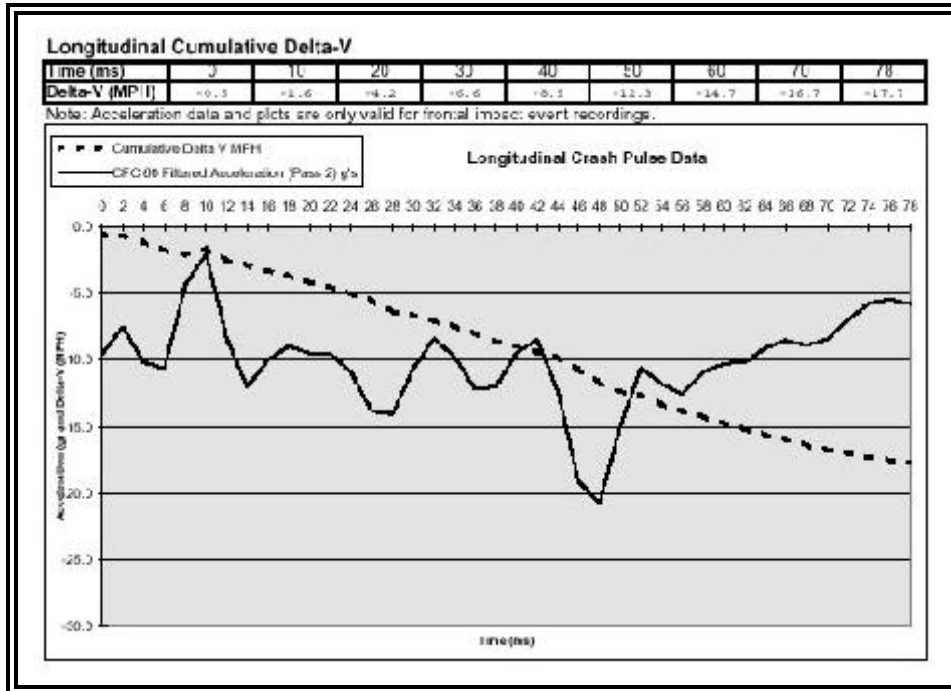
The RCM recorded the crash acceleration pulse for a duration of 78 milliseconds and calculated a delta V for that time frame. The 78 millisecond longitudinal delta V recorded by the RCM was approximately -28.5 km/h (-17.7 mph). The 78 millisecond lateral delta V was approximately 4.0 km/h (2.5 mph). Analysis of the acceleration pulse and velocity curves indicated that the majority of this crash event was recorded. The magnitude of the acceleration appeared to have maximized and the velocity curves had begun to plateau.

Figure 10: Longitudinal Delta V.

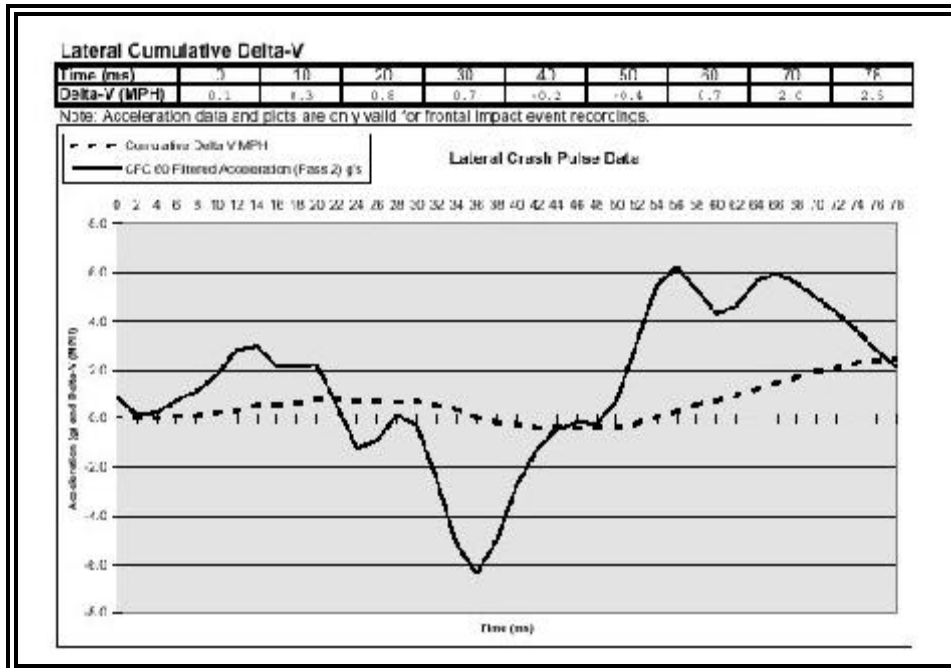
Figure 11: Lateral Delta V.
