**VERIDIAN ON-SITE AIR BAG RELATED ADULT DRIVER  
FATALITY INVESTIGATION**

**VERIDIAN CASE NO. CA01-038**

**VEHICLE - 1996 GEO METRO LSI**

**LOCATION - STATE OF PENNSYLVANIA**

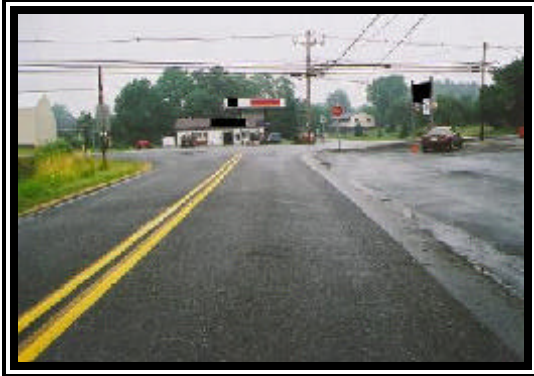
The 51 year old female driver of the 1990 Chevrolet Corvette was operating the vehicle northbound (**Figure 1**) when she slowed to a stop in anticipation of a left turn (west) at the 3-leg intersection.

**Figure 1. Northbound approach for the 1990 Chevrolet Corvette.**

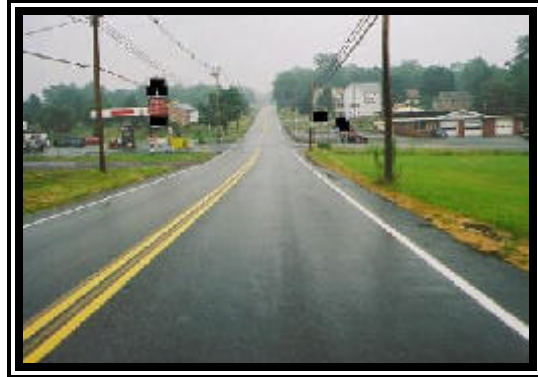
The 78 year old male driver of the 1996 Geo Metro was operating the vehicle eastbound (**Figure 2**) at a (passenger) reported speed of 48 km/h (30 mph) when he crested the hill and observed the Chevrolet cross his path of travel. Upon recognition of the impending harmful event, the Geo driver braked in avoidance, and remained in the eastbound lane prior to the collision.

**Figure 2. Eastbound approach for the 1996 Geo Metro LSI.**

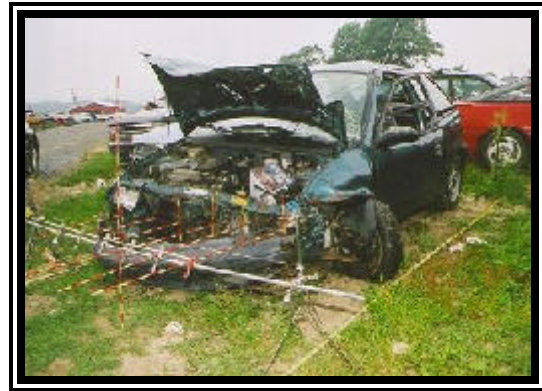
The 1996 Geo Metro LSI sustained moderate frontal damage as a result of the impact with the Chevrolet Corvette (**Figure 3**). The direct contact damage began at the front left bumper corner and extended 93.0 cm (36.6 in) inboard. The impact deformed the entire front end width resulting in a combined direct and induced damage length (Field L) of 103.0 cm (40.6 in). Six crush measurements were documented at the level of the reinforcement bar (*bumper fascia separation*):

C1= 48.0 cm (18.9 in), C2= 49.0 cm (19.3 in), C3= 50.5 cm (19.9 in), C4= 44.5 cm (17.5 in), C5= 20.0

cm (7.9 in), C6= 9.0 cm (3.5 in). The Collision Deformation Classification (CDC) for this impact to the Geo was 01-FYEW-3 with a principal direction of force of (+)20 degrees. The hood was deformed up and rearward from engagement against the side surface of the Chevrolet. The left fender was displaced rearward which restricted/deflated the left front wheel/tire. Induced contact damage produced buckling to the roof area at the left A-pillar and B-pillar. The left lower windshield was fractured from exterior impact forces and the left upper windshield from driver contact. Reduction in the left side wheelbase measured 22.5 cm (8.9 in) as reduction in the right side wheelbase measured 2.0 cm (0.8 in). The left front window was rolled completely down and was undamaged. A blood drip pattern was noted on the left exterior door panel.

**Figure 3. Front left damage to the 1996 Geo Metro LSI.**

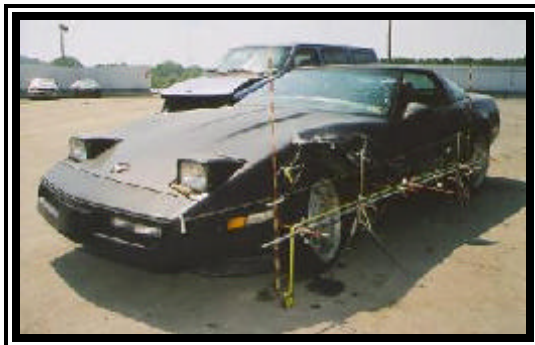
**Figure 4. Left front side surface damage to the 1990 Chevrolet Corvette.**

The 1990 Chevrolet Corvette sustained moderate left side surface damage as a result of the impact with the Geo Metro (**Figure 4**). The direct contact damage began 90.5 cm (35.6 in) forward of the left rear axle and extended forward 181.0 cm (71.3 in). The combined direct and induced damage length (Field L) began 39.5 cm (15.6 in) forward of the left rear axle and extended forward 244.0 cm (96.1 in). Although the vehicle's fiberglass exterior compromised accurate crush dimensions, six crush measurements were documented (*approximated*) at the level of the mid-door: C1= 0 cm, C2= 3.0 cm (1.2 in), C3= 2.0 cm

(0.8 in), C4= 0 cm, C5= 12.0 cm (4.7 in), C6= 0 cm. A maximum crush value of 14.0 cm (5.5 in) was documented 13.0 cm (5.1 in) aft of the C4 position. The CDC for this impact to the Chevrolet was 10-LYEW-2 with a principal direction of force of (-)50 degrees. The left (fiberglass) fender was shattered with the crush profile projected to the underlying frame. Direct contact damage was noted to the left front wheel with blue and gray paint transfers extending rearward towards the left door panel. The left front tempered glazing was disintegrated as the windshield was fractured along the left lower A-pillar from exterior impact forces. Reduction in the left side wheelbase measured 11.0 cm (4.3 in).

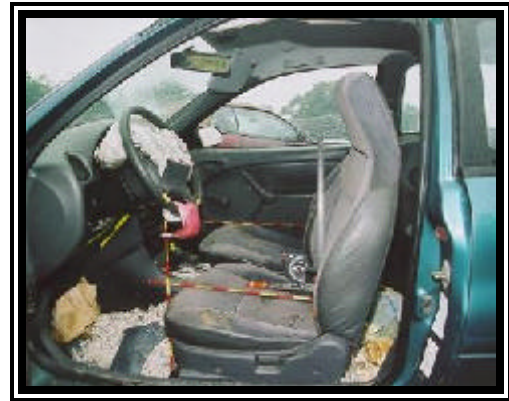
Interior damage to the Geo was moderate and was attributed to occupant contact and component intrusions (**Figure 5**). Indentations and scuff marks were documented on the left knee bolster. Deformation to the lower portion of the steering wheel rim measured 1.0 cm (0.4 in). No sheer capsule movement was identified. A small spider-web fracture pattern was noted on the upper left windshield, and attributed to the driver's left hand. The floor-mounted transmission lever was deformed forward. A heavy concentration of food was found to be splattered across the roof and front occupant space from ice coolers stowed in the rear seating area pre-crash. This cargo shift also deformed the driver seat back from a slightly reclined to an upright position. Scuff marks were documented on the glove compartment door which was also out-of-place. Longitudinal intrusions into the front occupant space involved 14.0 cm (5.5 in) of left toe pan, 6.0 cm (2.4 in) of left instrument panel/front left seat back, 4.0 cm (1.6 in) of center instrument panel, and 3.0 cm (1.2 in) of brake pedal intrusion. Lateral intrusions into the driver space involved 14.0 cm (5.5 in) of kick panel and 5.0 cm (2.0 in) of sill intrusion.

**Figure 5. Interior view of the 1996 Geo Metro LSI.**

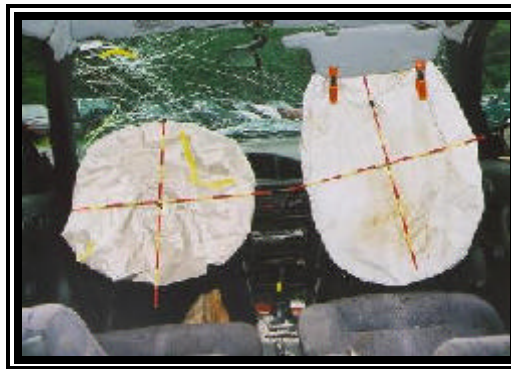
The 1996 Geo Metro was equipped with frontal air bags for the driver and front right passenger positions which deployed as a result of the crash (**Figure 6**). The driver air bag was identified by the following part number: PE5114100-01 with a bar coded lot number of: TBS6135B0113. The air bag was housed in the center of the steering wheel with a horizontally oriented flap tear seam (H-configuration). The flaps were nearly symmetrical in shape as the upper flap measured 15.4 cm (6.1 in) in width and 6.0 cm (2.4 in) in height while the lower flap measured 15.4 cm (6.1 in) in width and 7.8 cm (3.1 in) in height. Although no contact evidence was identified on the exterior surface of the module cover flaps, tissue transfers were documented to the upper right quadrant of the air bag face along with food spattering to the lower right quadrant on the rear aspect. The food spattering was attributed to the trays positioned in the passenger's lap pre-crash. The diameter of the driver air bag measured 63.0 cm (24.8 in) in its deflated state (**Figure 7**). The bag was tethered by two internal straps and vented by two 4.0 cm (1.6 in) diameter ports located at the 10 o'clock and 2 o'clock sectors on the rear aspect of the air bag. Rearward air bag excursion measured 25.0 cm (9.8 in) from the steering wheel hub.

**Figure 6. 1996 Geo Metro LSI deployed frontal air bag system.**

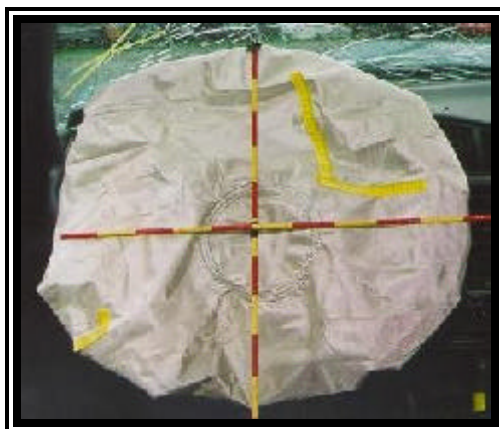
**Figure 7. 1996 Geo Metro LSI deployed driver air bag.**

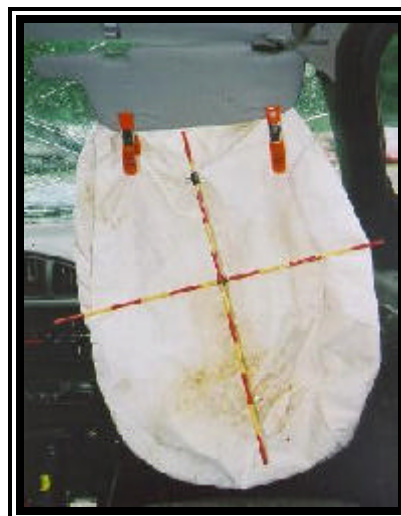
The front right passenger air bag deployed from the right mid-instrument panel area with a single cover flap design hinged at the top aspect. The cover flap was rectangular in shape and measured 34.5 cm (13.6 in) in width and 15.5 cm (6.1 in) in height. No contact evidence was identified on the exterior surface of the module cover flap. Heavy concentrations of food spattering (attributed to the food trays in the passenger's lap and coolers stowed in the rear seat) were noted across the lower portion of the air bag face along with blood spattering to the upper left quadrant. The passenger air bag measured 47.0 cm (18.5 in) in width and 65.5 cm (25.8 in) in height in its deflated state (**Figure 8**). No vent ports or internal tether straps were present. Rearward air bag excursion measured 50.0 cm (19.7 in) from the aft portion of the right instrument panel.

**Figure 8. 1996 Geo Metro LSI deployed passenger air bag.**

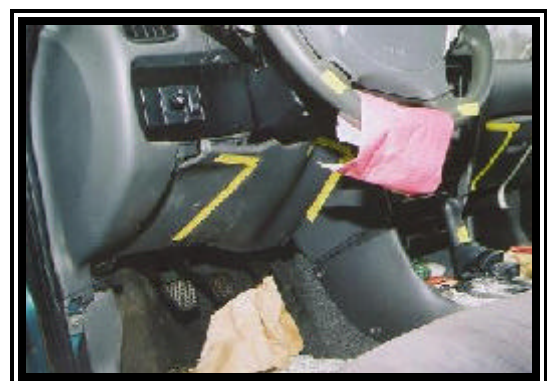
**Figure 9. Indentations to the driver knee bolster.**

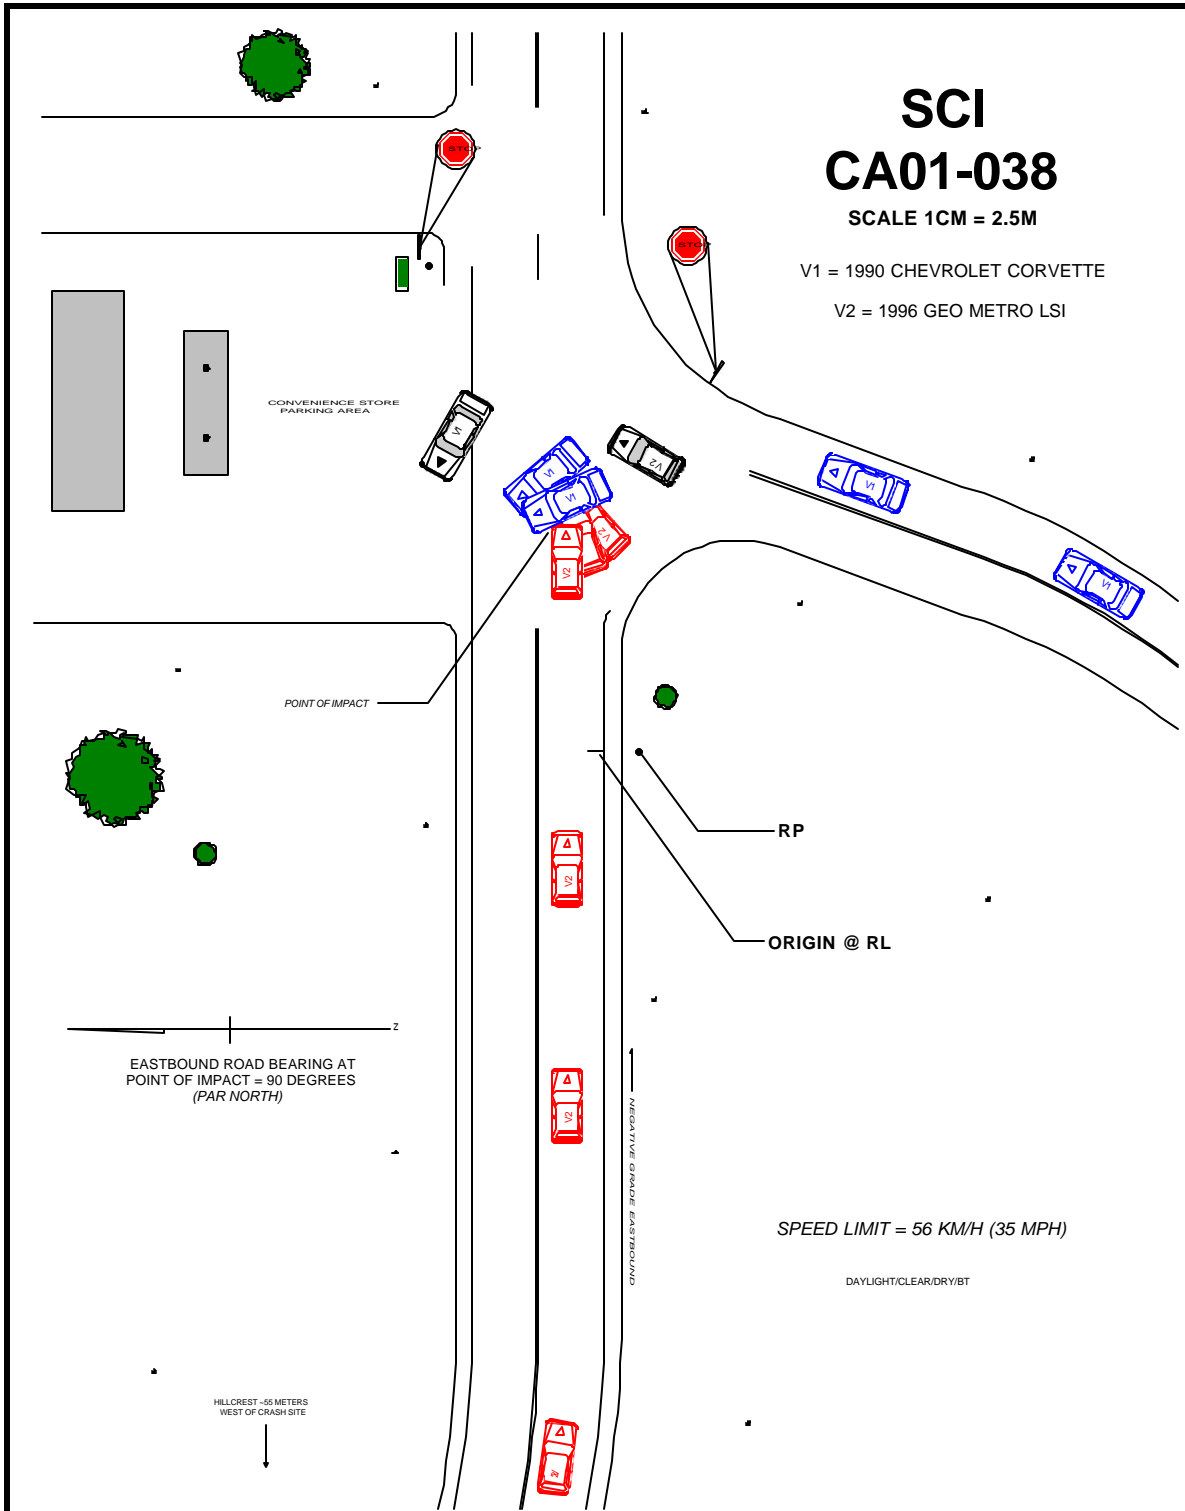
Figure 10. Scene Diagram.

This two vehicle crash occurred during the morning hours of June, 2001. At the time of the crash, it was daylight with no adverse conditions as the roads were dry. The crash occurred in the eastbound lane of a (straight) rural 3-leg “Y” intersection with a negative grade for eastbound traffic (**see Figure 10 - page 8**). A hillcrest was located approximately 55.0 meters (180.5 feet) south of the crash site. Traffic control through the intersection was controlled by a stop sign for northbound traffic. The posted speed limit at the crash site was of 56 km/h (35 mph).
