ON-SITE SEAT BELT FAILURE INVESTIGATION

VERIDIAN CASE NO. CA01-042

VEHICLE: 1995 GEO TRACKER

LOCATION: SOUTH CAROLINA

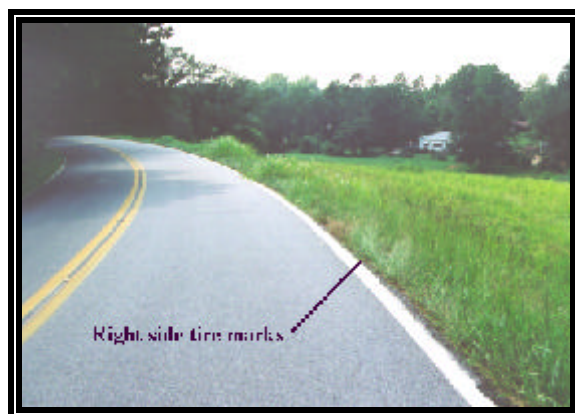
This single-vehicle crash occurred during the afternoon hours in July, 2001. At the time of the crash, it was daylight and the weather was not a factor. The asphalt road surface was dry. The crash occurred on a two-lane north/south roadway in a rural setting. There was a left curve for southbound traffic at the crash site. The radius of the curve measured approximately 229 m (750 ft) with a five degree super-elevation. The road width measured 6.3 m (20.8 ft). The west shoulder was narrow, approximately 1 m (3 ft) wide, and unimproved. From the road shoulder, the elevation of the off-road terrain dropped approximately 0.8 m (2.5 ft) into an open field that sloped away from the roadway with a negative grade. The average grade measured minus 18 percent. The speed limit in the area of the crash was 72 km/h (45 mph). **Figure 1** is a southbound trajectory view entering the left curve.

Figure 1: Trajectory view of the Geo.

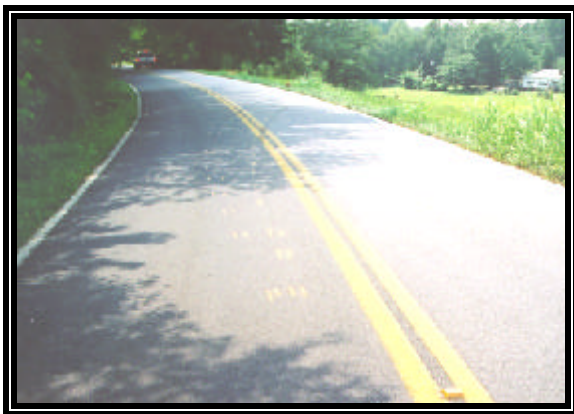
Inspection of the crash site revealed two yaw marks attributed to the vehicle's left side tires, **Figure 2 and 3**. The length of the left front and left rear marks measured 20.1 m(66.1 ft) and 18.1 m (59.5 ft), respectively. The average radius of curvature of the marks was determined to be approximately 94.4 m (310 ft). This average radius was measured over the first 12 m (40 ft) of the yaw mark. A critical speed calculation for this yawing trajectory was calculated to be approximately 92 km/h (57 mph). (It should be noted that the critical speed calculation is a minimum speed calculation.) This calculation was consistent with the reconstructed vehicle travel speed of approximately 100 km/h (mid 60's mph).

Figure 2: Southbound view along the vehicle's yawing trajectory.

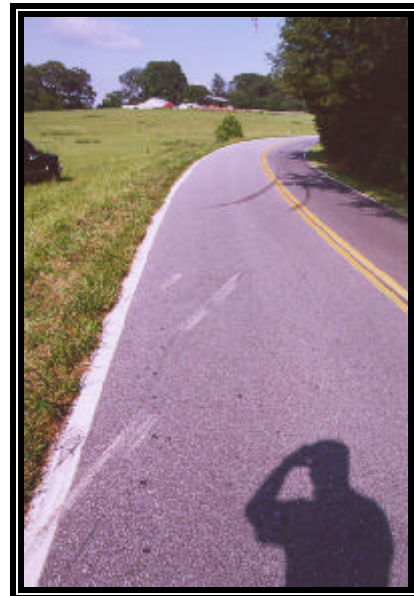
Figure 3: Look back view.

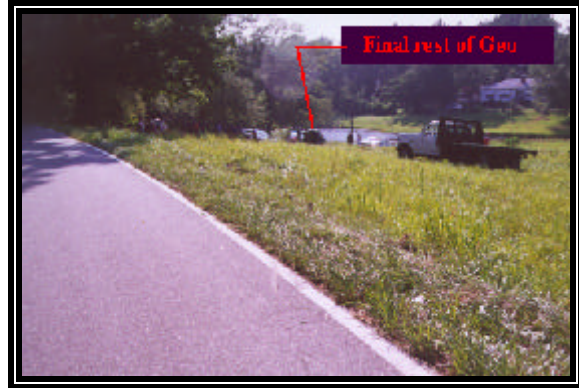
The Geo left the roadway and barrel rolled through the open field to rest, **Figure 4**. The vehicle came to rest on its left side approximately 54 m (177 ft) from the point where it left the road. A reconstruction of the roll sequence determined the Geo rolled 13 quarter turns (3-1/4 revolutions). The physical condition of the vehicle indicated roll sequence had an insignificant vertical component. The vertical deformation to the supporting roof structures was minimal. Rather, the physical evidence of the scene and vehicle supported a high velocity roll dynamic with a high roll rate.

Figure 4: View from the roadway to final rest location of the Geo.

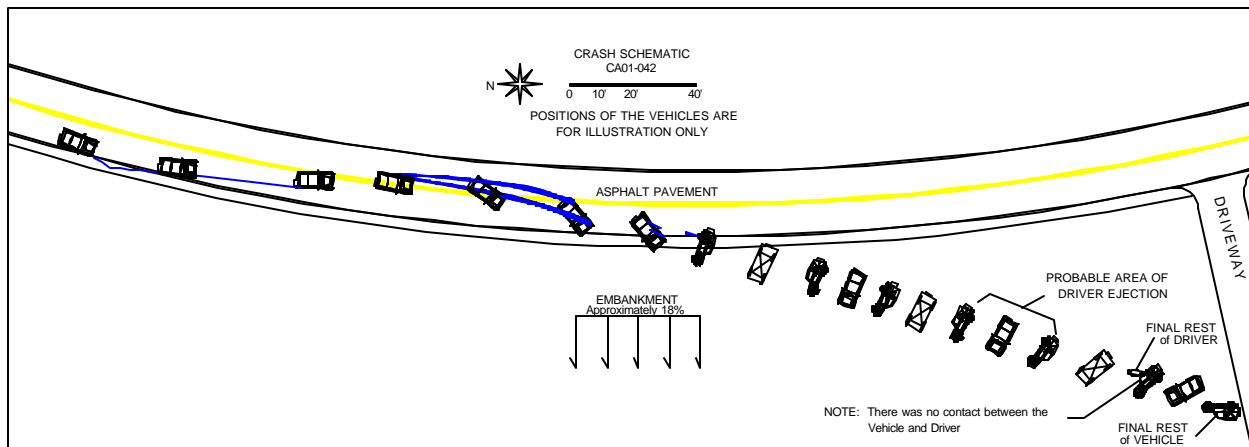
During the rollover sequence, the webbing of the left front (driver's) restraint failed and the driver was ejected, probably through the vehicle's left door window opening. (Refer to the manual restraint section below for further discussion regarding the webbing failure.) She was found outside the vehicle approximately 9 m (30 ft) from the vehicle's final rest position (refer to the crash schematic below). It was most likely she was ejected after the vehicle had rolled 10 quarter turns (2-1/2 revolutions). The driver had relatively minor exterior soft tissue injuries indicating she was probably deposited on the ground and rolled a short distance to rest, as the Geo rolled away from her. **Figure 5** is a schematic of the crash.

Figure 5: Crash Schematic.

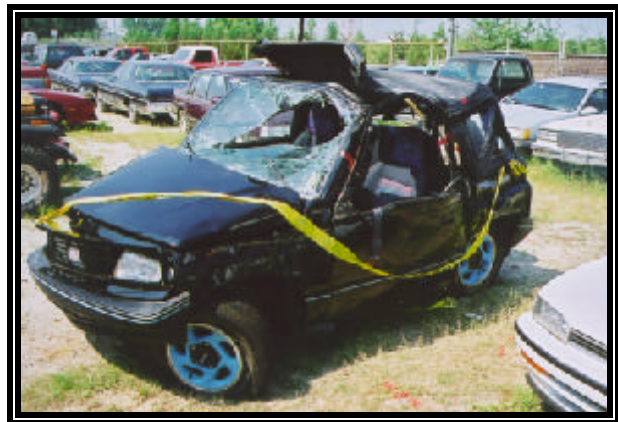
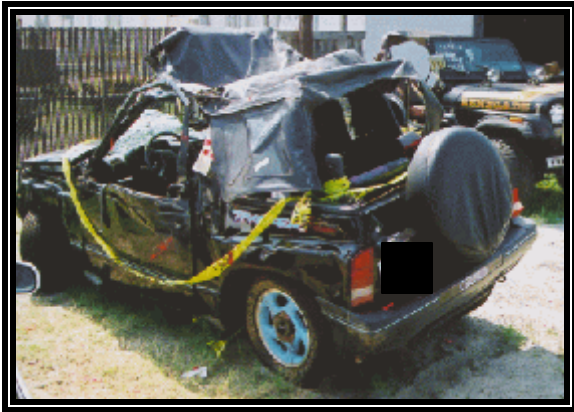
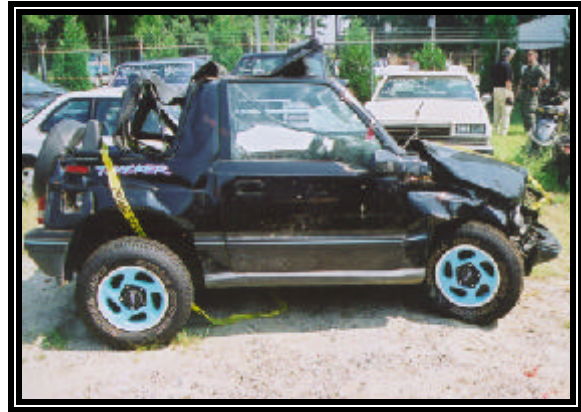
Figures 6 through 8 are left front, left rear and right side exterior views of the Geo, respectively. The vehicle sustained exterior damage consistent with a 3-1/4 revolution (13 quarter turn) left side leading lateral roll. The primary vehicle damage was to the left side roof structures, soft top and right front fender. The upper aspect of the left A-pillar was deformed approximately 5 cm (2 in) longitudinally rearward, 12.5 cm (5 in) laterally right and 5 cm (2 in) vertically down. The soft top was on the vehicle prior to the crash. Inspection of the soft top revealed the front supports were deformed rearward and the rear soft top supports had deformed forward. The left upper door frame and left roof rail were buckled. The left door was bowed outward approximately 13 cm (5 in) from occupant loading. The left door remained closed (jammed by deformation) during the rollover. The left front window was down prior to the crash and was disintegrated. The windshield had fractured. The right glazing was intact and the right door was operational. The right front fender was abraded and deformed leftward during the roll sequence. Dirt and debris was pocketed in the area. The deformed area about the right front fender measured 66 cm (26 in) longitudinally rearward from the front right bumper corner and 41 cm (16 in) laterally across the right front corner of the hood. The Collision Deformation Classification (CDC) of the damage was 00-TDDO-3.

Figure 6: Left front view of the Geo.

Figure 7: Left rear view of the Geo.

Figure 8: Right side view of the Geo.

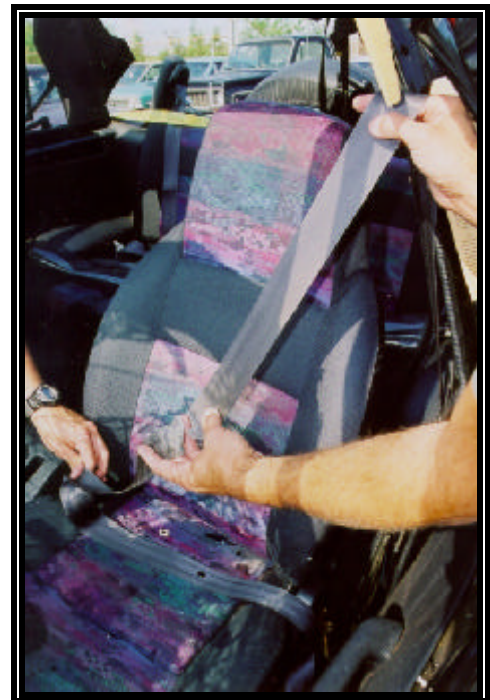
The left front (driver's) manual restraint system in the 1995 Geo Tracker consisted of a continuous loop 3-point lap and shoulder belt with an inertial activated locking retractor and a sliding latch plate. The retractor was located in the lower mid B-pillar. The D-ring was not adjustable. The inboard buckle was attached to a 21.6 cm (8.5 in) flexible stalk and was anchored to the floor. The webbing had separated during the rollover sequence allowing the driver to be ejected. The first responders observed the webbing separation and noted the latch plate was still buckled in the receiver. **Figure 9** is an interior view of the belt system with the webbing extended in a reconstruction of its pre-crash position.

The length of the webbing from the outboard anchor to the separation measured 135 cm (53 in). This measurement indicated the separation would have been initially located approximately between the driver's sternum and left shoulder. This section of webbing would have been stowed in the retractor when the belt was not in-use. Therefore, this section was not subject to deterioration from the elements (sun/weather/chemical) or from being caught in the door. The condition of the webbing was consistent with the age of the vehicle.

Inspection of the vehicle's interior determined there was an absence of a mechanism to cause the webbing separation at this location. There were no sharp metal edges to snag or cut the webbing. Additionally, there was no mechanism for the driver to sufficiently load the belt in this torso section to cause this failure. The driver's loading of the belt in this area would also induce belt loading in the lap portion of the webbing. Load sharing in this manner reduced the localized stress in any particular area of the webbing, given the belt system was extended and worn properly. In this crash, some of the driver's injuries were consistent with proper belt use. These injuries consisted of abrasions to the left neck and shoulder, chest and abdominal abrasions, abraded contusions to the right and left inguinal regions and two moderate spleen lacerations. Refer to the Driver's Injury table later in this report for a complete summary of the injuries.

Figure 9: Reconstructed belt path for the Geo's driver.

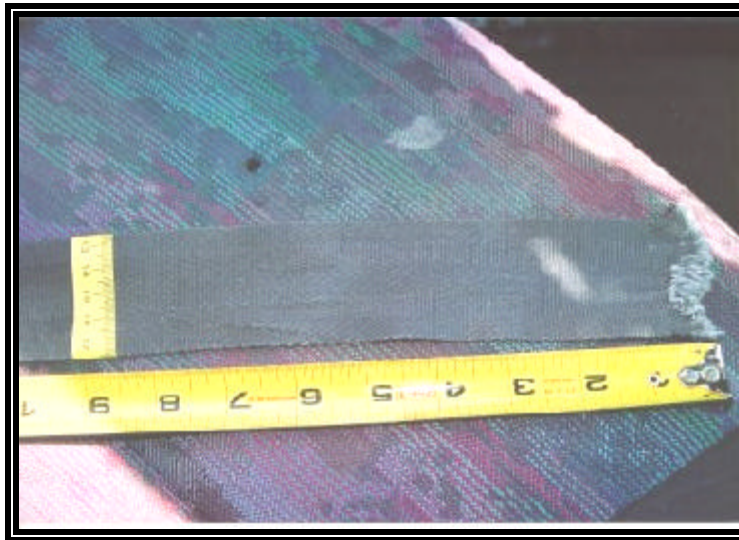
Figure 10 is a close-up view of the fixed section of webbing near the separation. This section of webbing was across the driver's pelvic region, through the latch plate and directed diagonally across her chest. Examination of the webbing revealed the fibers leading toward the separation were stressed and distorted over a length of 22.4 cm (8.8 in). Additionally, the webbing appeared to have possibly folded over and begun to "rope". This section of the webbing was the only region that appeared stressed. The width of the webbing measured 4.75 cm (1.87 in) at the separation indicating the belting was stretched. The width of the webbing at the out-board anchor measured 5.1 cm (2.0 in).

Figure 10: Stressed area of the webbing leading to the separation.

During the rollover sequence, this section of webbing migrated toward the latch plate due to occupant loading in lap portion of the belt system. Apparently the inertial retractor unlocked and allowed webbing to spool or pay-out of the retractor. This mechanism introduced slack into the restraint system. The retractor then locked again in response to the vehicle's inertial change causing the driver to reload the belt system. It was probable that the retractor locked/unlocked/re-locked multiple times during the rollover as the pendulum moved through the neutral position. In this manner, the area of the separation moved from the area of the driver's sternum to the latch plate. There was no debris (glass, metal, dirt, sand) noted on the webbing or embedded in the area of the failure.

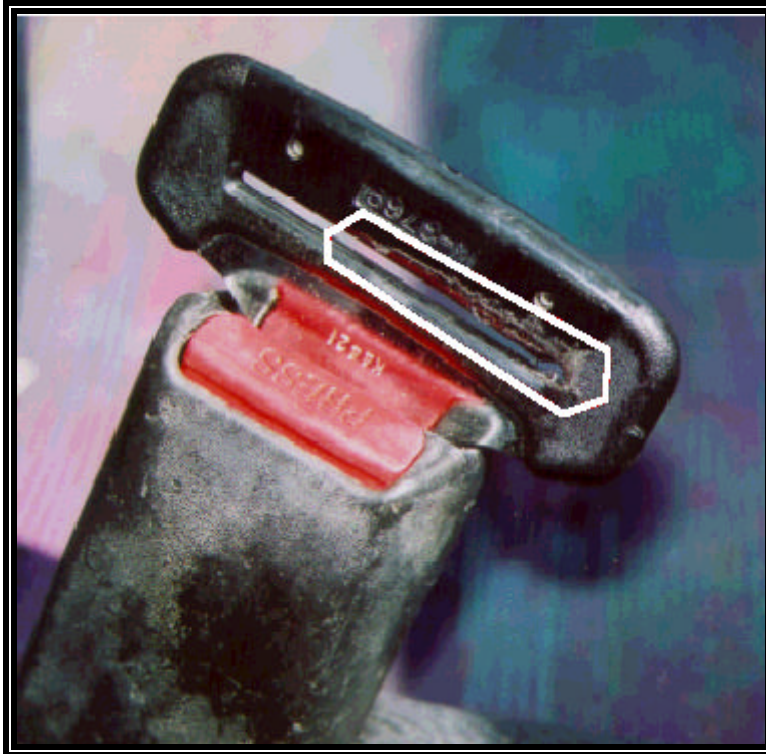
Figures 11 and 12 are views of the latch plate and webbing separation. The forward aspect (relative to the vehicle) of the latch plate hardware exhibited obvious evidence of frictional contact. The plastic hardware at the reaction surface was abraded as a result of the contact. The length of this abrasion measured approximately 3.3 cm (1.3 in) and wrapped around the forward corner of the loop, figure 11. This frictional contact, in combination with the possibility the webbing had folded over onto itself (roped) as it passed through the latch plate, induced a stress concentration in the webbing at the latch plate. The webbing probably became jammed as it passed through the plate and then failed under tension as a consequence of driver loading. The fibers at the separation were frayed and width of the webbing splayed consistent with a tensile failure, figure 12.

Figure 11: Close-up view of latch plate deformation.

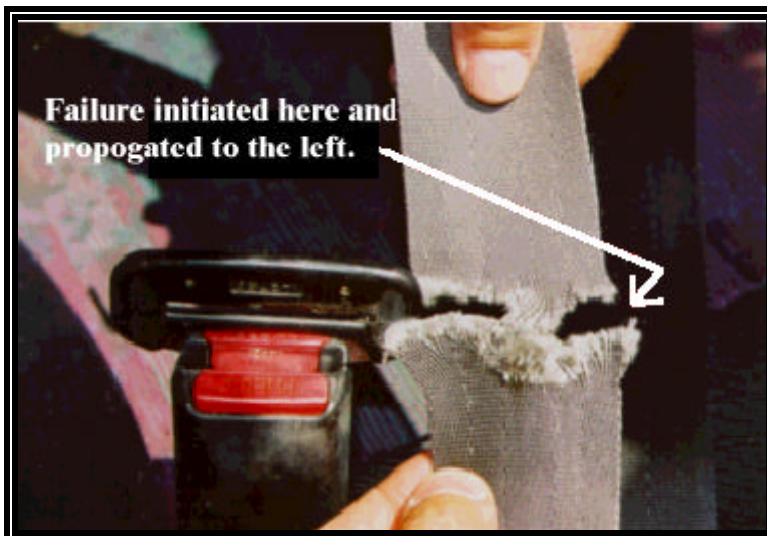
Figure 12: View of the latch plate and webbing separation.

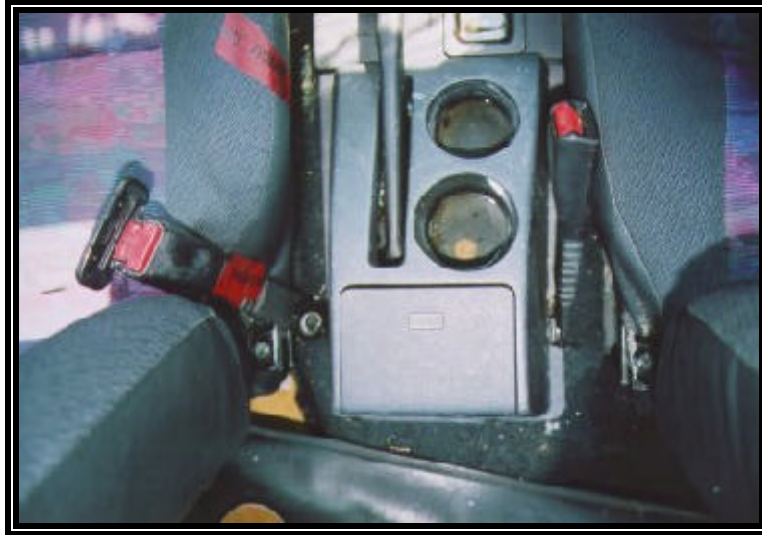
Figure 13 is an overhead view of the inboard buckle stalks. The lower end of the stalk was attached to the floor anchor by a 9.5 mm (0.375 in) diameter pin. The pin allowed fore/aft movement of the buckle stalk. The floor anchor consisted of a hinge section comprised of a pair of 3.1 mm x 33 mm x 33 mm (1/8 in x 1.3 in x 1.3 in) steel sections. The deformation of the driver's anchor occurred as a result of tension. The buckle stalk was bent leftward at approximately 45 degrees and was in contact with the seat. The deformation occurred at the hinge section.

Figure 13: Overhead view of the inboard buckles.
