**VERIDIAN ON-SITE SIDE IMPACT OCCUPANT PROTECTION SYSTEM CRASH
INVESTIGATION
SCI TECHNICAL SUMMARY REPORT**

VERIDIAN CASE NO. CA01-045

VEHICLE - 2001 HONDA CIVIC

CRASH DATE - AUGUST 2001

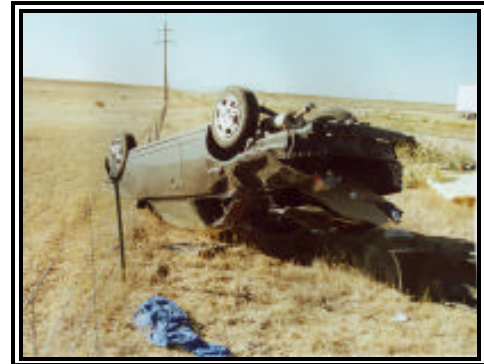
This on-site investigation focused on the roadside departure/rollover crash of a 2001 Honda Civic (**Figure 1**). The Civic was occupied by a 19-year-old male driver and four passengers ranging in age from 18 to 22-years-old. All of the occupants were probably restrained except the rear right passenger. The vehicle was equipped with frontal air bags and seat back-mounted side impact air bags for the front seated occupants. The front seats of the Civic were covered by after-market fleece seat covers. The driver lost control of the vehicle and departed the left side of the road. He overcorrected by steering right, and the vehicle crossed both travel lanes and departed the right roadside in a clockwise (CW) yaw. The Civic impacted two delineator posts and subsequently rolled over six quarter turns. The driver's side air bag deployed during the rollover event as a result of ground contact. The deployment sequence of the driver's side air bag was impeded by the seat cover which altered its normal deployment. The seat cover was torn in a saw-tooth pattern in the area surrounding the deployed side air bag. The unrestrained rear right passenger was ejected through the backlight and was fatally injured. The restrained occupants remained in the vehicle and sustained non-incapacitating and incapacitating injuries.

Figure 1. Damaged 2001 Honda Civic

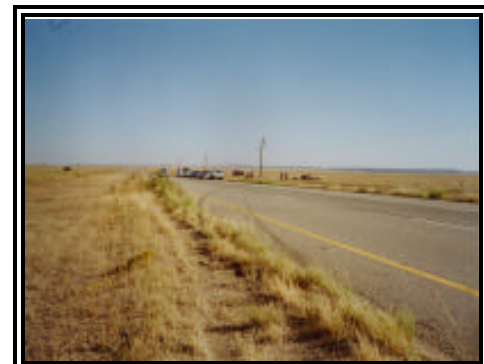
Figure 2. Northbound view of crash site and tire marks

This single-vehicle crash occurred during the daylight hours of August 2001 on the northbound lanes of a divided interstate highway (**Figure 2**). At the time of the crash, the asphalt

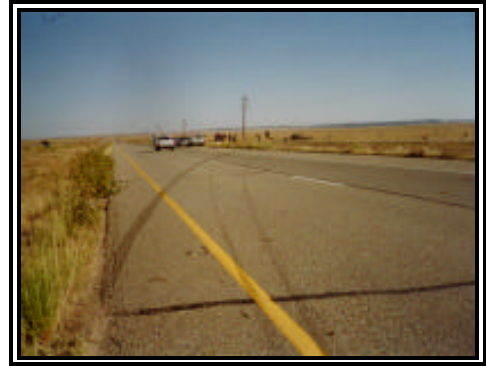
Figure 3. Northbound approach and tire marks

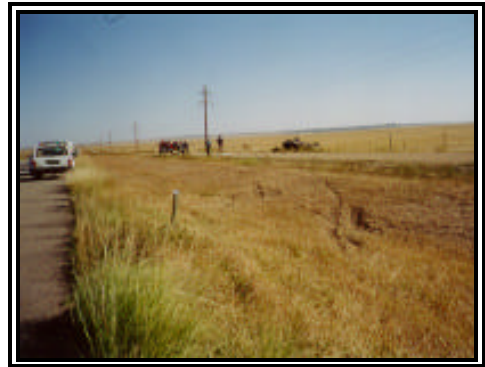
Figure 4. Gouges in the grassy ditch and damaged delineator post

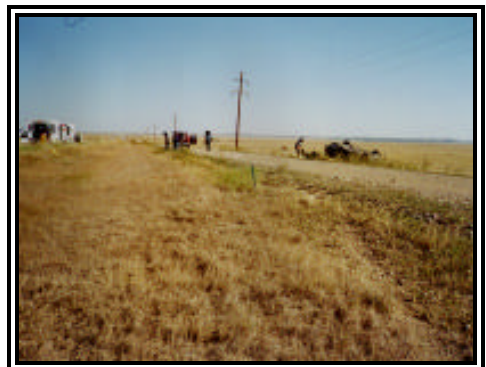
The 19-year-old male driver was operating the 2001 Honda Civic northbound on the inboard lane of the northbound travel lanes of the divided interstate highway. Police reported that the driver was operating the vehicle under the influence of a controlled substance, and that he may have fallen asleep. The driver lost control of the vehicle and the Civic departed the left roadside onto the left shoulder and traveled 16.8 m (55.2') on the grassy median. In an attempt to regain control, the driver overcorrected, steered right, and applied the brakes. The Civic initiated a clockwise yaw and traveled across both northbound lanes (**Figure 3**) and departed the right roadside. At the point of roadside departure, the Civic had rotated approximately 120 degrees in a clockwise direction. The Civic struck a delineator post with the left side as it traveled onto the east roadside (**Figure 4**). The vehicle traveled in a lateral direction across the grassy ditch which resulted in multiple gouge marks from the wheels. As the Civic approached the dirt/gravel frontage road, it impacted a second delineator post with the left side area and the raised uneven surface of the frontage road tripped a rollover with the left side leading (**Figure 5**).

Figure 5. Raised dirt/gravel frontage road and second damaged delineator post

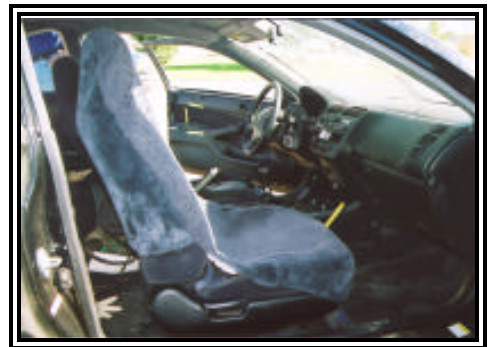
Aftermarket seat covers were installed on both front bucket seats (**Figure 6**). There was no identification markings on the seat covers. The top aspect of each cover fit over the adjustable head restraint in the full-down position and completely enveloped the seat back to 64.8 cm (25.5") below the top aspect of the head restraint. The bottom aspect of the seat cover was placed over the top aspect of the seat cushion.

Figure 6. View showing front right passenger's aftermarket seat cover

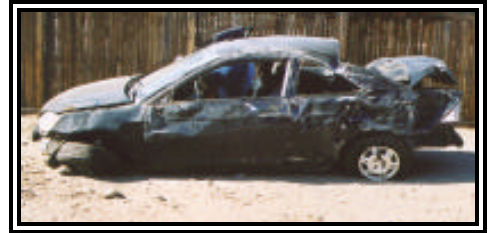
The 2001 Honda Civic sustained moderate damage as a result of the rollover (**Figure 7**). The front and rear bumper fascias were both completely separated from the vehicle. The hood, grille area, and lower radiator support were slightly displaced. The entire left side plane of the Civic sustained lateral abrasions, including the A, B, and C-pillars and the roof side rail. The left mirror was separated and the left door exhibited pocketing under the mirror area as a result of displacement against the door panel.

Figure 7. Left side view of the damaged Honda Civic

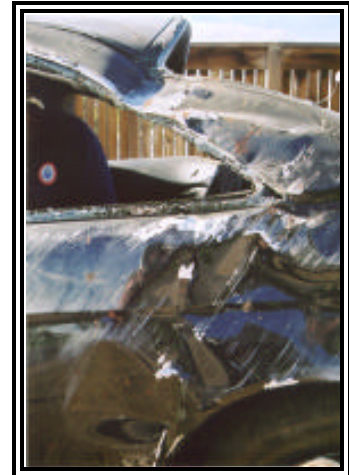
Impact with a delineator post resulted in a deep pocket in the side plane that measured 2.5 cm (1.0") in depth and was located 57.2 cm (22.5") aft of the face of the left B-pillar above the left rear wheel (**Figure 8**). A green paint transfer from the delineator was located 45.7 cm (18.0") aft of the face of the left B-pillar on the top aspect of the left C-pillar. The Collision Deformation Classification (CDC) for the first impact with the delineator post was 09-LPMN-1. The damage associated with the impact to the second delineator post could not be located since it was masked by the rollover damage. The CDC for the second impact with the delineator post was 09-L999-9.

Figure 8. Damage from the first delineator post

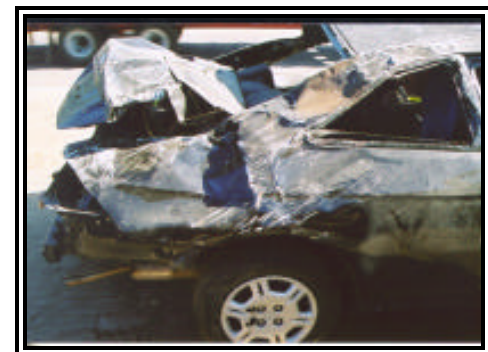
Figure 9. Abraded right rear quarter panel and displaced trunk lid

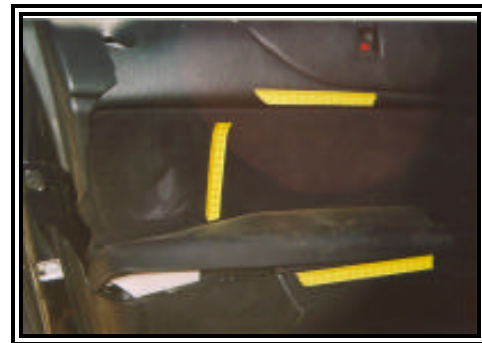
The left front sun visor was folded forward against the windshield, but there was no damage to the vanity mirror on opposite side of the visor. The interior left side door panel at the integral armrest was fractured from driver loading 16.5 cm (6.5") forward of the rear edge of the door and extended 7.6 cm (3.0") forward (**Figure 10**). The fracture was vertically located 29.2 cm (11.5") from the top of the door panel and extended downward 7.6 cm (3.0"). The pliable plastic panel below the arm rest was deflected outward approximately 3.8 cm (1.5"). The upper door panel was fractured from driver loading at the rear edge. The damage began at the rear edge and extended 8.9 cm (3.5") forward. The fracture was located 3.2 cm (1.3") below the top of the door panel and extended 10.8 cm (4.3") downward. The fabric on the rear edge of the left side interior door panel between the armrest and the upper plastic segments was abraded due to the contact with the deployed driver's side air bag. The abrasion was located 3.8 cm (1.5") forward of the rear edge of the left side door, and extended 7.6 cm (3.0") forward. The abrasion began 14.0 cm (5.5") below the top aspect of the door panel and extended 8.9 cm (3.5") downward.

Figure 10. Damaged left front door interior panel

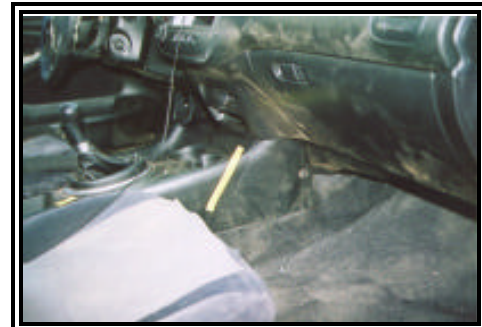
Figure 11. Fractured center console from occupant contact

The right side aspect of the center console was impacted by the front right occupant's left lower leg and was scuffed and fractured (**Figure 11**). The fracture measured 17.8 cm (7.0") vertically by 8.9 cm (3.5") horizontally. The top aspect of the plastic center console aft of the gear shifter was fractured as a result of

loading from the front right passenger's left thigh. The fracture was located 35.6 cm (14.0") rearward of the mid-panel and extended 5.1 cm (2.0") rearward. It was laterally located 0.6 cm (0.3") right of center on the console.

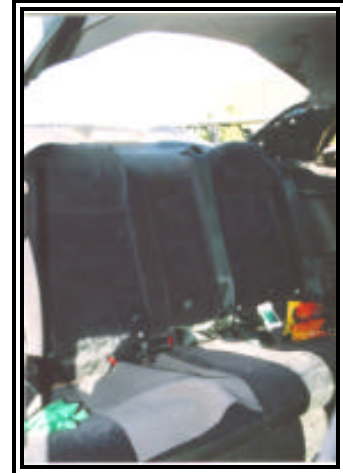
Body fluid stains were noted on the headliner at the backlight over the rear left position. Hair was noted on the left C-pillar in the top aspect of the fixed quarter window frame at the bond area. The roof intruded into the rear seat area at the C-pillars (**Figure 12**), and the lateral distance between the C-pillars measured 78.7 cm (31.0").

Figure 12. View of backlight area

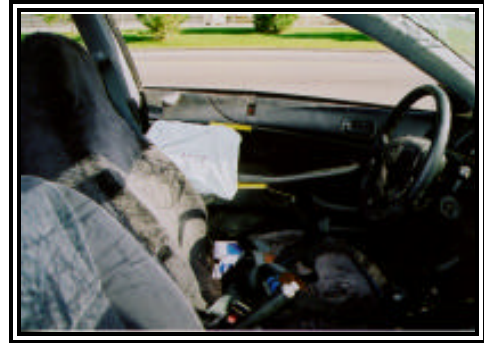
The 2001 Honda Civic was equipped with side impact air bags for the driver and front right passenger positions. The side air bags were located in the outboard aspects of the front seat backs. The driver's side air bag deployed as a result of the left side impact with the ground during the first quarter turn of the rollover. The side air bag deployed forward from the driver's seat back (**Figure 13**). The single plastic module cover measured 10.2 cm (4.0") in width and 22.9 cm (9.0") in height. The cover flap was hinged at the rear aspect and opened to the rear of the vehicle (**Figure 14**).

Figure 13. Driver's side air bag

The driver's side air bag measured 28.9 cm (11.4") in length at the top aspect and 24.1 cm (9.5") on the bottom aspect. The height measured 25.4 cm (10.0") at the front aspect and the rear aspect was angled downward into the module and measured 15.2 cm (6.0"). The air bag was vented by two circular 6.7 cm (2.6") diameter external ports located on the forward aspect (**Figure 15**). The top port was centered 7.0 cm (2.8") below the top seam and the bottom port was centered 5.7 cm (2.3") above the bottom seam. The driver's side air bag was tethered internally by a lateral tether that measured 5.7 cm (2.3") in length and 1.5 cm (0.6") in width. Superficial scuff marks were noted on the bottom aspect of the air bag.

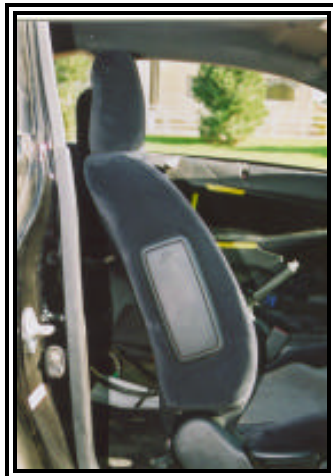
Figure 14. Side air bag cover flap with the seat cover removed

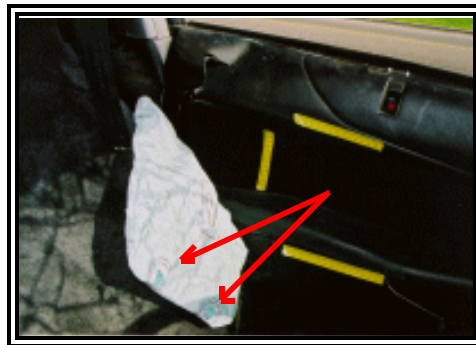
Figure 15. View of driver's side air bag showing vent ports
