**VERIDIAN ON-SITE SIDE IMPACT OCCUPANT PROTECTION
INVESTIGATION**

VERIDIAN CASE NO. CA01-047

VEHICLE - 2000 PONTIAC MONTANA

CRASH DATE - OCTOBER, 2001

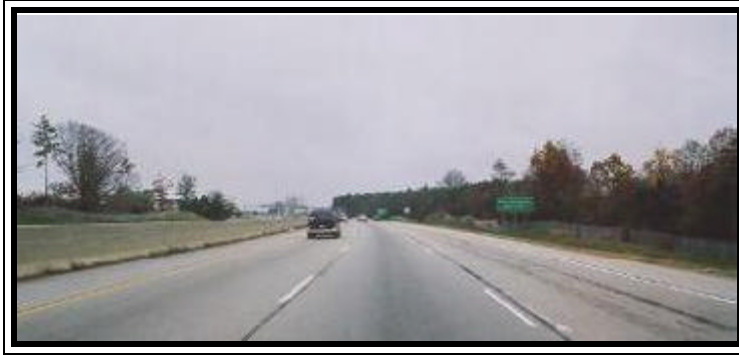
The 61 year old male driver of the 2000 Pontiac Montana was en-route to work, operating the vehicle southbound (**Figure 1**) on the inboard lane of a multi-lane state roadway and negotiating a left curve at a (driver reported) speed of 105 km/h (65 mph). The vehicle's Event Data Recorder (EDR) recorded a travel speed of 105 km/h (65 mph) at the pre-crash five second interval. As the Pontiac reached the apex of the curve, the vehicle broke traction on the wet road surface and began a counterclockwise yaw. The driver reported during the SCI interview that strong cross winds may have contributed to pre-crash circumstances. Upon recognition of the impending harmful event, the driver over steered a

Figure 1. Southbound approach for the 2000 Pontiac Montana.

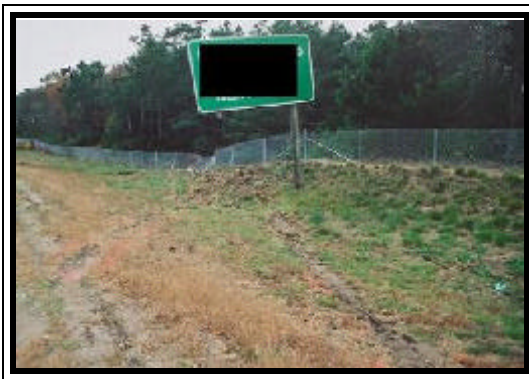
As the Pontiac departed the right (west) pavement edge, the vehicle traveled approximately 14.4 meters (47.2 feet) as the left side surface simultaneously impacted two signposts (**Figures 2 & 3**) resulting in minor damage. Although the impact was classified as out-of-scope (*yielding objects/simultaneous impacts*), the damage algorithm of the WinSMASH reconstruction program computed a barrier equivalent velocity change of 11.3 km/h (7.0 mph) with a latitudinal component of 11.1 km/h (6.9 mph). Impact resulted in deployment of the Pontiac's driver side impact air bag system. The Pontiac's EDR recorded a near deployment event (see **Figure 14 - page 9**). Fragments of the support structure subsequently struck the windshield which resulted in minor damage. At this point, the clockwise rotation continued as the vehicle proceeded in a southwesterly direction approximately 5.3 meters (17.4 feet) as the rear area struck a chain link fence resulting in minor damage. The Pontiac Montana came to rest against the chain link fence facing east.

Figure 2. Struck signposts and chain link fence.

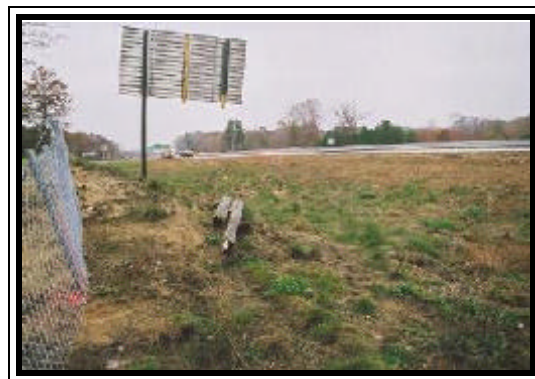
Figure 3. Look back view from vehicle final rest showing struck signposts.

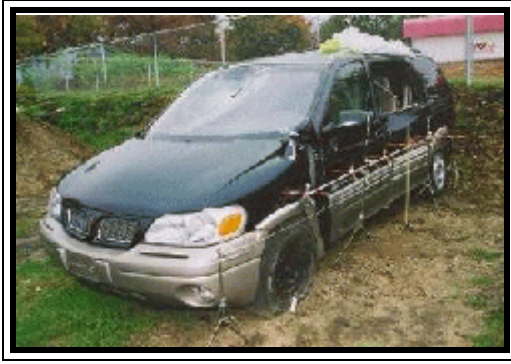
The 2000 Pontiac Montana sustained minor left side surface damage as a result of the impact with the two signposts (**Figures 4 & 5**). Narrow direct contact damage was identified 136.0 cm (53.5 in) forward of the left rear axle (B-pillar area) and 268.0 cm (105.5 in) forward of the left rear axle (A-pillar area) attributed to each struck post. The simultaneous and overlapping nature of these post impacts necessitated a single direct damaged area (*single crush profile*) which began 136.0 cm (53.5 in) forward of the left rear axle and extended forward 148.0 cm (58.3 in). The (overlapping crush profile) direct and induced damage length (Field L) began 36.0 cm (14.2 in) forward of the left rear axle and extended forward 286.0 cm (112.6 in). Six crush measurements were documented at the level of the mid-door: C1= 0 cm, C2= 4.0 cm (1.6 in), C3= 6.5 cm (2.6 in), C4= 0 cm, C5= 2.0 cm (0.8 in), C6= 0 cm. A maximum crush value of 14.0 cm (5.5 in) was documented 8.5 cm (3.3 in) aft of the C3 position. Although not inclusive of the documented crush profile, a secondary maximum crush value attributed to the A-pillar damage measured 11.0 cm (4.3 in). The Collision Deformation Classification (CDC) assigned to this *overlapping* impact to the Pontiac was 09-LYAW-2 with a principal direction of force of (-)100 degrees. Although not inclusive of CDC protocol, individual CDC's were 09-LPAN-2 and 09-LFEN-2. The left fender was deformed outward forward of the axle area as no crush or induced buckling was noted to the driver door area. Pocketing was noted to the left rear door (side tempered glazing disintegrated) as the contact damage extended vertically to the roof side rail. Induced contact damage produced minor buckling to the roof area. Pry marks were noted to the driver's door latch/striker assembly attributed to occupant extrication activities by rescue personnel post-crash. The left front tire was deflated (not restricted) with soil deposits noted in the left side wheels.

The windshield was fractured at the lower left A-pillar from exterior impact forces and the mid-center windshield was penetrated by fragments of the signpost support structure. The 18.0 cm (7.1 in) slit in the mid-windshield was attributed to a U-channel bracket that was found in the passenger compartment on the rear floor area. The CDC for this secondary (non-horizontal) impact to the Pontiac was 00-TPZW-3. Surface scratching was also noted to the rear tailgate (bumper fascia missing) and attributed to the chain link fence impact. The direct contact damage began at the rear left bumper corner (tail light area) and extended 155.0 cm (61.0 in) inboard. The CDC for this final impact to the Pontiac was 06-BDEW-1.

Figure 4. Windshield and left side surface damage to the 2000 Pontiac Montana.

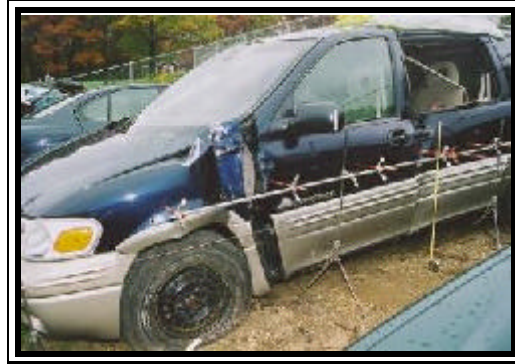
Figure 5. Left side view with direct contact damage to the A-pillar and B-pillar.

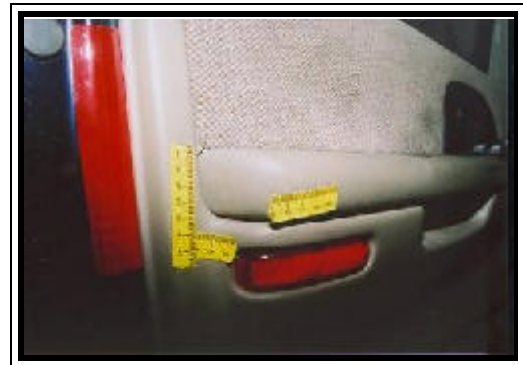
Interior damage to the Pontiac was minimal and was attributed to occupant contact and component intrusions. Scratches were documented on the upper and lower portions of the left front door armrest. Small areas of concentrated scratch marks were identified on the rigid upper component and lower armrest cover panel (just above the reflector lens). Induced B-pillar damage produced rearward/lateral movement of the adjacent handle bar and pillar cover panel. Driver interaction with the deployed left front side impact air bag produced white scuff marks on the armrest and upper door panel (**Figure 6**). Lateral intrusions into the driver space involved 7.0 cm (2.8 in) of B-pillar intrusion, 4.0 cm (1.6 in) of (left rear) handle bar intrusion, and 3.0 cm (1.2 in) of kick panel intrusion. Lateral intrusions into the left rear passenger space involved 13.0 cm (5.1 in) of door panel intrusion, 12.0 cm (4.7 in) window frame intrusion, 4.0 cm (1.6 in) of roof side rail intrusion, and 2.0 cm (0.8 in) of sill intrusion. Penetration of signpost debris into the passenger compartment (metal bracket) resulted in an approximated longitudinal intrusion >61.0 cm (>24.0 in). No vertical component intrusions were found in the vehicle.

Figure 6. Scuff marks to the driver door armrest.

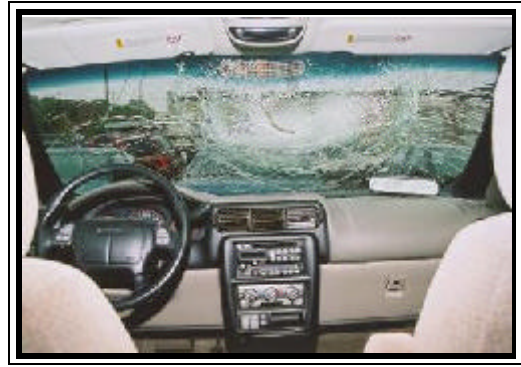
The 2000 Pontiac Montana was equipped with redesigned frontal air bags for the driver and front right passenger positions which did not deploy as a result of the crash (**Figure 7**). The driver air bag was housed in the center of the steering wheel with a vertically oriented flap tear seam (I-configuration). The front right passenger air bag was housed in the right top instrument panel area with a single cover flap design hinged at the forward aspect.

Figure 7. 2000 Pontiac Montana non-deployed frontal air bag system.

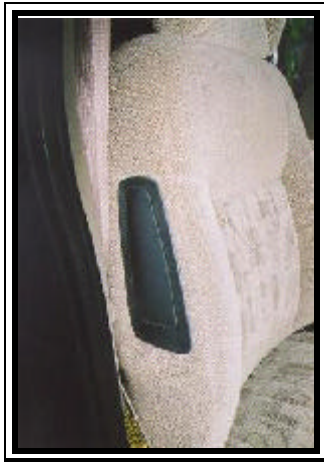
Figure 8. 2000 Pontiac Montana seat mounted side impact air bag.

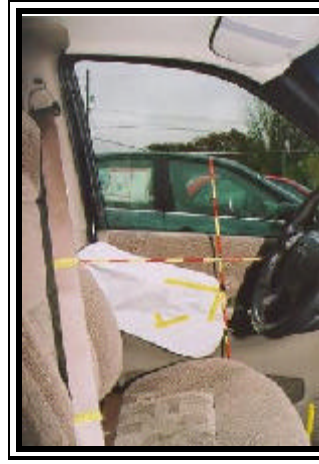
The Pontiac was equipped with seat-mounted side impact air bags for the front seated positions (**Figure 8**). The driver side impact air bag deployed as a result of the crash (**Figure 9**). The air bag modules were housed in the outboard side aspect of the front seat backs [45.7 cm (18.0 in) above floor level] with a single cover flap design. No contact evidence was identified on the exterior surface of the module cover flap, however, circular patterned black vinyl transfers were noted on the air bag face from expansion within the module. A 3.0 cm (1.2 in) black fabric transfer was also documented on the mid-portion of the air bag face, and attributed to the driver's jacket. In addition, driver interaction with the deployed air bag produced the noted scuff marks to the aft aspect of the left front door panel and rigid armrest. The design of the side impact air bag placed the right lower edge corner of the membrane approximately 5.0 cm - 7.0 cm (2.0 in - 2.8 in) lower to the floor level than the left lower (inboard) edge corner; with almost no coverage of the rigid apex of the door armrest. The air bag was rectangular in shape and measured 42.5 cm (16.7 in) in width and 27.0 cm (10.6 in) in height in its deflated state. The bag was vented by one port which measured 5.0 cm (2.0 in) in diameter and located on the outboard aspect of the air bag. No internal tether straps were present. The side impact air bag sensors were located in the (lower) B-pillars. The location/severity of each damaged area on the vehicle exterior (left A-pillar and B-pillar) in this multiple impact scenario and related spacing of the sign support posts suggested the driver may have loaded through a deflated (soft) air bag. The rate of inflation and deflation through the vent port was unknown.

Figure 9. 2000 Pontiac Montana deployed driver side impact air bag.

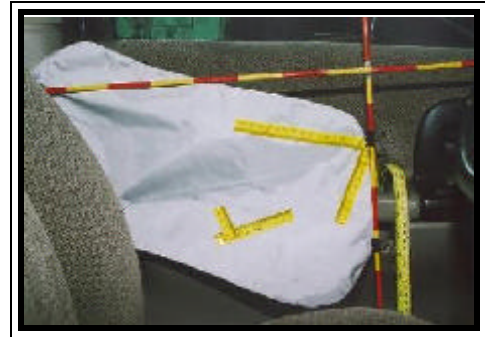
At impact with the signposts, the driver initiated a lateral trajectory in response to the 9 o'clock impact force and loaded the deployed left front side impact air bag and interior surface. Interaction with the deployed left front side impact air bag was confirmed by the black fabric transfer documented on the air bag face (**Figure 10**), which produced the noted white scuff marks identified on the adjacent door panel and armrest. Although preliminary SCI analysis suggested the driver's injuries were related to expansion of the side impact air bag membrane, the simultaneous nature of the post impacts indicated driver loading through a deflated (soft) air bag, or deployment late

Figure 10. 2000 Pontiac Montana deployed driver side impact air bag.

in the crash sequence. Furthermore, the nature of the injuries sustained (*rib fractures were more significant or pronounced in the lateral aspect, with associated proximal swelling*) indicated a direct loading force as opposed to an air bag expansion type injury. Air bag expansion from a seat back mounted module design would produce injury more prominent in the posterior regions, or "sideswiping the left side". However, the injuries are more prominent "in the middle of the left side" as soft tissue swelling occurred laterally, with a fractured rib just at the anterior edge of the swelling. Photographs provided by the driver (taken approximately five days following the crash) revealed a distinct left sided soft tissue contusion (in the area of the internal trauma) that initially appeared to match the location and deployment path of the expanding side impact air bag. However, further analysis implied this injury may not resemble the contact days later, and the pooling of blood masks any actual component association. That, combined with the nature of the spleen laceration, suggested these injuries were crash related and not air bag related. Loading of the left front door armrest resulted in contusions/abrasions to the left lateral chest and abdomen (*lower flank region - just above the left hip*), along with associated underlying multiple (unspecified) rib fractures and splenic trauma. This soft tissue injury extended *only slightly* into the posterior regions, indicative of an out-of-position driver.

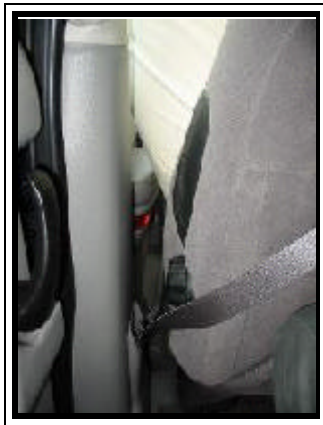
door armrest. This was evidenced by an exemplary study of the height/distance relationship to this component and a similar sized occupant (**Figures 11 & 12**). The kinematic response into the door armrest probably redirected the air bag deployment path in a downward direction. The distinct pattern and location of the soft tissue injuries clearly placed the lateral chest region on the rigid upper structure of the armrest, and abdominal (*flank*) region against the lower cover panel (*near the reflector lens*). These injury mechanisms were further evidenced by the scratch marks and transfers documented on these components. This mechanism also produced extensive underlying trauma which involved unspecified left side rib fractures and a splenic contusion/laceration. The driver's provisional diagnosis during emergency room treatment listed multiple left side rib fractures, however, radiology reports could not confirm the exact number or location. Subsequent analysis of driver medical records by SCI/NHTSA medical consultants revealed the (previously unspecified) fractures to be in the area of left rib #10. It should be noted that he also sustained a contusion to the descending wall of the colon, which could not be confirmed during hospitalization.

Figure 11. Exemplary view of lateral kinematic trajectory into the door armrest with a similar sized occupant (with seat friction).

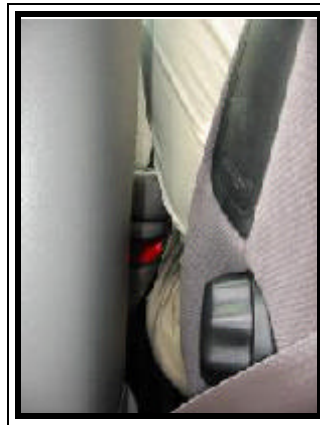
Figure 12. Exemplary view of lateral kinematic trajectory into the door armrest with a similar sized occupant (no seat friction).

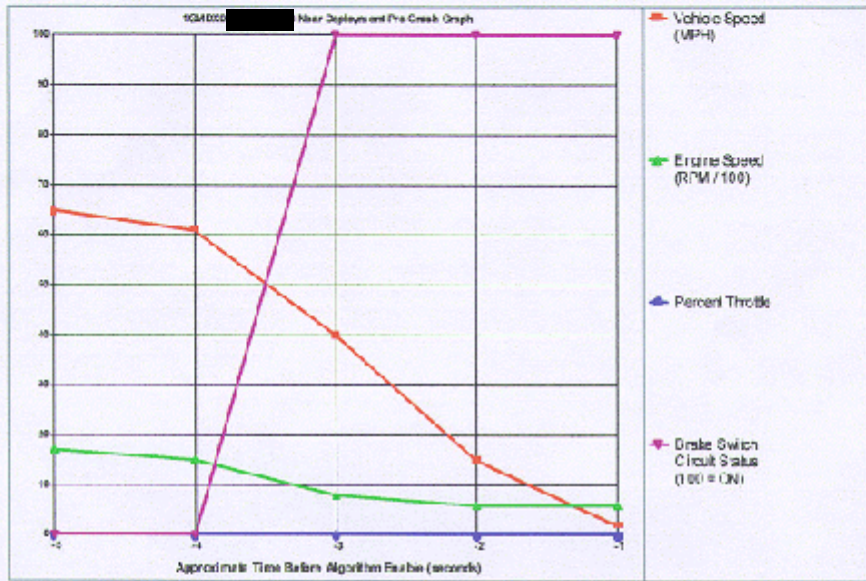
The 2000 Pontiac Montana Sensing and Diagnostic Module (SDM) was located under the front right seat as the event data was retrieved via the J1962 connector found to the left of the steering column. The EDR records deployment and near-deployment events for the frontal air bag system. In this crash, the EDR recorded a near deployment event at ignition cycle number 3016. The system status at near deployment reflected the driver's belt switch circuit status as "buckled". As the vehicle and engine speed decreased during the five second pre-crash interval, the brake switch circuit status went from "off" to "on" three seconds prior to algorithm activation.

Seconds Before AE	Vehicle Speed (MPH)	Engine Speed (RPM)	Percent Throttle	Brake Switch Circuit Status
-5	65	1364	0	OFF
-4	61	1472	0	OFF
-3	40	822	0	ON
-2	15	576	0	ON
-1	2	640	0	ON

Figure 14. 2000 Pontiac Montana EDR report.
