**TRANSPORTATION SCIENCES
CRASH DATA RESEARCH CENTER**

**ON-SITE SIDE IMPACT OCCUPANT PROTECTION SYSTEM CRASH
INVESTIGATION
SCI TECHNICAL SUMMARY REPORT**

VERIDIAN CASE NO. CA01-050

VEHICLE - 2001 HONDA CIVIC

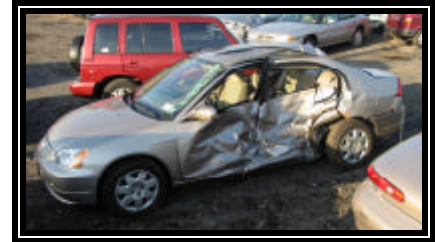
This on-site investigation focused on the side impact crash of a 2001 Honda Civic (**Figure 1**). The Civic was occupied by a 50-year-old female driver who was restrained by the manual 3-point lap and shoulder belt. The vehicle was equipped with frontal air bags and seat back-mounted side impact air bags for the front-seated occupants. The driver of the Civic initiated a left turn maneuver from the right roadside, but failed to detect a Toyota Tacoma pickup truck approaching from the rear. The front aspect of the pickup truck struck the left side passenger area of the Civic.

Figure 1. Damaged 2001 Honda Civic

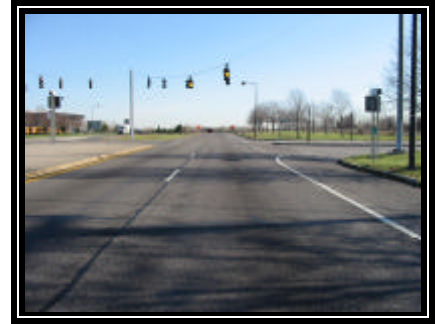
The 50-year-old female driver of the Honda Civic had stopped her vehicle on the right shoulder of the northbound lanes of the state roadway west of the four-leg intersection (**Figure 2**). At the time of the crash, the 3-phase traffic signal was green for northbound traffic. The driver initiated a left turn across both northbound travel lanes from the right shoulder. The driver stated that she could not recall why the turn was attempted. The driver of the Civic failed to detect the approaching 1999 Toyota Tacoma pickup truck that was traveling on the inboard northbound lane. The driver of the pickup truck detected the Civic on the right shoulder prior to the crash, and removed his foot from the accelerator pedal. The driver of the pickup truck did not attempt any further avoidance maneuvers.

Figure 2. Northbound approach view for both vehicles

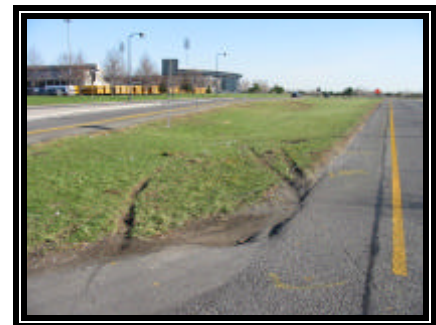
Figure 3. Area of final rest showing gouge marks from the Civic

The Civic rotated in a counterclockwise (CCW) direction as the entire front bumper of the pickup truck engaged the left passenger area of the Civic. The vehicles remained engaged as the Toyota pickup truck's momentum pushed the Civic in a lateral direction across the intersection and onto the grassy median. Gouge marks from the right wheels of the Civic were present on the asphalt road surface and gouge marks in the median were present from all four wheels of the Civic. The Civic came to rest facing northwest in the median. The Toyota pickup truck came to rest straddling the left road edge facing east.

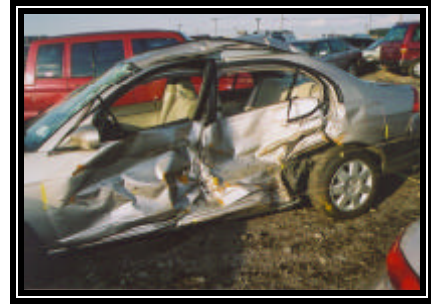
The 2001 Honda Civic sustained moderate damage as a result of the impact with the Toyota pickup truck (**Figure 4**). The direct contact damage began 8 cm (3") aft of the leading edge of the left front door and extended 132 cm (52") rearward. The combined direct and induced damage measured 252 cm (99") and began at the leading edge of the left front door and extended to 3 cm (1") aft of the rear edge of the left rear door. Both left side doors were crushed and displaced. The maximum crush was located on the left rear door approximately 50 cm (20") forward of the rear edge and measured approximately 50 cm (20") at the belt line and approximately 45 cm (18") at the mid-door. The front left door latch was separated from the striker plate (**Figure 5**). It appeared that the separation may have been due to an attempt by rescue personnel to open the door with hydraulic spreaders, but it could not be confirmed. The leading edge of the left front door was displaced outward approximately 3 cm (1") and displaced forward over the left front fender by approximately 3 cm (1").

Figure 4. Left side damage to the Honda Civic

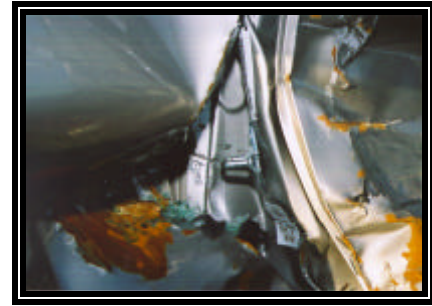
Figure 5. Close-up of the left front door latch/striker separation

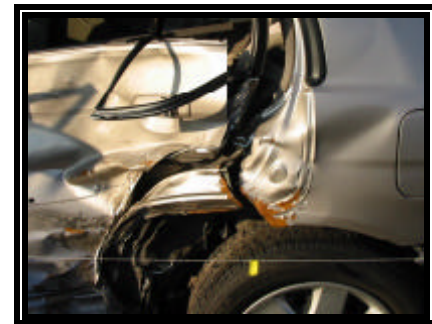
The left rear door latch was also separated from the striker plate and the sheet metal at the lower aspect of the C-pillar was torn above the left rear wheel (**Figure 6**). The striker plate appeared to have been pulled forward, away from the sheet metal prior to the disengagement from the door latch. Both left doors were abraded and crushed from the impact, however, there was no damage to the left front fender and minor induced buckling on the rear left quarter panel. The roof separated from the roof side rail above both left doors as a result of the lateral displacement of the left doors and the left B-pillar. The roof was buckled laterally. The rear aspect of the left sill was crushed laterally and forward from engagement of the right bumper and right frame rail of the Toyota pickup truck. The rear aspect of the left sill was also rotated slightly upward. The Collision Deformation Classification (CDC) was 09-LPEW-3. Six crush measurements were taken along the left side plane at the mid-door level and were as follows: C1 = 0.0 cm, C2 = 12.7 cm (5.0"), C3 = 43.2 cm (17.0"), C4 = 41.9 cm (16.5"), C5 = 15.9 cm (6.3"), C6 = 0.0 cm.

Figure 6. Close-up of left rear door latch/striker separation and torn sheet metal

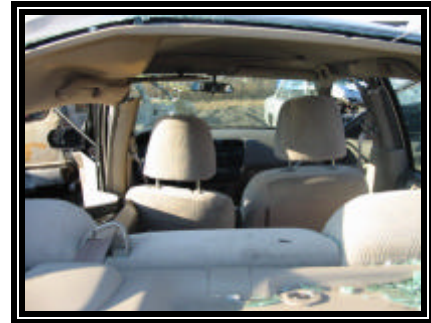
Interior damage was moderate and attributed to compartment intrusion (**Figure 7**). The windshield was fractured on the left aspect from impact forces. All of the left side window glazing disintegrated. The backlight glazing also disintegrated as a result of impact forces. Left side components that intruded into the driver’s seat area included: the left front door, the left roof side rail, and the left B-pillar. The left interior door panel was fractured and separated below the arm rest. The left front seat was crushed laterally and slightly displaced in a clockwise direction toward the middle of the Civic from contact with the left B-pillar and left rear door. The vertical separation between the seat cushion and the seat back measured 5 cm (2") on the outboard aspect. The center console was fractured. The driver’s armrest was in the up position against the inboard aspect of the driver’s seat back. There was no evidence of loading to the arm rest, but the driver could not recall if it was down at the time of the crash. The interior aspect of the B-pillar exhibited a scuff, most likely from the deployed driver’s side impact air bag. Body fluids were noted on the driver’s head restraint. There were no additional identifiable occupant contacts. The documented intrusions were as follows:

Figure 7. View through the backlight showing lateral intrusion

Position	Intruded Component	Intrusion	Direction
11	Left front door armrest	21.0 cm (8.3")	Lateral
11	Left front door (rear aspect)	29.2 cm (11.5")	Lateral
11	Left roof side rail	12.7 cm (5.0")	Lateral
11	Left B-pillar	27.9 cm (11.0")	Lateral
21	Left rear door	31.1 cm (12.3")	Lateral
21	Left roof side rail	15.2 cm (6.0")	Lateral

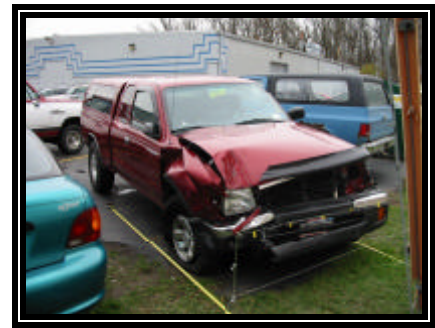
The 1999 Toyota Tacoma pickup truck sustained moderate frontal damage as a result of the impact with the Honda Civic (**Figure 8**). The direct damage measured 150 cm (59") from bumper corner to bumper corner. The maximum crush was located at the front right bumper corner and measured approximately 30 cm (12"). The bumper was crushed against the right front wheel and the wheel was displaced rearward and restricted between the bumper and the right fender. The right front tire was deflated and debanded. The right frame rail protruded forward from the plastic bumper fascia 8 cm (3"). The hood and grille area sustained direct contact damage, the hood was buckled, and the bug shield on the leading edge of the hood was fractured 13 cm (5") right of center. The cargo box was shifted approximately 3 cm (1") to the right as a result of the impact. The CDC for the impact with the Civic was 12-FDEW-2. Six crush measurements were taken along the front bumper of the Toyota Tacoma and were as follows: C1 = 0.0 cm, C2 = 0.0 cm, C3 = 5.7 cm (2.3"), C4 = 15.9 cm (6.3"), C5 = 25.9 cm (10.2"), C6 = 30.5 cm (12.0").

Figure 8. Damaged 1999 Toyota Tacoma pickup truck

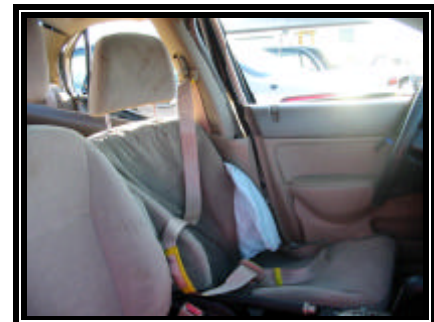
The front seat positions in the Honda Civic were equipped with manual 3-point, continuous loop, lap and shoulder belts with sliding latch plates and inertial lock/belt sensitive retractors. The front right lap and shoulder belt was also equipped with a switchable/automatic locking retractor (ALR). Both front manual restraints were configured with buckle pretensioners located on the inboard aspects of the front seat tracks which did not deploy in this crash. The driver's adjustable D-ring was in the full-up position and the front right D-ring was in the full-down position at the time of the vehicle inspection. The driver's manual restraint was restricted in the used position (**Figure 9**) and the webbing exhibited two triangular black transfers on the outboard aspect. The webbing was stretched from occupant loading, and abrasions were noted on the driver's D-ring and sliding latch plate that were indicative of occupant loading. The front right restraint webbing was cut below the D-ring to facilitate the cutting of the B-pillar to extricate the driver.

Figure 9. View of driver's manual restraint

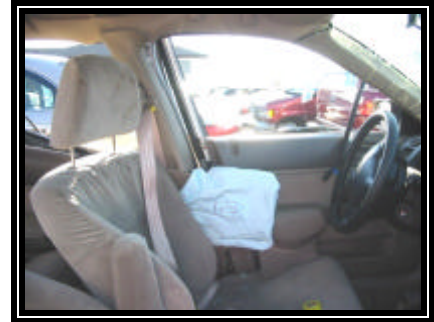
The driver's side impact air bag deployed as a result of the left side impact with the Toyota pickup truck (**Figure 10**). The driver's side impact air bag measured 28.9 cm (11.4") in length at the top aspect and 24.1 cm (9.5") on the bottom aspect. The height measured 25.4 cm (10.0") at the front aspect and the rear aspect was angled downward into the module and measured 15.2 cm (6.0"). The air bag was vented by two circular 6.7 cm (2.6") diameter external ports located on the forward aspect. The top port was centered 7.0 cm (2.8") below the top seam and the bottom port was centered 5.7 cm (2.3") above the bottom seam. The driver's side impact air bag was tethered internally by a lateral tether that measured 5.7 cm (2.3") in length and 1.5 cm (0.6") in width. Superficial scuff marks were noted on the bottom aspect of the air bag. The forward excursion of the driver's side air bag from the leading edge of the seat back measured 28 cm (11") at the top aspect and 20 cm (8") at the bottom aspect. The top aspect of the air bag was located 10 cm (4") below the top aspect of the seat back and the bottom aspect was located 18 cm (7") above the seat cushion.

Figure 10. Deployed driver's side impact air bag

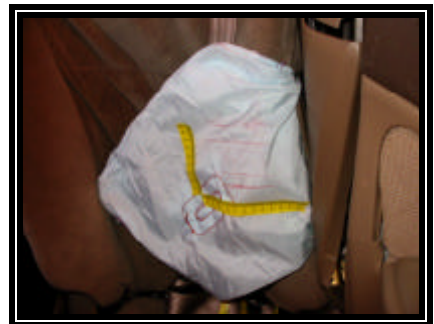
There was no contact evidence on the inboard aspect of the driver's side impact air bag, however, multiple thin, red linear transfers were noted on the outboard aspect of the air bag membrane (**Figure 11**). The transfers were located 15 cm (6") rearward of the leading edge of the air bag and 5 cm (2") below the top aspect.

Figure 11. View showing red linear transfers on the outboard aspect of the driver's side impact air bag

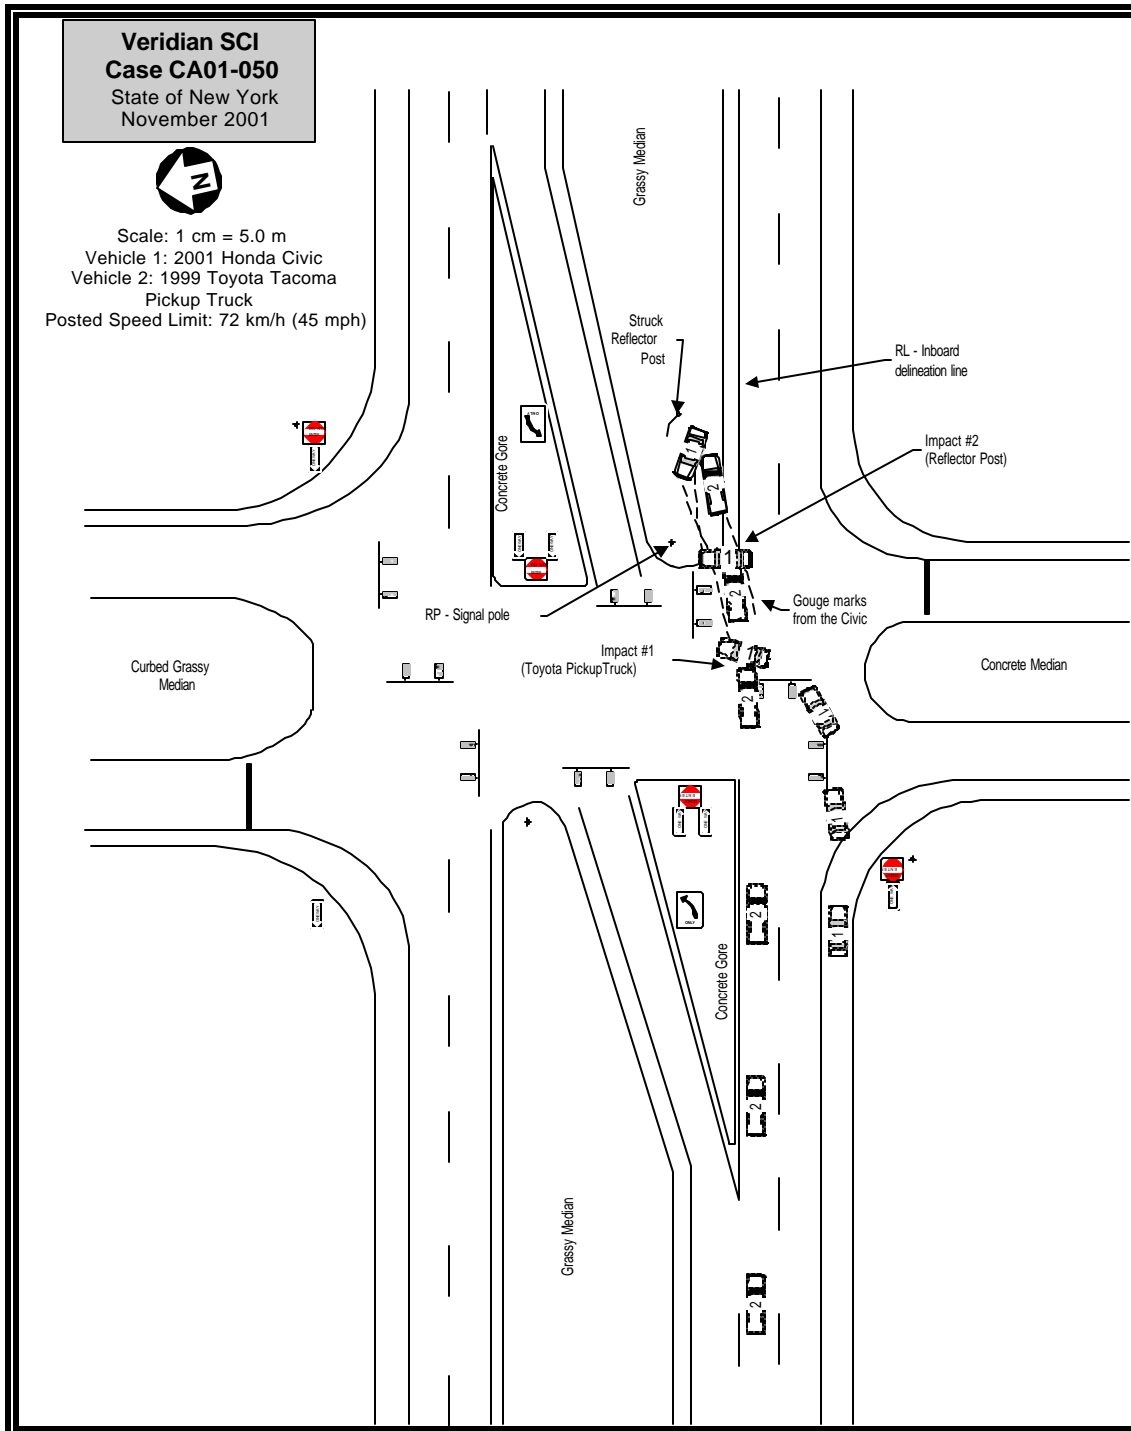
Figure 12. Scene schematic

This two-vehicle crash occurred during the daylight hours at the intersection of the northbound lanes of a divided state roadway and two divided local roadways. At the time of the crash, the asphalt roadway surface was dry and the weather was cloudy. The north/southbound roadway consisted of two travel lanes in each direction that were separated by a grass median. The travel lanes were bordered by asphalt shoulders. The roadway was configured in an east/west direction at the crash site. Traffic flow through the intersection was controlled by three-phase traffic signals for each leg of the intersection. Left turn lanes separated by triangular concrete gores and three-phase left turn signals controlled northbound/southbound traffic initiating left turns. The posted speed limit for the east/west roadway was 72 km/h (45 mph). The scene schematic is included as **Figure 12**.
