ON-SITE AIR BAG NON-DEPLOYMENT/DRIVER FATALITY INVESTIGATION

CASE NO.: CA01-051

VEHICLE: 1999 KIA SEPHIA

CRASH DATE: JUNE 2001

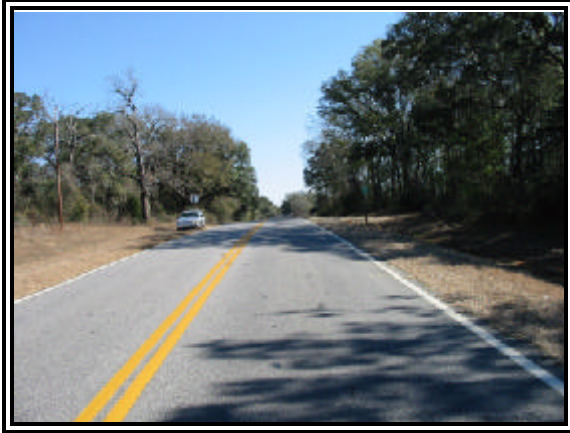
Figure 1: Northbound approach view.

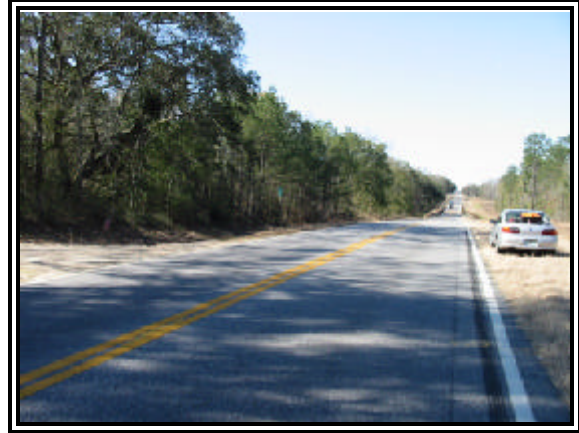
Figure 2: Southbound approach view.

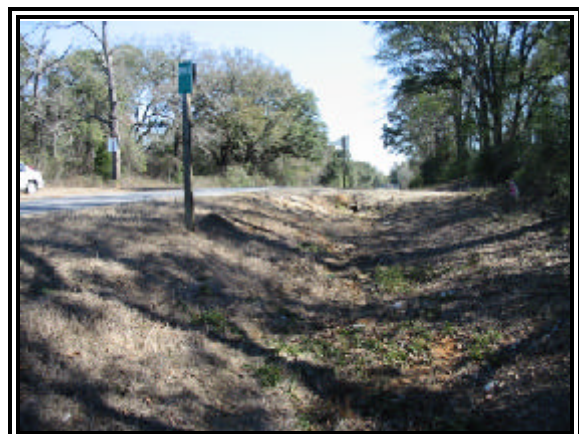
Figure 3: Look back view from the Kia's final rest to the POI.

the road. **Figure 3** is a look back view from the estimated final rest position of the Kia toward the point of impact. Its final rest location was an estimated 9.4 m (31.0 ft) southeast of the point of impact. The final rest location was estimated by a possible tire furrow in the ditch.

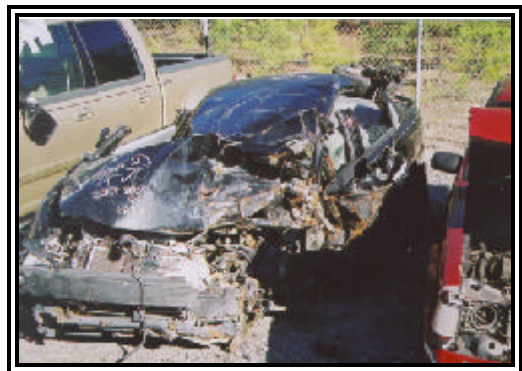
Figure 4 is a view of the vehicle upon initial inspection. It exhibited evidence of extensive extrication and had been exposed to the elements since the date of the crash. The 1999 Kia Sephia was identified by a Vehicle Identification Number (VIN): KNAFB1217X5 (production sequence deleted). The subject Kia was the base model. The four-door, front wheel drive sedan was equipped with a 1.8 liter, I4 engine linked to a 4-speed automatic transmission. The brakes were front disc/rear drum without ABS. The vehicle was reportedly purchased used by the driver from a local dealership. At the time of this purchase, the odometer had recorded approximately 63,915 km (39,716 miles). The odometer reading at the time of the inspection was 66,577 km (41,370 miles). The history of this vehicle prior to the subject driver's purchase was unknown.

Figure 4: Left front view of the Kia Sephia.

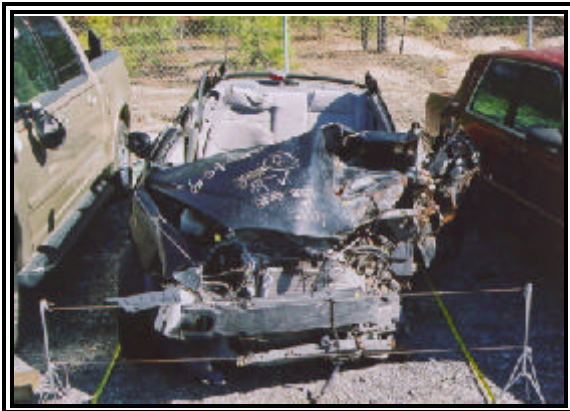
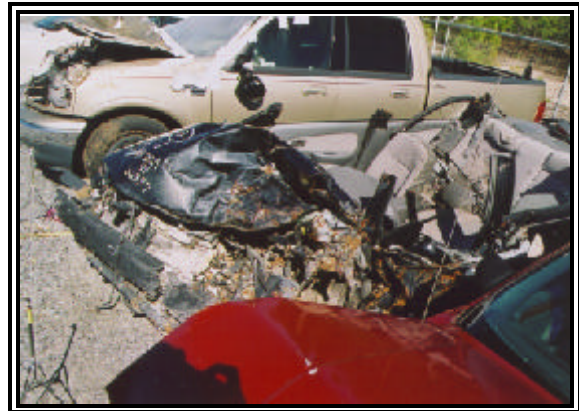
Figures 5 and 6 are front and left lateral views of the impact damage. The front plane of the Kia sustained 66 cm (26 in) of direct contact damage. The direct contact damage began 7.6 cm (3.0 in) left of center and extended to the left front bumper corner. The combined width of the direct and induced damage extended across the entire 137 cm (54 in) end width of the vehicle. The off-set frontal impact resulted in a left lateral end-shift that measured approximately 25 cm (10 in). The damage profile of the Kia was indicative of an underride. Therefore, the crush profile was documented at the bumper elevation and along the upper radiator support. The residual crush along the reinforcement bar was as follows: C1 = 72.0 cm (28.3 in), C2 = 39.0 cm (15.4 in), C3 = 24.0 cm (9.0 in), C4 = 3.0 cm (1.2 in). The crush profile measured along the upper radiator support was: C1 = 87.0 cm (34.3 in), C2 = 56.0 cm (22.0 in), C3 = 24.0 cm (9.4 in), C4 = 12.0 cm (4.7 in). An average of these documented profiles was used to assess the severity of the crash. The averaged profile used as the input to the WINSMASH model was as follows: C1 = 80.0 cm (31.5 in), C2 = 48.0 cm (18.9 in), C3 = 24.0 cm (9.4 in), C4 = 3.0 cm (1.2 in). The force of the impact separated the left front wheel and suspension from the vehicle. There was evidence of direct contact to the left front wheel rim. The hood buckled rearward and contacted the lower aspect of the windshield. The rake angle of the left A-pillar was nearly vertical and measured approximately 80 degrees. The roof, **Figure 7**, had buckled up and rearward over the driver's position. The left side direct contact damage extended rearward onto the mid aspect of the left door. The roof was removed by cutting all six pillars and the left door was forced opened during the driver's extrication. Sections of the windshield laminate were found lying about the vehicle's interior. The windshield was fractured in multiple locations from the exterior crash forces. The Collision Deformation Classification of the Kia was 12-FYEW-4.

Figure 5: Front view of the Kia.

Figure 6: Left lateral view.

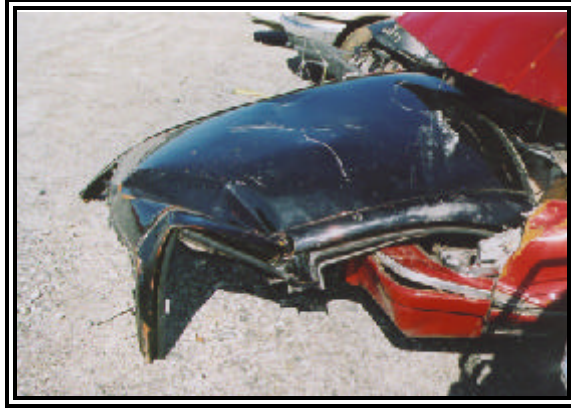
Figure 7: View of roof and left A-pillar damage.

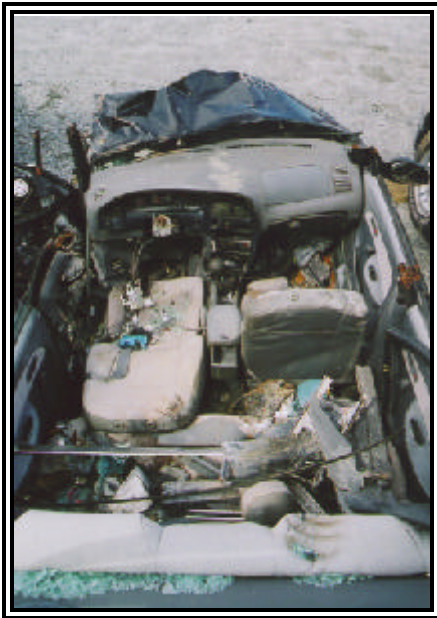
Figure 8 is an overall interior view of the Kia. The driver's occupant space sustained moderate intrusion as a result of the exterior crash force. The intrusion of the left A-pillar and left corner of the instrument panel measured 32.0 cm (12.6 in) and 23.0 cm (9.0 in), respectively. The toe pan intrusion measured on the steering column center line was approximately 26 cm (10 in).

Figure 8: Overall view interior view.

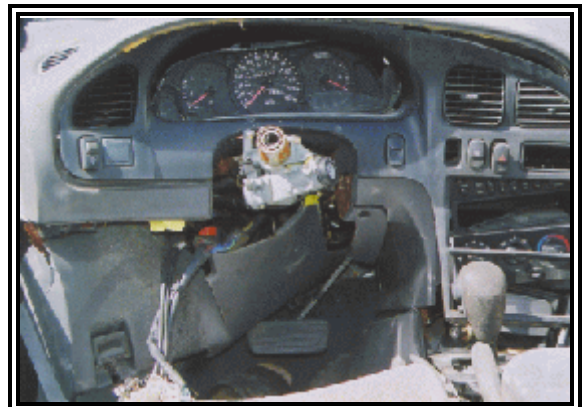
The left bolster exhibited evidence of contact and penetration from the driver's lower extremities, **Figure 9**. These contacts were located 10.9 cm (4.3 in) right and 12.7 cm (5.0 in) left of the steering column center line. The driver's foot wear was noted to be lying in the foot well.

Figure 9: Knee bolster deformation.

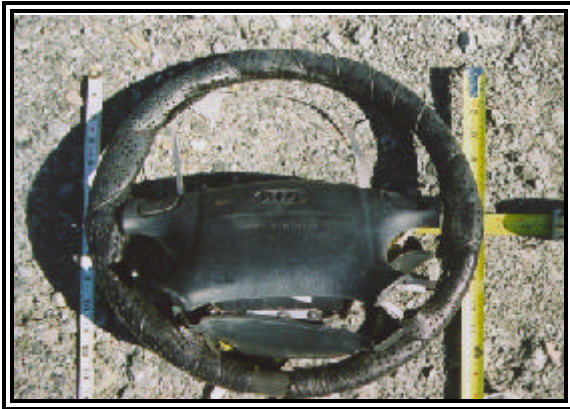
The driver's chest and abdomen contacted and deformed the lower aspect of the steering wheel rim, **Figure 10**. The lower rim deformation measured 3.8 cm (1.5 in). There was complete separation of the column from the shear capsules. The deformed steering wheel rim and non-deployed driver air bag assembly was found on the driver seat. The steering shaft had fractured below the upper bearing, **Figure 11**, and separated from the column. **Figure 12** is a view of the end of the steering column and the upper bearing. The cause of this separation could not be determined. The separation may have occurred during extrication procedures or due to the exterior crash force coupled with the dynamic steering wheel rim loading by the driver.

Figure 10: View of the steering wheel rim deformation and non-deployed driver air bag.

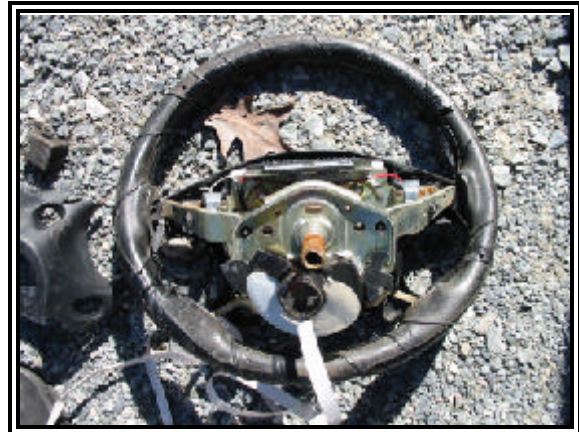
Figure 11: Fractured steering shaft.

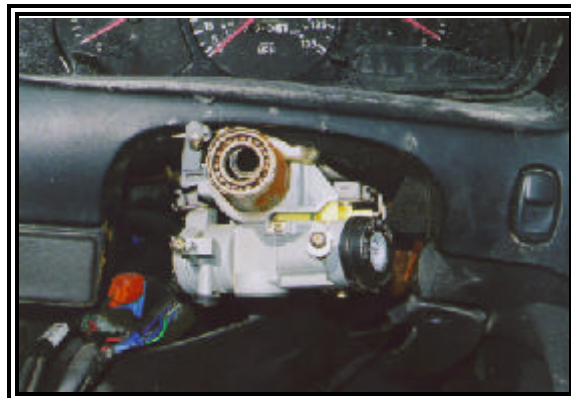
Figure 12: View of the end of the steering column and upper bearing.

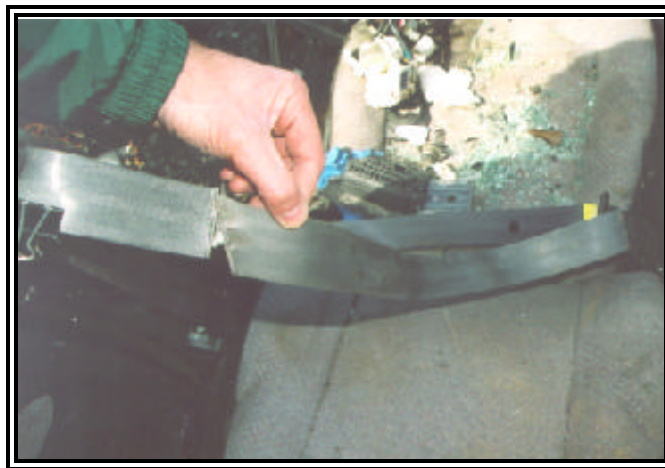
The driver's seat belt webbing was cut during the extrication process. The webbing was cut, at an angle, 137.2 cm (54.3 in) above the outboard floor anchor. Refer to **Figure 13**. Using the stop button as a reference, this cut was located 79.3 cm (31.3 in) above button. The balance of the webbing had spooled back into the left retractor. Upon examination, the end of the spooled webbing was cut straight across. A section of the webbing (length unknown) apparently was cut out of the webbing for unknown reasons.

Figure 13: View of the cut driver seat belt webbing.

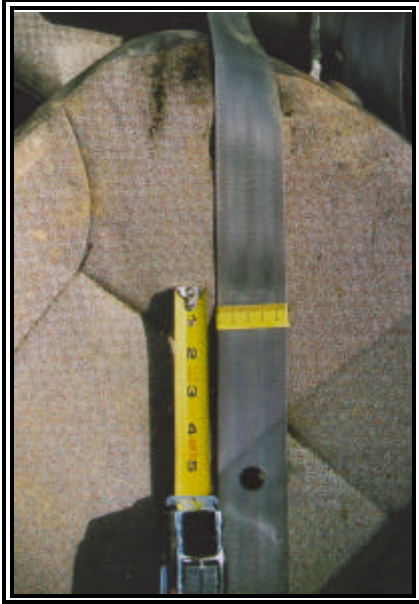
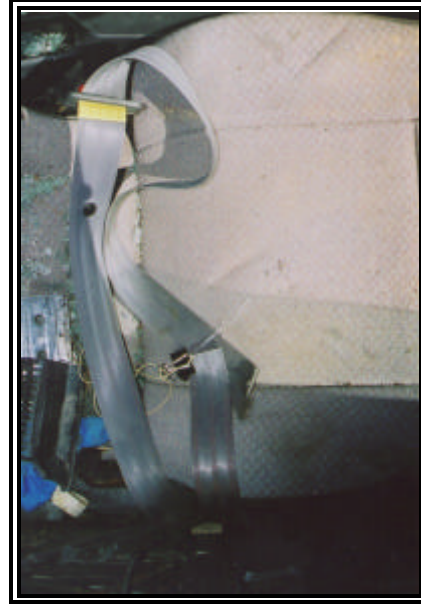
A crease in the driver's webbing was located 13 cm (5 in) above the stop button, **Figures 14 and 15**. The crease resulted from the driver loading to the webbing at the latch plate turning loop. The left D-ring was in the full up position. The friction surface exhibited a minor webbing transfer across its full width. The latch plate was located on the driver's seat cushion. Examination of the latch plate revealed evidence of historical use, however it should be noted, this evidence was more related to the historical use by the previous owner of the Kia. The deceased driver had only operated the vehicle approximately 2,662 km (1,654 miles). The plastic hardware of the turning loop revealed loading evidence related to the aforementioned webbing crease. The latch plate was inserted into the buckle and a positive latching occurred. The latch and buckle functioned as designed during the crash event. All evidence identified during the course of the inspection indicated the driver was restrained at the time of the crash.

Figure 14: View of the webbing crease.

Figure 15: Left overhead view of the driver's seat belt.
