**ON-SITE ADVANCED OCCUPANT PROTECTION SYSTEM CRASH INVESTIGATION
SCI TECHNICAL SUMMARY REPORT**

VERIDIAN CASE NO. CA01-053

VEHICLE - 2002 FORD WINDSTAR

CRASH DATE - DECEMBER 2001

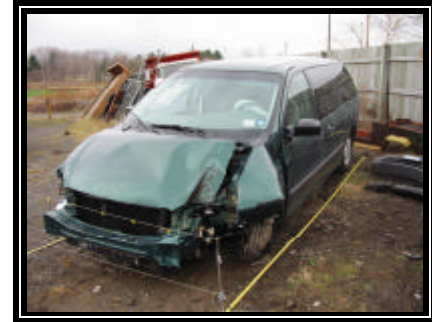
Figure 1. Damaged 2002 Ford Windstar

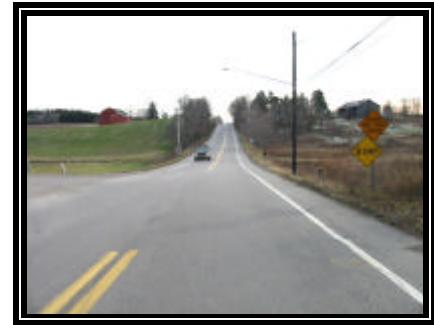
The 38-year-old female driver was operating the 2002 Ford Windstar southbound on the two-lane county roadway (**Figure 2**). As the Windstar crested the hill, the driver detected a non-contact vehicle stopped at the mouth of the intersection waiting to initiate a left turn onto the local roadway. The driver of the Ford Windstar steered right in an attempt to avoid the collision with the non-contact vehicle. The Windstar departed the right roadside in a tracking mode.

Figure 2. Southbound approach for the Windstar

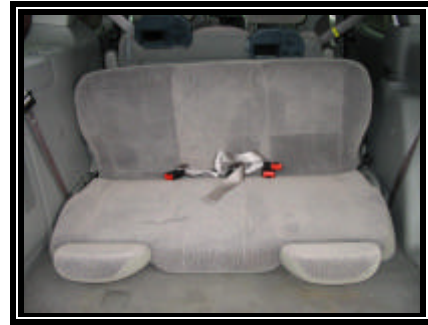
The Windstar was equipped with box-mounted captains chairs with integral head restraints for the driver and front right passenger positions. At the time of the vehicle inspection, the driver's seat track was adjusted to the full-forward position and the front right seat track was adjusted to the full-rear position. Both front seats traveled a total distance of 16.5 cm (6.5") fore and aft. The driver's seat back was reclined 30 degrees from vertical and the front right seat was reclined 10 degrees from vertical. The second row was configured with a two-person bench seat with adjustable head restraints. The left head restraint was adjusted 7.6 cm (3.0") above the seat back and the right head restraint was adjusted 6.4 cm (2.5") above the seat back. Plastic aftermarket mirror/cupholder accessories were affixed with single straps to each head restraint on the second seat. The adjustable seat back was reclined 25 degrees from vertical and the bench seat track was positioned at the full-rear position with a total travel distance of 10.2 cm (4.0"). The third row was configured with a three-person bench seat with adjustable head restraints on the outboard positions. At the time of the vehicle inspection, the forward anchors of the bench seat were disengaged from the floor anchor points and the seat was displaced rearward onto the floor resting on the seat back (**Figure 3**). It was not known if the displacement was crash related.

Figure 3. Displaced third seat

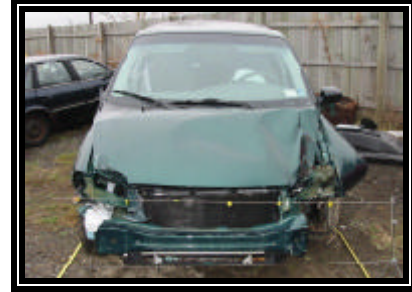
The 2002 Ford Windstar sustained moderate damage as a result of the multiple impacts (**Figure 4**). The vehicle exhibited minor front right damage as a result of the first impact with the non-breakaway sign. Narrow direct contact abrasions were located on the front right corner of the hood and measured 9.5 cm (3.8") in width and 10.2 cm (4.0") rearward from the forward aspect. The direct contact damage on the bumper fascia began 68.6 cm (27.0") right of the centerline and extended to the front right corner. The bumper fascia was fractured 74.3 cm (29.3") right of center and the corner of the fascia was separated. The right front fender sustained induced buckling and the head lamp assembly was displaced. The right side mirror was separated from the vehicle. The Collision Deformation Classification for the first impact with the sign was 12-FREN-1.

Figure 4. Frontal view of damaged Windstar

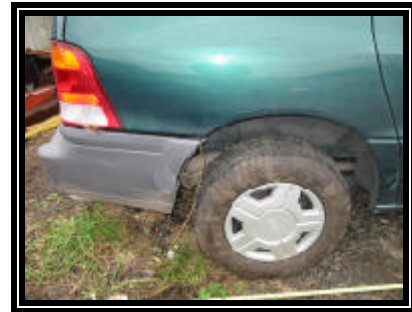
The impact with the telephone junction box resulted in minor sideswipe damage to the right side of the Windstar. Longitudinal abrasions were noted on the right front fender, lower right side sliding door, and on the right rear quarter panel. The lower plastic trim that extended forward from the rear bumper fascia on the right side was fractured from snagging on the telephone box (**Figure 5**). The CDC for the sideswipe event was 12-FRES-1.

Figure 5. Right rear damage from the sideswipe impact

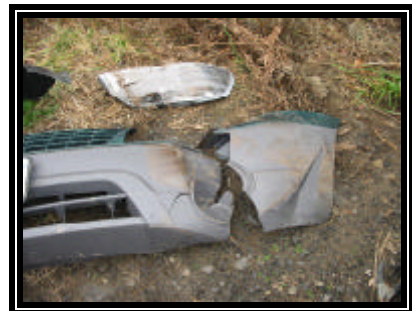
The impact with the utility pole resulted in moderate damage to the Windstar. The direct contact damage began 54.6 cm (21.5") to the left of center on the bumper fascia and extended to the front left corner and around the left side aspect of the fascia (**Figure 6**). The front right aspect of the bumper fascia was fractured 82.6 cm (32.5") left of center at the left corner.

Figure 6. Damaged left aspect of front bumper fascia

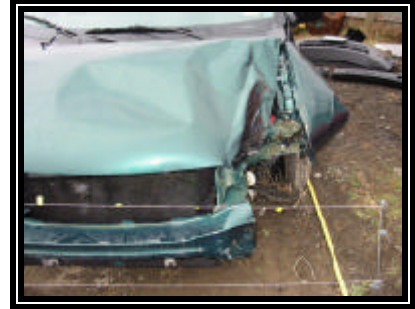
The direct contact on the hood began 45.7 cm (18.0") left of center and extended laterally 38.1 cm (15.5") to the left front fender (**Figure 7**). The combined direct and induced damage involved the entire frontal width of the Windstar. The multiple frontal impacts and overlapping nature of combined direct and induced frontal damage necessitated a single crush profile. The total combined direct and induced damage length measured 125.1 cm (49.3") along the bumper beam. Crush measurements were documented at the level of the bumper beam and at the upper radiator support. The residual maximum crush was located at the front left corner of the bumper beam at C1 and was approximately 13 cm (5"). The maximum crush at the same location on upper radiator support was approximately 27 cm (11"). The impact was primarily outboard of the left frame rail, and the outboard aspect of the left frame rail exhibited longitudinal abrasions from the pole on the forward aspect.

Figure 7. Direct damage from pole impact

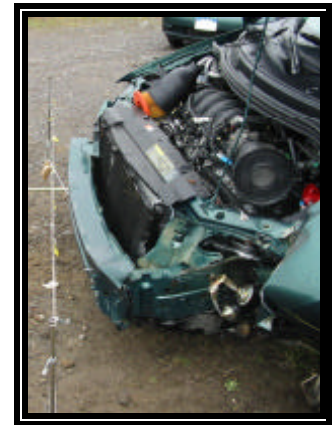
The direct contact on the left corner of the bumper beam was minimal, however, the impact resulted in the induced displacement of the entire beam (**Figure 8**). Direct contact abrasions were present on the left corner of the hood and the entire hood was buckled rearward. The pole impact also resulted in rearward and outward displacement of the left front fender. The aft edge of the left fender was displaced inboard of the leading edge of the partially restricted left front door. The crush resulted in incapacitating damage to the exterior fuse box, which resulted in complete power loss to the vehicle. The corner impact allowed the pole to penetrate rearward and contact the left front wheel assembly. The left front wheel was restricted against the rear aspect of the left front fender and rotated slightly CCW. The rearward left front wheel displacement reduced the left wheelbase by 42.7 cm (16.8"). The CDC for the pole impact was 12-FLEE-2. A crush profile was taken across the front bumper beam and on the upper radiator support. Based on approximate free space values, the estimated crush profile at the bumper beam was as follows: C1 = 13 cm (5"), C2 = 8 cm (3"), C3 = 5 cm (2"), C4 = 3 cm (1"), C5 = 3 cm (1"), C6 = 0.0 cm. The estimated crush profile along the upper radiator support was as follows: C1 = 27 cm (11"), C2 = 16 cm (6"), C3 = 10 cm (4"), C4 = 5 cm (2"), C5 = 3 cm (1"), C6 = 0.0 cm.

Figure 8. Lateral view of direct and induced frontal damage

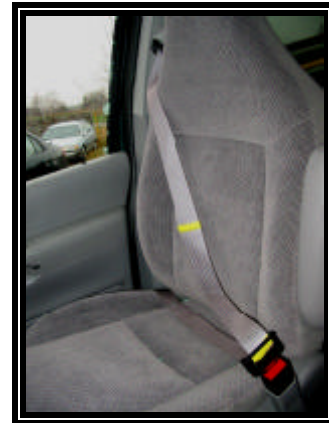
The front seat positions in the 2002 Ford Windstar were equipped with manual 3-point lap and shoulder belts and inertial lock/belt sensitive, load limiting retractors. The driver's manual restraint was configured with a sliding latch plate and the remaining manual restraints were configured with lightweight locking (cinching) latch plates. The front right lap and shoulder belt was also equipped with a switchable/automatic locking retractor (ALR). Both front manual restraints were configured with retractor pretensioners located in the lower B-pillars. Although both front seat restraints were restricted in the used position and it is highly likely that both front seat belt pretensioners fired, it could not be confirmed with certainty due to their position in the retractors. The driver's adjustable D-ring was in the full-down position and the front right D-ring was 2.5 cm (1.0") below the full-up position at the time of the vehicle inspection. The driver's D-ring and latch plate were abraded from occupant loading and pretensioner firing, and the front right passenger's D-ring and latch plate showed abrasions consistent with occupant loading and pretensioner firing. Both frontal seat belts exhibited distinct lateral fold patterns on the webbing which were not consistent with occupant positions and did not appear to be crash related. (Figure 9).

Figure 9. View of front right manual restraint

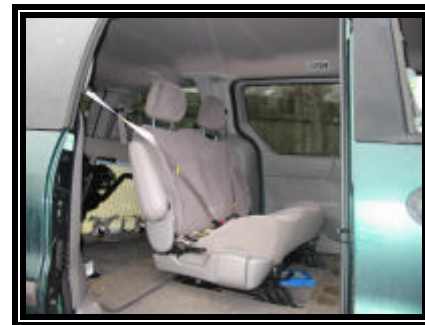
The second seat positions were configured with manual 3-point lap and shoulder belts with sliding latch plates and inertial lock/belt sensitive, load limiting retractors (Figure 10). Both lap and shoulder belts were equipped with switchable/ALR's. The second seat manual restraints were equipped with adjustable D-rings. The second seat left D-ring was in the full-down position and the second seat right D-ring was 2.5 cm (1.0") below the full-up position at the time of the vehicle inspection. There were no abrasions on either second seat D-ring or latch plate. The left position 3-point lap and shoulder belt was permanently anchored to the floor. The second seat right seat belt was anchored to the right rear side aspect of the seat with a latch plate and buckle mechanism. Multiple creases were noted on the webbing indicative of a child safety seat installation, and both second seat belts exhibited multiple lateral fold patterns on the webbing which were not consistent with occupant positions and did not appear to be crash related.

Figure 10. View of second seat restraints

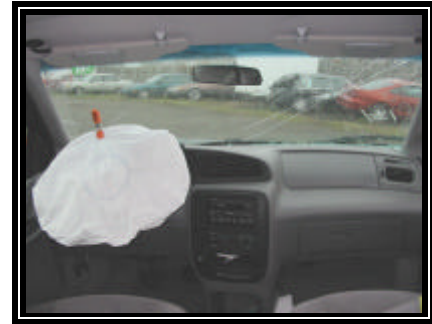
The driver's air bag deployed as a result of the utility pole impact (**Figure 11**). The air bag deployed from the center of the steering wheel from asymmetrical H-configuration module cover flaps. The top flap measured 15.2 cm (6.0") in width at the top aspect and 7.6 cm (3.0") in height. The width at the tear seam measured 16.8 cm (6.6"). The bottom flap measured 10.2 cm (4.0") in width at the bottom aspect and 4.4 cm (1.8") in height. The driver's air bag measured 53.3 cm (21.0") in diameter in its deflated state. The air bag was vented by two circular ports that measured 2.5 cm (1.0") in diameter and were located in the 12 o'clock sector 7.0 cm (2.8") from the seam. The air bag was tethered by two internal straps at the 12 and 6 o'clock positions that measured 11.4 cm (4.5") in width.

Figure 11. Deployed driver's air bag

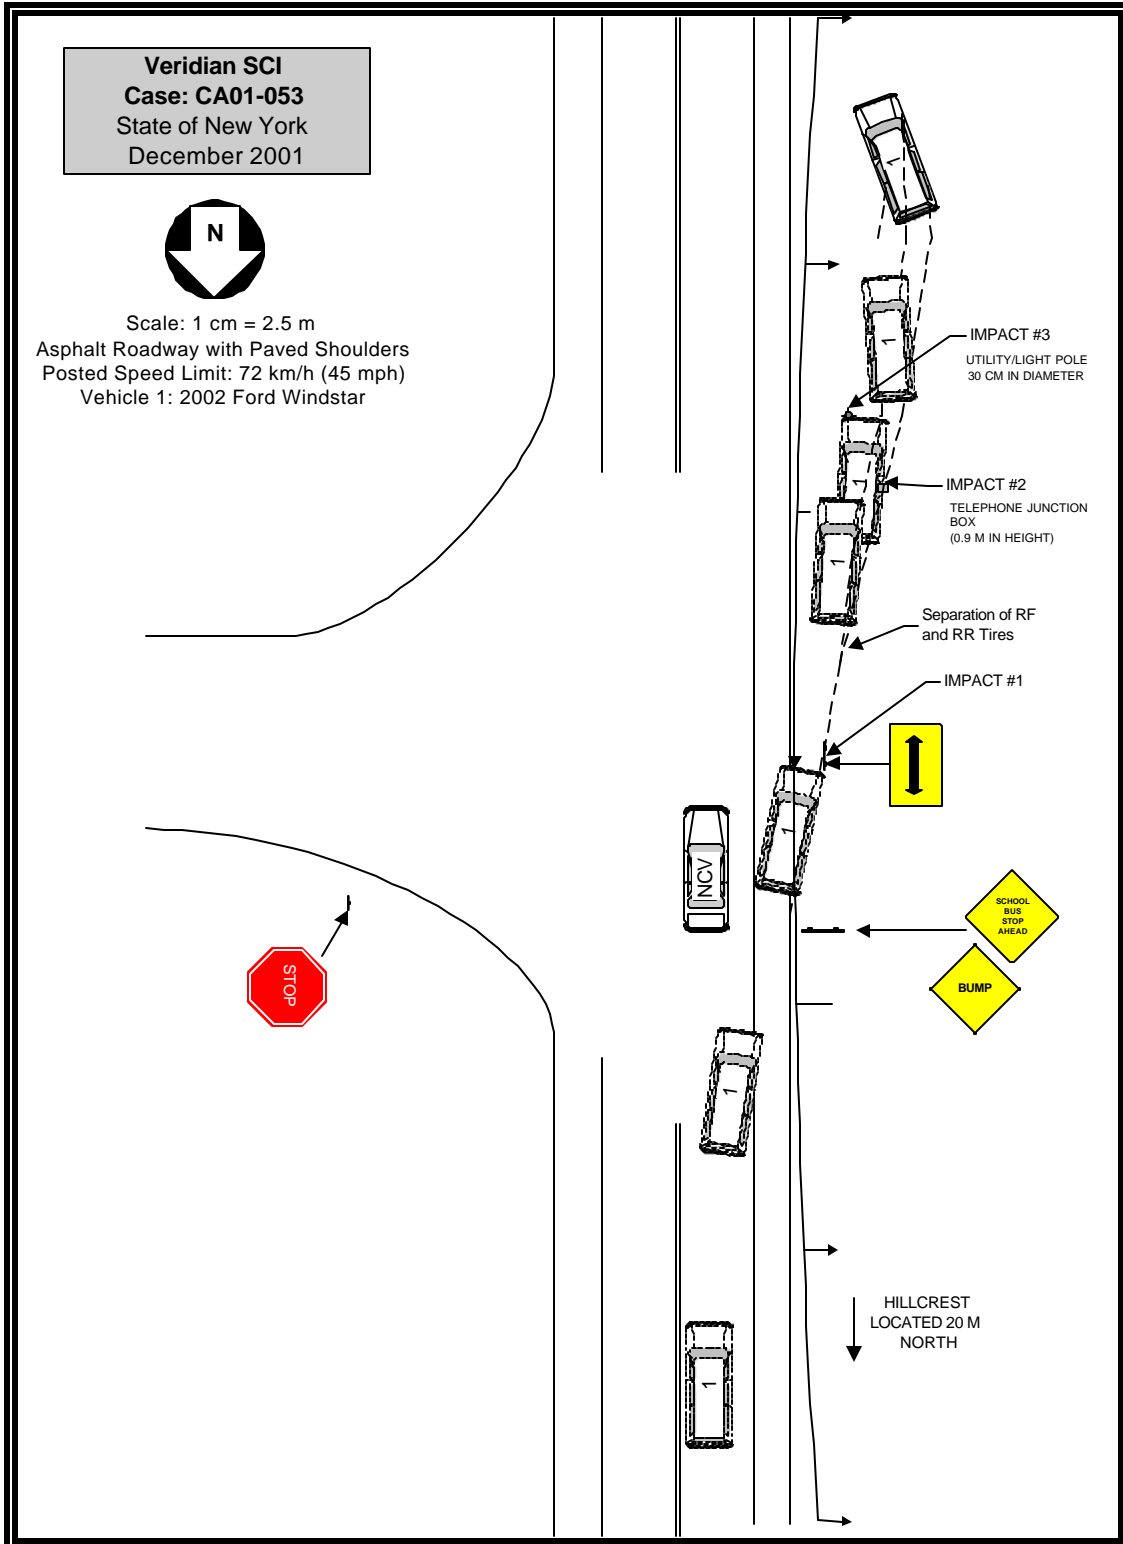
Figure 12. Scene schematic

(36") in height was located on the west roadside 4.0 m (13.0') west of the road edge. The west roadside also had a negative slope. Traffic flow at the intersection was controlled by a stop sign for westbound traffic. A "Bump" sign and a "School Bus Stop Ahead" sign were located at the intersection on the west roadside for southbound traffic. A yellow sign with opposite arrows was located south of the other warning signs on the west roadside for westbound traffic at the intersection to identify the "T" intersection. The posted speed limit was 72 km/h (45 mph) for the north/south roadway. The scene schematic is included as **Figure 12**.
