**REMOTE NASS/SCI COMBINED  
ADVANCED OCCUPANT PROTECTION/DRIVER FATALITY INVESTIGATION**

**VERIDIAN CASE NO. 2002-05-013A**

**VEHICLE - 2001 VOLVO S40**

**CRASH DATE - JANUARY, 2002**

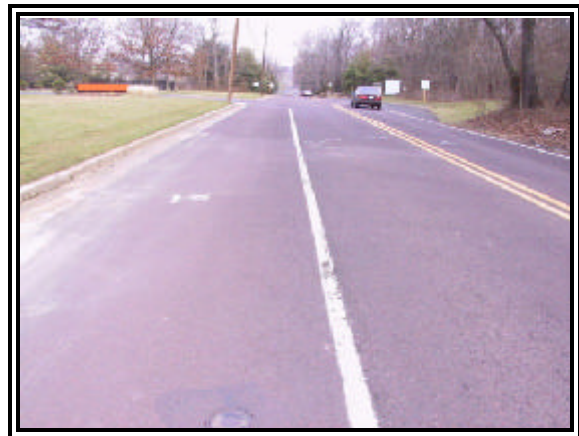
**Figure 1:** Northward view of the point of impact and the vehicle's final rest positions.

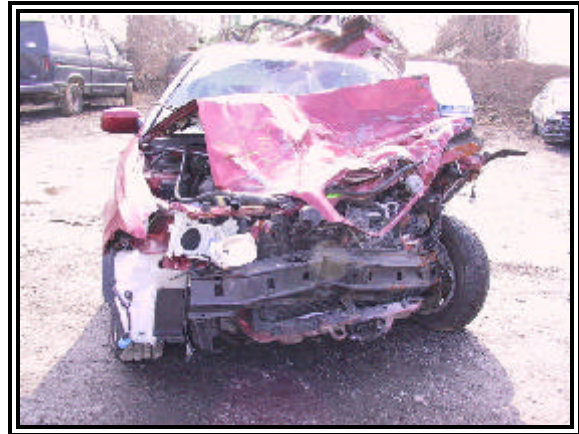
**Figure 3:** Front view of the Volvo.

The front plane of the Volvo sustained severe contact damage that extended across the entire 150 cm (59 in) end width. The damage pattern was biased to the left side indicative of the off-set impact configuration. The impact force collapsed the left aspect of the engine compartment longitudinally rearward into the left side of the cowl and left A-pillar. The left front aspect of the roof was buckled. The induced damage extended rearward along the left side of the vehicle to the C-pillar and along the right side to the B-pillar locations, respectively. The left front door was jammed shut due to the deformation and removed during the driver's extrication. The left rear door was also jammed. The left wheelbase was foreshortened 24.3 cm (9.5 in). The right doors remained operational. There was no change in the right wheelbase dimension. The crush profile measured along the bumper reinforcement was as follows: C1 = 93 cm (36.6 in), C2 = 67 cm (26.4 in), C3 = 53 cm (20.9 in), C4 = 42 cm (16.5 in), C5 = 18 cm (7.1 in), C6 = 21 cm (8.3 in). The Collision Deformation

Classification (CDC) of the Volvo was 12-FDEW-4. The Principle Direction of Force was an estimated +10 degrees. The delta V calculated by the Damage Algorithm of the WINSMASH model was 68 km/h (42.3 mph). The longitudinal and lateral components were -66.9 km/h (-41.6 mph) and -11.7 km/h (-7.3 mph), respectively.

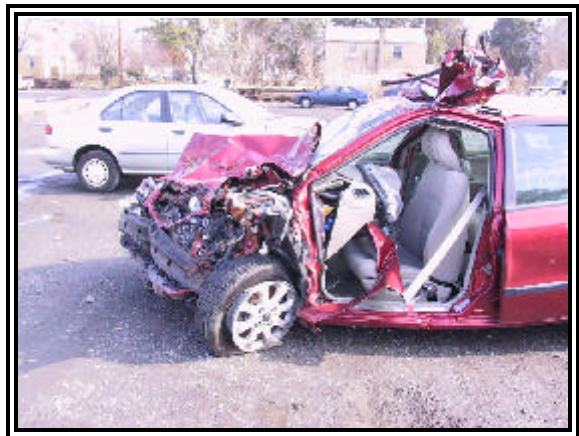
**Figure 4:** Left lateral view.

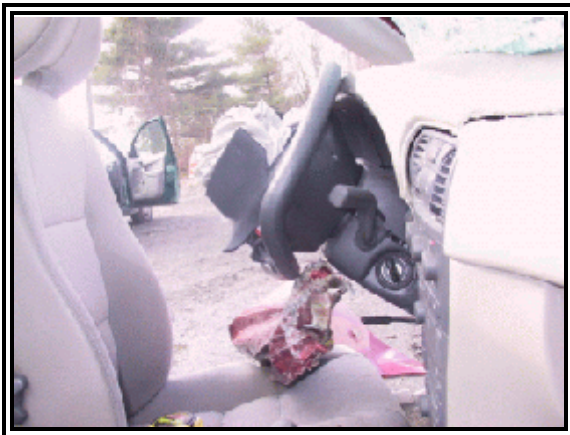
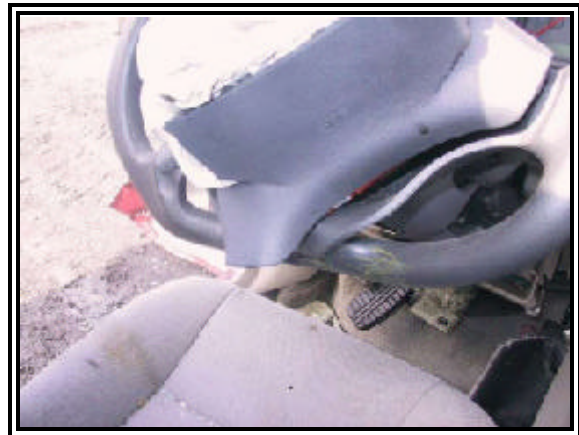
**Figures 5 and 6** are interior views of the Volvo and depict the deformed steering wheel rim and steering column displacement. The steering wheel rim was deformed throughout its 5 to 9 o'clock sectors. The maximum deformation measured 6.0 cm (2.4 in). The steering wheel was rotated approximately 30 degrees counterclockwise at the time it was loaded by the driver. The location of the upper sector of the steering wheel rim in-close proximity to the brow of the instrument panel indicated there was compression of the steering column.

**Figure 5:** Right lateral interior view.

**Figure 6:** Deformed steering wheel rim.

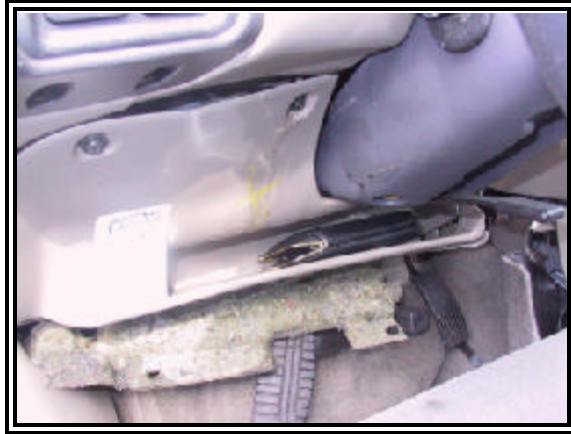
Lower extremity contacts were noted to the intruding bolster panel consistent with the driver's injuries. Refer to **Figure 7**.

**Figure 7:** Lower extremity contacts to the intruding bolster.

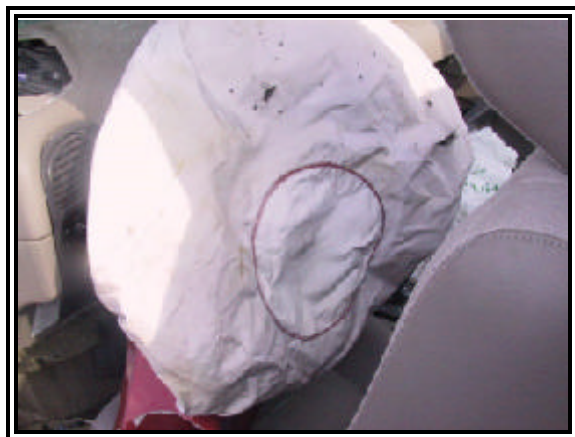
The driver air bag, **Figure 8**, deployed as designed from its module located on the center hub of the steering wheel rim. The symmetrical H-configuration cover flaps measured 16 cm by 7 cm (6.3 in by 2.8 in), width by height. There was no evidence of occupant contact to the cover flaps. The air bag measured 55 cm (22 in) in diameter in its deflated state. The air bag was tethered by 4 internal straps sewn to the face of bag and was vented by two ports located in the 11/1 o'clock sectors on the back side of the bag. There was no direct evidence of occupant contact noted during the inspection.

**Figure 8:** Driver air bag.

Multiple “dicing-type” lacerations were noted within the 12 to 4 o’clock sector on the face of the air bag. These minor lacerations occurred post-deployment as a result of flying glass from the disintegrated front left window.

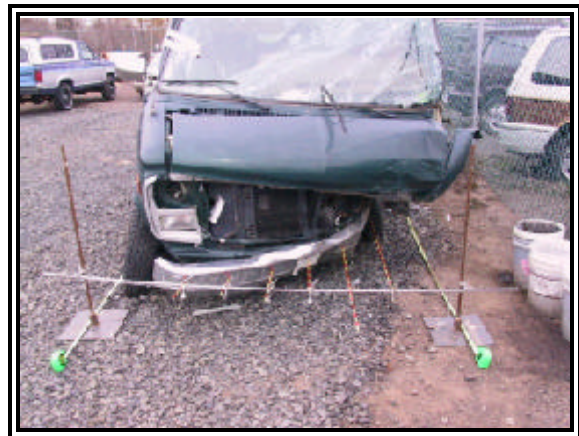
**Figure 9:** Front view of the Chevrolet.

The vehicle’s front plane sustained 58 cm (23 in) of direct contact damage that began 25 cm (10 in) left of center and extended to the left corner of the front bumper. The combined width of the direct and induced damage extended across the van’s entire 170 cm (67 in) end width. The resultant damage pattern was triangular in shape biased to the left. The impact force collapsed the left side of the engine compartment into the cowl. The left front suspension deformed rearward shortening the left wheelbase approximately 30 cm (12 in). The residual crush profile measured along the front bumper was as follows: C1 = 117 cm (46.0 in), C2 = 63 cm (24.8 in), C3 = 42 cm (16.5 in), C4 = 26 cm (10.2 in), C5 = 12 cm (4.7 in), C6 = 0. The Principle Direction of Force (PDOF) was an estimated -10 degrees. The Collision Deformation Classification (CDC) of the Chevrolet was 12-FLEW-7. The delta V calculated by the Damage Algorithm of the WINSMASH model was 42.0 km/h (26.1 mph). The longitudinal and lateral delta V components were -41.3 km/h (-25.7 mph) and 7.2 km/h (4.5 mph), respectively.
