**VERIDIAN REMOTE ADVANCED OCCUPANT PROTECTION SYSTEM  
INVESTIGATION  
SCI TECHNICAL SUMMARY REPORT**

**NASS/SCI COMBO CASE NO. 02-08-148E**

**VEHICLE – 2003 DODGE STRATUS**

**CRASH DATE – AUGUST 2002**

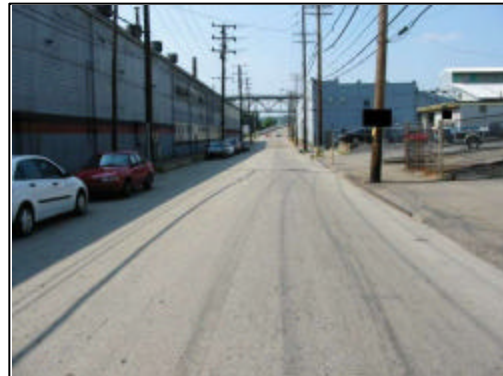
**Figure 3. Northbound trajectory for the 2003 Dodge Stratus**

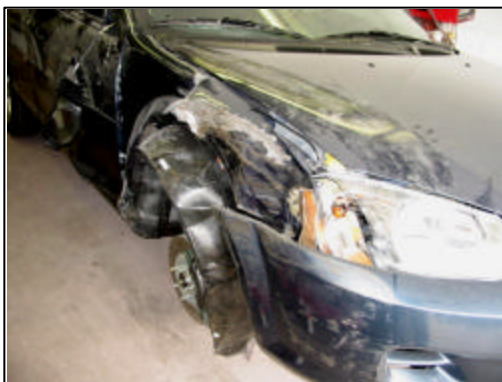
**Figure 4. View of right front damage**

The 2003 Dodge Stratus sustained moderate right front side damage as a result of the impact with the utility pole (**Figure 4**). The direct damage from the frontal impact began at the front right bumper corner and extended 2.0 cm (0.8") across the bumper. A crush profile measured across the front bumper confirmed that there was no residual crush to the frontal structure. The combined direct and induced damage involved the entire width of the bumper. The damage deformation and abrasions continued 204 cm (81") in a sideswipe configuration down the right side aspect to 58 cm (23") aft of the leading edge of the right front door. The right front fender was crushed laterally and abraded from the pole contact. The hood was not displaced. The right aspect of the front bumper fascia was partially separated. The rear aspect of the wheel opening and leading edge of the right sill were deformed and abraded from contact with the right front wheel, which was displaced rearward (**Figure 5**). The post-crash right wheelbase was reduced by 3.0 cm (1.2"). The Collision Deformation Classification (CDC) for the impact with the utility pole was 12-FRES-6.

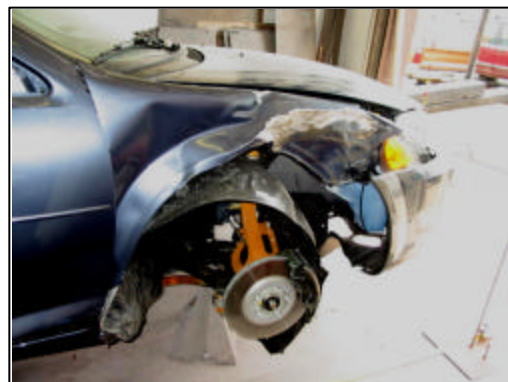
**Figure 5. View of right front damage and wheel opening**

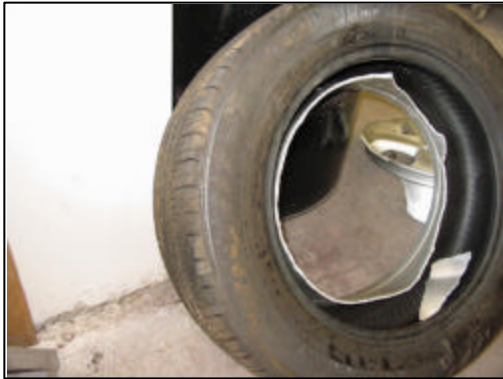
The right front alloy wheel fractured around the circumference of the wheel (**Figures 6 and 7**). It appeared that the wheel was removed from the vehicle post-crash, as there was no visible damage to the lugs. Inspection of the front right axle, rotors, and caliper did not identify and damage to those components.

**Figure 6. View of front right wheel and inboard aspect of fractured alloy wheel**

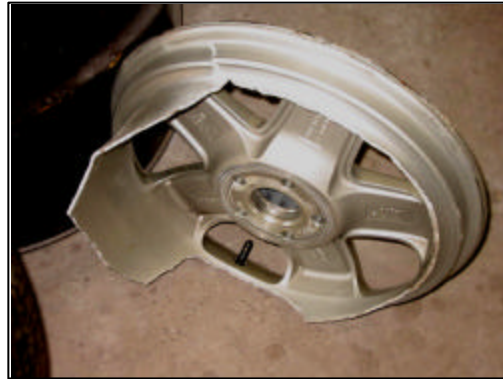
**Figure 7. View of outboard aspect of the fractured alloy wheel**

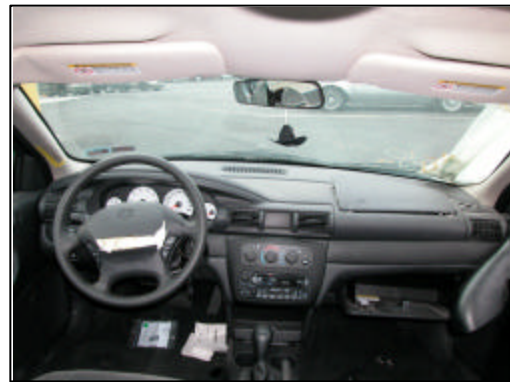
The 2003 Dodge Stratus sustained minor interior damage as a result of the impact (**Figure 8**). The right front door was jammed shut, but the remaining doors were operational. The right front window was fully opened prior to the crash, and the vehicle glazing was not damaged. The right A-pillar and right instrument panel intruded 3.0 cm (1.2”) longitudinally into the occupant space. The rear view mirror was displaced and fractured from contact with the unrestrained driver’s head. The knee bolster was scuffed on the right aspect from contact with the driver’s right knee.

**Figure 8. View of instrument panel area and fractured rear-view mirror**

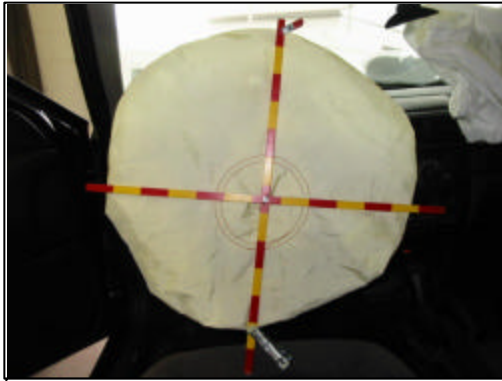
**Figure 9. Driver's air bag**

module was configured with H-configuration cover flaps. The top flap measured 17 cm (7") in width and 8 cm (3") in height and the bottom flap measured 13 cm (5") in width and 3 cm (1") in height. The driver's air bag measured 60 cm (24") in diameter in its deflated state (**Figure 9**). The air bag did not exhibit any occupant contact evidence. The driver's air bag was vented by a single circular port that measured 3.2 cm (1.3") in diameter and was located at the 12 o'clock position on the top rear aspect of the air bag. The air bag was tethered by two internal straps.

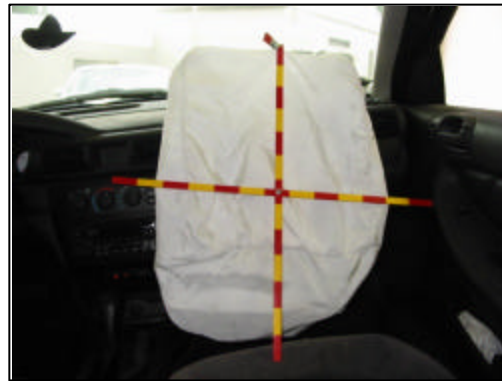
**Figure 10. Front right passenger's air bag**

The front right passenger's air bag measured 45 cm (18") in width and 50 cm (20") in height (**Figure 10**). The air bag was vented by two circular vent ports at the 3 and 9 o'clock positions on the side panels. The air bag was not tethered. The front right passenger's air bag deployed from a top-mount module configured with a rectangular cover flap hinged at the aft aspect (closest to occupant). The cover flap opened rearward, toward the front right occupant position. The pliable vinyl cover flap measured 22 cm (9") in height and 36 cm (14") in width (**Figure 11**). The leading edge of the flap opened at the forward aspect (closest to the windshield) and pivoted upward and rearward around the face of the instrument panel as the air bag deployed. The total flap excursion beyond the face of the instrument panel (**Figure 12**) measured 13 cm (5"). The hinge in the cover flap was located 3.0 cm (1.5") forward of the aft edge of the cover flap. In a NHTSA NCAP frontal test film of a 2001 Dodge Stratus with the same cover flap design, the air bag deployed upward against the windshield as the flap opened. The deflection against the windshield resulted in fractures of the windshield as the air bag inflated. The windshield was not damaged in this crash.

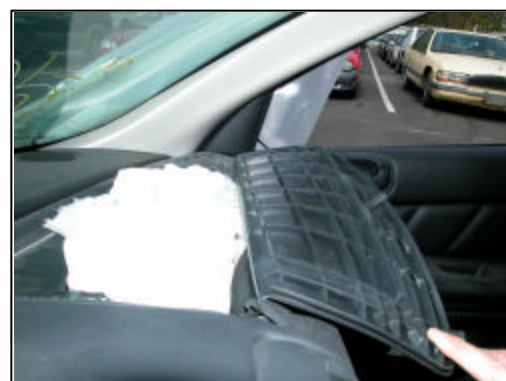
**Figure 12. Lateral view from left-to-right showing excursion of front right passenger's air bag cover flap**
