**VERIDIAN REMOTE ADVANCED 208-COMPLIANT VEHICLE INVESTIGATION  
SCI TECHNICAL SUMMARY REPORT**

**NASS/SCI COMBO CASE NO. 02-08-235E**

**VEHICLE – 2003 HONDA ODYSSEY**

**CRASH DATE – DECEMBER 2002**

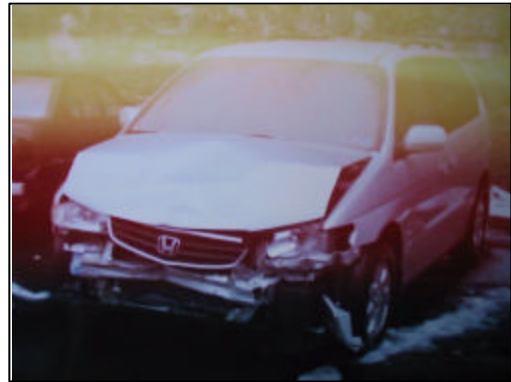
**Figure 1. Damaged 2003 Honda Odyssey**

moderate severity front-to-rear crash with a 2001 Ford Excursion, which was displaced forward into a 2002 Dodge Intrepid. The impact was sufficient to deploy the driver's air bag and driver's safety belt pretensioner in the Odyssey. The driver sustained a cervical spine strain, multiple teeth dislocations, multiple lip and gum lacerations, a left corneal abrasion, a left eyelid contusion, a second-degree burn to the right forearm, a laceration and abrasion to a finger on the right hand, and bilateral knee contusions. She was transported by ambulance to a local hospital where she was treated for her injuries and released. The children in the vehicle were not injured and did not receive medical treatment.

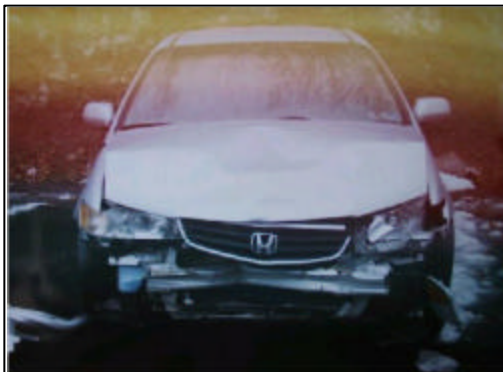
The 2003 Honda Odyssey sustained moderate frontal damage as a result of the impact with the 2001 Ford Excursion. The Odyssey was partially disassembled at the time of the vehicle inspection, and the NASS researcher's damage assessment was supported by damaged parts and pre-repair photographs of the vehicle. Due to repair status of the vehicle, crush measurements could not be documented. Photographs obtained from the vehicle's owner (**Figures 3 and 4**) illustrated the pre-repair damage of the Odyssey. The direct damage began 29 cm (11") left of the centerline and extended 98 cm (39") laterally to the right across the frontal plane. The combined direct and induced damage involved the entire frontal width of the vehicle. The hood was buckled rearward and slightly abraded on the leading aspect. The bumper beam was crushed in the center aspect. The bumper fascia was separated from the vehicle and exhibited multiple fractures. The left head lamp was fractured and the grille was displaced. The right front fender was displaced outward slightly. There was no reduction of the wheelbases. The Collision Deformation Classification for the frontal impact to the Odyssey was 12-FDEW. The extent zone was estimated to be a zone 1.

**Figure 4. Frontal view of damage to the Odyssey**

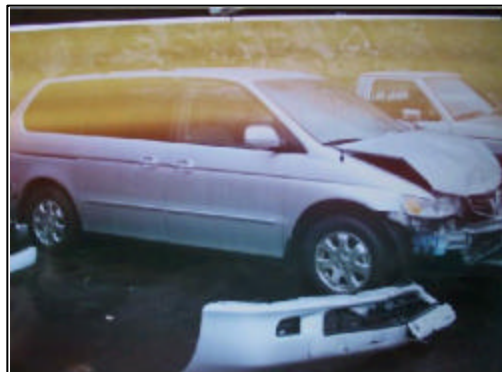
**Figure 3. Right front view of the damaged Odyssey**

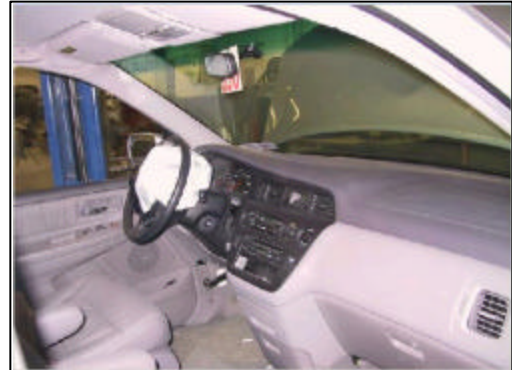
The 2003 Honda Odyssey sustained minor interior damage (**Figure 5**) as a result of the crash. Based on pre-repair images, it did not appear that the vehicle sustained damage to the windshield or vehicle glazing. There was no integrity loss and no passenger compartment intrusion. The driver's lap belt was scuffed as a result of occupant contact.

**Figure 5. Interior view of front row**

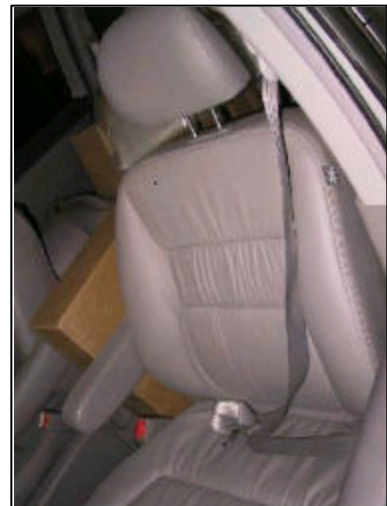
The 2003 Honda Odyssey was equipped with manual 3-point lap and shoulder belts for each seating position. The driver's safety belt was configured with a sliding latch plate and a belt-sensitive Emergency Locking Retractor (ELR). Stretch marks on the driver's lap and shoulder belt were visible in the NASS photographs from occupant loading (**Figure 6**). The remaining safety belts were configured with sliding latch plates and belt-sensitive switchable ELR/Automatic Locking Retractors (ALR). Both front seat safety belts were equipped with retractor-mounted pretensioners and adjustable D-rings. The second row restraints were also equipped with adjustable D-rings. The second row bucket seats were equipped with both tether and lower LATCH anchors. The third row bench seat was equipped with tether anchors only.

**Figure 6. View of driver's safety belt**

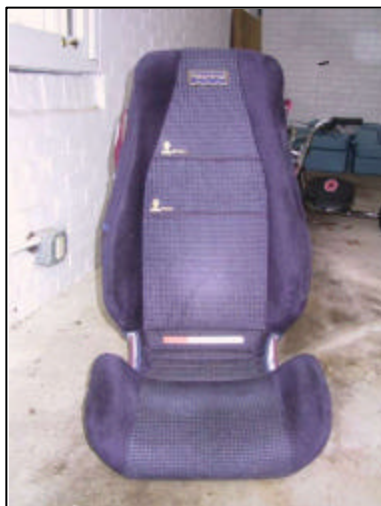
There was no identifiable damage to the Fisher-Price CSS .

**Figure 8. Fisher-Price booster CSS**

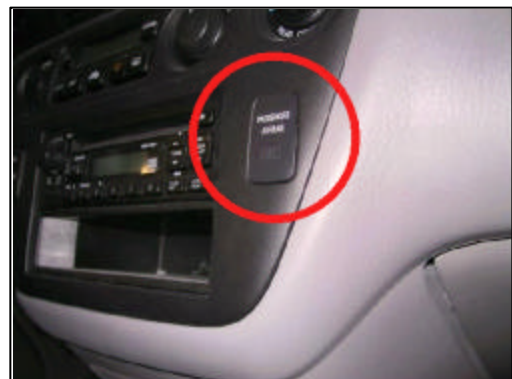
**Figure 10. Front right passenger's air bag cutoff indicator**

The front right passenger's air bag did not deploy in this crash. Given that the front right seat was unoccupied, it was probable that the passenger seat weight sensor suppressed the front right passenger's air bag. The front right seat was positioned in the mid-track position, although since the seat was not occupied, the seat track position sensor probably did not provide input into the system's non-deployment decision.

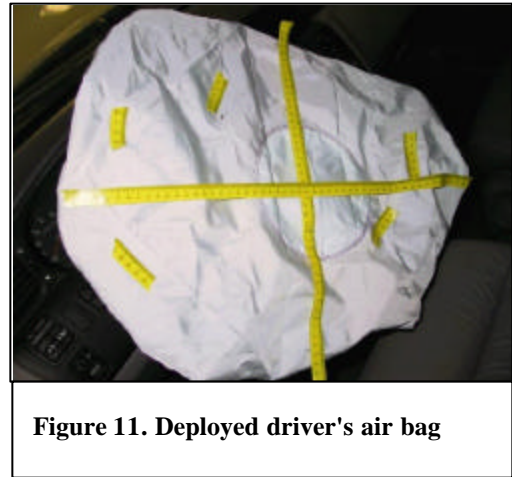
The driver's air bag deployed as a result of the frontal impact with the Ford Excursion. It was not known if the deployment was a single or dual stage deployment. The air bag deployed from the steering wheel hub through H-configuration module cover flaps. The top flap measured 9 cm (4") in height and the bottom flap measured 7 cm (3") in height. Both flaps measured 16 cm (6") in width at the tear seam. The driver's air bag (Figure 11) measured 58 cm (23") in diameter and was vented by two ports at the 10 and 2 o'clock positions on the rear aspect of the air bag. The air bag was tethered by two internal straps. Small amounts of body fluid were present on the upper left quadrant of the air bag from the driver.
