**GENERAL DYNAMICS REMOTE ADVANCED OCCUPANT PROTECTION SYSTEM
INVESTIGATION**

NASS/SCI COMBO CASE NO. - 02-011-011C

VEHICLE – 2001 BMX X5

CRASH DATE – JANUARY 2002

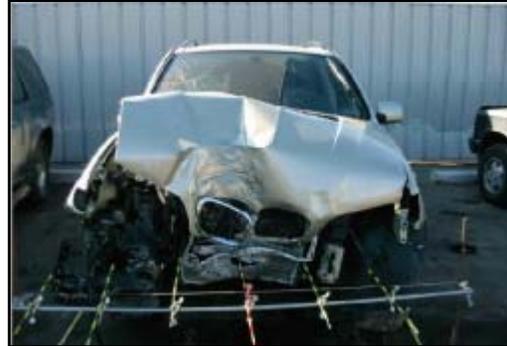
Figure 1. Front damage to the BMW X5 sport utility vehicle.

impacts with a stop sign, two trees and a mile marker post. The tree impact resulted in the deployment of the driver's frontal air bag. Although there was no direct side impact associated with this crash sequence, the door panel mounted side impact air bag deployed. The HPS did not deploy. The BMW came to rest and a small fire ensued in the center instrument panel. The BMW was equipped with an Event Data Recorder (EDR) that was retrieved from the vehicle and provided to BMW for download. The recorded data identified that the frontal air bag deployed both stages and that the safety belt pretensioners did not fire. The driver did not utilize the safety belt; therefore the AOPS did not fire the pretensioners. The driver sustained a left eyelid contusion, a superior facial abrasion, nasal rupture of the mucosal/vessels, posterior cervical spine facet fracture, and a posterior cervical spine fracture of the transverse process. He was transported by ambulance to a local hospital where he was diagnosed for his injuries. The driver was despondent over the crash and departed the hospital against the advice of the medical staff.

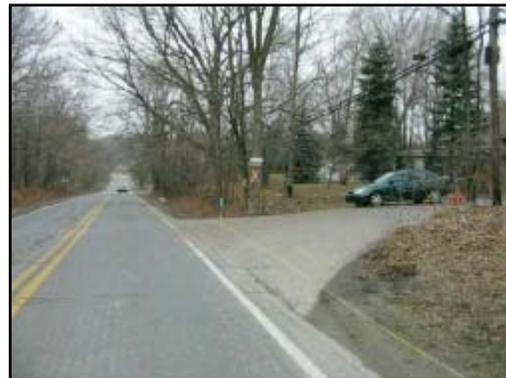
The 46-year old male driver of the 2001 BMW X5 sport utility vehicle was traveling in a westerly direction on the two-lane road on an approach to the three-leg T-intersection (**Figure 2**). As the driver exited the curve, he allowed the vehicle to drift to the right onto the intersecting roadway. The BMW traversed the mouth of the intersection in a tracking mode and departed the northwest corner of the rural intersection. There was no physical evidence at the scene to support avoidance maneuvers (i.e., braking, steering). The driver’s loss of control was attributed to possibly falling asleep at the wheel while driving under the influence of alcohol.

Figure 2. Pre-crash approach to the intersection.

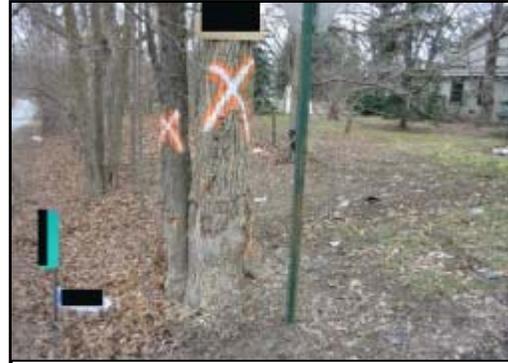
The center frontal area of the X5 impacted a tree cluster that was located between the sign posts (**Figure 3**). The 12 o'clock direction of force impact crushed the frontal structure of the vehicle. The damage algorithm of the WinSMASH program was utilized by the SCI investigator to compute a revised total velocity

Figure 3. Struck objects by the frontal area of the BMW.

change of 25.0 km/h (15.5 mph) with longitudinal and lateral components of -25.0 km/h (-15.5 mph) and 0 km/h respectively. The impact was sufficient to deploy the driver frontal air bag and the Battery Safety Terminal (BST). The EDR data that was downloaded by BMW for this vehicle indicated a Stage 2 deployment for the driver's air bag, with Stage 2 deploying 35 ms after Stage 1 was deployed. The driver's seat belt buckle pretensioner did not deploy. The EDR data also indicated that the front right seat was not occupied, therefore the front right air bag did not deploy.

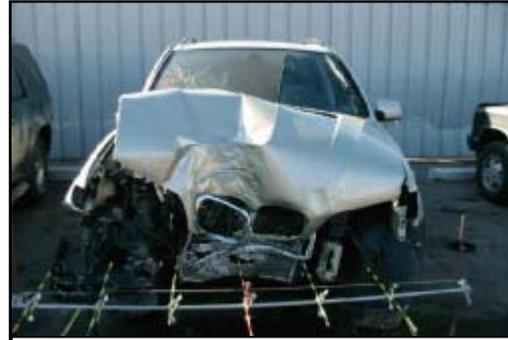
The 2001 BMW X5 sustained moderate frontal damage as a result of the impacts with the multiple fixed objects (**Figure 4**). The frontal damage from the stop sign consisted of a narrow vertically dent to the hood that was located approximately 25.0 cm (10.0”) right of the centerline. The Collision Deformation Classification for this impact was 12-FREN-1. The second impact with a mile marker post and was located 20.0cm (8.0”) left of center and was approximately 10.0cm (4.0”) in width. The Collision Deformation Classification for this impact was 12-FLEN-1. The subsequent tree impact deformed the frontal structure and separated the bumper system (fascia and beam) from the vehicle. The right outboard aspect of the bumper beam was attached to the right frame rail. The remainder of the beam had separated from the BMW, exposing both frame rails.

Figure 4. NASS image of crush profile.

The tree impact resulted in moderate frontal damage. The NASS researcher documented the direct contact damage from the tree impact on the separated bumper fascia. The damage began 44.0 cm (17.5”) inboard of the front left bumper corner and measured 48.0 cm (18.9”) in length. The combined direct and induced damage length (Field L) was 148.0cm (58.3”), which spanned the full frontal width of the vehicle. Due to the separation of the bumper beam, the researcher estimated a crush profile at bumper level. These estimated crush measurements were as follows: C1= 6.0 cm (2.4”) C2= 23.0 cm (9.1”) C3= 40.0 cm (15.7”) C4= 29.0 cm (11.4”) C5= 12.0 cm (4.7”) C6= 3.0 cm (1.2”). The Collision Deformation Classification for this impact was 12-FDEW-2. It should be noted that the SCI review of the NASS EDCS resulted in several enhancements to the electronic file. The right lateral shift was removed from the CDC (60 incremented to the 12 o’clock direction of force) and the documented crush was considered an estimate of the bumper beam profile. The calibrated measurement rods were not positioned against the structure of the vehicle (i.e., frame rails and lower radiator support).

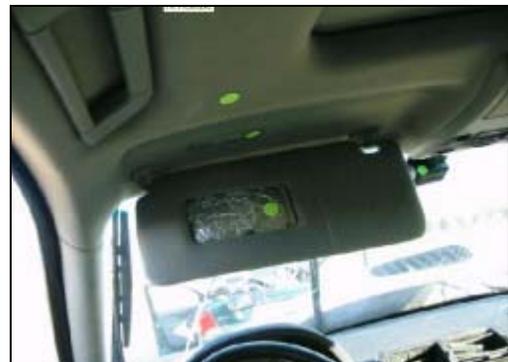
The 2001 BMW X5 sustained moderate interior damage as a result of the crash. The damage consisted of occupant contacts to the interior components (**Figures 5 and 6**) and minor fire damage to the center instrument panel. There were no intrusions of interior components into the passenger compartment. The unrestrained driver was probably out of position forward at impact with the tree cluster. The expanding air bag contacted his face. His torso subsequently loaded through the air bag and deformed the

Figure 5. Occupant contact to sunvisor and headliner.

The air bag expansion elevated the driver in a vertical and rearward direction as he rebound from his initial forward trajectory. His superior scalp impacted and deformed the left sun visor. The contact also fractured the integral vanity mirror of the visor. His head scuffed the headliner. Strands of hair were noted at the location of the headliner contact.

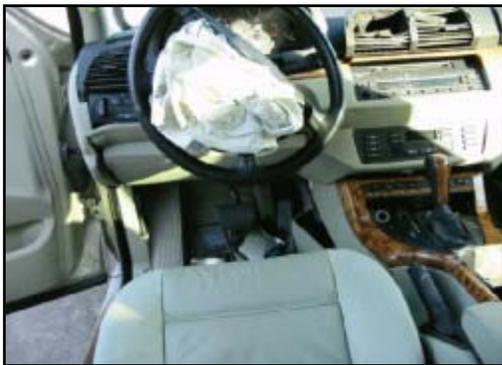
steering wheel rim. The lens for the center front dome light was cracked and the rear view mirror was displaced, consisted with a fling related contact from the driver's right hand. The left A-pillar was scuffed indicating a fling related contact from the driver's left hand. The driver's head impacted and deformed the sun visor and cracked the vanity mirror in the sun visor. Additionally, his head scuffed the headliner aft of the stowed visor location. Strands of hair were noted in the area of the headliner contact. The driver's left knee contacted and deformed the knee bolster. The researcher documented the front left seat back as deformed by occupant contact. This probably resulted from the driver rebounding into the seat back where he came to rest. The damage from the fire was contained to the interior of the center instrument panel air ducts, above the radio cluster (**Figure 7**). The fire melted the center air vents and the inner parts of the instrument panel. The minor severity fire did not require extinguishing.

Figure 6. Deformed steering wheel rim and occupant contact lower left knee bolster.

The driver's chest loaded through the air bag and deformed the upper aspect of the steering wheel rim. No injury resulted from the chest loading. His left knee contacted and deformed the left aspect of the knee bolster. Although no injury occurred to the left knee, the driver complained of pain over the right knee.

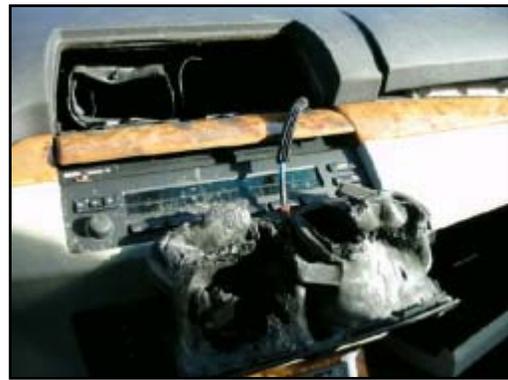
As the BMW came to rest, an instrument panel fire originated in the center mid instrument panel. This fire did not result in significant damage to the vehicle.

Figure 7. Fire damage to center instrument panel.

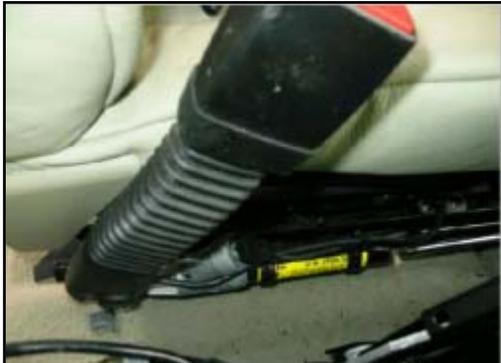
The 2001 BMW X5 AOPS consisted of dual stage frontal air bags for the driver and front right passenger positions, occupant sensing for the front right seating position and safety belt buckle pretensioners. The driver's safety belt was not used in the crash and the pretensioner did not actuate (**Figure 8**). The driver's frontal air bag deployed (**Figure 9**) as a result of the impact with the tree. The EDR data indicated that both stages of the air bag deployed. The air bag module consisted of two cover flaps that had a common width of 16.0 cm (6.3"). The upper flap was 6.0cm (2.4") in height while the lower flap measured 7.0cm (2.8") in height. The diameter of the air bag was 57.0 cm (22.4"), measured in its deflated state. The bag was vented by two ports located at the 11 and 1 o'clock positions on the backside of the bag membrane. The air bag was tethered

Figure 8. Non-fired status of the front left buckle pretensioner.

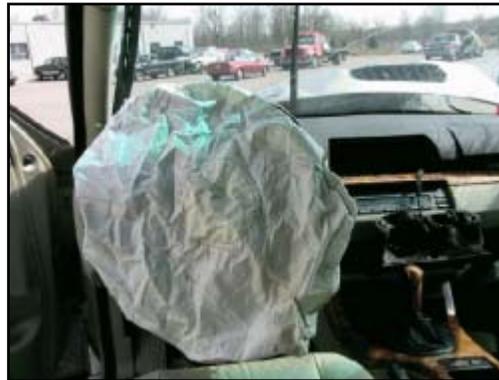
internally by two tethers. No damage was documented to the deployed frontal air bag. The front right seat was not occupied; therefore the AOPS system did not deploy the air bag or the pretensioner.

Figure 9. Deployed front left air bag.

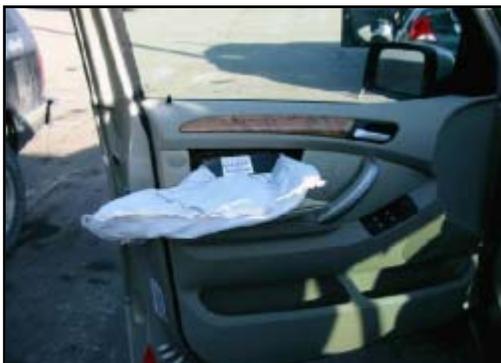
The left door mounted side impact air bag deployed during the crash; however, the left side HPS did not deploy. There was no side impact crash during this event to warrant the deployment of the side air bag system. The vehicle did rotate CW, which resulted in a lateral deceleration due to the side slipping of the left side tires. This deceleration should not have produced a lateral pulse sufficient to deploy the side air bag system.

The 2001 BMW X5 was equipped with side impact air bags and a Head protection System (HPS) for the front-seated positions. The side impact air bags were located in the front door panels (**Figure 10**) and the HPS were located in the roof side rails (**Figure 11**), tethered between the A- and C-pillars. The side impact air bag system utilized impact sensors that were located under the front seats near the B-pillars. Although the BMW did not sustain a side impact event in this crash, the front left door mounted side impact air bag deployed. The HPS in the left roof side rail did not deploy. Based on previous SCI investigations, this side impact air bag system should have deployed both the left door and HPS air bags. The BMW did undergo a lateral deceleration that was associated with the post-crash spin-out. This event should not have produced the required lateral deceleration required to deploy the side impact air bag system.

Figure 10. Deployed door panel mounted side impact air bag.

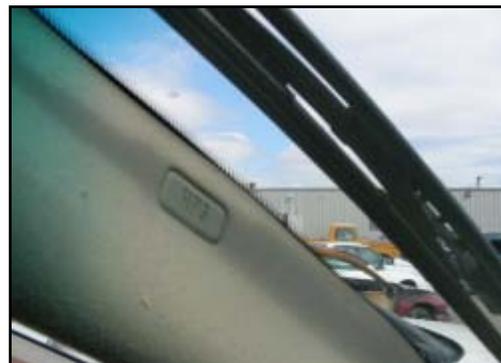
Figure 11. Identification acronym for the non-deployed HPS at the left pillar.

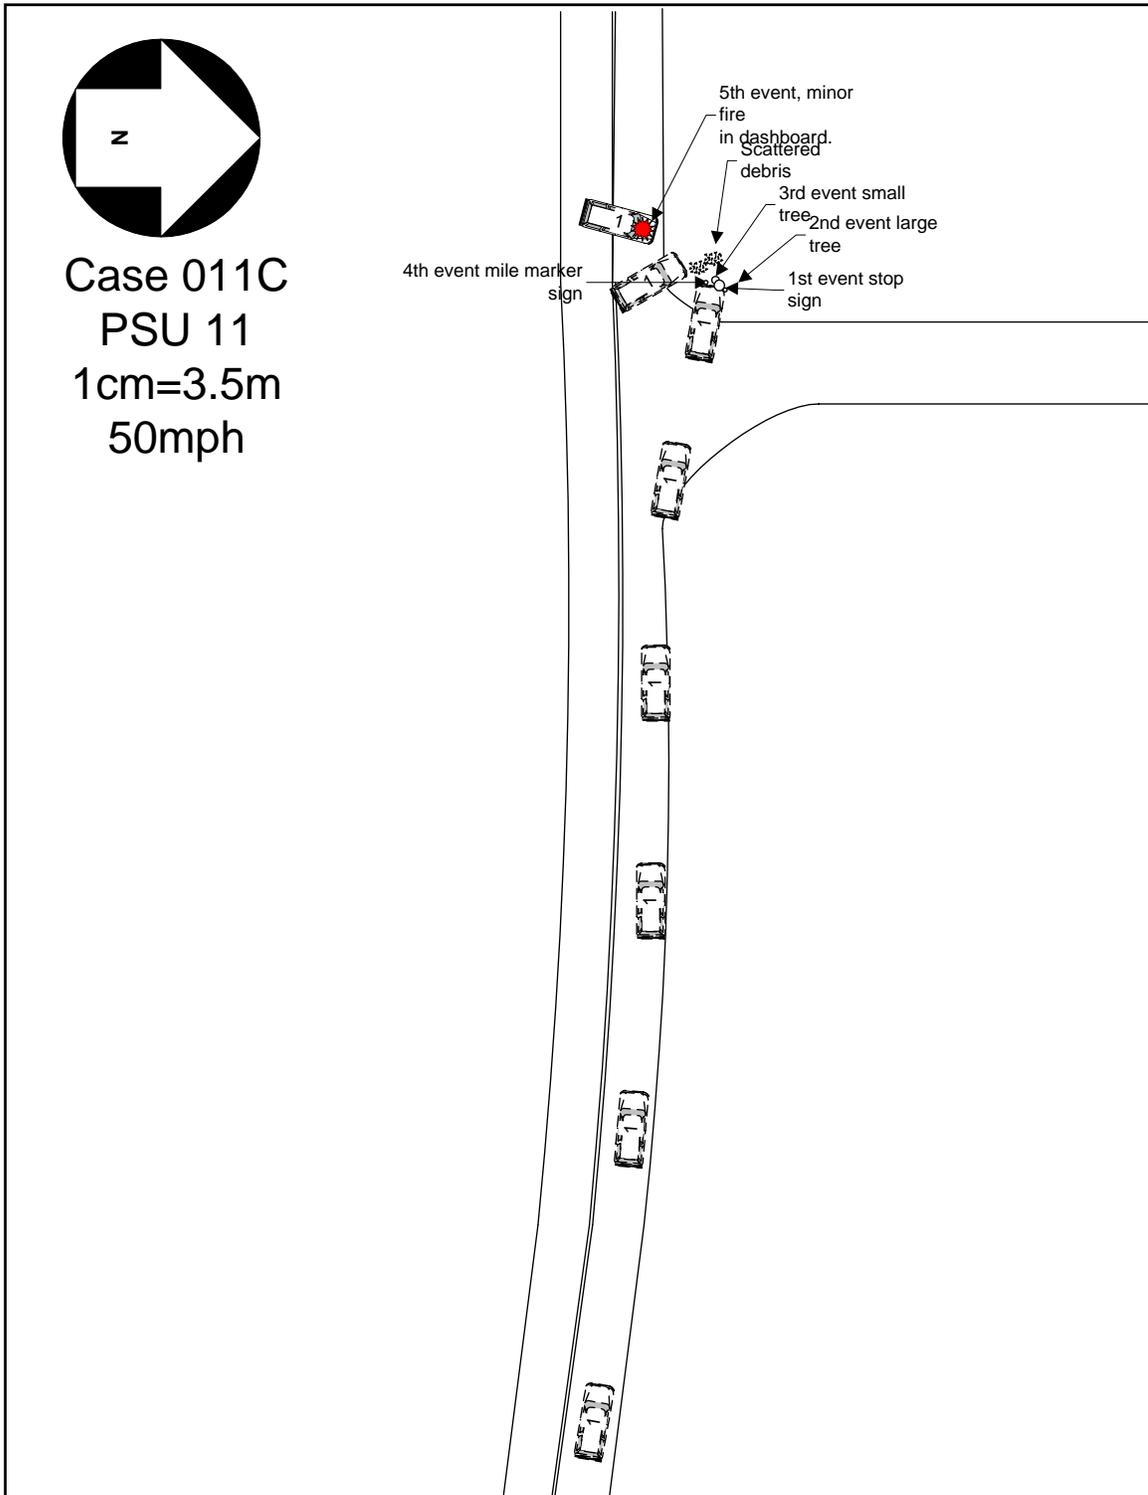
Figure 12: Scene Schematic

The crash occurred at a “T” intersection of an east/west roadway that intersected a north/south roadway. At the time of the crash, it was dark and the road was dry with adverse weather conditions. The east/west roadway was configured with two travel lanes in each direction that were separated by a double-yellow centerline. The roadway curved left for westbound travel with a downhill grade. The east/west roadway was bordered with a white fog line on the north and south road edge. Traffic flow through the intersection was not controlled for the east/west travel lanes. The posted speed limit for the east/west roadway was 80 km/h (50 mph). The NASS scene schematic is included as **Figure 12** of this report.
