## NASS/SCI COMBINATION CASE REPORT

CASE NUMBER - NASS-2002-48-074J

VEHICLE - 2001 LEXUS LS 430

CRASH DATE - May 2002

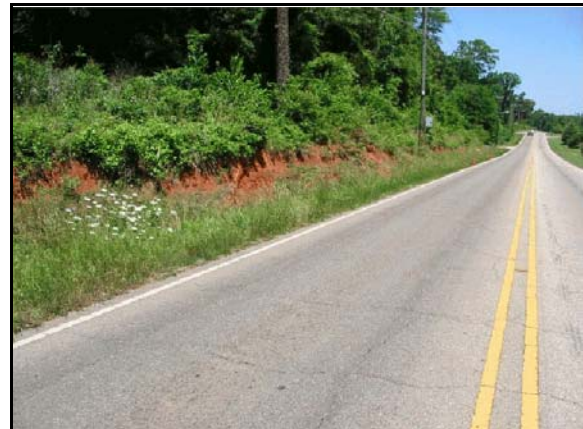
The case vehicle departed the north road edge and its front left corner impacted an earthen embankment that was immediately adjacent to the road (**Figure 1**). The vehicle traveled along the embankment for a short distance and got into a non-horizontal attitude with the left side wheels riding up the slope. The rear bumper cover was torn loose on the right, probably due to scraping along the ground. The case vehicle continued along the embankment in a non-horizontal attitude and the front left corner of the case vehicle impacted a timber utility pole, causing the driver's front air bag to deploy (**Figure 2**). The case vehicle traveled a short distance beyond the pole and came to rest on the north side of the road headed east. The pole did not sustain any significant damage.

**Figure 1:** Case vehicle's east bound approach toward left side departure and impacts with the earthen embankment and the timber utility pole

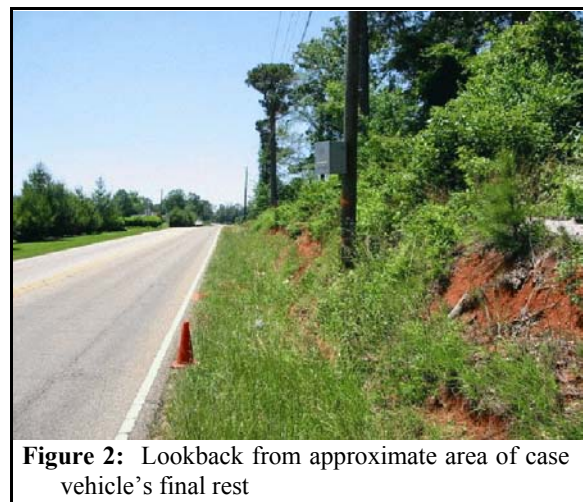
**Figure 2:** Lookback from approximate area of case vehicle's final rest

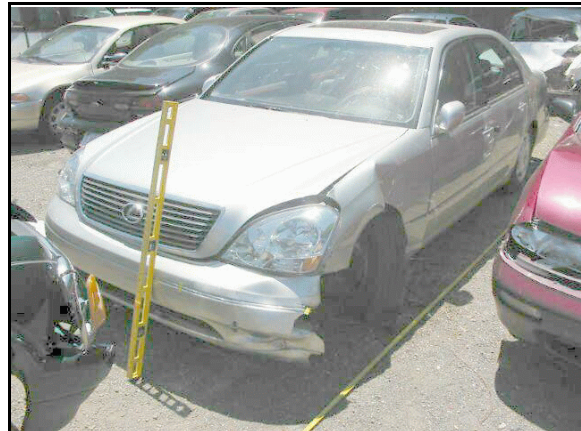
The Lexus sustained direct contact damage at the front left corner of the bumper and along the left side (**Figure 3**). This area of damage was caused by the vehicle's first impact with the embankment (event #1) and its impact with the timber utility pole (event #3). The impact with the embankment could not be measured due to the overlapping damage from the pole impact. The CDC for the first impact with the embankment was determined to be **12-FLLW-1 (350)**. This impact was out of scope for the WinSMASH reconstruction program, but the severity for the case vehicle was judged to be moderate. The impact with the pole was a narrow engagement involving the front left corner of the vehicle, extending down the left side with the left front wheel and tire snagging against the pole. Direct contact with the pole was measured as 23 centimeters [9.1 inches] wide at the front left corner and extended down the left side 75 centimeters [29.5 inches]. The leftmost area of the bumper cover was torn and scraped, and the left headlight and turn signal assembly was slightly displaced but intact. The leading edge of left front fender was crushed slightly inward, displaced slightly rearward and sustained induced buckling in the wheel well area. The left front wheel assembly was pushed rearward and rotated with the leading edge outward and the trailing edge of the tire inward and jammed against the back of the wheel well (**Figure 4**). The wheelbase was shortened by 28 centimeters [11.0 inches] on the left side and 4 centimeters [1.6 inches] on the right. The CDC for the utility pole impact (event #3) was determined to be **12-FLEE-3 (0)**. This impact was out of scope for the WinSMASH reconstruction program, but the severity for the case vehicle was judged to be moderate. While the case vehicle was traveling along the embankment in a non-horizontal attitude, the right edge of the back bumper cover snagged on the ground, pulling the bumper cover loose but not tearing

**Figure 3:** Overlapping damage from embankment and pole impacts at front left corner

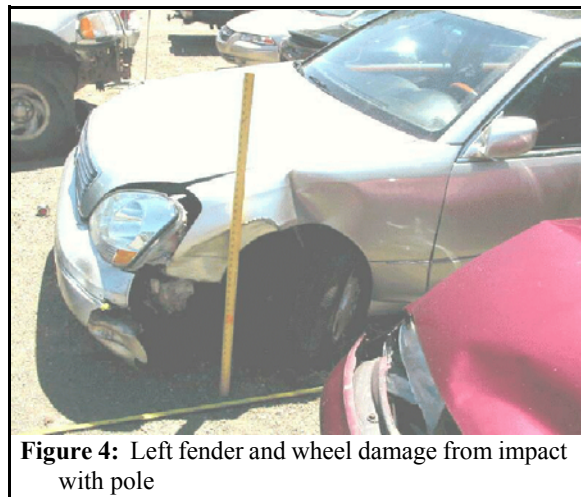
**Figure 4:** Left fender and wheel damage from impact with pole

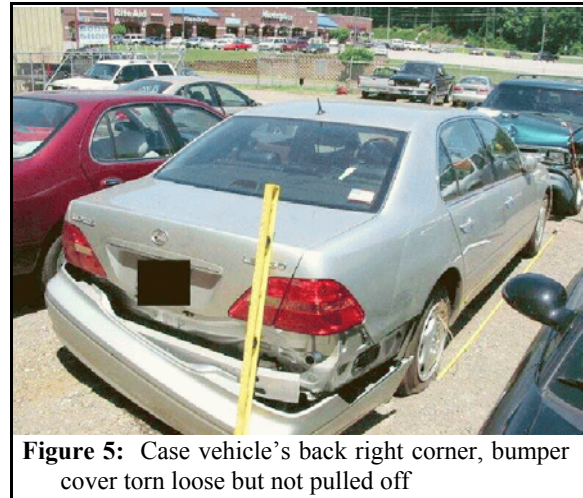
it off (event #2) (**Figure 5**). The CDC for this impact could not be completely determined, but a partial undercarriage CDC was coded as **00-U999-99 (non-horizontal)**. The left front tire was deflated and the wheel was restricted. The right rear tire was deflated, with grass and mud embedded in the wheel cover and tire. The front right tire also had grass and mud embedded, but it was not otherwise damaged. The left rear tire was entirely undamaged. All of the doors remained closed and operational and there was no glazing damage.

**Figure 5:** Case vehicle's back right corner, bumper cover torn loose but not pulled off

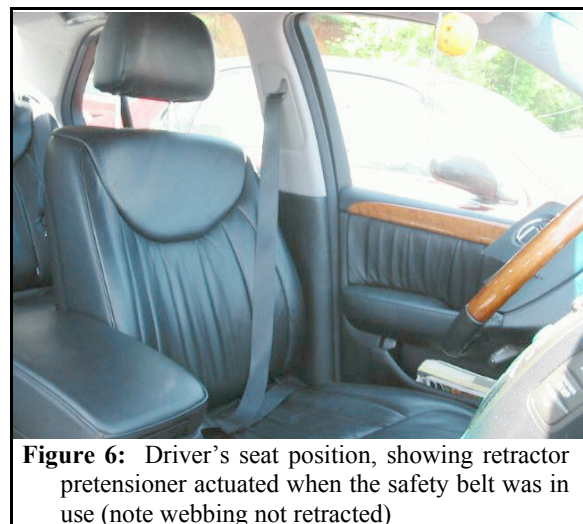
The case vehicle was also equipped with retractor pretensioners at the four outboard seat positions and all four pretensioners actuated. The driver's safety belt was locked with a substantial amount of webbing drawn out off the spool, indicating that the belt was in use when the pretensioner actuated (**Figure 6**). At the three other outboard positions, the webbing was fully retracted and locked, indicating that the pretensioner actuated and the belt system was not in use at these positions.

**Figure 6:** Driver's seat position, showing retractor pretensioner actuated when the safety belt was in use (note webbing not retracted)

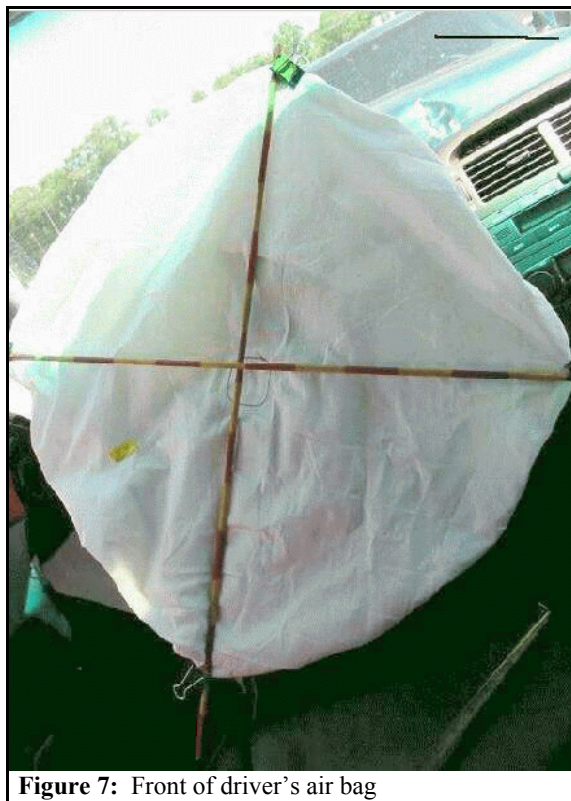
the designated tear points and there was no damage to the flaps or the air bag. The cover flap center seam measured 15 centimeters [5.9 inches] horizontally, with the upper flap measuring 6 centimeters [2.4 inches] and the lower flap 7 centimeters [2.8 inches] vertically. The deployed air bag was round with a diameter of 65 centimeters [25.6 inches]. There was a small smudge of unknown origin in the lower left quadrant (**Figure 7**).

**Figure 7:** Front of driver's air bag
