Combination Investigation / Vehicle to Vehicle
Dynamic Science, Inc. / Case Number: 2002-75-053A
2000 Toyota 4-Runner SUV
Colorado
May, 2002

1. Report No. 2002-75-053A	2. Government Accession No.		3. Recipient Catalog No.	
4. Title and Subtitle In-Depth Accident Investigation		5. Report Date February 3, 2003

Description: This possible front right seat occupant air bag related fatality case was generated through NASS PSU 75. The case vehicle is equipped with redesigned air bags. DSI was assigned the case on May 28, 2002. This three-vehicle case was investigated as a combination case.

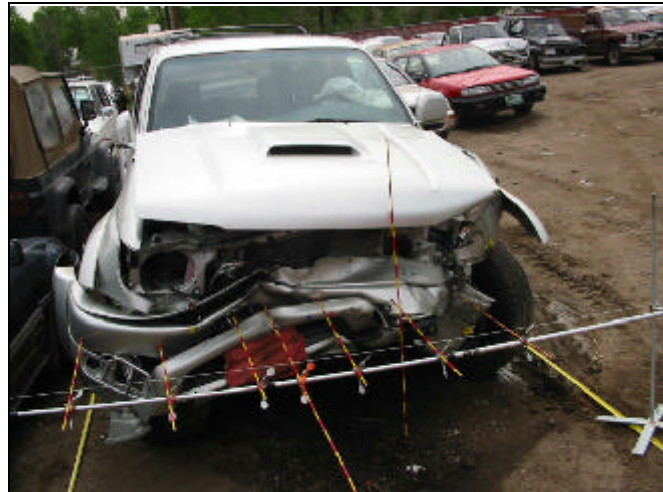
Figure 3. Front, case vehicle

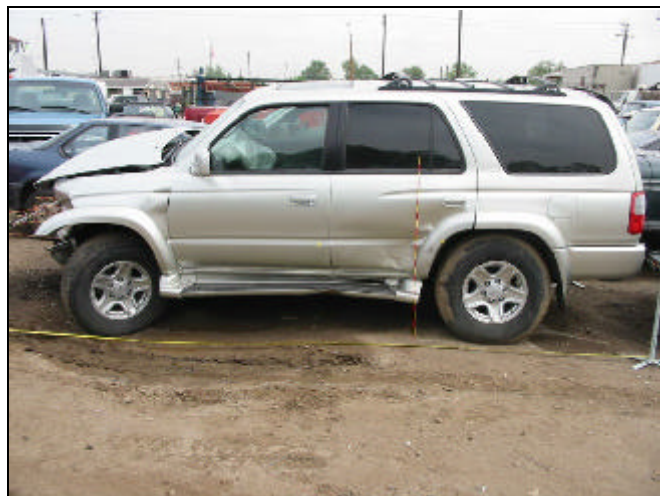
Figure 4. Left side, case vehicle

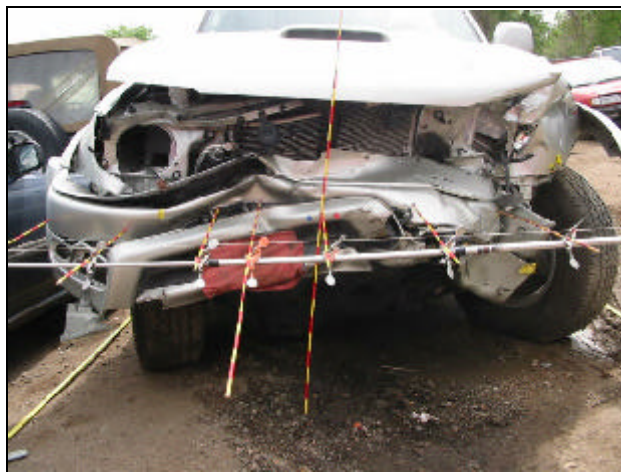
**Figure 8.** Front, case vehicle

During the initial impact, the case vehicle sustained 104 cm (41 in) of direct contact that extended across the entire frontal end width of the vehicle. Maximum crush was located 19 cm (8 in) right of C3 and measured 50 cm (20 in). The principle direction of force was within the 11 o'clock sector and was an estimated 340 degrees. The impact energy was managed by the forward structures of the vehicle. The damaged components included the bumper fascia and reinforcement bar, upper and lower radiator supports, and the hood. There was a 10 cm (3.9 in) reduction of the wheelbase on the left side.

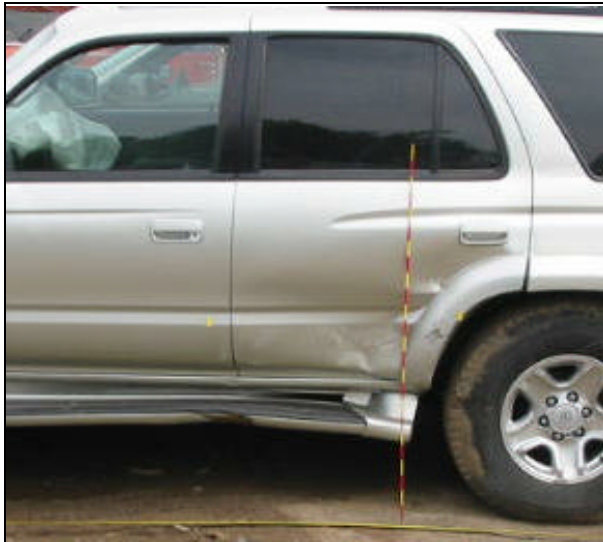
Figure 9. Left side, case vehicle

During the second impact, the vehicle sustained 78 cm (31 in) of direct contact that extended just forward of the rear wheel well. Maximum crush was located 40 cm (16 in) forward of the rear axle and measured 3 cm (1 in). The principle direction of force was within the 9 o'clock sector and was an estimated 270 degrees. This was a minor side-slap type impact. The damaged components included the left rear door and the frame rail.

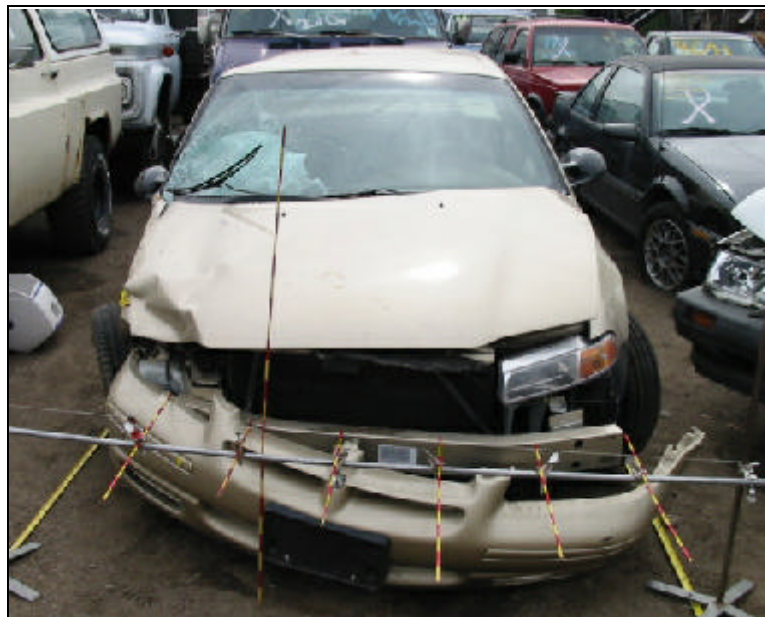
Figure 10. Front, Status—initial impact

During the initial impact, the case vehicle sustained 36 cm (14.2 in) of direct across the front bumper starting at the front right bumper corner. Maximum crush was located at C6 and measured 10 cm (4 in). There was direct contact that extended from the bumper corner rearward to the front right door. The principle direction of force was within the 1 o'clock sector and was an estimated 40 degrees. The impact energy was managed by the forward structures of the vehicle. The damaged components included the bumper fascia, right fender, right tire, and the hood. There was impact related damage to the windshield. There was a slight reduction of the wheelbase on the right side.

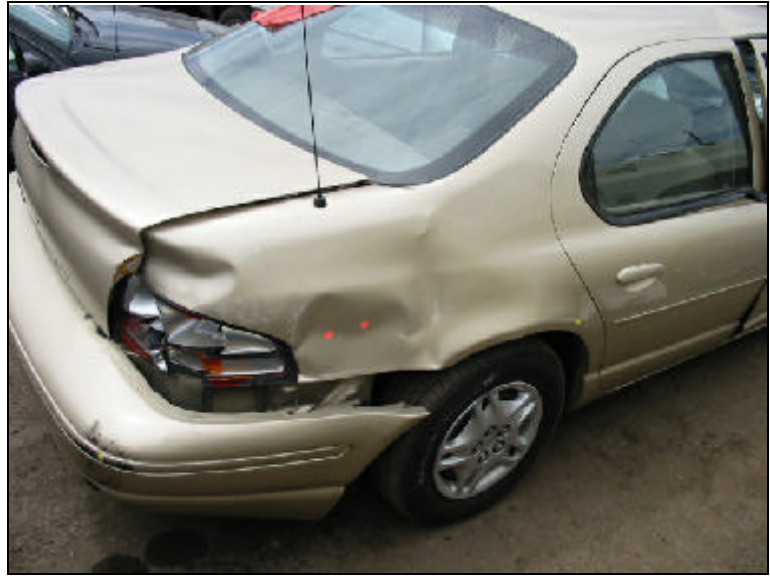
Figure 11. Right side, Stratus—second impact

During the second impact, the vehicle sustained 107 cm (42 in) of direct contact to the right rear. Maximum crush was located at C1 and measured 18 cm (7.1 in). The principle direction of force was within the 3 o'clock sector and was an estimated 90 degrees. The damaged components included the rear bumper fascia, right rear tail light, and right rear quarter panel.

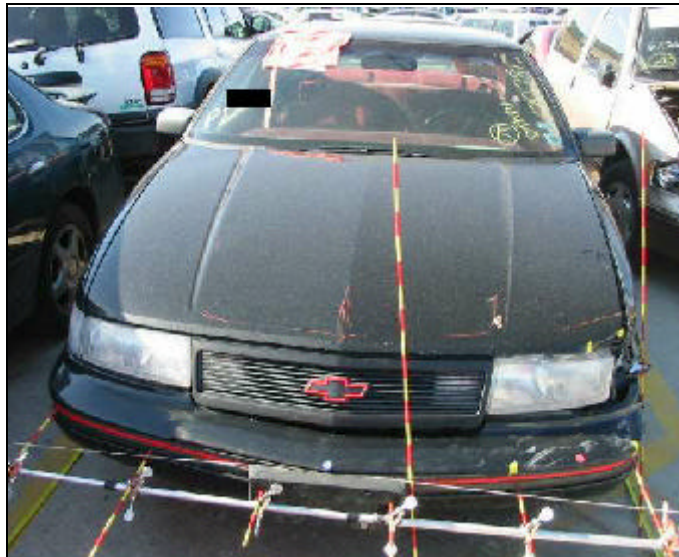
Figure 12. Front, Lumina

During this impact, this vehicle sustained 29 cm (11 in) of direct contact to the front left bumper. The maximum crush was located at C1 and measured 4 cm (2 in). The principle direction of force was within the 11 o'clock sector and was an estimated 340 degrees. The impact energy was managed by the forward structures of the vehicle. The damaged components included the bumper facia and reinforcement bar and the left fender. There was no measured change in the wheelbase dimensions. There were no glazing fractures and all doors remained operational.

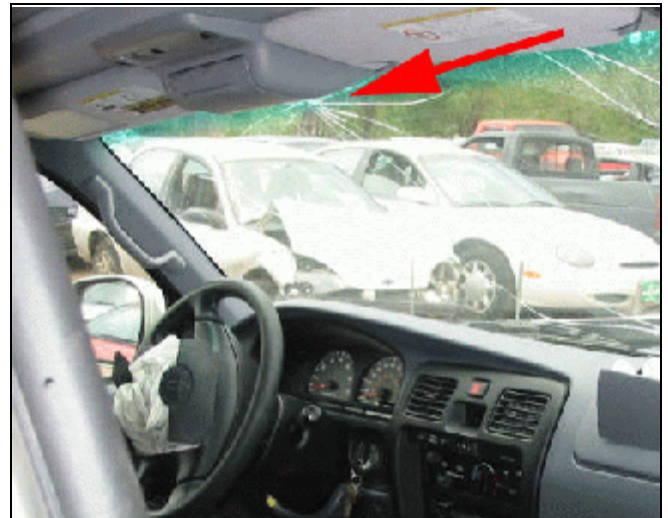
The front left seat was occupied by a lap and shoulder belt restrained 32-year-old female (170 cm/67 in, 53 kg/117 lbs). She was seated in a bucket seat that had been adjusted to between the middle and rear most track position. The seat belt anchorage was in the full up position. Both hands were on the steering wheel. This seat position was equipped with a driver's air bag, a seat belt pretensioner, and seat belt force limiters. Upon impact, the driver's pretensioner fired and the frontal air bags deployed. The driver responded to the 11 o'clock direction of force by moving forward and to the left and loading the pretensioned and locked manual restraint system. She likely contacted the air bag to some degree, but there were no residual occupant contacts. Her right hand came off the steering wheel and struck the windshield—causing a minor contusion. An unspecified part of her right leg struck the knee bolster—causing a contusion.

Figure 14. Hand contact to windshield

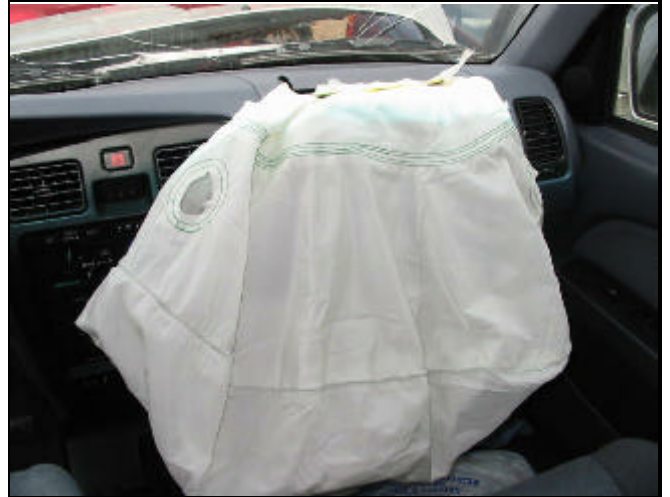
The front right passenger air bag module was located in the transition between the top and middle instrument panel. The module cover had an H-configuration. The upper flap measured 23 cm (9 in) wide by 7 cm (3 in) high. The lower flap measured 23 cm (9 in) wide by 7 cm (3 in) high. The deflated air bag measured 60 cm (24 in) high by 55 cm (22 in) wide. The air bag was untethered and had two vent ports (3 and 9 o'clock positions). There was no contact evidence on the face of the air bag.

Figure 15. Deployed passenger air bag

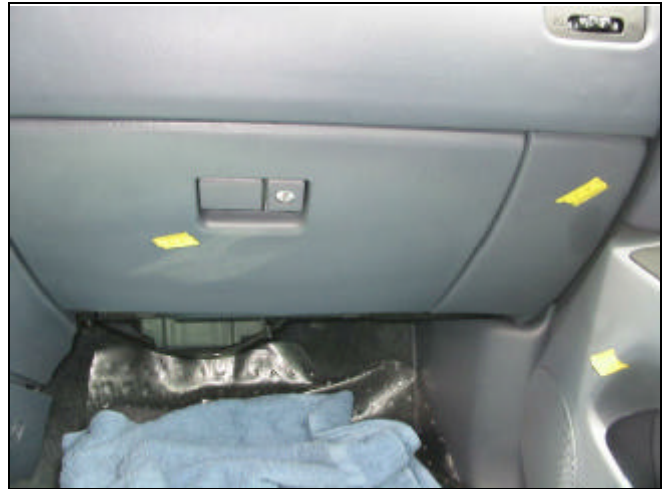
Figure 17. Front right occupant knee contacts to glove compartment
