Combination Investigation / Vehicle to Vehicle
Dynamic Science, Inc. / Case Number: 2002-82-104F
2003 Volkswagen Passat GLS four-door
Washington
December, 2002

1. Report No. 2002-82-104F		2. Government Accession No.		3. Recipient Catalog No.	
4. Title and Subtitle Side Air Bag Crash Investigation				5. Report Date September 2, 2003

Dynamic Science, Inc.
Accident Investigation
Case Number: 2002-82-104F

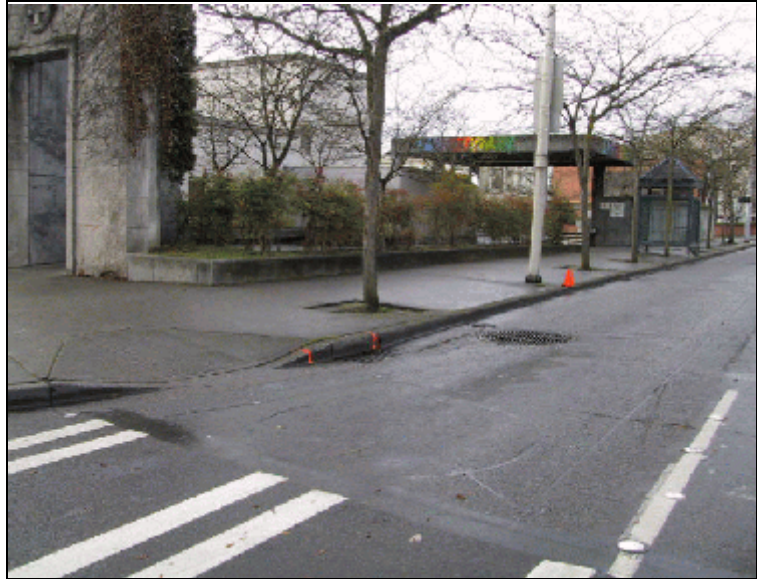
As both vehicles entered the intersection, the driver of the case vehicle began braking. The front of the case vehicle struck the right side of the other vehicle (11FLEE2). The total velocity change calculated by the WinSmash collision model was 10 km/h (6 mph). The longitudinal and lateral delta V components were -9 km/h (6 mph) and 3 km/h (2 mph), respectively. The front right passenger's air bag deployed and the driver's pretensioner fired at this point. The case vehicle was redirected to the right, entered the western leg of the intersection and struck a curb on the south side of the roadway with its left front tire (10LFWN1). This impact caused the driver's side curtain and seat mounted side impact air bag to deploy.

Figure 3. Case vehicle impact with curb

During the case vehicle to curb side impact, the driver's side curtain and seat mounted side air bag deployed.

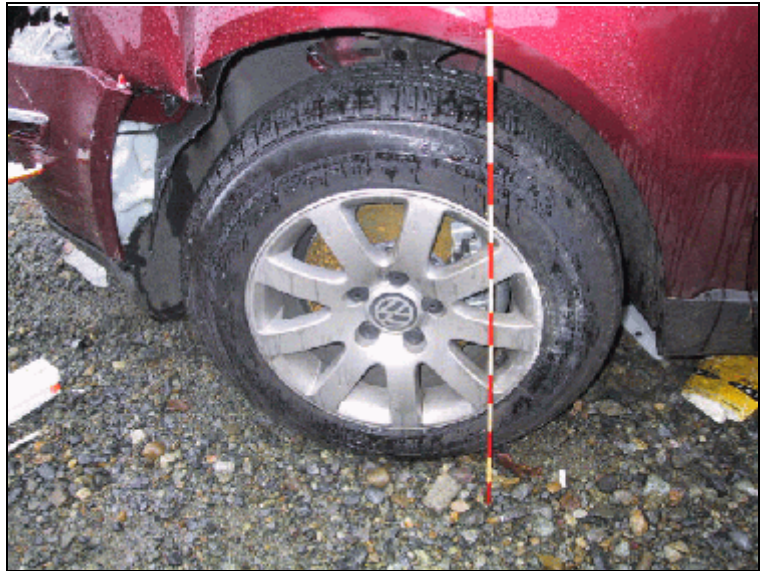
Figure 5. Damage to front left tire/rim

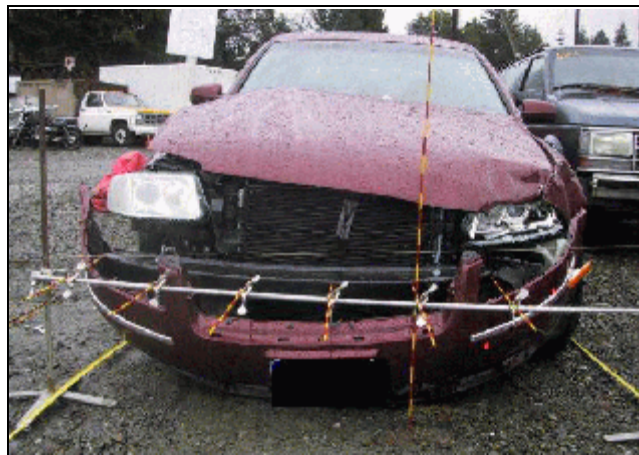
The Passat sustained 22 cm (9 in) of direct contact damage that began at the left bumper corner. The residual crush measured across the front bumper was as follows: C1=3 cm (1 in), C2=5 cm (2 in), C3=6 cm (2 in), C4=6 cm (2 in), C5=4 cm (2 in), C6=0 cm (0 in). The maximum crush was located between C2 and C3; it measured 6 cm (2 in). The principle direction of force was within the 11 o'clock sector was an estimated 340 degrees. The impact energy was managed by the forward structures of the vehicle. The damaged components from the initial

Figure 8. Front, case vehicle

impact included the bumper fascia and reinforcement bar, the hood, and the left fender. There were no glazing fractures and all the doors remained closed and operational. There was scratching/scuffing to the front right tire/rim.

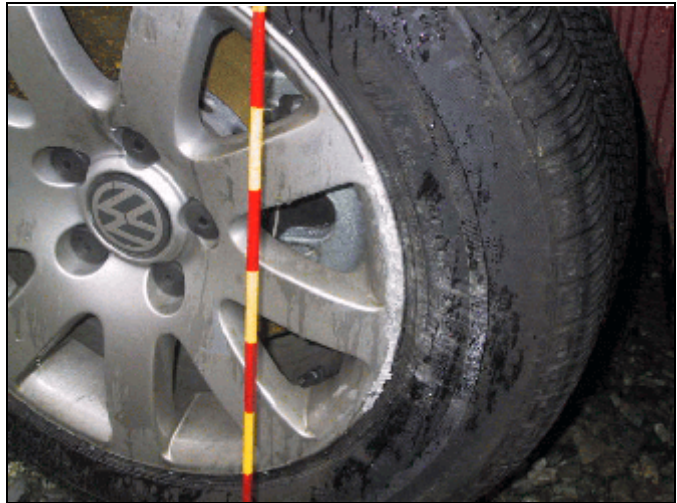
Figure 9. Close up of front left tire

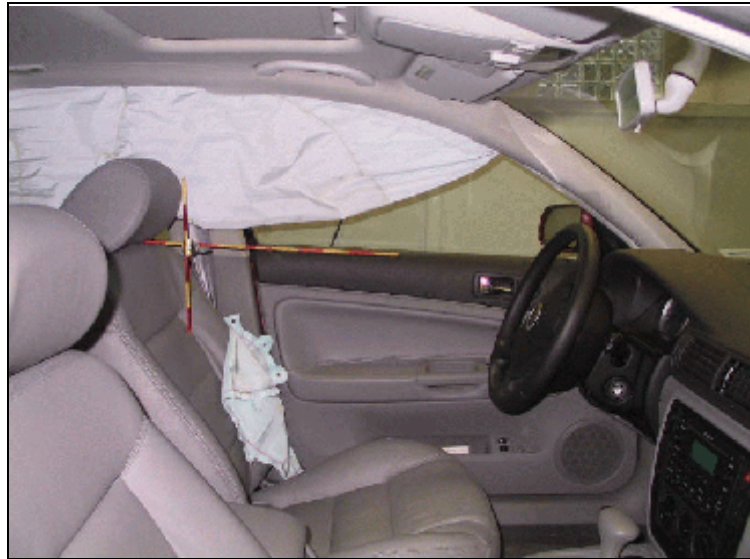
Figure 10. Driver's seat back mounted side impact air bag and side air curtain.

The driver's side curtain measured 150 cm (59 in) wide by 30 cm (12 in) tall. The driver's side impact air bag measured 16 cm (6 in) wide by 60 cm (24 in) tall. The front right passenger's air bag measured 65 cm (26 in) wide by 70 cm (28 in) tall. There was no evidence of contact or damage to any of the deployed air bags.

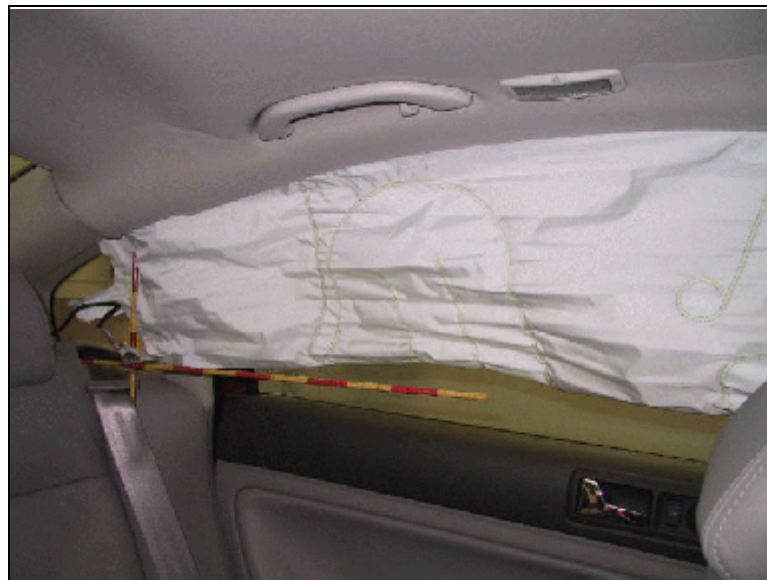
Figure 11. Side air curtain, right left seat

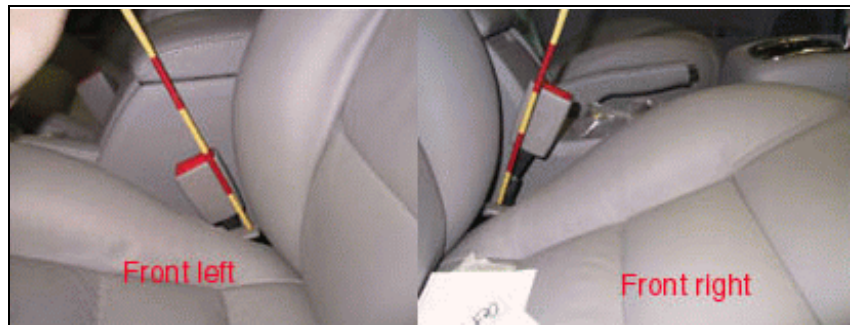
During the case vehicle to vehicle impact, the driver's pretensioner fired and the front right passenger's air bag deployed. This appears appropriate for this collision. The front right passenger's air bag responded as if there were an unbelted occupant in that seat position. There would be a higher threshold for the driver's air bag since the driver was restrained.

Figure 12. Driver's pretensioner fired, front right passenger pretensioner did not fire

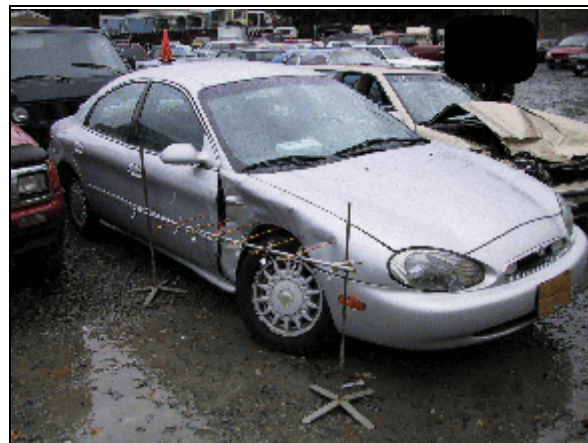
The Sable sustained 116 cm (295 in) of direct damage beginning 215 cm (136 in) forward of the right rear axle. The residual crush measured at the mid-door level was as follows: C1=1 cm (.5 in), C2=8 cm (4 in), C3=9 cm (4 in), C4=7 cm (3 in), C5=4 cm (2 in), C6=0 cm (0 in). The maximum crush was located 256 cm (116 in) forward of the right rear axle and measured 9 cm (4 in). The principle direction of force was within the 3 o'clock sector and was an estimated 100 degrees. The damaged components included the right fender and right tire/rim. There were no glazing fractures and all the doors remained closed and operational.

Figure 13. Right side, other vehicle
