**ON-SITE CHILD SAFETY SEAT CRASH INVESTIGATION
SCI TECHNICAL SUMMARY REPORT**

VERIDIAN CASE NO. CA02-003

VEHICLE - 1989 GMC JIMMY

CRASH DATE - JANUARY 2002

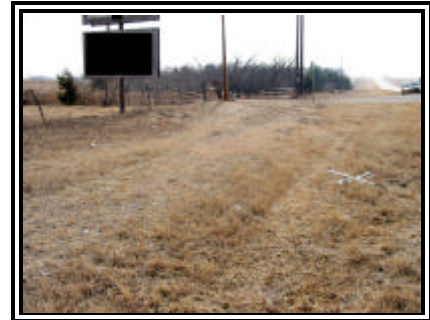
The right front aspect of the Tahoe contacted the left rear corner of the Jimmy in a sideswipe configuration. Although the Tahoe was overtaking the Jimmy, the Jimmy was the dominant vehicle as it attempted the passing maneuver. The direction of force was in the 4 o'clock sector for the Tahoe and in the 10 o'clock sector for the Jimmy. The initial impact resulted in minor damage to both vehicles. The left aspect of the Jimmy's rear bumper appeared to snag on the front right corner of the Tahoe. The Jimmy initiated a CCW rotation on the northbound lane and departed the left roadside in a CCW yaw. The Jimmy traveled onto the west roadside and initiated a rollover with the right side leading (**Figure 3**). The Jimmy rolled ten-quarter turns over an approximate distance of 45 m (150') in a southeast direction on the roadside. Numerous gouge marks were present on the soft roadside in the vehicle's trajectory. After the tenth quarter turn, the Jimmy was upside-down and struck a utility pole with the left front door area. The direction of force was non-horizontal (00) and the rollover event resulted in moderate damage to the Jimmy. The Jimmy came to rest upside down against the pole (**Figure 4**).

Figure 4. View of utility pole and final rest of the Jimmy

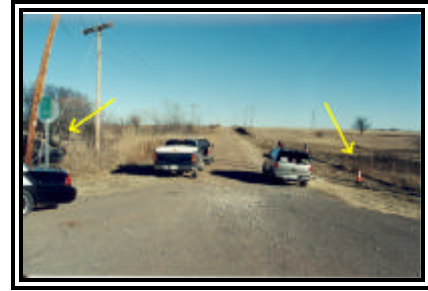
Figure 6. View showing final rest position of the ejected infant relative to the Jimmy

The infant was ejected from the CSS and from the vehicle through the left rear side window opening during the final quarter turn as the Jimmy struck the utility pole. She was found approximately 16 m (51') south of the final rest position of the vehicle. Based on the lack of contact evidence in the vehicle and distance of the infant's final rest position relative to the vehicle, it appears the infant's trajectory out of the vehicle was unobstructed. As a result of the ejection and impact with the ground, she sustained a transtentorial herniation completely obliterating the basilar cisterns, third and fourth ventricles and sulci, a brain stem injury with the basilar cisterns, sulci, third and fourth ventricles completely effaced, subarachnoid hemorrhage was noted throughout the basilar cisterns and sulci diffusely and globally, pneumocephalus within the suprasellar cistern and anterior fossa, a linear transverse fracture that extended vertically from the vertex of the cranium to the right aspect of the posterior parietal, initially lateral to the lambdoid suture and became diastatic, with the most medial and posterior aspect depressed anteriorly approximately 4 mm (0.2"). She also sustained minimal diastasis of the left coronal suture, a large piece of cortical bone was lifted in a cephalad direction approximately 1 cm (0.5"), multiple complex facial abrasions, multiple complex facial lacerations, and a right parietal scalp abrasion as a result of the ejection and ground impact. She was transported by ambulance to a local hospital, transferred to a regional children's hospital, and expired five hours following the crash.

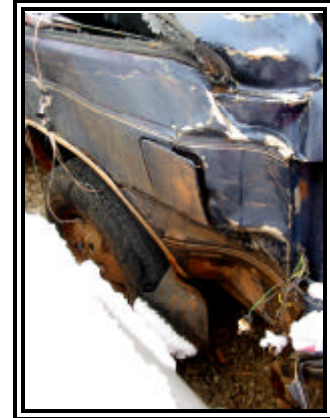
The initial sideswipe impact with the Tahoe resulted in minor damage on the left rear side aspect of the Jimmy. Although the rear bumper was deformed forward from rollover damage, the left corner of the rear bumper was torn rearward from snagging the Tahoe's right front corner. Longitudinal abrasions were also noted on the left rear quarter panel and 5 cm (2") of lateral crush was noted on the quarter panel forward of the bumper from this contact (**Figure 7**). The Collision Deformation Classification (CDC) for the initial impact with the Tahoe was 10-LBES-1.

Figure 7. Initial contact damage

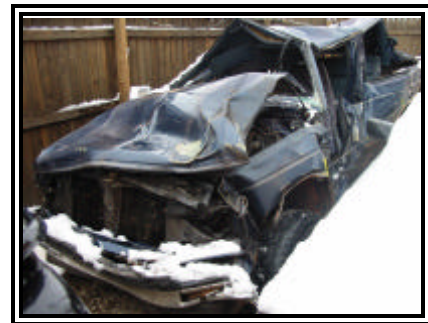
The 1989 GMC Jimmy sustained moderate damage as a result of the rollover event (**Figure 8**). The front headlights and grille were separated from the vehicle and the front bumper was displaced. The hood was buckled and displaced. Both front fenders were deformed. The roof sustained severe crush at the right B-pillar and both C-pillars due to the rollover, and the roof rack was fractured and separated. The maximum left roof side rail crush was located 15 cm (6") forward of the B-pillar, and measured 10.2 cm (4.0") vertically. The left roof side rail was buckled upward 58 cm (23") aft of the leading edge of the left rear window 8.9 cm (3.5"). The maximum roof crush measured 41.9 cm (16.5"). The left and right A-pillars, B-pillars, and C-pillars were displaced from the rollover. The lateral and rearward displacement of the right A-pillar contributed to the upward bowing of the windshield header at the centerline and the windshield header was crushed vertically on the right side. The left B-pillar was crushed inward and the right B-pillar was bowed outward at the belt line. The left C-pillar was displaced forward and nearly compressed against the bottom aspect of the left rear window (**Figure 9**). The right C-pillar was displaced laterally and forward. The backlight header was crushed downward with the most severe crush on the rear left corner. The right front door was deformed and bowed outward. It appears it may have been displaced by hydraulic spreaders during rescue attempts. The right rear quarter panel was deformed from contact with the ground. The rear tail gate and rear hatch were separated from the vehicle. Both front tires were deflated and deboned. Lateral abrasions from the rollover were

Figure 8. View of rollover damage

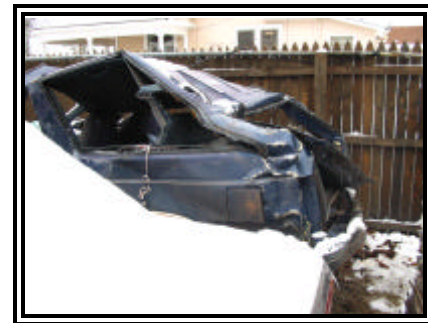
Figure 9. Damage to rear aspect of roof and left C-pillar

present on the right roof side rail and the right side aspect of the Jimmy exhibited a large amount of dirt below the belt line and minor amounts of grass and dirt in the exterior trim. The CDC for the rollover event was 00-TDDO-4.

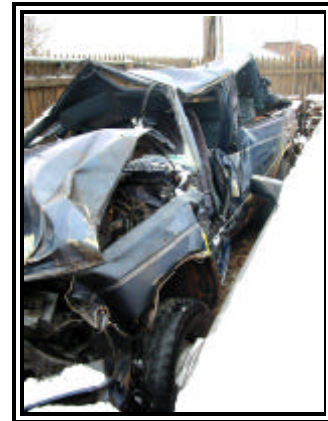
The subsequent utility pole impact resulted in moderate left front door area damage to the Jimmy. (**Figure 10**). The left front door was removed from the vehicle by rescue personnel, and exhibited direct contact damage from the pole impact. The direct damage on the left front door was located 5 cm (2") forward of the rear aspect of the door, and extended forward 28 cm (11") in length. The maximum crush on the door panel measured 18 cm (7"). The left sill also sustained direct damage as a result of the pole impact. The damage along the left sill was located 3 cm (1") forward of the B-pillar and extended forward 28 cm (11") in length. The combined direct and induced damage along the left side from the pole impact began 27 cm (11") forward of the rear edge of the left front fender and extended rearward 198 cm (78") to 69 cm (27") aft of the left B-pillar at the mid-door level. Six crush measurements were taken along the left sill and were as follows: C1 = 0, C2 = 8 cm (3"), C3 = 13 cm (5"), C4 = 25 cm (10"), C5 = 11 cm (4"), C6 = 0. The maximum crush on the left sill was located 20 cm (8") forward of the left B-pillar and measured 30 cm (12"). The CDC for the utility pole impact was 00-LPEN-3.

Figure 10. Left side damage from pole impact

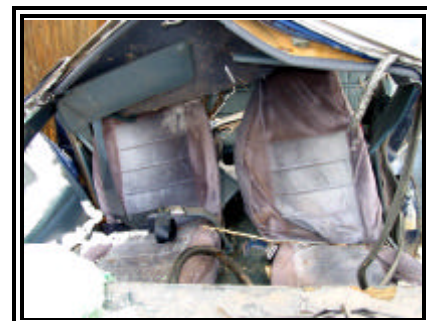
Interior damage to the 1989 GMC was severe and attributed to compartment intrusion. The windshield was completely separated and all of the glazing was disintegrated from impact forces. The most severe roof intrusion was at the front right aspect where the roof was crushed vertically against the front right seat back (**Figure 11**). The intrusions were as follows:

Figure 11. View through windshield showing intrusions

Position	Component	Intruded	Direction
11	Left roof side rail	10.2 cm (4.0")	Vertical
11	Roof	25.4 cm (10.0")	Vertical
13	Right roof side rail	41.9 cm (16.5")	Vertical

Position	Component	Intruded	Direction
13	Roof	41.9 cm (16.5")	Vertical
13	Right roof side rail	24.1 cm (9.5")	Lateral
21	Roof	32.4 cm (12.8")	Vertical
21	Left side interior panel	11.4 cm (4.5")	Lateral
21	Left B-pillar	15.2 cm (6.0")	Lateral
23	Right roof side rail	19.1 cm (7.5")	Vertical
Rear cargo area	Backlight header	32.4 cm (12.8")	Vertical

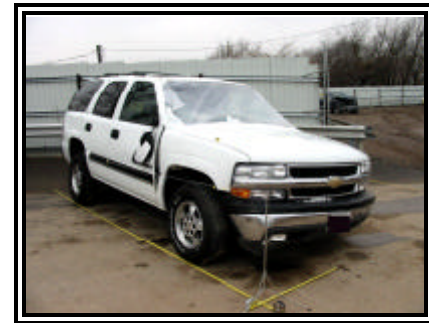
The initial sideswipe contact with the GMC Jimmy resulted in minor right front side damage to the 2000 Chevrolet Tahoe (**Figure 12**). The direct contact damage began at the right front corner on the bumper and extended 23 cm (9") rearward. The combined direct and induced damage began at the front right bumper corner and extended rearward 40 cm (16"). The maximum lateral crush was located 23 cm (9") aft of the right front corner and measured 5 cm (2"). Longitudinal abrasions were present on the right front bumper corner from the direct contact. The CDC for the initial contact with the GMC Jimmy was 04-RFES-1.

Figure 12. View of damaged 2000 Chevrolet Tahoe

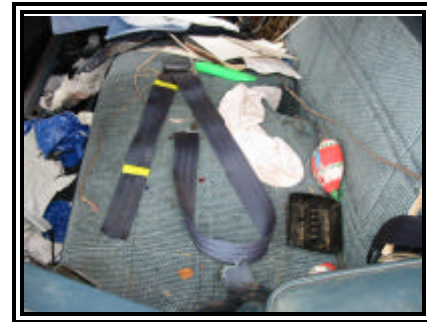
The rear bench seat was equipped with manual 3-point lap and shoulder belts with locking latch plates for both positions. The rear left seat belt webbing had been cut in two places in an attempt to remove the child safety seat from the vehicle (**Figure 13**). At the time of the vehicle inspection, the rear left retractor was restricted in the used position and the cut webbing was still through the latch plate which was engaged in the buckle. The length of the webbing that was restricted in the retractor measured 51 cm (20"). Based on the position of the locking latch plate, the remaining shoulder belt webbing measured 84 cm (33") in length and the remaining lap belt webbing measured 47 cm (19") in length. The fixed D-ring for the rear left manual restraint was displaced rearward and outward from the roof deformation. Creases were noted in the webbing from the installation of the CSS, but there was minimal loading on the webbing as a result of the crash.

Figure 13. Cut rear left manual restraint

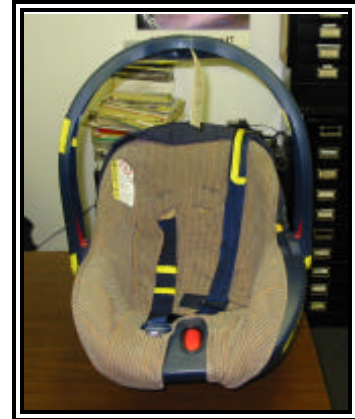
A Cosco Turnabout infant child safety seat (**Figure 14**) with a detachable base was installed in the rear left seat of the GMC Jimmy. The model number was 02 758 TCD and the date of manufacture was June 7, 2000. There were no NHTSA recalls associated with this seat. The seat was received new by the parents as a gift approximately four months prior to the crash and the parents stated that they had read the owner's manual and used it as a guide during the initial installation. They mentioned that the owner's manual was difficult to follow, as they had no prior CSS experience. At the time of inspection, the owner's manual was not with the CSS, and the locking clip was stowed on the pivoting kick stand on the lower front aspect of the CSS. The infant seat was designed to be used with or without the detachable base and for infants who weighed 10 kg (22 lb) or less and measured 6 cm (26") or less. The infant seat was occupied by a 4-month-old female that weighed 4.8 kg (10.5 lb) and measured 63.5 cm (25.0") in length. The infant was within the manufacturer's recommended height and weight limits outlined in the instruction manual for use of the rear-facing infant seat. The infant CSS was configured with a single-loop 3-point harness system. The shell was configured with three sets of harness slots, however, the fabric cover and styrofoam padding were configured with two sets of harness slots. At the time of the inspection, the right harness strap was threaded through the bottom slot and the left harness strap was pulled forward and completely out of the bottom left slot. The latch plate was engaged in the buckle.

Figure 14. Cosco infant CSS

The infant CSS exhibited signs of wear and damage associated with the crash. The detachable base sustained abrasions on the forward aspect and the left side longitudinal plastic guide on the forward aspect of the base was deformed 0.6 cm (0.3") to the left. The inboard edges of the belt path sustained minor abrasions from the vehicle's manual restraint webbing.

The infant CSS also sustained damage as a result of the crash. A moderate amount of dust/dirt was noted on the bottom aspect of the seat. The carrying handle exhibited moderate stress points that measured 8 cm (3") in length on the outboard aspects which appeared to have resulted from vertical loading to the handle, which was in the upright position at the time of the crash. Both outboard aspects of the carrying handle showed multiple scuffs and scrapes.

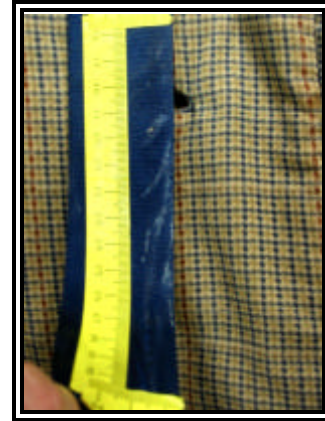
Scrapes were present on the left rear aspect of the plastic shell, aft of the carrying handle. The inboard aspect of the left lower harness slot showed signs of stress and minor abrasions from the loading and subsequent pull-out of the harness webbing. The left harness webbing was completely removed from the left slot. The right harness was threaded through the right harness slot and the harness adjustment slide was attached to the end of the right harness webbing on the rear aspect of the CSS. The left harness exhibited a 30 cm (12") longitudinal crease in the center of the webbing. Diagonal plastic transfers were also present on outboard aspect of the webbing 27 cm (10") above the location of the harness retainer clip and 5 cm (2") forward of the end of the webbing (**Figure 15**). The plastic transfers appeared to have resulted from staggered loading to the harness system from the infant during the rollover. The right harness strap also exhibited a longitudinal crease on the center aspect 30 cm (12") above the latch plate. Distinct creases were present on the webbing from the harness retainer clip spaced 3 cm (1") apart and located 22 cm (9") above the latch plate. The harness webbing was gathered in the plastic latch plate slot, and the plastic latch plate housing showed stress marks in the plastic around the perimeter. The latch plate showed heavy abrasions which indicated frequent usage.

Figure 15. View of plastic transfers on harness webbing
