INDIANA UNIVERSITY

ON-SITE CHILD AIR BAG-RELATED FATALITY INVESTIGATION

CASE NUMBER - IN-02-004
LOCATION - INDIANA
VEHICLE - 1994 VOLKSWAGEN JETTA GL
CRASH DATE - July 2002

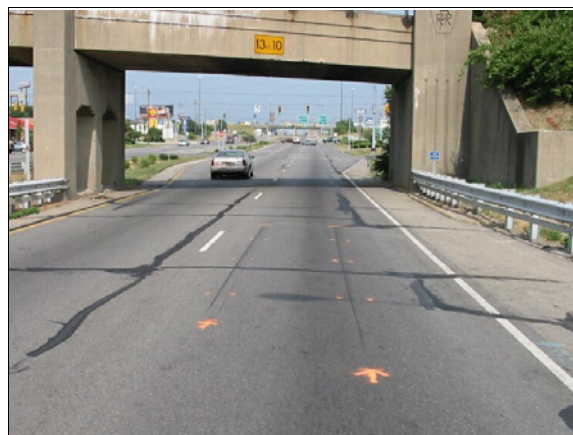
The case vehicle was stopped, heading east in the outside lane of a four-lane, divided, U.S. highway and intended to continue eastward (i.e., both the east and westbound roadways had two through lanes). The case vehicle was stopped behind several other eastbound vehicles at a traffic light that regulated a four-leg intersection. The Ford F-150 was also stopped, directly in front of the case vehicle. The Ford Tempo was traveling eastbound in the same lane of the same roadway and was approaching the line of stopped vehicles. The Tempo’s driver attempted to stop, depositing 10.3 meters (33.8 feet) of straight line skid marks prior to impact (**Figure 1**).

Figure 1: Southward travel path of Ford pickup, case vehicle, and Ford Tempo in outside lane of southbound roadway, showing Tempo’s straight line, pre-crash skid marks (case photo #01)

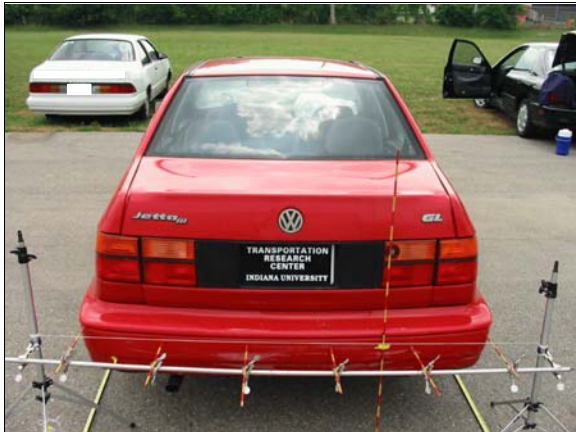
Figure 2: Damage to case vehicle's back bumper from impact (1st event) by Tempo; Note: contour gauge present at bumper level (case photo #23)

The case vehicle's contact with the Ford Tempo involved the majority of the back bumper (Figure 2 above). Direct damage began at the back right bumper corner and extended 134 centimeters (52.8 inches) leftward along the back bumper. Residual maximum crush was measured as 2 centimeters (0.8 inches) at C_6 (Figure 8). All measurements were taken at bumper level. The case vehicle's contact with the Ford pickup involved only the small portion of the front right bumper (Figures 9 and 10) which struck a trailer ball hitch on the back of the pickup (Figure 4 above). Direct damage began 18 centimeters (7.1 inches) from the front right bumper corner and extended leftward 18 centimeters (7.1 inches) along the bumper (Figure 9). The case vehicle's wheelbase was unaltered from the crash. The case vehicle's front and back bumper fascia as well as the right fog lamp, directly under the front bumper, were directly damaged and crushed rearward. None of the case vehicle's tires were damaged, deflated, or physically restricted. The case vehicle's front bumper fascia and grille sustained induced damage as a result of the direct contact with the pickup's trailer hitch. No other obvious induced damage or remote buckling was noted to the remainder of the case vehicle's exterior.

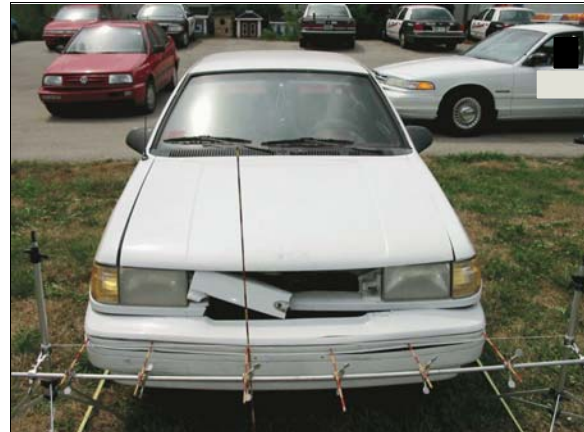
Figure 3: Ford Tempo's frontal damage from impact (1st event) to back of case vehicle; Note: contour gauge present a bumper level (case photo #67)

The Ford Tempo's contact with the case vehicle involved the entire front. Direct damage began at the front left bumper corner and extended, a measured distance of 147 centimeters (57.9 inches), to the front right bumper corner. Residual maximum crush was measured as 4 centimeters (1.6 inches) at C₁ and C₆ (**Figure 3** above and **Figure 17**).

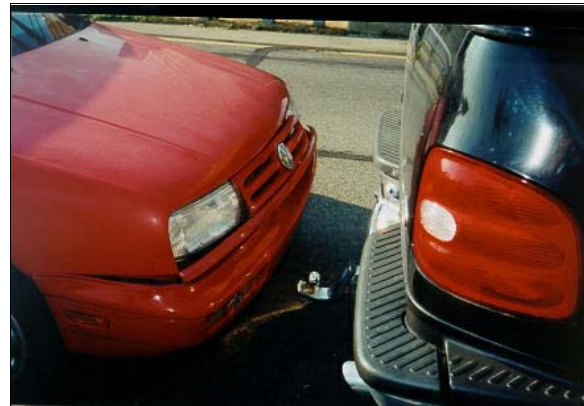
Figure 4: On-scene view of final rest positions of case vehicle and Ford pickup (2nd event), showing rear-end impact configuration; Note: trailer hitch on pickup's back bumper damaged case vehicle's front (case photo #12)

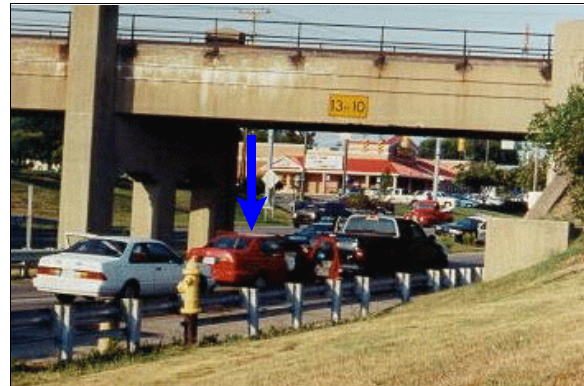
Figure 5: On-scene view from southern roadside of Ford Tempo, case vehicle (arrow), and Ford F-150 at final rest in outside lane of eastbound roadway (case photo #13)

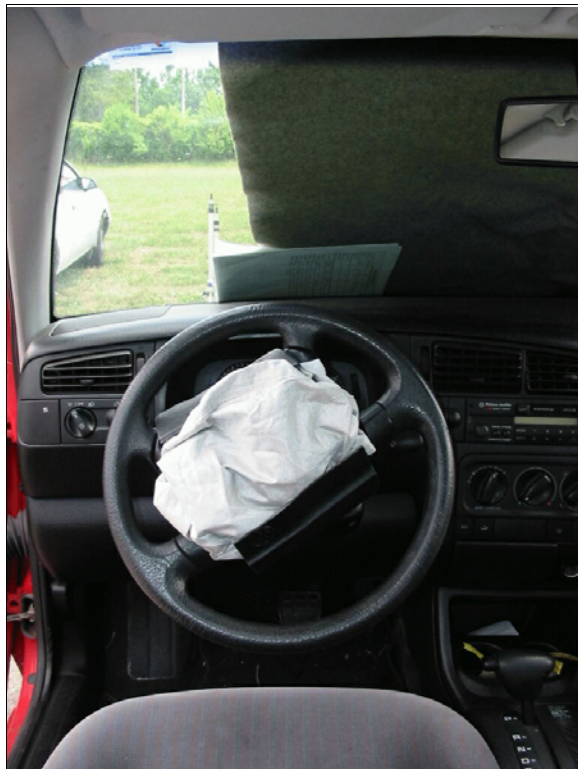
Figure 6: Vertical view of case vehicle’s driver seating area showing deployed driver air bag and no apparent occupant contact evidence on steering wheel rim or greenhouse areas (case photo #36)

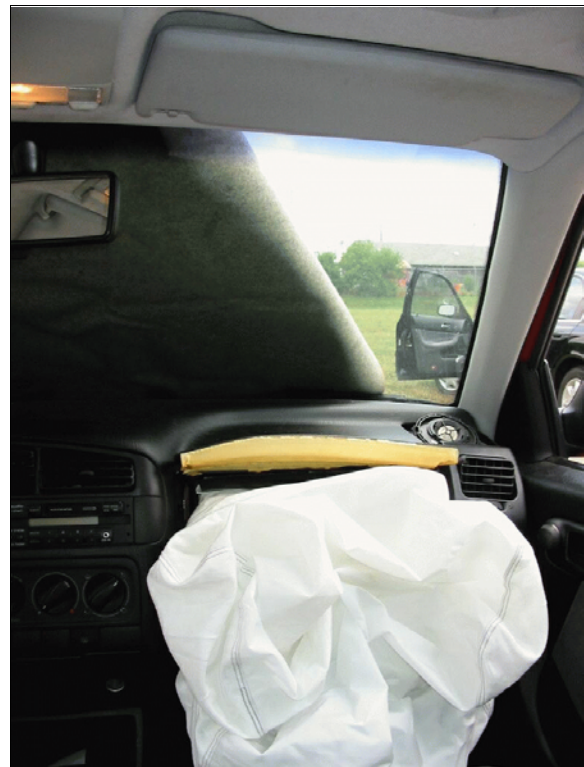
Figure 7: Vertical view of case vehicle’s front right passenger seating area showing deployed front right passenger air bag and underneath surface of air bag module’s cover flap; Note: no contact evidence on windshield’s glazing or on right “A”-pillar, sun visor, or roof (case photo #65)

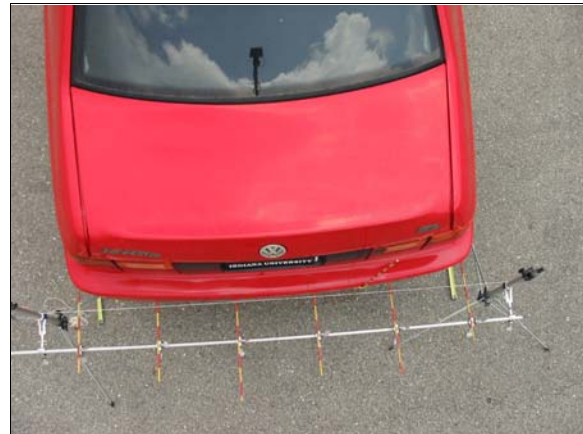
Figure 8: Overhead view of case vehicle's back damage from impact with Ford Tempo (1st event) with contour gauge positioned at bumper level (case photo #26)

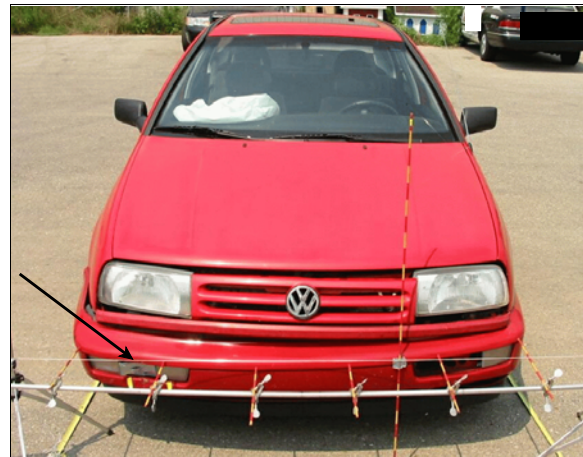
Figure 9: Case vehicle's frontal damage with contour gauge present at bumper level; Note: arrow indicates impact location of pickup's trailer hitch (case photo #15)

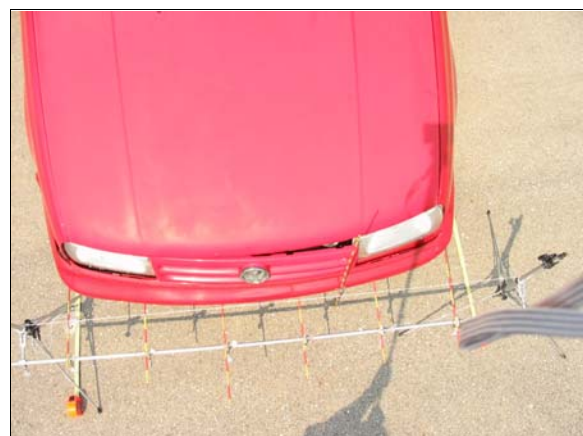
Figure 10: Overhead view of case vehicle's frontal damage from impact with Ford F-150 (2nd event) with contour gauge positioned at bumper level (case photo #14)

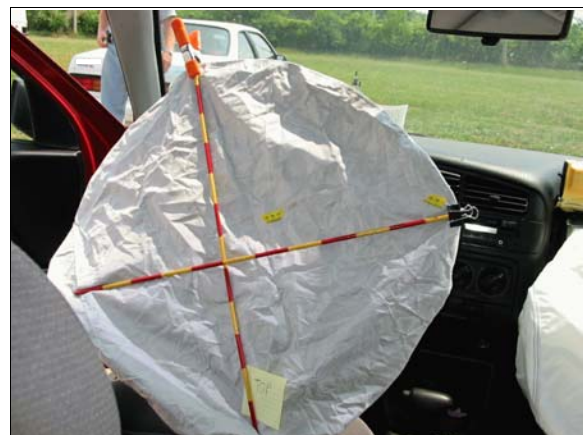
Figure 11: Case vehicle's deployed driver air bag showing faint smudges (i.e., yellow tape); Note: steering wheel has been rotated approximately 170 degrees clockwise (case photo #46)

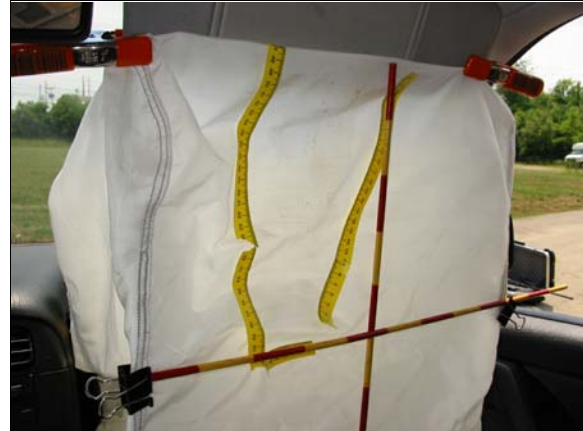
Figure 12: Case vehicle's deployed front right passenger air bag showing skin smudges in upper left quadrant of bag's front surface (case photo #53)

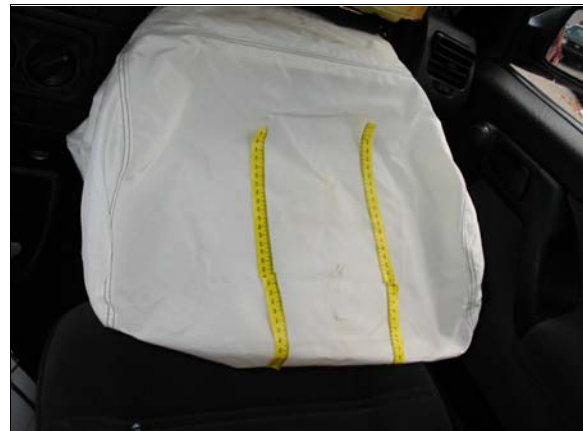
Figure 13: Top surface of case vehicle's deployed front right air bag; Note: blood and scuff marks (case photo #60)

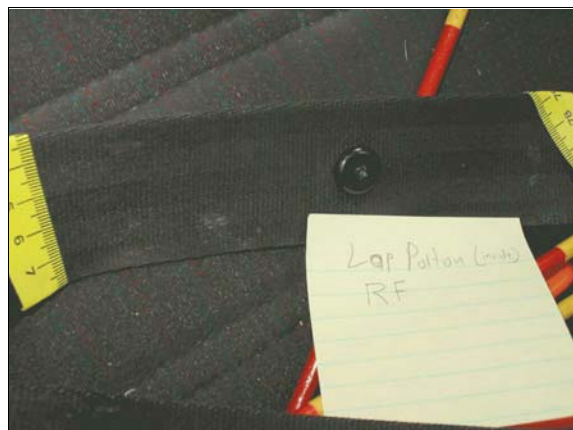
webbing, latch plate, and “D”-Ring showed light evidence of loading and signs of bodily fluid on the lap belt portion of the webbing (**Figure 14**).

Figure 14: Close-up of case vehicle's front right seat belt webbing showing wear marks and body fluids (case photo #44)

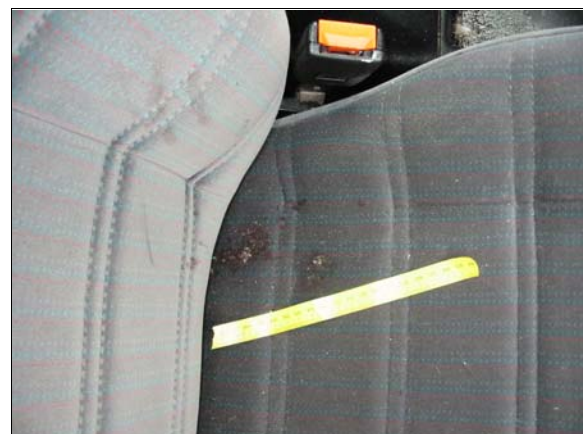
The case vehicle was stopped, and the case vehicle's driver made no known pre-crash avoidance maneuvers. As a result and independent of the use of her available safety belts, the front right passenger's pre-impact body position did not change just prior to the initial back impact. The case vehicle's impact by the Ford Tempo caused the front right passenger to move directly backwards and most likely slightly upwards, loading her seat back. The front right passenger then rebounded and moved directly forward, loading the lap portion of her safety belt. Whether she also loaded the torso portion of her safety belt or, more likely, slipped out from underneath it, is unknown. The case vehicle impacted the Ford pickup, most likely causing this occupant to move slightly upwards while jackknifing over the lap portion of her safety belt and enabling her head to move forward and slightly downward where it was struck by the deploying air bag. The deploying front right passenger air bag most likely hyper-extended this occupant's neck and knocked her backwards into her seat back. This occupant's exact posture at final rest is unknown, but based on the physical evidence she was most likely slumped to the left with her head on or near the center console (**Figures 15 and 16**).

Figure 15: Overhead view of case vehicle's front right seat showing vomit and blood evidence on seat's cushion (case photo #40)

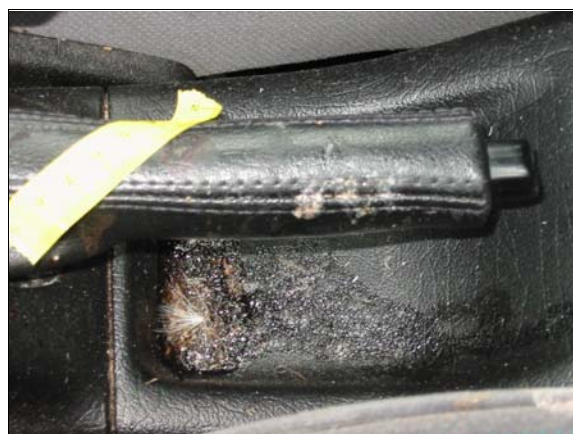
Figure 16: Overhead close-up view of case vehicle's parking brake lever and center console showing vomit on parking brake and vomit and blood evidence on center console (case photo #41)

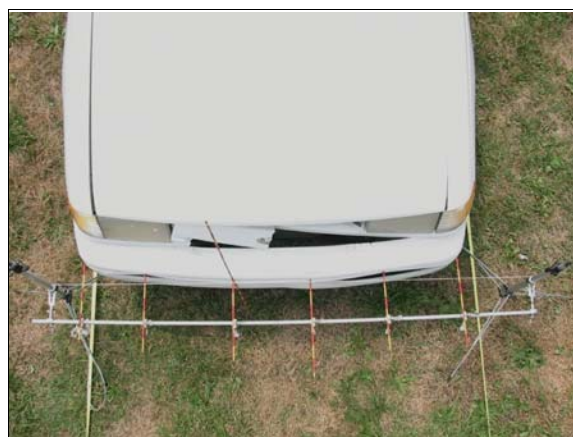
Figure 17: Overhead view of Ford Tempo's frontal damage from impact with case vehicle (1st event) with contour gauge positioned at bumper level (case photo #70)

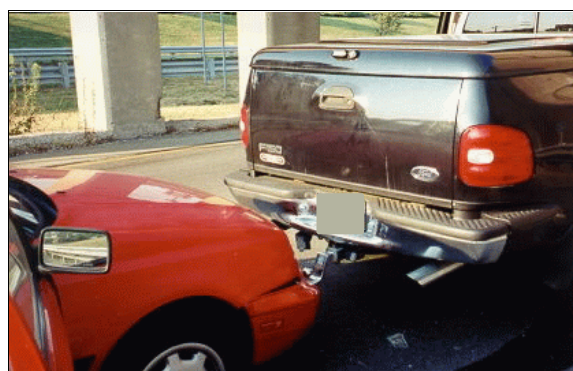
Based on available on-scene photographs, the CDC for the Ford pickup was estimated as: **06-BCEN-1 (180 degrees)**. The WinSMASH reconstruction program, missing vehicle algorithm was used on the pickup's highest severity impact. The Total, Longitudinal, and Lateral Delta V's are, respectively: 8.0 km.p.h. (5.0 m.p.h.), +8.0 km.p.h. (+5.0 m.p.h.), and 0.0 km.p.h. (0.0 m.p.h.). It should be noted that, according to the interviews with the responding police officers and the on-scene photography (**Figure 18**), the only contact to the pickup involved its rear trailer "ball-type" hitch that was connected to the back. The pickup was driven from the scene.

Figure 18: On-scene view of back of Ford pickup showing no obvious damage to back bumper but damage to trailer hitch (case photo #11a)
