**VERIDIAN ON-SITE CHILD SAFETY SEAT CRASH INVESTIGATION
SCI TECHNICAL SUMMARY REPORT**

VERIDIAN CASE NO. CA02-006

VEHICLE - 1990 FORD F-150 PICKUP TRUCK

CRASH DATE - DECEMBER 2001

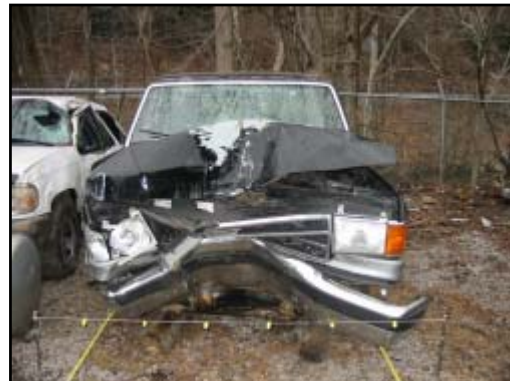
Figure 1. Damaged Ford F-150 pickup truck

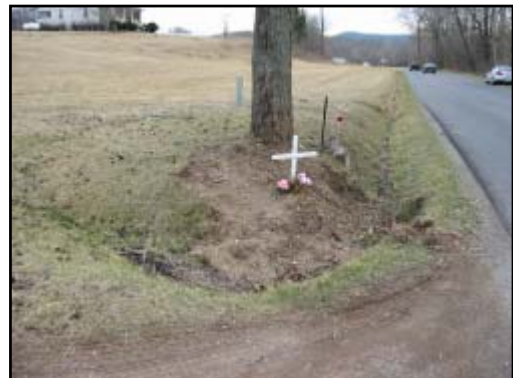
The Ford F-150 pickup truck struck a tree with the front center area (**Figure 3**). The tree measured 56 cm (22") in diameter and the impact resulted in severe damage to the Ford pickup truck. The resultant direction of force was within the 12 o'clock sector for the pickup truck. The damage algorithm of the WinSMASH program computed a total delta-V of 44.0 km/h (27.3 mph) based on the frontal crush profile on the pickup truck. The longitudinal and latitudinal components were -44.0 km/h (-27.3 mph) and 0.0 km/h, respectively. There was no scene evidence indicating where the pickup truck came to final rest. However, considering the impact was slightly right of the centerline of the vehicle, the pickup truck probably rotated clockwise (CW) slightly prior to coming to rest.

Figure 3. Point of impact

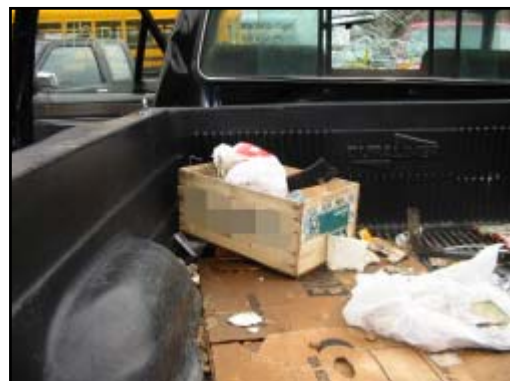
A wood box that measured approximately 61 cm (24") in length, 30 cm (12") in width, and 30 cm (12") in height was found in the rear box of the pickup truck (**Figure 4**). Numerous ceramic items and accessories were present in the box. According to a family member, the box was in the cab of the pickup truck at the time of the crash, presumably on the center aspect of the bench seat. Numerous fractured ceramic items were present on the seat cushion and on the floor areas at the time of the vehicle inspection.

Figure 4. Wood box with ceramic items

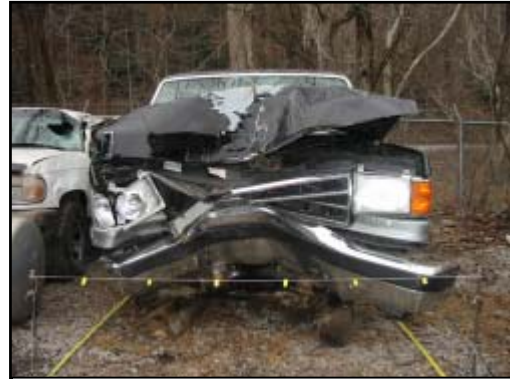
The Ford F-150 sustained severe frontal damage as a result of the impact with the tree (**Figure 5**). The direct contact damage began 28 cm (11") left of the centerline on the bumper and measured 61 cm (24") laterally across the bumper. The combined direct and induced damaged involved the entire frontal width of the pickup truck and measured 146 cm (58"). The direct damage on the hood also began 28 cm (11") left of the centerline and measured 72 cm (28") laterally across the leading edge of the hood. Abrasions from direct contact with the tree were present on the center aspects of the bumper and hood. The bumper and bumper trim exhibited grass and dirt from contact with the drainage ditch adjacent to the tree. The center aspect of the front bumper was crushed rearward and the maximum crush at the bumper level was located 10" right of the centerline and measured 68 cm (27"). The left corner of the bumper was displaced inward and forward as a result of the crush. The grille and right headlight were fractured. The right front fender sustained induced outward buckling. The rear cargo box was displaced as a result of the impact, and the separation from the cab at the top aspect measured 8 cm (3") on the left side and 13 cm (5") on the right side (**Figure 6**). The rear aspect of the cab was bowed forward approximately 8 cm (3") in the center aspect. The bottom aspect of the back light exhibited a 3 cm (1") longitudinal separation that extended 53 cm (21") along the bowed contour of the cab. The Collision Deformation Classification (CDC) for the tree impact was 12-FZEW-3. Six crush measurements were taken along the front bumper and were as follows: C1 = 0.0 cm, C2 = 9 cm (4"), C3 = 50 cm (20"), C4 = 63 cm (25"), C5 = 37 cm (15"), C6 = 15 cm (6").

Figure 5. Frontal view of damaged F-150

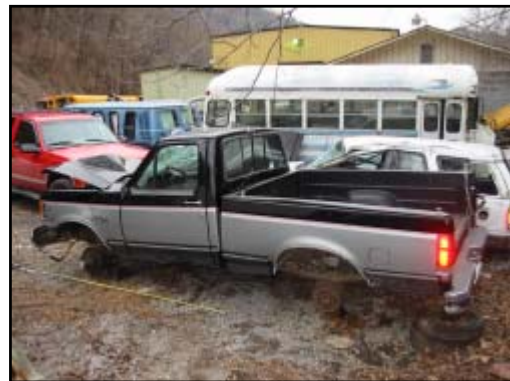
Figure 6. Left side view showing displacement of the cargo box

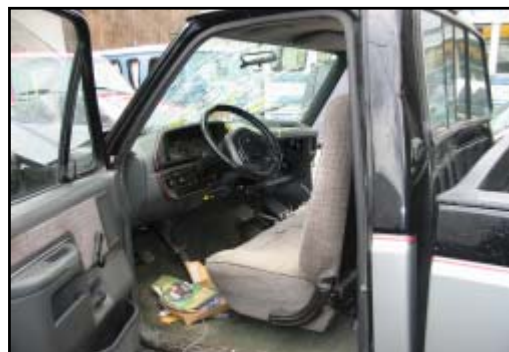
The 1990 Ford F-150 pickup truck sustained moderate interior damage as a result of compartment intrusion and occupant contact (**Figure 7**). The windshield glazing was fractured in three distinct places from interior contacts. The windshield contact located 8 cm (3") right of center and 37 cm (15") from the windshield header had a small number of thin green fabric strands that were embedded in the fractured laminate. There were no hair or tissue transfers in the windshield fractures. The rear view mirror was displaced upward and forward. The top half of the

Figure 7. Left side interior view

steering wheel rim was deformed forward 2.0 cm (0.8") and the bottom half deformed forward 0.6 cm (0.3") from occupant loading. The tilt steering column was jammed in the full-up position and the steering column was compressed, as the right shear capsule was displaced forward 0.6 cm (0.3").

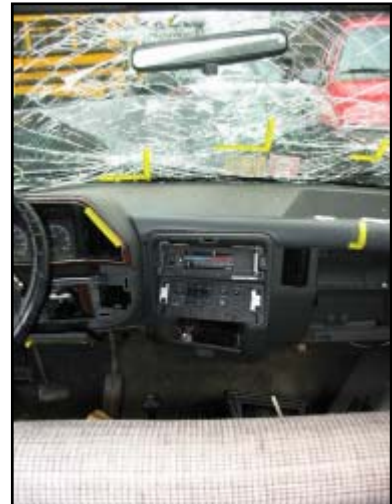
Contact evidence was documented in the Ford F-150 pickup truck (**Figure 8**). The instrument panel to the right of the steering column was fractured and separated. The left lower instrument panel was displaced and partially separated from occupant contact on the right aspect. A diagonal abrasion that measured 9 cm (4") in length was located on the inboard edge of the driver's upper instrument panel. The center instrument panel was displaced on the left side, and the trim panel around the radio and HVAC controls was separated. The floor-mounted transmission selector lever was completely separated at the floor. The glove box door was separated as a result of the impact and a longitudinal fracture was present on the front right upper instrument panel. The fracture measured 6.4 cm (2.5") in length and was located 33 cm (13") to the right of the centerline. Longitudinal intrusions were measured and were as follows:

Figure 8. View of contact evidence

Position	Component	Intruded	Direction
FL	Left toe pan	5.1 cm (2.0")	Longitudinal
FC	Rear aspect of cab (below window)	7.0 cm (2.8")	Longitudinal
FR	Right toe pan	3.2 cm (1.3")	Longitudinal

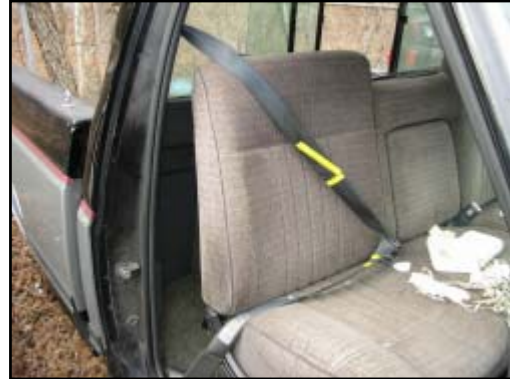
The front right passenger's manual restraint was used to install the CSS on the front right position of the pickup truck's bench seat. At the time of the vehicle inspection, the retractor did not appear to have sustained damage, and the webbing was not restricted (**Figure 9**). The sliding latch plate and front right D-ring exhibited moderate abrasions from the loading of the CSS. A lateral abrasion was present on the webbing 89 cm (35") from the floor anchor and measured 3.2 cm (1.3") in length across the webbing and 0.6 cm (0.3") in width. A plastic transfer from the child safety seat that measured 5.7 cm (2.3") in length and 2.5 cm (1.0") in width was present on the webbing 127 cm (50") from the floor anchor.

Figure 9. Front right passenger's safety belt

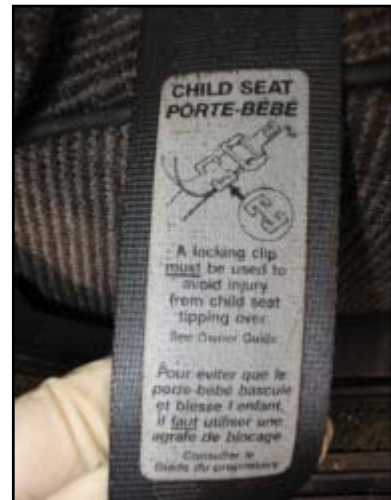
A label was present on the front right restraint webbing 44 cm (18") from the floor anchor that read: "CHILD SEAT - A locking clip must be used to avoid injury from child seat tipping over (see owner's guide)." When the restraint was in the buckled position, the label was on the outboard aspect of the lap belt webbing at the level of the seat cushion (**Figure 10**).

Figure 10. CSS label

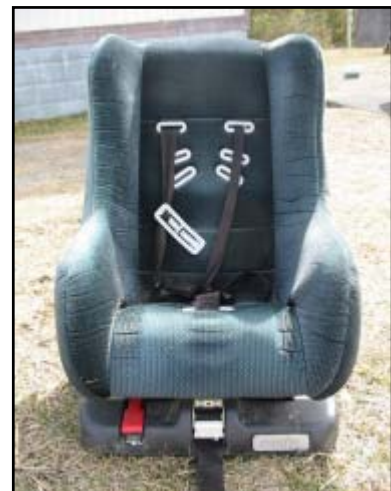
An Evenflo Utara Premier Convertible Child Safety Seat (**Figure 11**) was installed in the front right position of the Ford F-150 pickup truck. The model number was 234119P1 and the date of manufacture was April 22, 1996. There were no NHTSA recalls associated with this seat. The seat was purchased new by the parent approximately five years prior to the crash, and was previously used by another child. The parent indicated that the seat was used in three different vehicles, and re-installed approximately once a week. At the time of the vehicle inspection, the locking clip was not attached to the CSS, and the instruction manual was not available. The convertible seat was designed to be used forward facing by children who weighed between 9 kg (20 lbs) and 20 kg (43 lbs) and who measured between 66 cm (26") and 109 cm (43"). The CSS was occupied by a 3-year-old female who weighed 15 kg (32 lb) and measured 102 cm (40") in height. The child was within the manufacturer's recommended height and weight limits outlined in the instruction manual for use of the forward-facing convertible seat. The CSS was configured with a 5-point harness system. The CSS was also configured with three sets of harness slots, and the shoulder harness straps were routed through the top set of slots at the time of the inspection.

Figure 11. Evenflo CSS

The labels that illustrated the installation guidelines and weight and height guidelines were partially removed on the outboard aspects of the CSS.

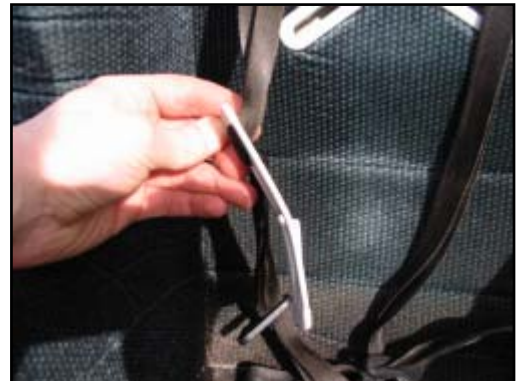
The convertible CSS exhibited signs of wear and damage associated with the crash. The forward-facing belt path showed abrasions from the vehicle's 3-point manual restraint. The entire length of the left harness strap was folded in half. The right harness strap was creased and folded in half between the harness slot and the lower right outboard slot. The fold extended through the harness retainer clip and through the latch plate loop. The left half of the harness retainer clip (**Figure 12**) was deformed forward approximately 3 cm (1"). A family member stated that the deformation to the harness retainer clip was due to frequent usage, although, minor abrasions were noted on the left harness strap at the level of the harness retainer clip. The rear aspect of the top left harness slot showed a stress mark in the plastic at the center of the bottom aspect. Both latch plates were abraded and showed signs of frequent usage.

Figure 12. Horizontal view of the deformed harness retainer clip
