ON-SITE ADVANCED OCCUPANT PROTECTION SYSTEM INVESTIGATION

CASE NUMBER - IN-02-006
LOCATION - TEXAS
VEHICLE - 2003 TOYOTA COROLLA LE
CRASH DATE - August 2002

March 23, 2004

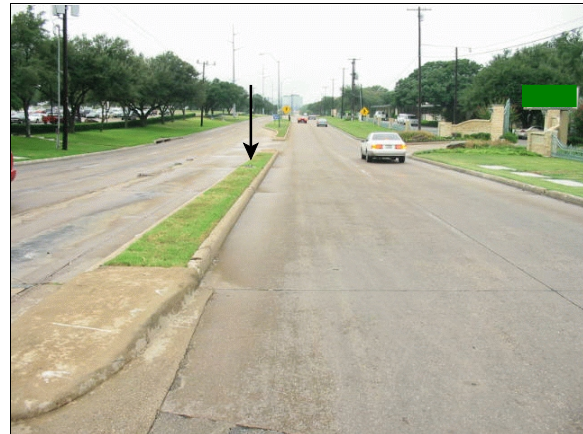
The case vehicle was passing through a four-leg intersection, traveling west in the inside lane of a five-lane, divided, city trafficway (**Figure 1** below), and intended to continue traveling straight ahead (i.e., on the west leg of the intersection, both the east and westbound roadways had

Figure 1: Case vehicle's westward travel path in inside westbound lane showing impact location (i.e., arrow) with light pole, mounted in median (case photo #04)

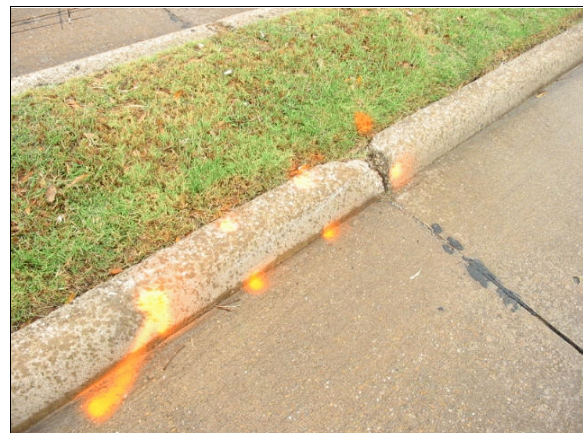
The left front tire and wheel of the case vehicle impacted the median curb (**Figure 2**) approximately 7 meters (23.0 feet) east of the light

Figure 2: Northeastward close-up view of impact to median curb from case vehicle's left front wheel (case photo #07)

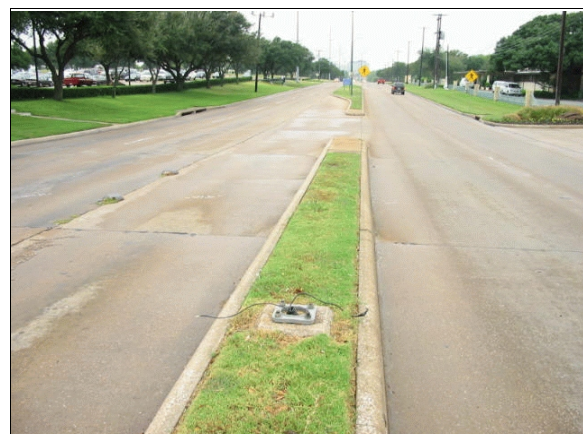
Figure 3: Base of light pole, located in median, that was sheared by contact with case vehicle's left front wheel assembly (case photo #09a)

pole, depositing an approximate 1 meter (3.3 foot) scrape along the curb's concrete. The case vehicle continued westward and impacted the light pole in the median of the trafficway (**Figure 3** above). Although the front bumper fascia was not present with the case vehicle at the time of this contractor's inspection, the damage to the case vehicle indicates that front left corner (**Figure 4**) of the case vehicle collided with the light post, causing the case vehicle's driver and front right passenger supplemental restraints (air bags) to deploy. According to the case vehicle's driver, the case vehicle re-entered the westbound roadway and came to rest in the inside lane heading in a westerly direction (**Figure 5**).

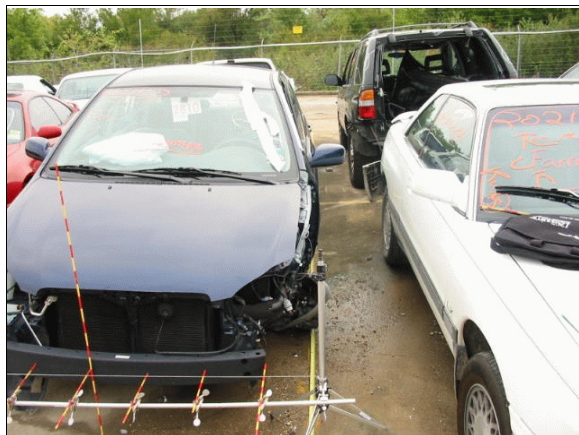
Figure 4: Case vehicle's very narrow front left corner impact viewed along left side (case photo #16)

vehicle (**Figure 9** above), as were the front bumper fascia, grille, and left and right headlight and turn signal assemblies (**Figures 4** and **6** above); although, it should be noted that these items may have been manually removed from the vehicle post crash. The case vehicle's right front and rear tires were not damaged, deflated, or physically restricted. Induced damage was also noted to the left front door. No obvious induced damage or remote buckling was noted to the remainder of the case vehicle's exterior.

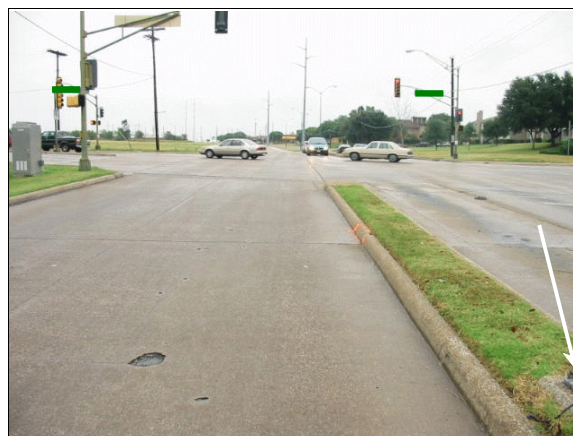
Figure 5: Eastward view in inside westbound lane from case vehicle's approximate final rest position; Note: wheel contact along median curb (orange paint) base of light pole (arrow) in median (case photo #09b)

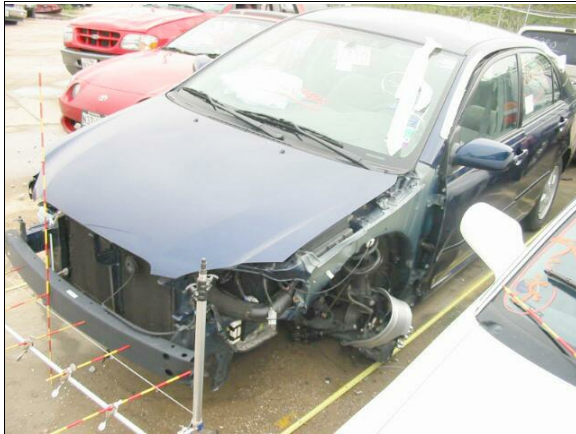
Figure 6: Elevated view of case vehicle's very narrow front left corner impact; Note: left fender and left front wheel were torn off during impact (case photo #17)

The case vehicle's contact with the light post involved a small portion of the front left bumper corner as well as a large amount of the left front fender and wheel assembly (**Figure 6**). Direct damage began at the front left bumper corner and extended a short, but unknown distance toward the vehicle's center. Residual maximum crush was measured as 6 centimeters (2.4 inches) at C_1 (**Figures 7 and 8**). More heavily damaged was the left fender, where most of the direct contact took place. The case vehicle's left front wheel was also sheared from the vehicle and this contributed to the wheelbase on the case vehicle's left side being shortened approximately 27 centimeters (10.6 inches) while the right side was extended approximately 1 centimeter (0.4 inches). The case vehicle's left fender was sheared from the

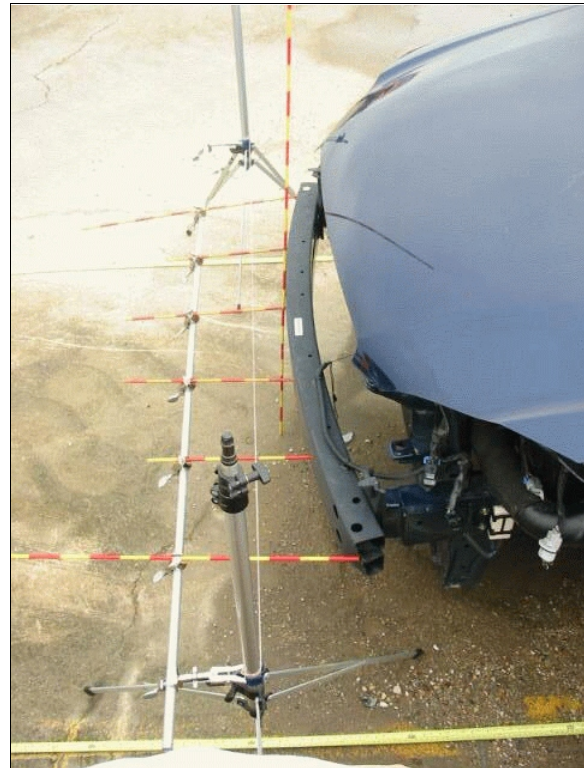
Figure 7: Case vehicle's very narrow front left corner impact viewed along front reference line (case photo #12)

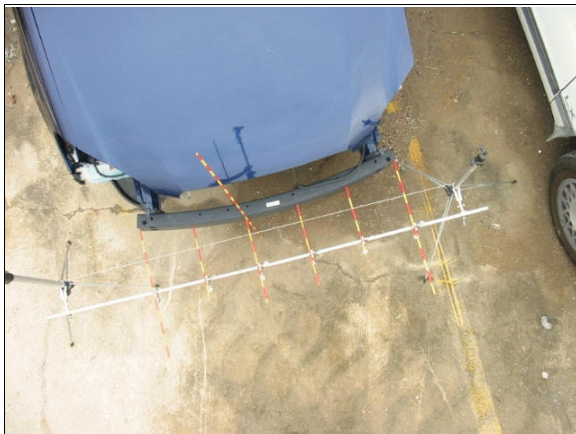
Figure 8: Overhead view of case vehicle crush profile with contour gauge present (case photo #13)

Based on the vehicle inspection, the CDCs for the case vehicle were determined to be: **12-FLEE-4 (0 degrees)**–for the light pole impact (2nd event), and **12-FLWN-3 (0 degrees)**–for the curb impact (1st event). The WinSMASH reconstruction program, damage only algorithm was used on the case vehicle's highest severity impact with the light pole. The preliminary Total, Longitudinal, and Lateral Delta Vs are, respectively: 13.0 km.p.h. (8.1 m.p.h.), -13.0 km.p.h. (-8.1 m.p.h.), and 0.0 km.p.h. (0.0 m.p.h.). It should be noted that the light pole impacted by the case vehicle was sheared off by the case vehicle's left front wheel assembly. For this reason, the WinSMASH barrier results should be considered borderline and represent the uppermost limit of a delta V for this crash. However, based on this contractor's experience, the results appear reasonable.

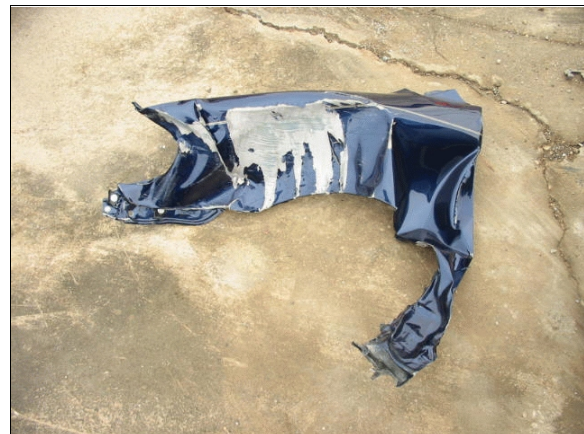
Figure 9: Case vehicle's left fender torn-off during impact with light pole; Note: slot for left headlight is towards left of photo (case photo #18)

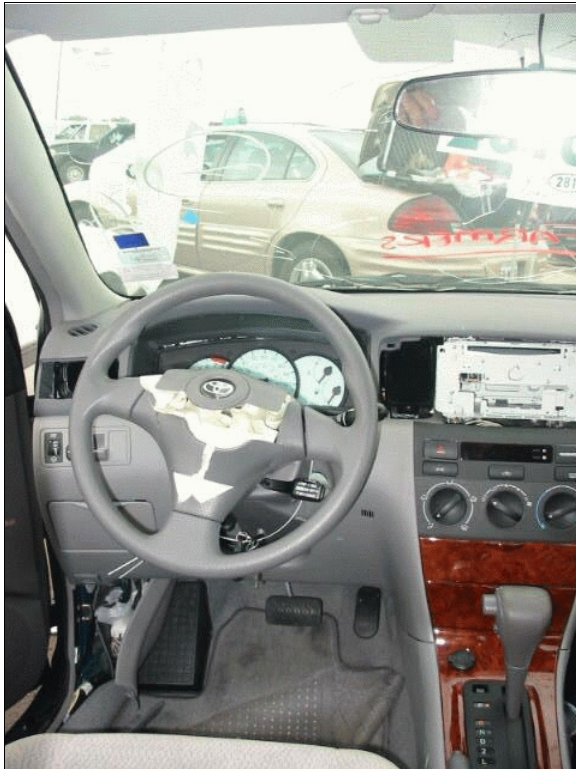
Figure 10: Vertical view of case vehicle's driver seating area showing residual of deployed driver air bag absence of obvious occupant contact evidence (case photo #33)

Inspection of the case vehicle's interior revealed that there was no other evidence of occupant contact on the interior surfaces of the case vehicle (**Figures 10** and **11**). However, the right windshield's glazing was cracked but this was attributed to contact by the deploying front right passenger air bag's fabric. Furthermore, there was no evidence of intrusion to the case vehicle's interior, no evidence of compression to the energy absorbing shear capsules in the steering column, and no deformation to the steering wheel rim (**Figure 12**).

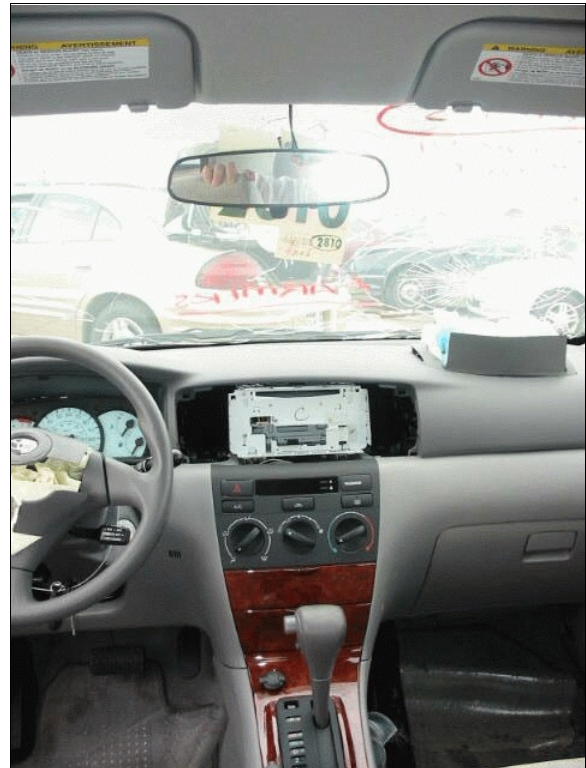
Figure 11: Vertical view of case vehicle's front seating and greenhouse areas showing absence of obvious occupant contact evidence and cracked right windshield's glazing—cracked from contact by front right air bag's fabric (case photo #34)

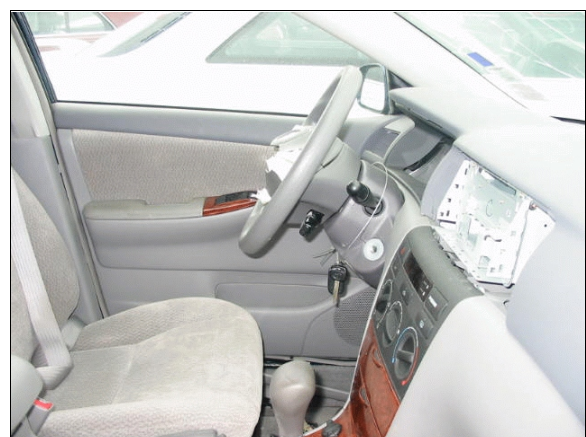
Figure 12: Case vehicle's undeformed steering wheel viewed from right and left "A"-pillar and side interior surfaces without occupant contact evidence (case photo #37)

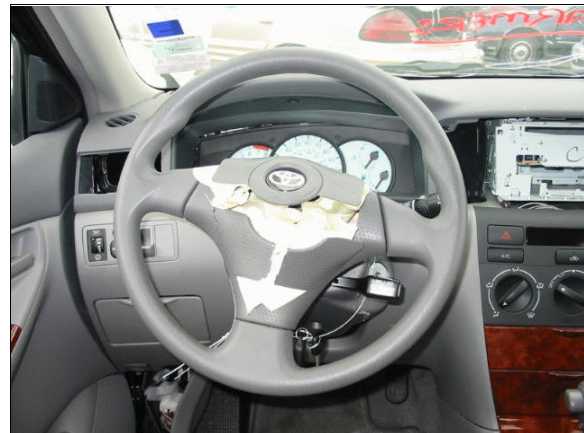
The case vehicle was equipped with a Supplemental Restraint System (SRS) that contained advanced frontal air bags at the driver and front right passenger positions. Both frontal air bags deployed as a result of the frontal impact with the traffic light pole (2nd event). The case vehicle's driver air bag was located in the steering wheel hub. The module cover consisted of an inverted, triangular, curvilinear-shaped cover that contained three asymmetrical flaps made of thick vinyl. The top and largest flap was somewhat semicircular in design while the left and right lower flaps were obliquely oriented. The top cover flap had overall dimensions of 16 centimeters (6.3 inches) horizontally and 9 centimeters (3.5 inches) vertically at its widest point. The two bottom flaps were mirror imaged and each measured 8 centimeters (3.1 inches) horizontally to the hub and had an overall height of 8 centimeters (3.1 inches) vertically. An inspection of the air bag module's cover flaps and the air bag's fabric revealed that the cover flaps opened at the designated tear points, and there was no evidence of damage during the deployment to the cover flaps (**Figure 13**). Because the air bag's fabric was cut away from the module/wheel hub (**Figure 14**), the existence, number, and size of tethers or vent ports could not be assessed nor could the shape or size of the driver's air bag be described. The Police Crash Report made no mention of any evidence of contact or damage to the air bag's fabric.

Figure 13: Case vehicle's steering wheel showing deployed driver air bag module's cover flaps and residual of cutout air bag's fabric (case photo #39)

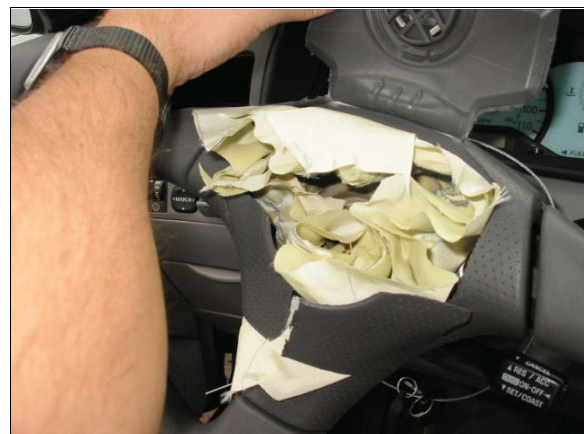
Figure 14: Interior of case vehicle's driver air bag module showing residual of cutout air bag (case photo #42)

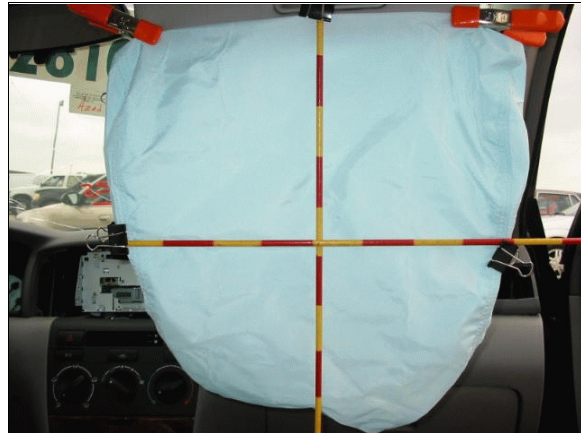
thick vinyl with overall dimensions of 20.5 centimeters (8.1 inches) at the horizontal seam and 6 centimeters (2.4 inches) vertically for both the upper and lower flaps. The profile of the case vehicle's instrument panel resulted in a 13 centimeter (5.1 inch) setback of the leading edge of the cover flap relative to the protruding right instrument panel. An inspection of the front right air bag module's cover flaps and the air bag's fabric revealed that the cover flaps opened at the designated tear points, and there was no evidence of damage during the deployment to the air bag or the cover flaps. The front right passenger's air bag was designed with without any tethers. The front right air bag had two vent ports, approximately 5.5 centimeters (2.2 inches) in diameter, located at the 10:30 and 2:30 o'clock positions. The deployed front right air bag was rectangular with a height of approximately 45 centimeters (17.7 inches) and a width of approximately 42 centimeters (16.5 inches). An inspection of the front right air bag's fabric revealed no contact evidence readily apparent on the air bag's fabric (**Figure 15**). Furthermore, there was no right front occupant, and there is no indication or evidence that driver contacted the front right air bag.

Figure 15: Case vehicle's deployed front right passenger air bag showing no occupant contact evidence (case photo #43)

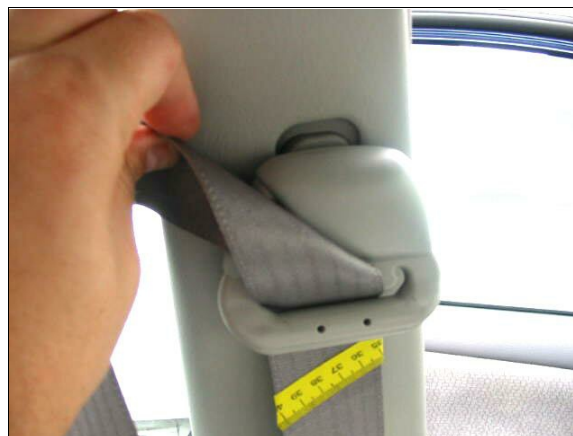
The case vehicle's driver was restrained by his available, active, three-point, lap-and-shoulder, safety belt system; the belt system was equipped with a retractor-mounted pretensioner. Furthermore, the inspection of the driver's seat belt webbing, "D"-ring, and latch plate revealed that the pretensioner had actuated, and the webbing was not retractable into the "B"-pillar, indicating it was in use at the time of the crash. In addition, there was trace evidence of loading on webbing near the "D"-ring (**Figure 16** below).

Figure 16: Case vehicle's driver "D"-ring and webbing showing trace evidence of usage on webbing (case photo #29)
