**VERIDIAN ON-SITE AIR BAG RELATED ADULT
DRIVER FATALITY INVESTIGATION**

VERIDIAN CASE NO. CA02-008

VEHICLE - 1998 FORD RANGER XLT

LOCATION - STATE OF ILLINOIS

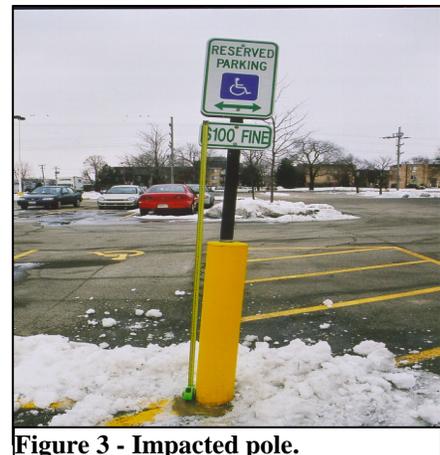
The front right area of the Ranger impacted the signpost concrete support base (**Figure 3**) which resulted in moderate damage. Impact speeds and velocity changes were computed utilizing the WinSMASH reconstruction program. The trajectory algorithm calculated a speed *at impact* of 38.1 km/h (23.7 mph), as the damage algorithm computed a barrier equivalent velocity change of 29.2 km/h (18.1 mph) with a matching negative longitudinal component. Impact resulted in deployment of the Ford's redesigned frontal air bag system. The

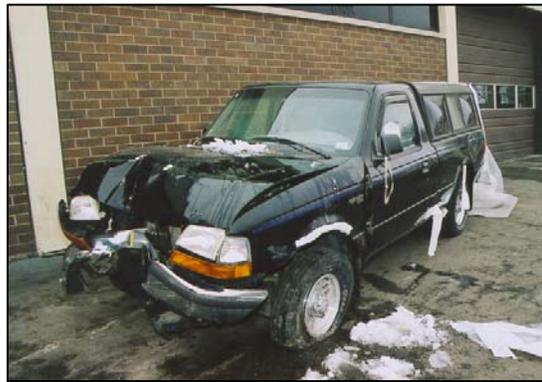
The 1998 Ford Ranger XLT sustained moderate frontal damage as a result of the impact with the signpost concrete support base (**Figures 4**). The direct contact damage began 58.0 cm (22.8 in) inboard of the front right bumper corner and extended left 17.0 cm (6.7 in). The impact deformed the entire front end width resulting in a combined direct and induced damage length (Field L) of 129 cm (50.8 in). Six crush measurements were documented at the level of the bumper: C1 = 0 cm, C2 = 4 cm (1.6 in), C3 = 17 cm (6.7 in), C4 = 41 cm (16.1 in), C5 = 17 cm (6.7 in), C6 = 4 cm (1.6 in). The Collision Deformation Classification (CDC) for this impact was 12-FCEN-2 with a principal direction

Figure 4 - Damaged 1998 Ford Ranger Pickup.

of force of 0 degrees. The hood was deformed up and rearward from engagement against the support base. The bumper corners were displaced inward due to the narrow contact damage. The right fender was deformed slightly rearward. The left front tire was deflated (not restricted) with abrading to the wheel noted which was attributed to post-crash damage. Pre-existing damage was noted along the right rear side surface. The windshield was fractured at the right lower A-pillar from exterior impact forces (only). No induced roof buckling or wheelbase reduction was identified.

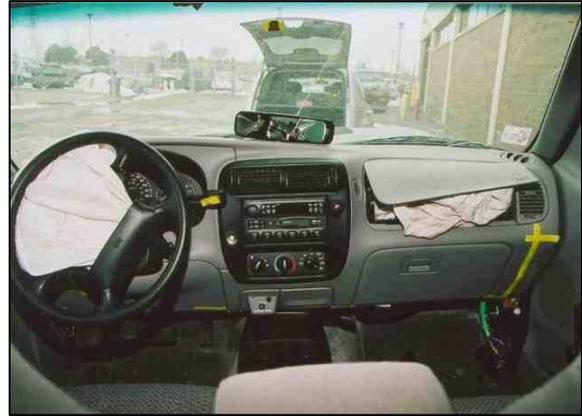
Interior damage to the Ford Ranger was moderate and was attributed to occupant contact. Scuff marks were documented on the left knee bolster along with a large indentation to the right knee bolster. Deep scratch marks were identified on the (column mounted) transmission selector lever. The rear view mirror was fractured and separated from the windshield. Abrasions and scrub marks were documented on the right sun visor (vanity mirror undamaged). Blood spattering was noted on the headliner adjacent to the left windshield header and right backlight header. Additional blood spattering was noted on the right B-pillar and backlight. No steering wheel rim deformation or column compression was identified; however, the steering mechanism was separated. No component intrusions were found in the vehicle. **Figure 5** is an overall view of the instrument panel.

Figure 5 - Overall view of the instrument panel.

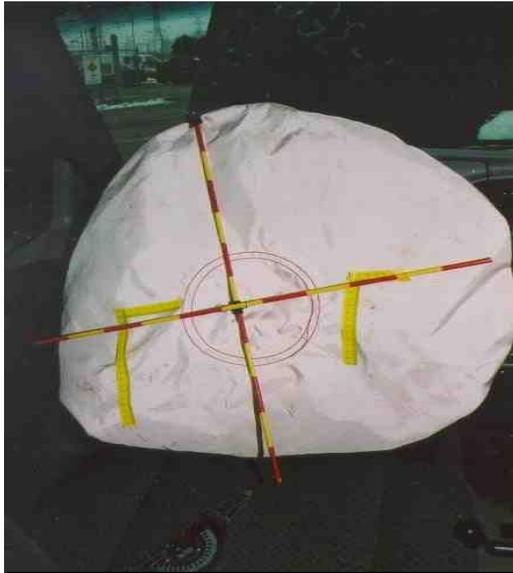
The 1998 Ford Ranger XLT was equipped with redesigned frontal air bags for the driver and front right passenger positions which deployed as a result of the crash (**Figures 6 and 7**). The driver air bag was housed in the center of the steering wheel with a horizontally oriented flap tear seam (H-configuration). The flaps were rectangular in shape as the upper flap measured 17.0 cm (6.7 in) in width and 6.5 cm (2.6 in) in height while the lower flap measured 17.0 cm (6.7 in) in width and 4.0 cm (1.6 in) in height. No contact evidence was identified on the exterior surface of the module cover flaps. The diameter of the driver air bag measured 63.3 cm (24.9 in) in its deflated state. The air bag

was tethered by two internal straps and vented by two 2.0 cm (0.8 in) ports located at the 11 o'clock and 1 o'clock sectors on the rear aspect of the air bag. Although heavily stained by dirt and mold from exposure to the environment post-crash, inspection of the driver air bag identified a light colored fabric transfer at the lower left quadrant and a dark colored fabric transfer at the mid-right section of the air bag face.

Figure 6 – Driver's air bag.

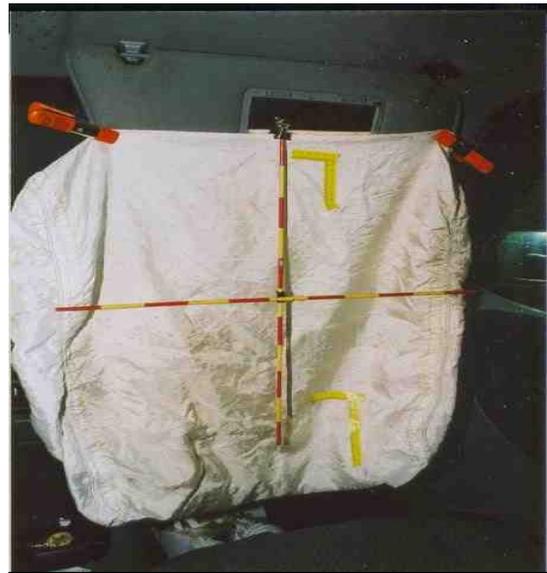
The front right passenger air bag was housed in the right mid-instrument panel area with a single cover flap design hinged at the top aspect. The flap was rectangular in shape and measured 37.0 cm (14.6 in) in width and 17.5 cm (6.9 in) in height. No contact evidence was identified on the exterior surface of the module cover flap. The passenger air bag measured 62.5 cm (24.6 in) in width and 72.5 cm (28.5 in) in height in its deflated state. No vent ports or internal tether straps were present. Also stained by dirt and mold post-crash, contact evidence consisted of a dark blue fabric transfer documented at the upper right quadrant and a light blue fabric transfer which began on the bottom right portion of the membrane and extended into the lower right quadrant of the air bag face. The vehicle was also equipped with a passenger air bag cutoff switch which was set to the air bag "on" position.

Figure 7 - Passenger's air bag.
