Advanced Occupant Protection Investigation / Vehicle to Vehicle
Dynamic Science, Inc. / Case Number: DS02009
2002 Ford Taurus SE Four-door Sedan
California
May, 2002

**Dynamic Science, Inc.
Crash Investigation
Case Number: DS02009**

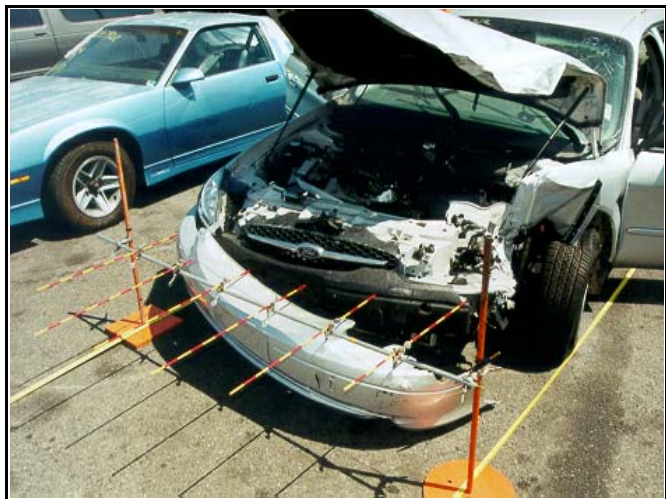
Damage Description:	Moderate frontal damage with a maximum crush of 19.0 cm (7.5 in) at C1. There was direct and induced damage across the entire front bumper, grille, and radiator. There was 41.0 cm (16.1 in) of direct damage that began at the front left bumper corner and extended laterally to the right across the bumper fascia. There was also damage to the left front fender that extended rearward from the front left bumper corner.		
CDC:	12FLEE3		
Delta V:	Total	25.0 km/h (15.5 mph)	
	Longitudinal	-25.0 km/h (-15.5 mph)	
	Lateral	4.0 km/h (1.6 mph)	
	Energy	21429 joules (15805 ft-lbs)

The case vehicle sustained 133.0 cm (52.4 in) of direct and induced contact damage that began at the front left bumper corner and extended across the entire frontal end width of the vehicle. The impact energy was managed by the forward structures of the vehicle. The damaged components included the bumper fascia and reinforcement bar, upper and lower radiator supports, the grille area, the hood, the left front fender, and the windshield was cracked by the deployment of the front right passenger's air bag and hood. Six crush measurements were documented at the bumper back bar level: C1= 19.0 cm (7.5 in), C2= 15.0 cm (5.9 in), C3= 11.0 cm (4.3 in), C4= 8.0 cm (3.1 in), C5= 0.0 cm (0.0 in), C6= 0.0 cm (0.0 in). A Collision Deformation Classification of 12FLEE3 was assigned to the damage. The principal direction of force was within the 12 o'clock sector and was an estimated 350 degrees. There was a 9.0 cm (3.5 in) reduction of the left side wheelbase, and an elongation of 6.0 cm (2.4 in) of the right side wheelbase. All doors remained closed and operational. The case vehicle was towed from the scene due to damage.

Figure 2. Exterior damage to case vehicle.

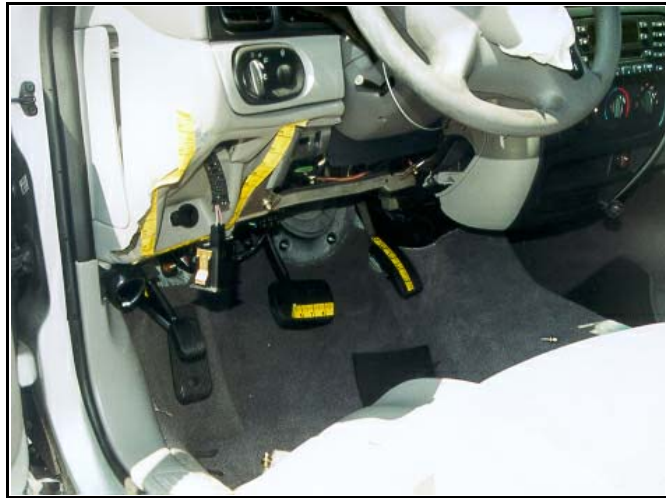
Interior damage to the 2002 Ford Taurus was moderate and attributed to occupant contact, passenger compartment intrusion and the deployment of both frontal air bags. The left instrument panel was cracked and displaced by the left knee of the driver. Both the brake and gas pedals had been displaced laterally to the right by contact with the driver's feet. The toe pan had intruded longitudinally 4.0 cm (1.6 in). The shear capsules had been displaced 1.5 cm (0.6 in) on the left side and 1.0 cm (0.4 in) on the right side by the driver loading the steering column.

Figure 3. Damage to instrument panel.

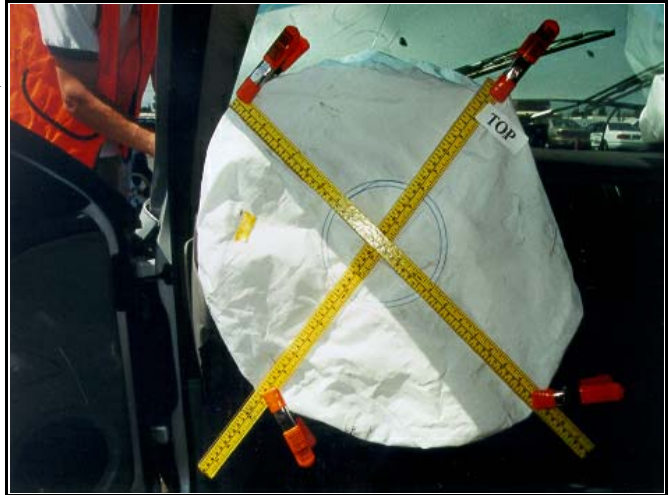
The driver's air bag was circular and measured 50.0 cm (19.7 in) in diameter in its deflated state. It was equipped with two tethers and two vent ports at the 1 and 11 o'clock positions. On the top right and left quadrants of the face of the air bag were black transfer marks that appeared to be from the module cover. There was a spot on the lower left quadrant that appeared to be

Figure 4. Driver's air bag.

blood. There was also grease on the lower aspect of the air bag. The dual module covers opened in an "H" tear configuration. There were no indications of any damage to driver's air bag or the module covers. The driver's air bag had a maximum excursion of 30.0 cm (11.8 in) in its post deflated state.

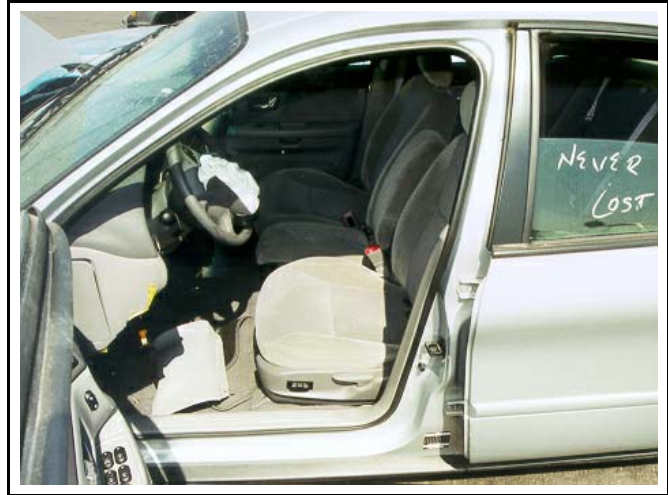
Figure 5. Driver's area

left. He struck the left instrument panel with his left knee . It was also noted during the vehicle inspection that both the gas and the brake pedals were displaced laterally to the right, but no apparent injuries were sustained as a result of this contact. The driver came into contact with the air bag during its initial deployment, there was also a small blood stain located on the left lower quadrant of the air bag fabric and he sustained an abrasion to his left cheek and left temple as a result of contacting the driver's air bag. The driver loaded the steering wheel and sustained a comminuted fracture to right mid-clavicle as a result of striking the steering wheel rim. He was initially treated at the scene by fire emergency rescue personnel and was unresponsive. He was extricated from the vehicle and transported to a trauma center. The driver was treated in the emergency room and later was admitted to the hospital. He was released the next day at 1330 hours.
