**ADVANCED OCCUPANT PROTECTION SYSTEM INVESTIGATION**

**VERIDIAN CASE NO: CA02-013**

**VEHICLE: 2002 AUDI ALLROAD QUATTRO**

**CRASH DATE: APRIL 2002**

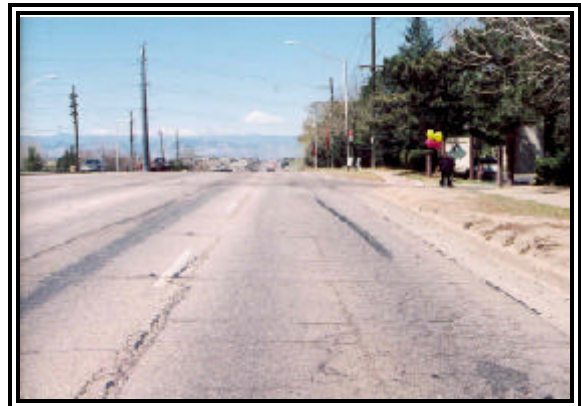
**Figure 1:** Westbound trajectory view.

The 2002 Audi Allroad Quattro was driven by a 37 year old restrained male. The driver's estimated height and weight were 183 cm (72 in) and 100 kg (220 lb). He was the Audi's sole occupant. The Audi was westbound in the outboard lane of the road at a police reported speed of 113 km/h (70 mph). An off-duty police officer, traveling behind and in pursuit of the Audi, provided the speed estimate to the police investigation. The Dodge Neon was exiting south out of the apartment complex on the Audi's right, via its private driveway. The Dodge was occupied by a 21 year old unrestrained male driver and a 19 year old unrestrained male front right passenger. It was the intension of the driver to turn left and travel eastbound. The trailing off-duty officer reported the Audi's brake light came on immediately prior to impact. A 1 m (3 ft) skid mark attributed to the left front tire of the Audi and a gouge mark adjacent to the tire mark identified the point of impact. It should be noted that the long tire mark depicted in Figure 1 was not related to this crash.

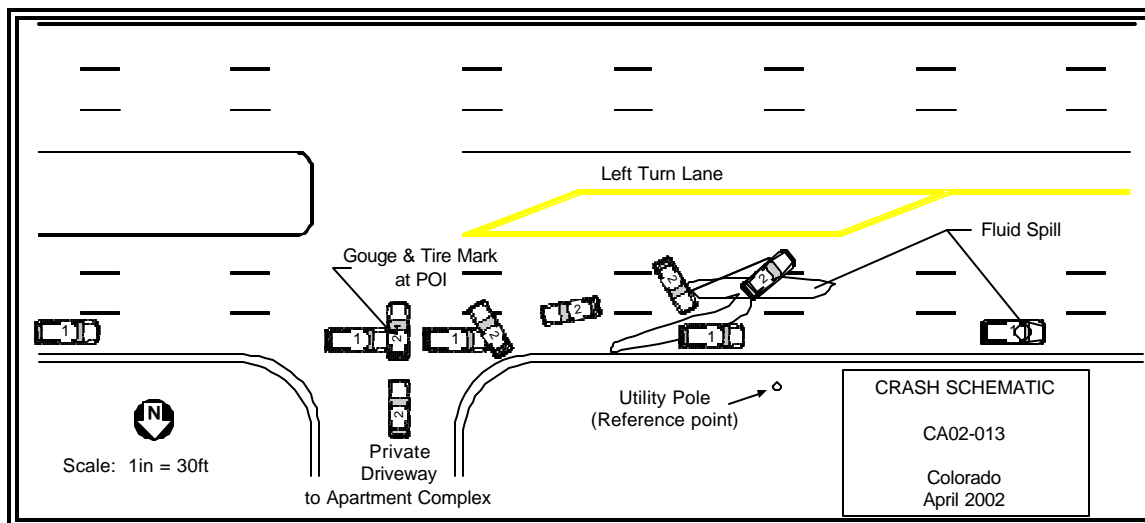
Upon impact, the Audi's driver's seat belt retractor pretensioner fired and the front right passenger air bag deployed. The total velocity changes (delta Vs) calculated by the Damage algorithm of the WINSMASH model were 35.3 km/h (21.9 mph) and 52.8 km/h (32.8 mph) for the Audi and Dodge, respectively. The impact speeds for the Audi and Dodge calculated by a Conservation of Momentum analysis were 87 km/h (54 mph) and 10 km/h (6 mph), respectively. **Figure 2** is a schematic of the crash.

**Figure 2:** Crash schematic.

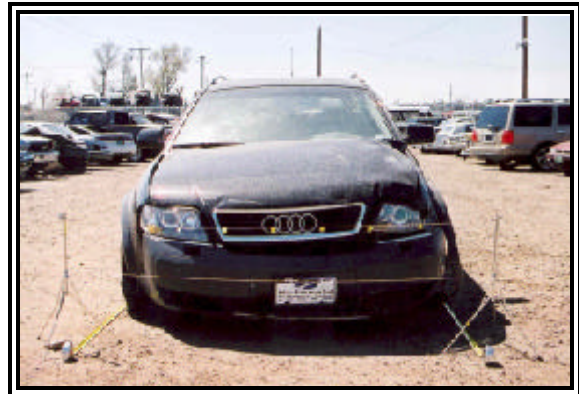
**Figure 3:** Front view of the Audi A6.

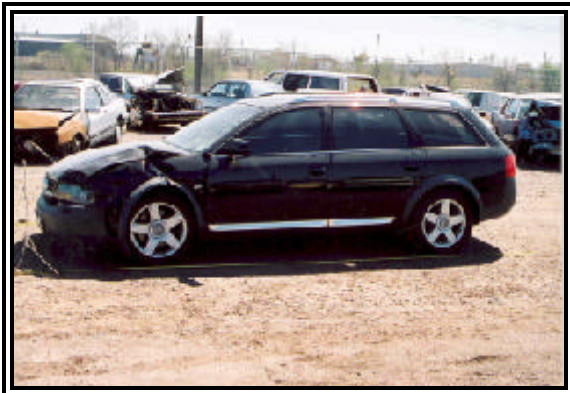
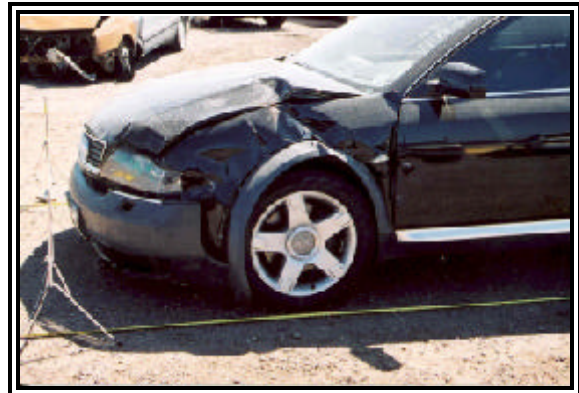
**Figures 4 and 5** are the left side and left lateral views of the Audi All Road. The direct contact damage pattern to the frontal plane extended across the entire 137 cm (54 in) end width of the vehicle. The impact damage was managed by the vehicle's bumper system and the forward portion of the sub-frame. The damage pattern was biased to the left indicative of the right-to-left lateral direction of the Dodge. The hood and left front fender were buckled. Surface abrasions on the Audi's hood, indicative of direct contact to the Dodge, extended longitudinally rearward 84 cm (33 in) from the front of the vehicle. The location of these abrasions was an indicator of the Audi's maximum penetration into the left side of the Dodge. The frontal damage wrapped around the left front corner and extended along the left front fender to the forward aspect of the left front door. This contact pattern measured 89 cm (35 in) and was consistent with the post-impact counterclockwise rotation and separation of the Dodge. White transfers were identified within the contact pattern and were linked to the fiberglass repair of the left front fender of the Dodge. All four doors and the rear hatch remained operational and there was no damage to the side glazings. The left

wheelbase was foreshortened 4.8 cm (1.9 in). The right wheelbase was unchanged. The right front tire was punctured and had aired out. The crush profile measured at the bumper elevation was as follows: C1 = 14.7 cm (5.8 in), C2 = 10.2 cm (4.0 in), C3 = 11.4 cm (4.5 in), C4 = 9.1 cm (3.6 in), C5 = 2.5 cm (1.0 in), C6 = 0. The Collision Deformation Classification was 12-FDEW-1.

Figure 4: Left side view of the Audi.

Figure 5: Left lateral view.

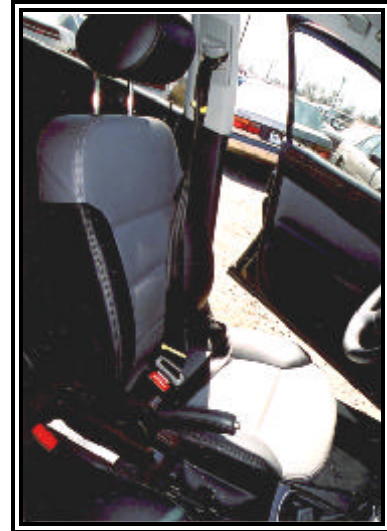
Each seat position was equipped with a manual 3-point lap and shoulder belt system with retractor-pretensioners. The retractors were designed with a force limiting feature. The driver's restraint was stowed within the retractor and the retractor was operational upon initial inspection. Examination of the latch plate revealed minimal historical usage evidence, however, this was consistent with the age of the vehicle. Examination of the friction surfaces of the latch plate hardware revealed a full width abrasion to the plastic surface. A corresponding abrasion to the lap portion of the webbing was identified by extending the webbing into a simulated buckled condition, **Figure 6**. The abraded webbing measured 13 cm (5 in) in length and began 69 cm (27 in) above the outboard anchor, **Figure 7**. A 8 cm (3 in) abrasion from D-ring contact was identified on the shoulder section of the webbing, **Figure 8**. This transfer began 160 cm (63 in) above the outboard anchor. Although the retractor was operational at inspection, it was probable that the retractor-pretensioner fired during the crash, considering the operating logic of the AOPS system. The retractor had subsequently relaxed over time. It was not possible to disassemble the restraint system at the time of the inspection.

**Figure 6:** Driver's restraint.

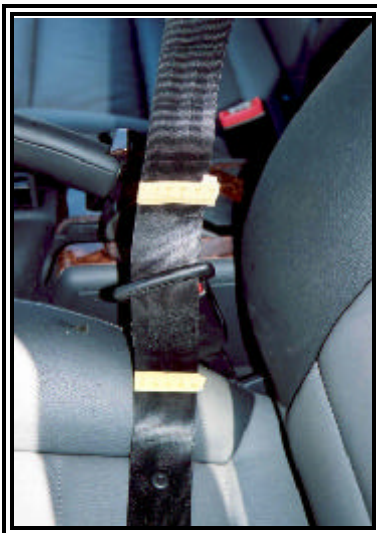
**Figure 7:** Webbing abrasion at the latch plate.

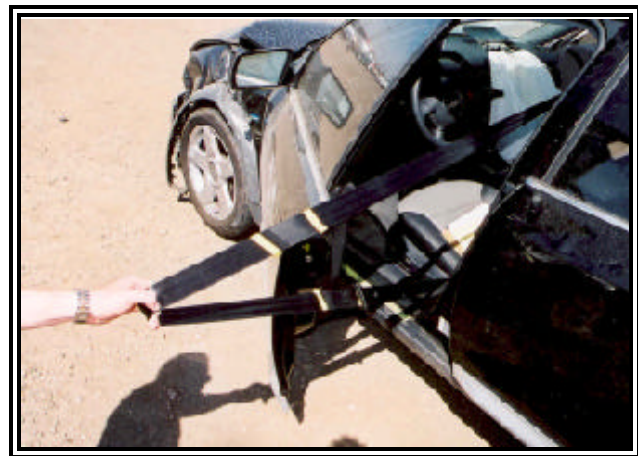
**Figure 8:** View of the webbing abrasions.

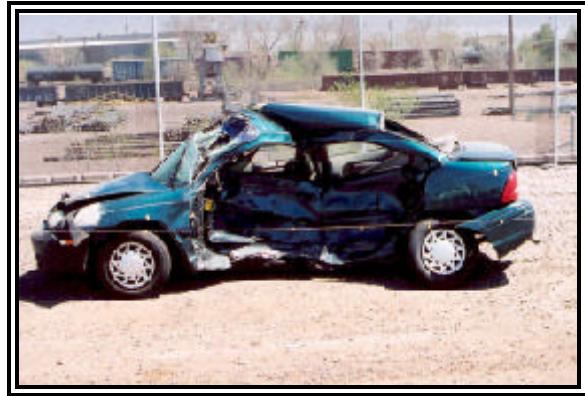
**Figure 9** is a left side view of the Dodge. The vehicle sustained 190 cm (75 in) of direct contact damage that began at the hinge pillar of the left front door and extended to trailing edge of the left rear door. The Audi's direct contact was centered on the left B-pillar. An imprint of the Audi's license plate was identified on the Neon's sheet metal at that location. The combined length of the direct and induced damage measured 281 cm (110.5 in). The induced damage began on the left rear quarterpanel 41.9 cm (16.5 in) aft of the left front axle and extended forward onto the left front fender 17.8 cm (7.0 in) aft of the left front axle. The roof buckled downward due to the B-pillar intrusion. The left wheelbase was reduced 16.3 cm (6.4 in) due to bending of the unibody structure. The right wheelbase was unchanged. The right front door opened from occupant loading. The right rear door was operational.

**Figure 9:** Left side view of the Dodge.

The vehicle's crush profile measured at the mid-door level (Field L = 281 cm) was as follows: C1 = 0, C2 = 20 cm (8 in), C3 = 77 cm (30 in), C4 = 93 cm (37 in), C5 = 70 cm (28 in), C6 = 0. It was noted during the inspection that the left front door hinge failed by overload. The structural failure overstated the residual crush at the trim elevation. Therefore, the crush profile was also documented along the sill (Field L= 137 cm). The damage profile at that elevation was: C1 = 58 cm (23 in), C2 = 66 cm (26 in), C3 = 61 cm (24 in), C4 = 50 cm (20 in). Initially, an average of the measured profiles was used to analyze the crash. The averaged profile used in the analysis was as follows: C1 = 0, C2 = 39 cm (15 in), C3 = 77 cm (30 in), C4 = 77 cm (30 in), C5 = 60 cm (24 in), C6 = 0. However as previously discussed, the use of the averaged crush profile over-estimated the severity of the crash. A more representative delta V was calculated using the crush profile measured along the sill. Using that profile, the Damage Algorithm of the WINSMASH model determined the total velocity change of the Dodge was 52.8 km/h (32.8 mph). The longitudinal and lateral delta V components were -9.2 km/h (-5.7 mph) and -52.0 km/h (-32.2 mph), respectively. The Collision Deformation Classification (CDC) was 09-LPEW-6.

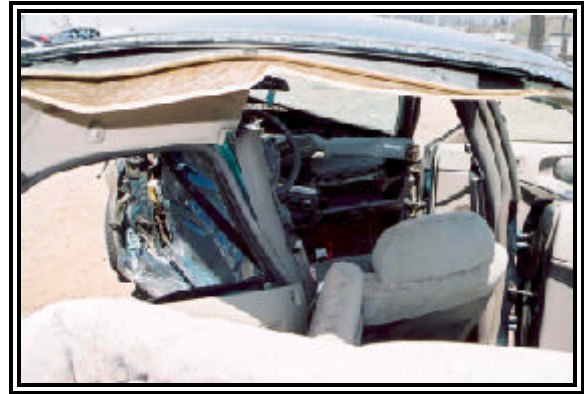
The left side intrusion reduced the interior space within the vehicle by approximately 50 percent. Refer to **Figure 10**. The left B-pillar overrode the driver's seat cushion and rotated the seat back

counterclockwise. The post-impact location of the B-pillar was at the center console. The lateral distance from the deformed pillar to the right B-pillar measured 67.8 cm (26.7 in). The intrusion of the forward aspect of the left front door impacted and deformed the steering wheel rim. The tilt mechanism was fractured and the steering wheel shifted to the right. The horizontal distance between the steering wheel center line and the right corner of the instrument panel was 74 cm (29 in).

**Figure 10:** Rear view depicting the intrusion.
