On-Site Child Safety Seat Investigation / Vehicle Rollover
Dynamic Science, Inc. / Case Number: DS02013
1999 Chevrolet Blazer
Colorado
July, 2002

1. Report No. DS02013	2. Government Accession No.		3. Recipient Catalog No.	
4. Title and Subtitle On Site Child Safety Seat Investigation			5. Report Date January 17, 2006

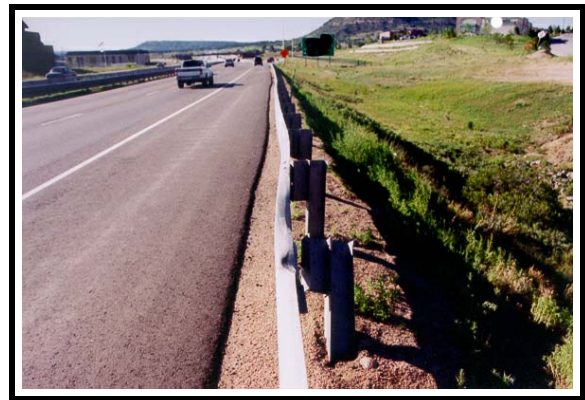
The case vehicle swerved from the right lane into the left lane. The driver then overcorrected to the right. The vehicle rotated clockwise, rolled over eight quarter turns as it headed towards the right shoulder area. The vehicle struck the metal guardrail with its left front (see Figure 3); there was minor damage to the top part of the guardrail. Witnesses indicated that during the rollover on the right shoulder area the driver was ejected out of the driver's window. The driver was found laying on the right shoulder area approximately 1.8 meters (6 ft) west of the guardrail. The vehicle continued in a clockwise yaw and rolled over three quarter turns, vaulted upward and the vehicle's rear left door struck the top backside of the guardrail. After striking the guardrail, the case vehicle then traveled down a 63% grade embankment rolling ten quarter turns. Both the front right and 2nd row right occupants were fully ejected. The vehicle traveled 24.4 meters (80 ft) down the embankment and came to final rest on top of a concrete drainage ditch facing south on all four wheels.

Figure 3. Left side of case vehicle impact top-back side of guardrail and rollover embankment.

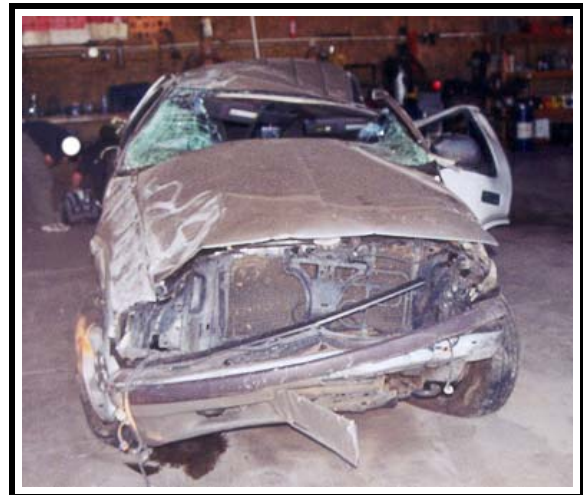
The case vehicle sustained major rollover type damage about the entire vehicle. Three of the four doors were jammed shut. All the glazing, with the exception of the driver's window (it was rolled down) disintegrated. There was significant intrusion to the vehicle's passenger

compartment; mainly the roof intruding into the driver's area. The vehicle is equipped with driver and front right passenger air bags which did not deploy. The vehicle was towed from the scene due to damage and was being held by the police.

Figure 5. Damage to case vehicle.

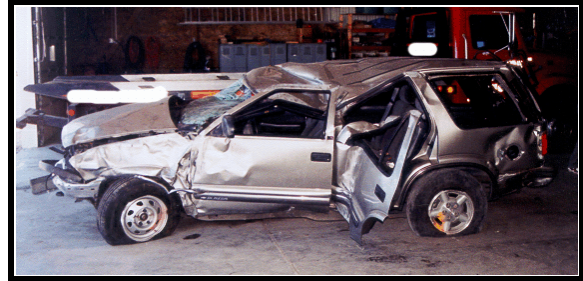
The Chevrolet Blazer sustained major damage all over the vehicle due to the rollover and contacts to the guardrail. Three of the four doors were jammed shut. All the glazing, with the exception of the driver's window (it was rolled down) disintegrated. There was significant intrusion to the vehicle's passenger compartment; mainly the roof intruding into the driver's area. Both front tires were restricted. The left front, left rear and right rear tires were deflated. The rims on the two rear tires were cracked. The Collision Deformation Classification (CDC) for the rollover was 00TDD02. The CDC for the first guardrail impact was 00LPEW3. The CDC for the second guardrail impact was 00LPEW3.

Figure 6. Left side, Chevrolet Blazer

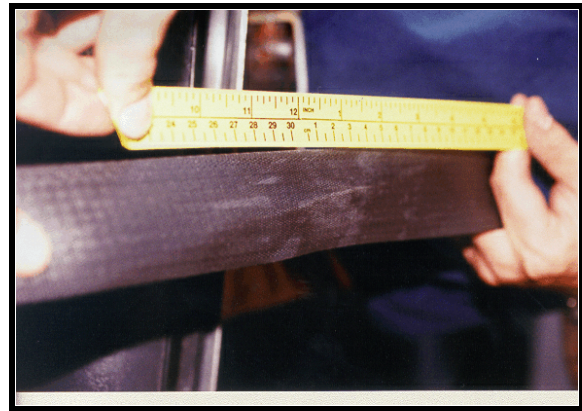
The lap belt in the 2nd row middle seat position was used to secure the child safety seat. The lap belt measured 135.0 cm (53.1 in). There were loading marks to the belt. The first measured 21.0 cm (8.3 in) along the webbing and began 23.0 cm (9.0 in) from the tip of the tang. The second measured 16.0 cm (6.3 in) along the webbing and began 50.0 cm (19.7 in) from the tip of the tang.

Figure 7. 2nd row middle seat belt webbing

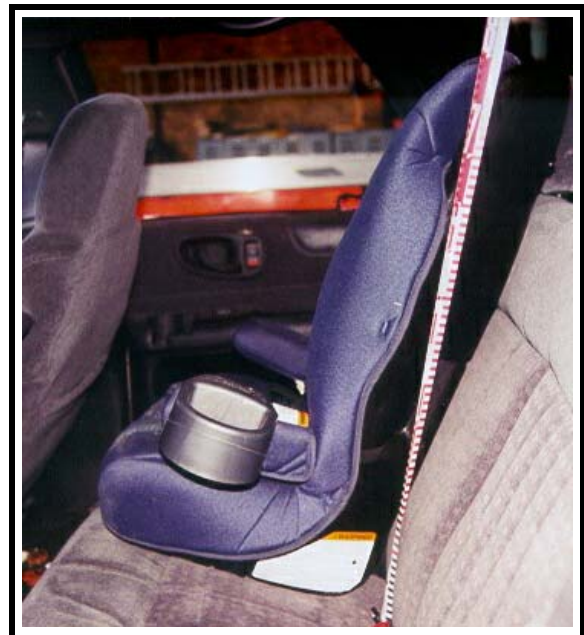
Figure 9. Child seat in case vehicle post impact.

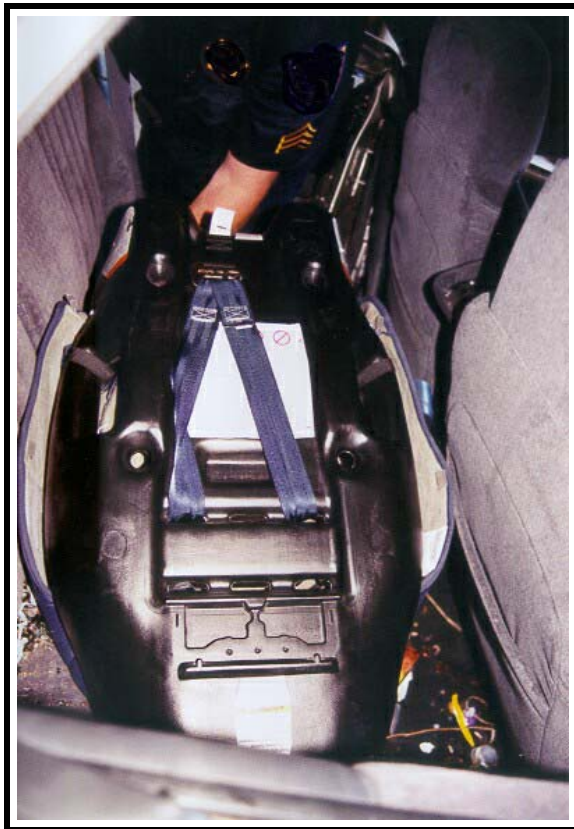
The police reported that the child seat was in a forward facing position and that the vehicle's lap belt was used and routed through the vehicle belt paths located on the sides and through the back of the child seat. The investigating officer indicated that emergency rescue personnel unbuckled the vehicle's lap belt from the child seat. The police officer was familiar with the child seat and indicated that the low position of the vehicle belt path on the sides of the child seat caused it to tip easily. Emergency rescue personnel reported finding the child seat tipped over to the right facing down on the 2nd seat. This investigator anchored the child seat using the vehicle's lap belt and was unable to position the child seat tipped over to the right facing down. The lap belt had to be released to position the child seat in this fashion.

Figure 10. Reported position of child seat at final rest.

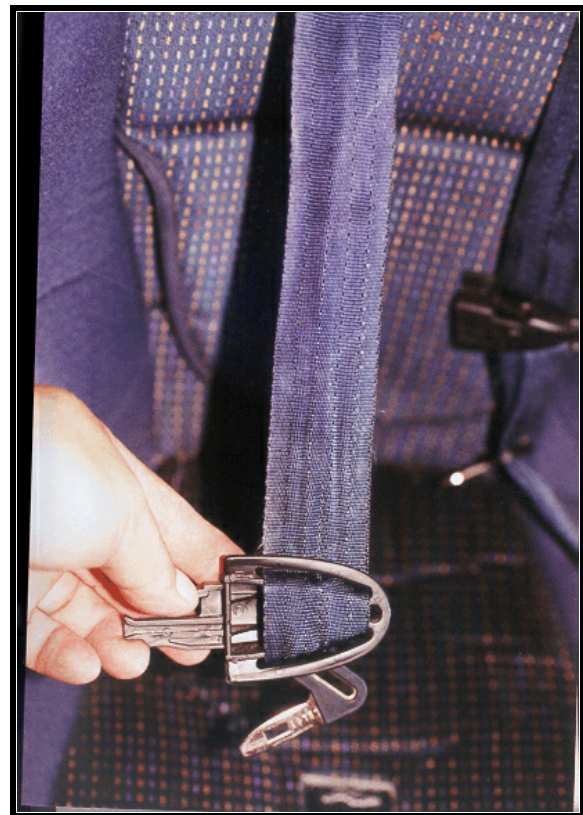
The child safety seat was inspected, but it had been removed from the vehicle prior to inspection. The 5-point harness appeared to operate properly and the latch locked into the buckle. The harness system was slotted through the bottom slot. The harness webbing showed usage and was abraded/scored (see Figure 11). The harness clip was very low. A tether was not present.

Figure 11. Loading marks to child safety seat harness
