**CALSPAN ON-SITE ADVANCED OCCUPANT PROTECTION SYSTEM
CRASH INVESTIGATION**

CASE NO: CA02-014

VEHICLE: 2001 BMW 325i

CRASH DATE: APRIL 2002

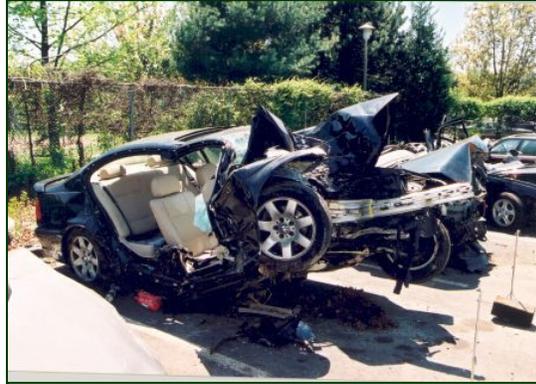
Figure 1. Front right view of the 2001 BMW 325i.

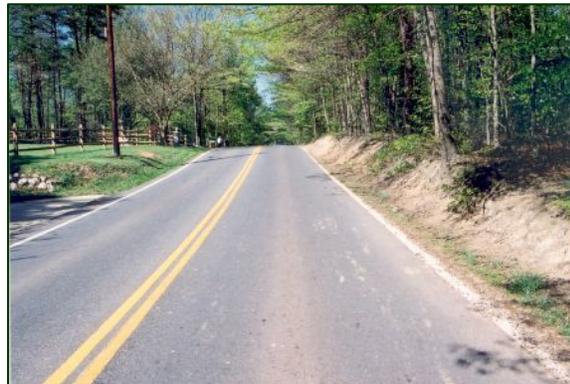
Figure 2. Overall view of the approach to the crash site.

shallow drainage ditches that were located immediately outboard of the travel lanes and earthen embankments with a mix of large and small diameter trees (**Figure 2**). The struck tree was a 42 cm (16.5”) diameter pine that was located 2.4 m (8’) off-road. The Crash Schematic is included as **Figure 11** of this narrative report.

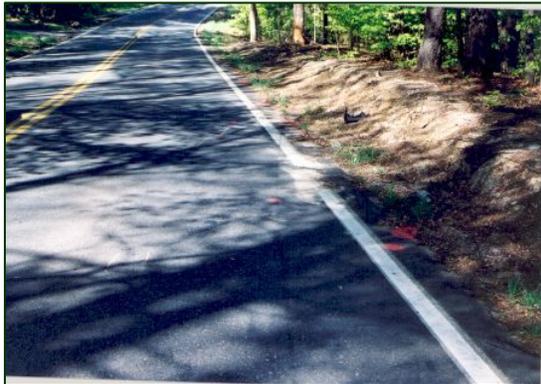
The front center and right area of the BMW impacted a 42 cm (16.5”) diameter pine tree

(**Figure 3**) that resulted in an impact force of 12 o'clock. The impact deformed the entire frontal area of the vehicle and crushed the front bumper to a depth of 124 cm (48.75"). The damage algorithm of the WinSMASH program computed a total velocity change of 88 km/h (55 mph) with longitudinal and lateral components of -88 km/h (-55 mph) and -16 km/h (-10 mph).

Figure 3. Roadside departure of the BMW.

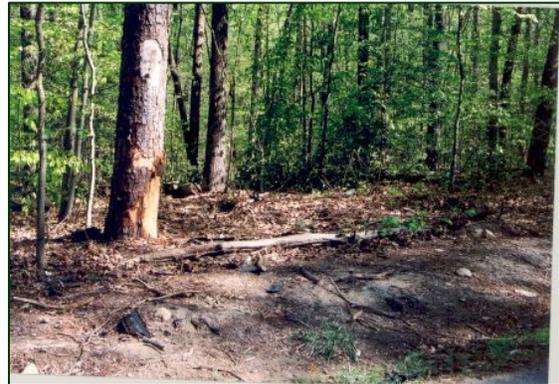
The BMW deflected off the tree and rebounded in a rearward direction while rotating in a counterclockwise direction. The vehicle rotated approximately 150 degrees counterclockwise coming to rest with its center of gravity 2.6 m (8') rearward of its at crash position and 3.4 m (11') laterally to the right (**Figure 4**). At rest, the vehicle was facing in a westerly direction, diagonal to its initial trajectory.

Figure 4. Struck tree and rotation to final rest.

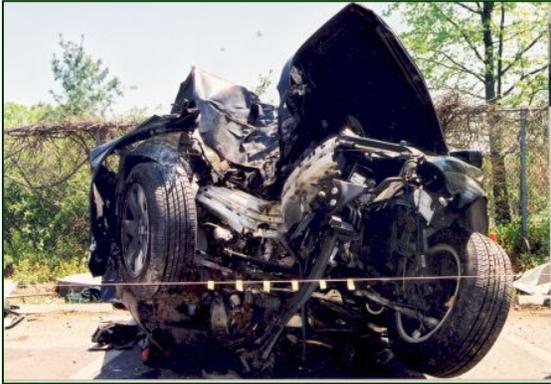
The BMW sustained severe frontal damage as a result of the impact with the tree. Maximum crush was 124 cm (48.75") located on the bumper beam 51.4 cm (20.25") right of center. The direct contact damage began at the centerline of the vehicle and extended 43 cm (17") to the right. The damage deformed the full frontal width of the vehicle and deformed the bumper beam to a U-shape. The Field L measurement of the combined direct and induced damage length was 42 cm (16.5") that spanned the corners of the

deformed bumper beam (**Figure 5**). A crush profile was measured along this damage with using six equidistant points and was as follows: C1 = 0 cm, C2 = 31 cm (12.25”), C3 = 122 cm (48”), C4 = 124 cm (48.75”), C5 = 122 cm (47.9”), C6 = 120 cm (47.4”). The Collision Deformation Classification (CDC) this tree impact was 32-FZEW-6. The 12 o’clock direction of force was incremented with a value of 20 to reflect the vertical displacement of the frontal structure (**Figure 6**).

Figure 5. Frontal view of the direct contact damage.

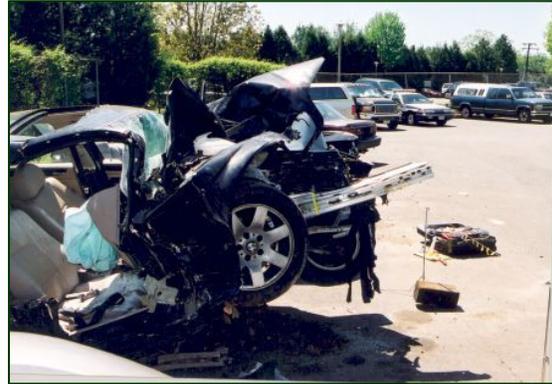
Figure 6. Lateral view documenting the extent of frontal crush. And vertical displacement.

As the frontal area of the vehicle crushed against the tree, the rear of the BMW pitched upward resulting in severe bending of the vehicle’s structure at the A- to B-pillar area. This upward deflection is reflected in the CDC noted above.

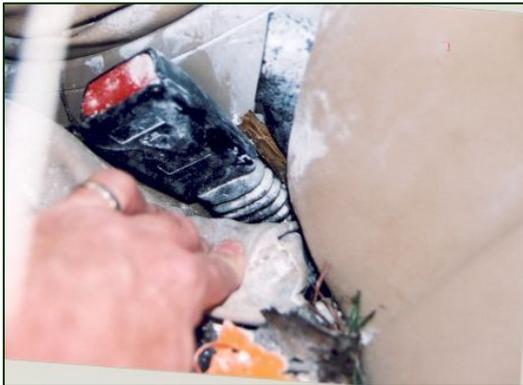
The BMW was equipped with manual 3-point lap and shoulder belts for the four outboard seated positions. All safety belt systems utilized continuous loop webbing and sliding latch plates and webbing sensitive retractors. The driver's retractor was an emergency locking (ELR) while the remaining three utilized switchable ELR/Automatic Locking Retractors (ALR). Both front buckles were equipped with pyrotechnic retractors. The driver's belt system was not utilized in this crash; therefore there was no related loading to the safety belt system or firing of the buckle pretensioner (**Figure 7**).

Figure 7. Non-fired driver's buckle pretensioner.

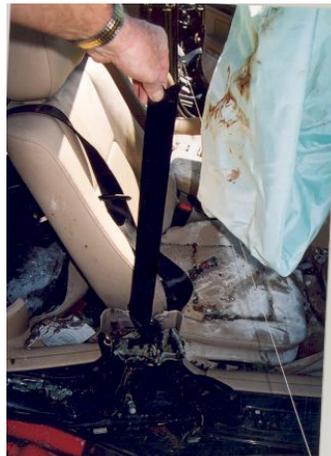
The front right belt system displayed loading evidence that consisted on a probable D-ring transfer on the webbing 38-42 cm (15-16.5”) above the stop button. The full width of the latch plate was abraded on the back side from frictional interaction with the belt webbing. Rescue personnel cut the shoulder belt webbing 57-58 cm (22.5-23”) above the floor anchor (**Figure 8**). The front right buckle pretensioner fired as a result of the impact.

Figure 8. Cut front right passenger's belt webbing.

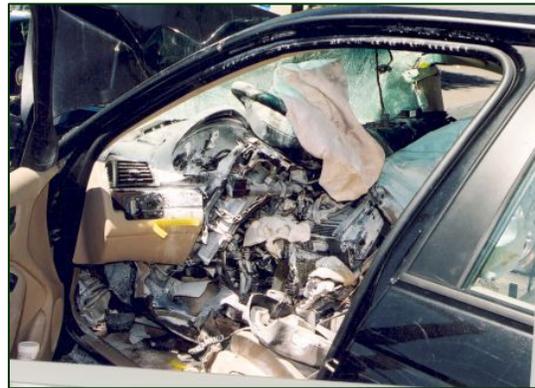
The driver's torso and face contacted the deployed driver's air bag. His loading force was transmitted through the air bag into the steering assembly. The lower steering wheel rim was deformed forward 1.9 cm (0.75"). The right steering column shear bracket was compressed 1 cm (0.5") while the left side remained fully engaged. Due to the severity of the crash and the upward motion of the rear of the vehicle at maximum engagement, the driver loaded through the deployed air bag and engaged the steering assembly, deflecting the column upward and forward to a measured

Figure 9. Driver trajectory and contact points.

column angle of 75 degrees, 50 degrees above the normal column angle. As result of the engaging the steering assembly, the driver sustained a chest wall contusion and a fracture of the left clavicle. Figure 9 is a view of the driver's trajectory and contact points.

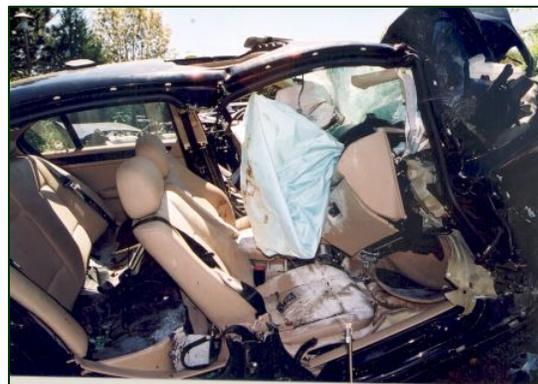
His knees and lower legs engaged the right instrument panel and the glove box door which resulted in lower leg injuries. He sustained a left ankle fracture from the intruding toe and floor pans (**Figure 10**). The front right passenger also sustained dicing lacerations of the face from flying glass that was captured in the deployed air bag. He rebounded into the front right position where he came to rest.

Figure 10. Lateral view of the front right passenger's position and the deployed air bag.
