Advanced Occupant Protection Investigation / Rollover
Dynamic Science, Inc. / Case Number: DS02014
2001 Volkswagen Jetta
Colorado
July, 2002

1. Report No. DS02014	2. Government Accession No.		3. Recipient Catalog No.	
4. Title and Subtitle Advanced Occupant Protection System Investigation			5. Report Date April 13, 2004

**Dynamic Science, Inc.
Crash Investigation
Case Number: DS02014**

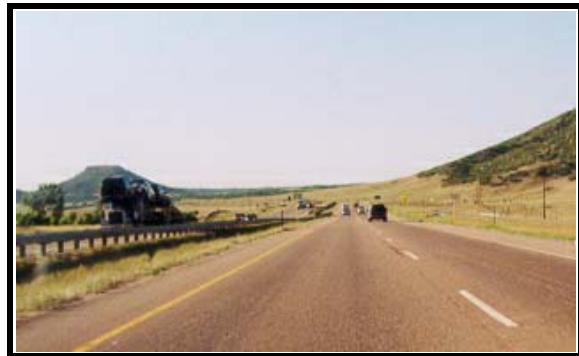
Figure 1. Overview of vehicle path (north)

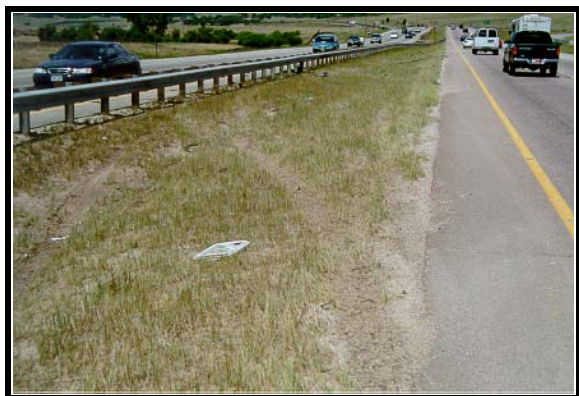
Figure 2. Vehicle path into guardrail (first event)

The driver of the Jetta lost control of the vehicle. The vehicle traveled off the left side of the roadway into the grass covered median and began a counterclockwise rotation. The vehicle left 28.7 m (94 ft) of furrowing in the median prior to striking the center median metal guardrail with its right side (04RDAW3). Given the height of the guardrail contact to the Jetta, this vehicle would have had to have been partially rolled over prior to impact. At impact, the front right passenger's side air bag and head impact air bag both deployed. The Jetta traveled backwards while engaged with the guardrail for 21.3 m (70 ft). The vehicle then began a counterclockwise rotation away from the guardrail. The vehicle rotated until the right side of the vehicle began leading. The vehicle tripped at this point and began to roll along its longitudinal axis. The vehicle rolled six quarter turns (00TZDO3). The top of the hood engaged the guardrail on the sixth turn (00TFDW6). The vehicle continued to roll two additional quarter turns before coming to rest on its wheels with its front end partially on the guardrail facing southwest. The distance between the separation from the initial guardrail impact and final rest was 58.2 m (191 ft).

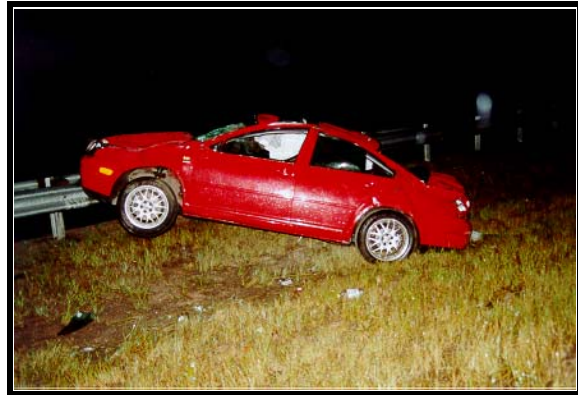
Figure 3. Case vehicle at final rest on top of guardrail

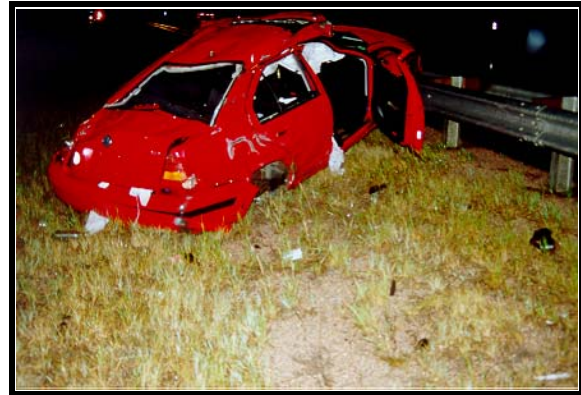
Figure 4. Case vehicle at final rest on top of guardrail; right side of vehicle

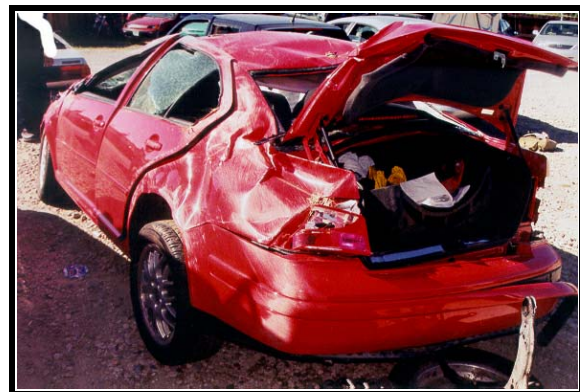
Damage Description: The Jetta sustained major damage about the entire vehicle. Both of the rear doors were jammed shut. The windshield was cracked and holed and all the remaining glazing disintegrated.

Figure 6. Left side, Volkswagen Jetta

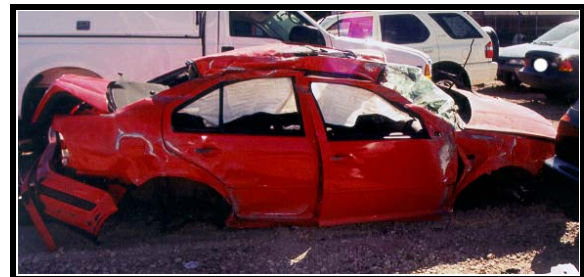
Figure 7. Right side, Volkswagen Jetta

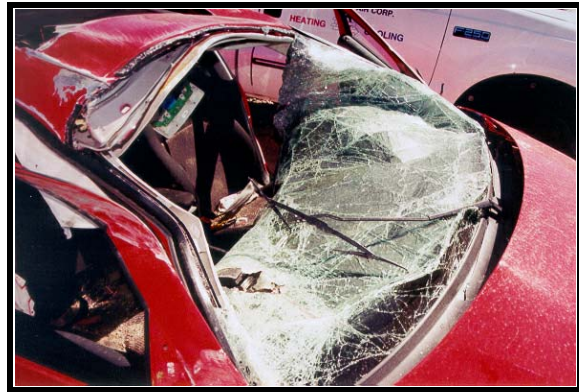
Interior damage to the 2001 Volkswagen Jetta was significant and attributed to occupant contact and passenger compartment intrusion. The entire windshield was fractured from impact forces. The right side of the windshield was holed. The side glass for all four doors was disintegrated from impact forces, as was the backlight and the roof glass. Both rear doors were jammed shut. There was lateral intrusion into the driver's and front right passenger's compartment area through the A/B pillars and window frames.

Figure 8. Windshield integrity loss

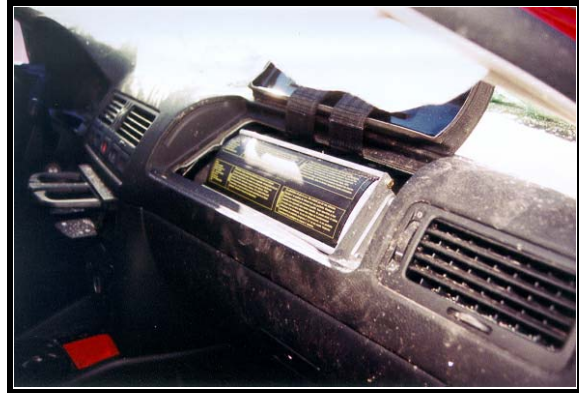
Figure 9. Displaced passenger's air bag module cover

The front air bags were of a dual-threshold design. The safety belts for the front seat positions have seat belt status sensors that indicate if the seat belts are latched or not. If they are latched, the front air bags will deploy at a slightly higher rate of deceleration than if the seat belt is not latched. The front air bags did not deploy. The air bag module cover on the front right passenger air bag was displaced during the crash.

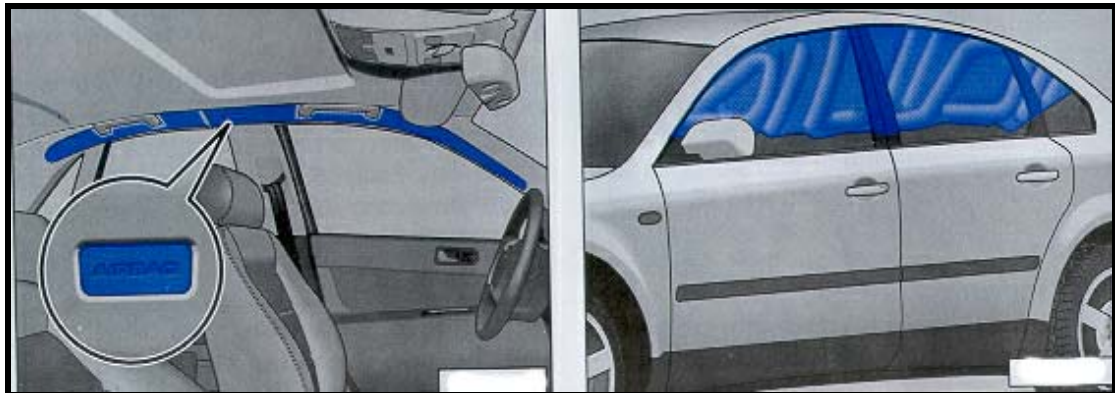
Figure 10. Overview of head impact air bag

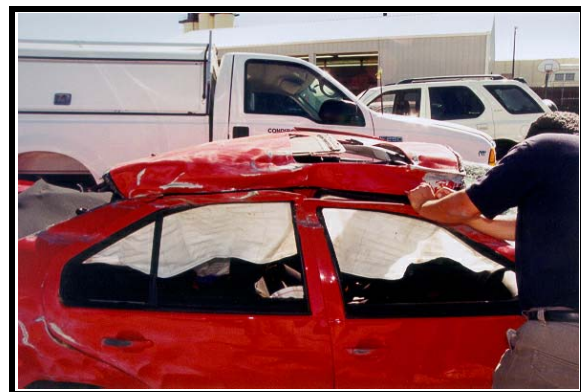
Figure 11. Exterior view of head air bag

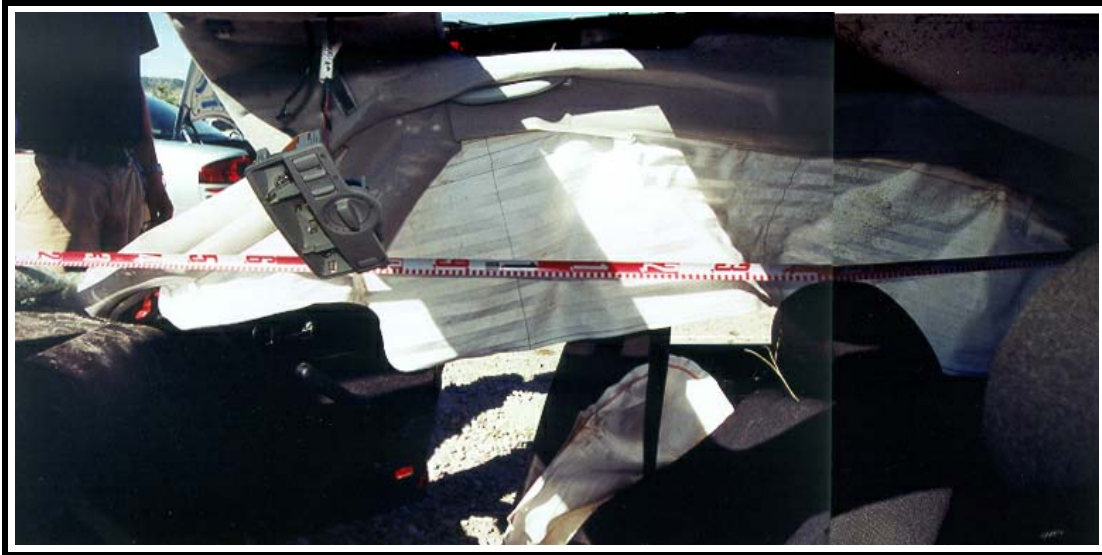
The front right passenger side air bag and the right side head air bag both deployed. The front right side air bag measured 19.0 cm (7.5 in) by 25.0 cm (9.8 in). It was housed within a plastic module. The side air bag was internally vented and was not tethered. There were red smears on the inner middle portion of the air bag that was possibly blood. The right side head air bag measured 38.0 cm (15.0 in) high by 174.0 cm (68.5 in) long. It was internally vented and was not tethered. There were no indications of occupant contact to the head air bag.

Figure 12. Right side head impact air bag deployed

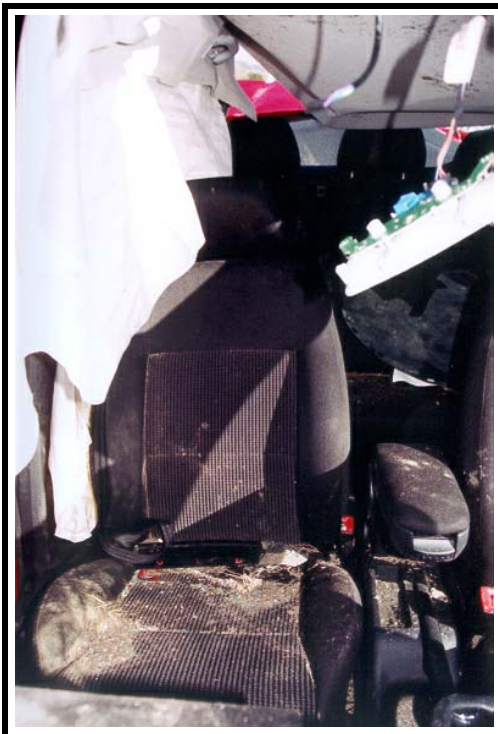
Figure 13. Front right-side air bag and head impact air bag activated

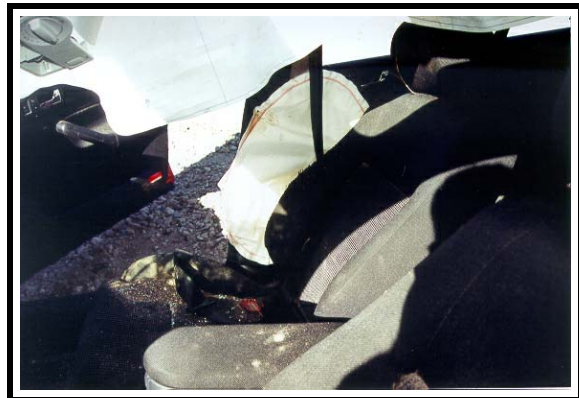
Figure 14. Front right side air bag

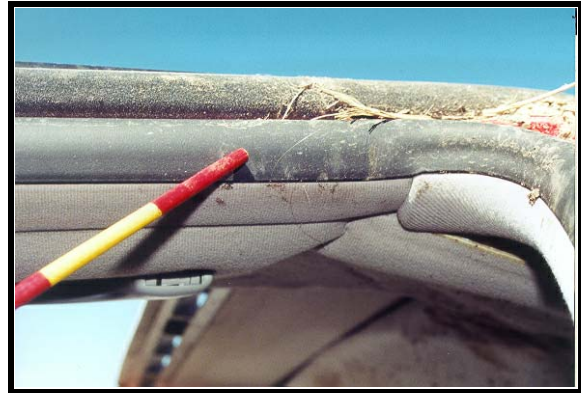
Figure 15. Hairs found on left upper window frame

This occupant was held in place by the seat belts but was experiencing loading to the right due to the spinning motion. At impact, she pitched sharply to the back right in response to the 4 o'clock direction of force. As the vehicle separated from the guardrail she would have experienced more lateral motion, first to the left where the left side of her head struck the window frame—causing a contusion, and then to right as the vehicle began to rollover. This occupant remained belted in place as the vehicle tripped and rolled eight quarter turns. She sustained multiple contusions and abrasions but the locations of the injuries are not known. She also sustained a wrist strain. This is likely connected to her efforts to hold onto steering wheel.
