ON-SITE REDESIGNED AIR BAG INVESTIGATION

CASE NUMBER - IN-02-015
LOCATION - Indiana
VEHICLE - 2000 SATURN SL2
CRASH DATE - November 2002

IN-02-015

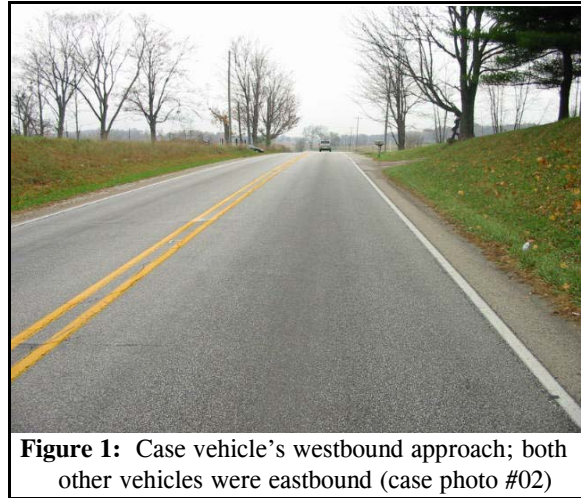
The case vehicle was traveling west in the westbound lane of a two-lane, undivided state highway and intended to continue straight ahead. The Ford and Mercedes were both traveling east in the eastbound lane of the same roadway, with the Ford ahead of the Mercedes, both intending to continue straight ahead (**Figure 1**). The weather was cloudy with no precipitation and it was dark. The asphalt surface was dry and free of defects, with white edge lines on both sides and the opposing lanes separated by double solid yellow lines. The paved surface was 7.4 meters [24.4 feet] from edge to edge. The surrounding landscape was open county and the crash location was on an elongated hill crest, with a slight positive slope for the approach from both directions. All three vehicles were traveling at or near the posted speed limit of 86 km.p.h. [55 m.p.h.]. The case vehicle driver apparently feel asleep and drifted over the center line and into the eastbound lane. The Ford and the Mercedes drivers observed the threat and both steered to their right (south). The case vehicle driver made no known avoidance maneuvers. The crash occurred in the eastbound lane of the roadway.

Figure 1: Case vehicle's westbound approach; both other vehicles were eastbound (case photo #02)

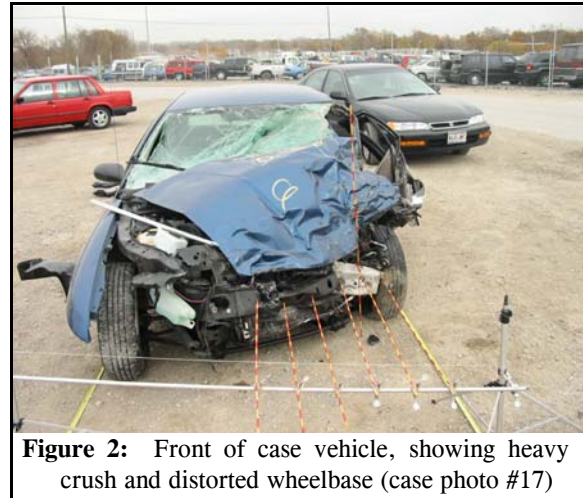
The exact location of the first impact on the case vehicle is not known because of overlapping damage from the second impact, but it is likely that it was limited to a small portion of the left front corner. The case vehicle's highest severity impact was with the Mercedes and involved the entire front bumper (**Figure 2**). The exact length of direct damage is unknown because the bumper fascia was absent, but direct plus induced damage was measured as 71 centimeters [28 inches] from bumper corner to bumper corner. Maximum crush was measured as 109 centimeters [42.9 inches] at C1. The wheelbase on the left side was shortened 53 centimeters [20.1 inches] while the right side was lengthened 7 centimeters [2.8 inches]. The case vehicle's front bumper and fascia, grille, hood, radiator, both headlamp and turn signal assemblies, and left fender were directly damaged and crushed rearward. The left front wheel was

Based on inspection, the CDC for the case vehicle's most severe (second) impact was determined to be: **12-FDEW-5 (10)**. The WinSMASH reconstruction program, damage only algorithm, was used on the case vehicle's highest severity impact. The Total, Longitudinal, and Lateral Delta Vs are, respectively: 70.0 km.p.h. [43.5 m.p.h.], -68.9 km.p.h. [-42.8 m.p.h.], and -12.2 km.p.h. [-7.6 m.p.h.]. The case vehicle's second most severe impact (first event, with the Ford) was masked by overlapping damage and a CDC could not be assigned. The WinSMASH Missing Vehicle algorithm, based on the damage to the Ford and treating the case vehicle as missing, was used on the case vehicle's second most severe impact. The Total, Longitudinal and Lateral Delta Vs are, respectively: 14.0 km.p.h. [8.6 m.p.h.], -13.8 km.p.h. [-8.5 m.p.h.] and +2.4 km.p.h. [+1.5 m.p.h.]. This is a borderline reconstruction, but the results appears reasonable.

Figure 2: Front of case vehicle, showing heavy crush and distorted wheelbase (case photo #17)

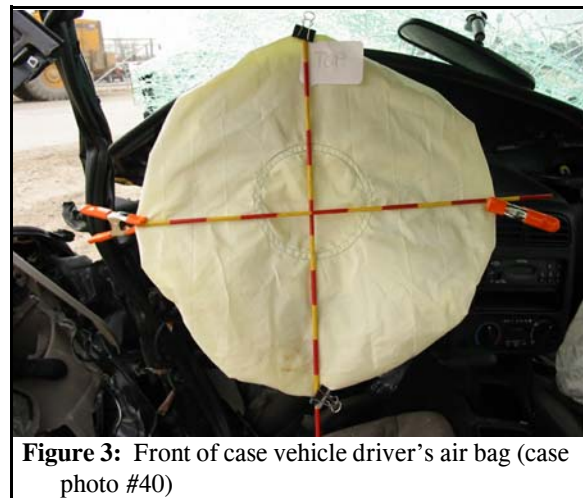
The case vehicle driver's air bag was located in the steering wheel hub (**Figure 3**). An inspection of the air bag module's cover flaps and air bag revealed that the cover flaps opened at the designated tear points, and there was no evidence of damage during the deployment to the air bag or the cover flaps. The deployed driver's air bag was round with a diameter of 55 centimeters [21.6 inches]. It was designed with two tethers, each 15 centimeters [5.9 inches] in width, and had no vent ports. There was little contact evidence despite the severity of the crash and the fact that the driver was not restrained. A scuff or makeup transfer was found on the lower center of the driver's air bag.

Figure 3: Front of case vehicle driver's air bag (case photo #40)

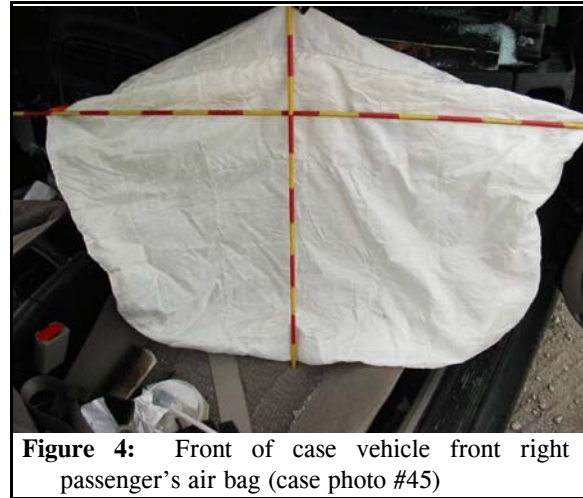
The front right passenger's air bag was located in the middle of the instrument panel (**Figure 4**). An inspection of the front right air bag module's cover flaps and air bag revealed that the cover flap opened at the designated tear points, and there was no evidence of damage during the deployment to the air bag or the cover flap. The deployed front right air bag was rectangular, measuring approximately 50 centimeters [19.7 inches] vertically and approximately 75 centimeters [29.5 inches] horizontally. It was designed with without any tether(s) or vent ports. There was no contact or damage evidence on the front right air bag.

Figure 4: Front of case vehicle front right passenger's air bag (case photo #45)

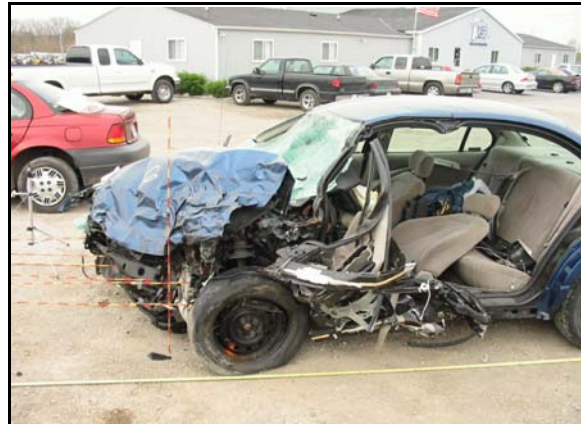
pushed rearward and was restricted while the right front wheel was pulled forward and was not damaged or restricted. Both left side doors were jammed and required removal to extricate the driver (**Figure 5**). The windshield was shattered across the entire width, with separation of the bonding over much of the perimeter. Left side glazing could not be evaluated due to the doors being removed. The backlight and right side glazing were intact.

Inspection of the case vehicle's interior revealed heavy intrusion, primarily in the driver's seat area (**Figures 5 and 6**). Components intruding longitudinally included: the left upper A-pillar, 66 centimeters [26.0 inches]; the driver's toe pan, 49 centimeters [19.3 inches]; the left portion of the instrument panel, 40 centimeters [15.7 inches]; and the side panel forward of the A-pillar, 28 centimeters [11.0 inches]. The driver's door sill intruded 30 centimeters [11.8 inches] laterally; intrusion by left side door components could not be evaluated because the door had been removed. The driver's seat cushion was deformed by intruding components. Evidence of contacts by the driver were found on the driver's knee bolster, the steering wheel rim and the front of the driver's air bag.

Figure 5: Case vehicle's left side, showing driver's seat area (doors removed for extrication) (case photo #20)

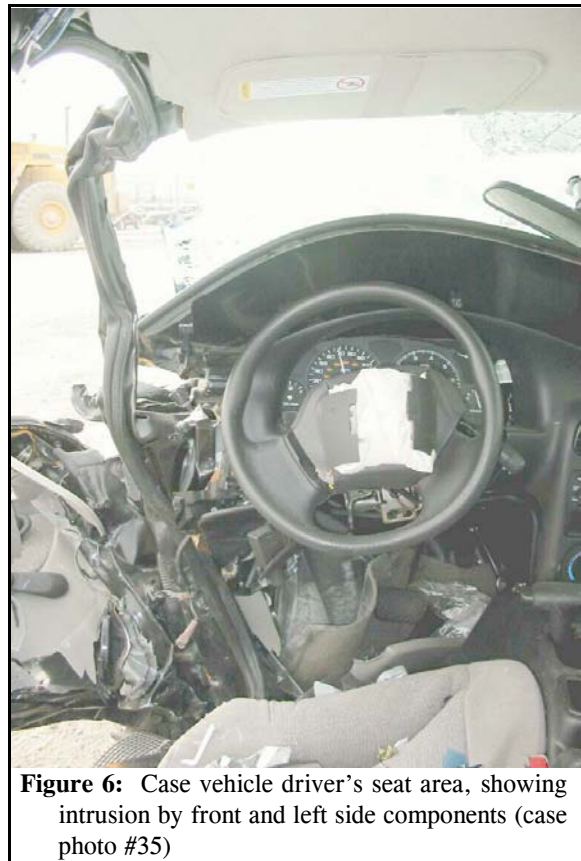
Immediately prior to the crash, the case vehicle's driver (34-year-old female, white, non-Hispanic, 157 centimeters and 61 kilograms [62 inches, 135 pounds]) was seated in an unknown posture. The police and the driver's husband (non-occupant) suspected the driver had fallen asleep and she may have been leaning (i.e., not upright) in her seat. Her left foot was probably on the floor, her right foot was probably on the accelerator and she presumably had at least one hand of the steering wheel. The SDM report indicates there was no pre-crash braking and only minor modulation of the throttle input. Her seat track position could not be determined due to damage to the seat but, given the height and weight of the driver, a center position is most likely. At the time of inspection, the seat back was in a fully reclined position, approximately 60 degrees from vertical (**Figures 5 and 6**).

Figure 6: Case vehicle driver's seat area, showing intrusion by front and left side components (case photo #35)

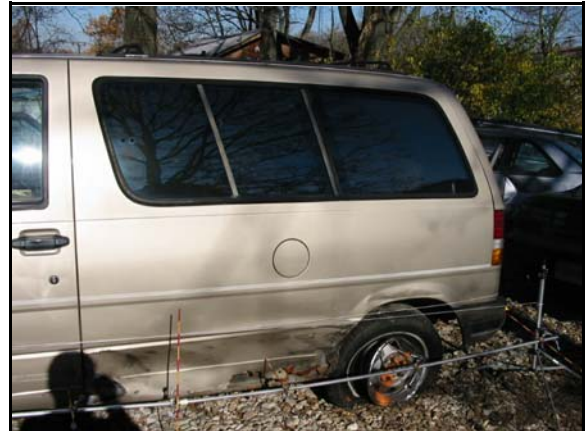
The first other vehicle was a 1990 Ford Aerostar front wheel drive, 3-door minivan (VIN: 1FMCA11UXLZA-----). Based on the vehicle inspection, the CDC for the Ford was determined to be **11-LDEW-2 (340)** (maximum crush was 16 centimeters [6.3 inches]). The WinSMASH reconstruction program, missing vehicle algorithm, was used on the Ford's single impact, based on the Ford's measured crush profile and treating the case vehicle as missing (because of overlapping damage on the case vehicle). The Total, Longitudinal and Lateral DeltaV's for the Ford are: 9.0 km.p.h. [5.6 m.p.h.], -8.5 km.p.h. [-5.2 m.p.h.] and +3.1 km.p.h. [+1.9 m.p.h.]. This is a borderline reconstruction but the results appear reasonable. The Ford was towed from the scene but appeared not to have been truly disabled, except for the damage to the left rear wheel and tire (**Figure 7**). The Aerostar's driver (46-year-old female) sustained police-reported "B" (evident, non-incapacitating) injuries. Her treatment status and specific injuries are not known. There were no other occupants in the Aerostar.

Figure 7: Left side of Ford Aerostar, showing area of maximum crush (case photo #57)

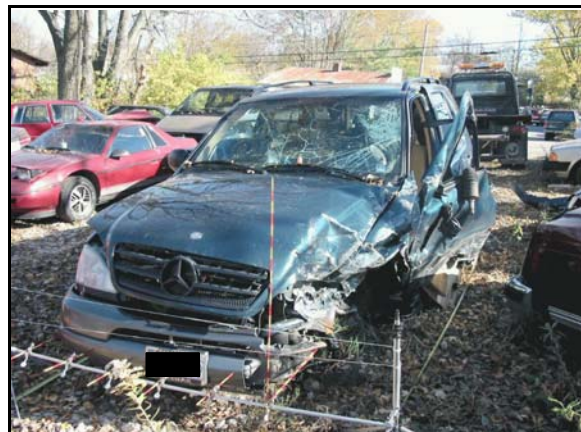
The second other vehicle was a 1998 Mercedes Benz ML 320 four wheel drive, four-door sport utility vehicle (VIN: 4JGAB54E0WA-----). Based on the vehicle inspection, the CDC for the Mercedes was determined to be **12-FLEE-9 (350)** (maximum crush was 37 centimeters [14.6 inches]). The WinSMASH reconstruction program, damage algorithm based on the crush profile of both vehicles, was used on the Mercedes' single impact. The Total, Longitudinal and Lateral DeltaVs for the Mercedes are, respectively: 40.0 km.p.h. [24.8 m.p.h.], -39.4 km.p.h. [-24.5 m.p.h.] and +6.9 km.p.h. [+4.3 m.p.h.]. The Mercedes was equipped with front impact air bags and door-mounted side impact air bags. The driver and front right passenger frontal air bags and the driver's side impact air bag deployed. The Mercedes was towed due to damage (**Figure 8**). The Mercedes' driver (42-year-old male) sustained police-reported "B" (evident, non-incapacitating) injuries. His treatment status and specific injuries are not known. There were no other occupants in the Mercedes.

Figure 8: Front and left side of Mercedes SUV, showing heavy damage from offset frontal impact (case photo #70)
