ON-SITE ADULT AIR BAG-RELATED FATALITY INVESTIGATION

CASE NUMBER - IN-02-016
LOCATION - Texas
VEHICLE - 1993 FORD CROWN VICTORIA
CRASH DATE - November 2002

Submitted:
September 18, 2003

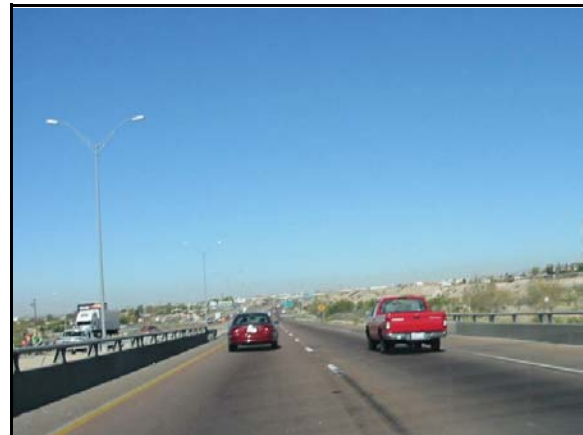
The case vehicle was traveling north in the inside northbound lane of a two-lane roadway that was part of a divided, Interstate trafficway and apparently intended to continue straight ahead (**Figure 1**). It was daylight, the weather was clear and the asphalt road surface was free of defects. The speed limit was 97 km.p.h. [60 m.p.h.], but there was a construction zone ahead. The Oldsmobile was also traveling north in the same lane, ahead of the case vehicle, and was slowing due to traffic merging to the left because the right lane was closed ahead for a construction project. The case vehicle's driver made no known avoidance maneuvers prior to the crash. Several witnesses stated that the case vehicle driver was slumped against the steering wheel and she may have passed out or fallen asleep. The crash sequence began in the inside northbound lane of the roadway.

Figure 1: Case vehicle's pre-crash northbound path of travel; the right lane was closed ahead with traffic slowing and merging left (case photo #01a)

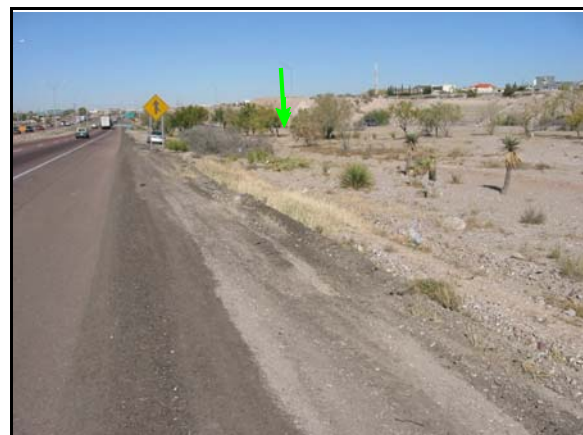
Figure 2: Case vehicle's northeastward path to final rest against a tree (arrow) (case photo #02)

shoulder and onto the unimproved dirt roadside (Figure 2). The case vehicle continued in a northeasterly direction for approximately 79 meters [260 feet], when the front of the case vehicle encountered a small tree and came to rest (Figure 3).

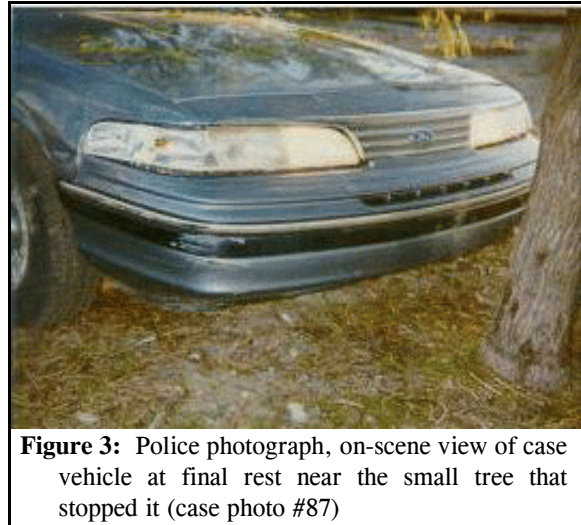
Figure 3: Police photograph, on-scene view of case vehicle at final rest near the small tree that stopped it (case photo #87)

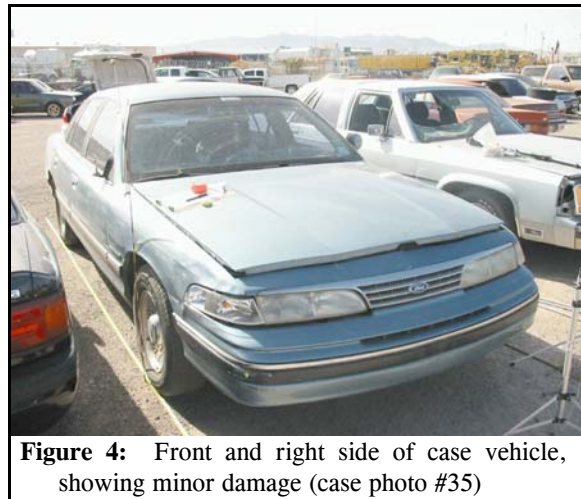
The case vehicle's initial contact with Oldsmobile involved the left three-quarters of the front bumper. Direct damage began at the front left bumper corner and extended 126 centimeters [49.6 inches] inward along the front bumper. Maximum crush was measured as 3 centimeters [1.2 inches] at C1. The wheelbase on the case vehicle's left side was shortened 2 centimeters [0.8 inches] while the right side wheelbase was unchanged. The case vehicle's bumper was directly damaged, but the amount of crush was slight. There was also direct contact along most of the right side of the case vehicle, with only surface scratches and very minor or no crush damage. The front right turn signal lens was broken. There was some light remote damage to the hood such that it could not be closed properly (Figure 4).

Figure 4: Front and right side of case vehicle, showing minor damage (case photo #35)

Based on the vehicle inspection, the CDCs for the case vehicle were determined to be: **12-FDLW-1 (0)** for the first impact, **12-RDES-1 (0)** for the second impact, and **12-FCEN-1 (0)** for the third impact. The WinSMASH reconstruction program, damage algorithm based on the measured crush profile for both vehicles, was used on the case vehicle's highest severity (first) impact. The Total, Longitudinal, and Lateral Delta Vs are, respectively: 16 km.p.h. [9.9 m.p.h.], -16 km.p.h. [-9.9 m.p.h.], and 0 km.p.h. [0 m.p.h.]. No reconstruction program was used on the second and third events because the second was a swiping-type impact and the third involved a small tree that yielded. The crash severity for the case vehicle was low (14-23 km.p.h.

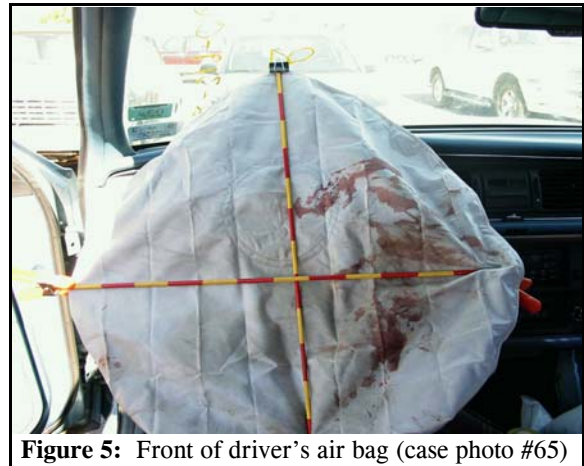
Inspection of the case vehicle's interior revealed heavy blood stains on the front of the driver's air bag (**Figure 5**), with no blood or other evidence of contact on the back of the air bag. The top half of the steering wheel rim was bent forward 5 centimeters [2.0 inches]. The safety belt webbing was cut, presumably to enable extrication. There was blood and mucus splattered on the windshield, the driver's door window glazing and the driver's sun visor (**Figure 8**). There was what appeared to be a small piece of flesh on the head liner fabric, near the front header.

Figure 5: Front of driver's air bag (case photo #65)

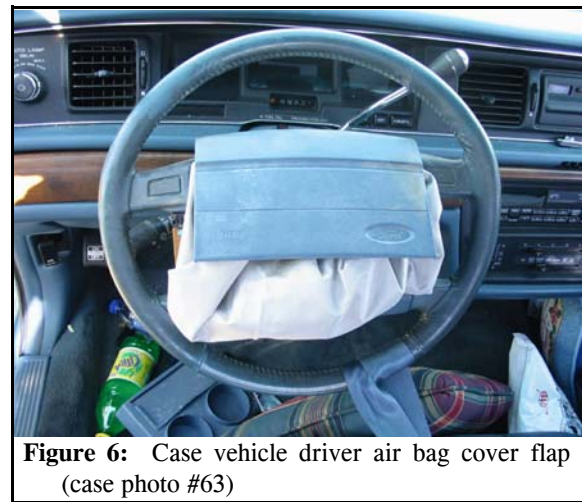
The case vehicle driver air bag was located in the steering wheel hub. Inspection of the air bag module's cover flaps and air bag revealed that the cover flaps opened at the designated tear points, with no evidence of damage to the air bag or the cover flap (**Figure 6**). The deployed driver's air bag was round with a diameter of 68 centimeters [26.8 inches]. The air bag was designed with four tethers, each 6 centimeters [2.6 inches] wide, and two vent ports, each approximately 3.5 centimeters [1.4 inches] in diameter, located at the 11 and 1 o'clock positions. There was a substantial amount of blood on the front of the driver's air bag. There was no front right passenger air bag, and no other automatic restraint system, in this 1993 vehicle.

Figure 6: Case vehicle driver air bag cover flap (case photo #63)

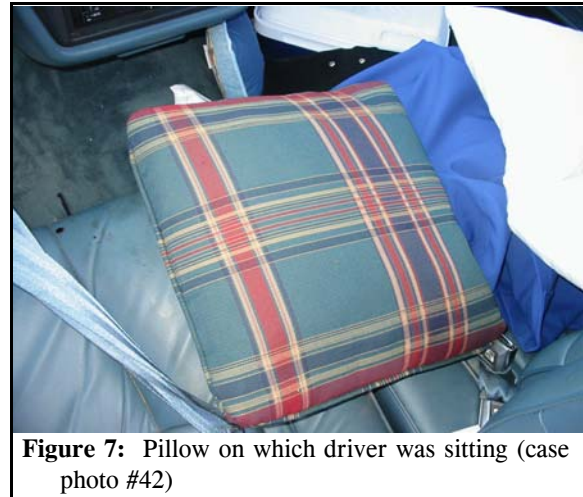
The case vehicle driver (82-year-old female, white, non-Hispanic, 155 centimeters and 67 kilograms [61 inches, 148 pounds]) was sitting on a large cushion/pillow, apparently in an effort to raise her seated height (**Figure 7**). Her pre-crash posture is otherwise not known, but several witnesses stated that the case vehicle driver was slumped against the steering wheel and she may have passed out or fallen asleep. She was probably leaning forward against the steering wheel rim with her left foot on the floor and right foot stuck on the accelerator. Her hand/arm positions are unknown. Her seat track was located between its middle and forward-most positions. At the time of inspection, the seat back was fully reclined, probably due to rescue efforts.

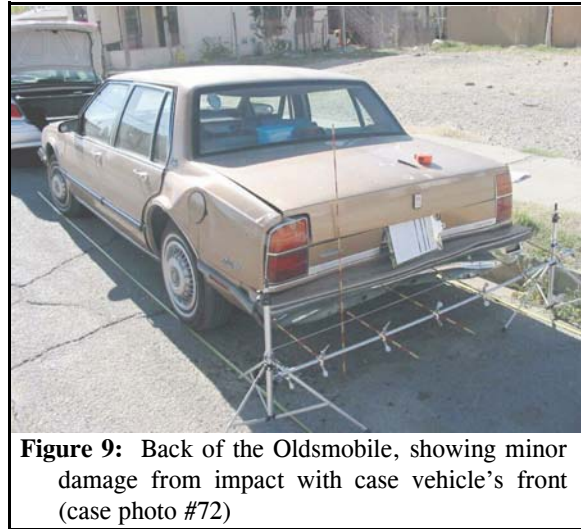
The other vehicle was 1988 Oldsmobile Delta 88 Royale Brougham front wheel drive, four-door, six-passenger sedan (VIN: 1G3HY54C1JW-----). Based on the vehicle inspection, the CDC for the Oldsmobile's most severe (first) impact was determined to be: **06-BDLW-2 (180)** (maximum crush was 23 centimeters [9.1 inches]). The second impact CDC was: **06-LBES-1 (180)**. This second impact involved surface scratches only, with no crush damage, and no measurements were taken. The WinSMASH reconstruction program, damage algorithm based on the measured crush profile for both vehicles, was used on the Oldsmobile's highest severity(first) impact. The Total, Longitudinal and Lateral DeltaVs are, respectively: 19.0 km.p.h. [11.8 m.p.h.], +19 km.p.h. [+11.8 m.p.h.] and 0 km.p.h. [0 m.p.h.]. The Oldsmobile was towed, but not due to damage (**Figure 9**).

Figure 9: Back of the Oldsmobile, showing minor damage from impact with case vehicle's front (case photo #72)
