On-scene Investigation / Vehicle to Vehicle  
Dynamic Science, Inc. / Case Number: DS02017  
2002 Toyota Camry  
California  
June, 2002

1. Report No. DS02017		2. Government Accession No.		3. Recipient Catalog No.	
4. Title and Subtitle In-Depth Accident Investigation				5. Report Date	
				6. Performing Organization Report No.

**Dynamic Science, Inc.**  
**Accident Investigation**  
**Case Number: DS02017**

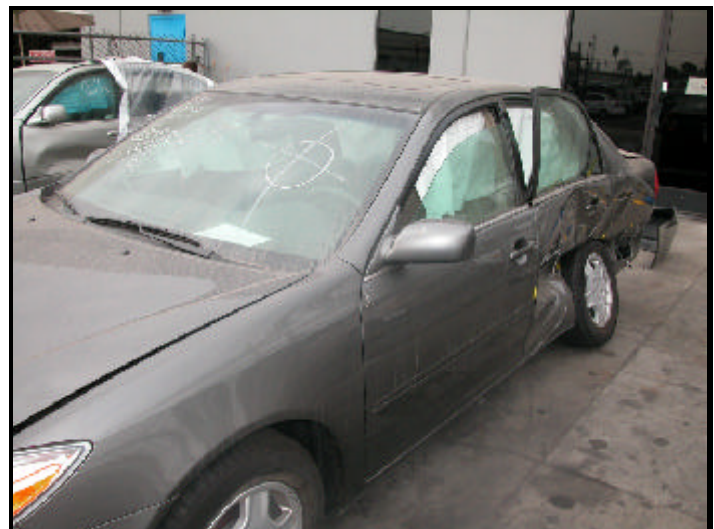
**Figure 2.** Left side, case vehicle – 2<sup>nd</sup> impact

The case vehicle rotated clockwise and struck the front of the stopped Mercedes with its left side (09LZEW2). The total velocity change for the second impact calculated by the Missing Vehicle algorithm of the WINSMASH collision model was 18.0 km/h (11.2 mph). The longitudinal and lateral delta V components were -3.1 km/h (-1.9 mph) and 17.7 km/h (11.0 mph), respectively. The left side curtain deployed at this point. The seat mounted side air bag did not deploy.

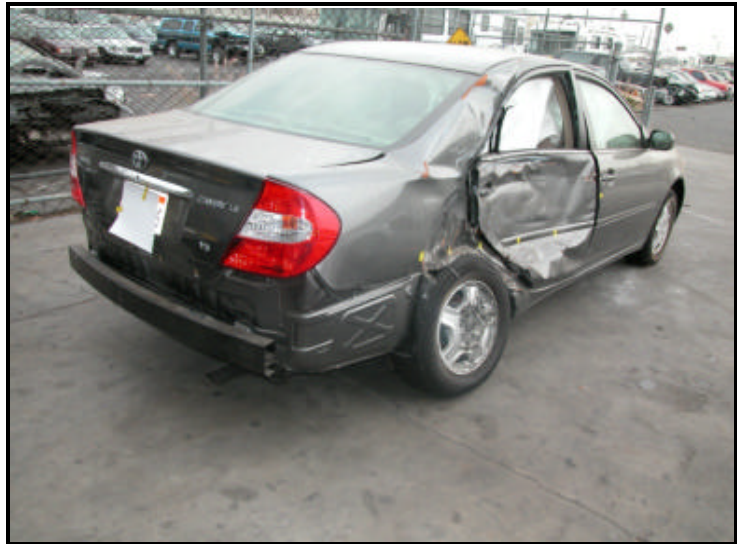
intersection at the same time. The front of the GMC truck struck the right side of the case vehicle (02RZAW2).

**Figure 3.** Right rear, case vehicle – impact 1

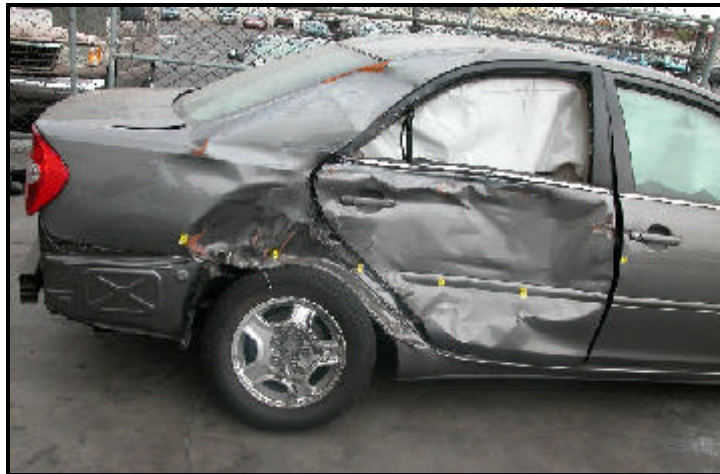
The right side of the case vehicle sustained 160 cm (62.9 in) of direct contact that extended from just rear of the rear tire to the B pillar. The maximum crush of 14 cm (5.5 in) was found at the C3 location. The principle direction of force was within the 2 o'clock sector and was an estimated 70 degrees. The rear door was jammed shut and the sideglass had disintegrated as a result of crash damage.

**Figure 6.** Right side, initial impact

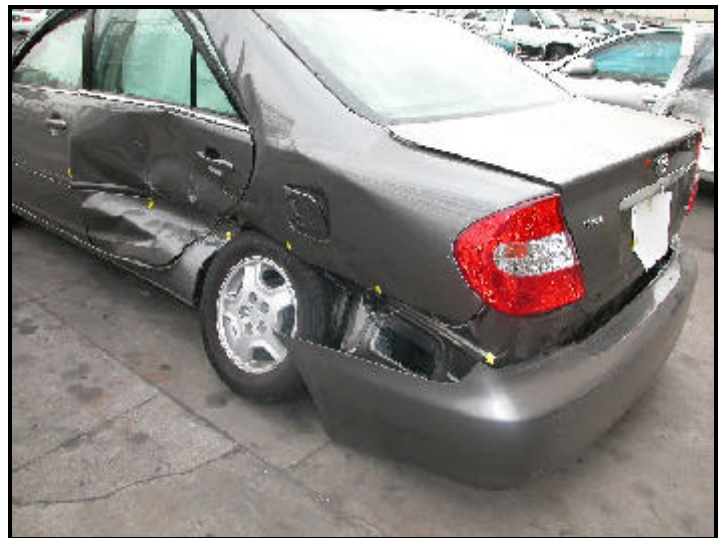
The left side of the case vehicle sustained 163 cm (64 in) of direct contact that extended from the rear of the vehicle to the B pillar. The maximum crush of 25.5 cm (10 in) was found at the C4 location. The principle direction of force was in the 9 o'clock sector and was an estimated 280 degrees. The rear door was jammed shut. The rear door window frame was bowed outward at the top.

**Figure 7.** Left side, second impact

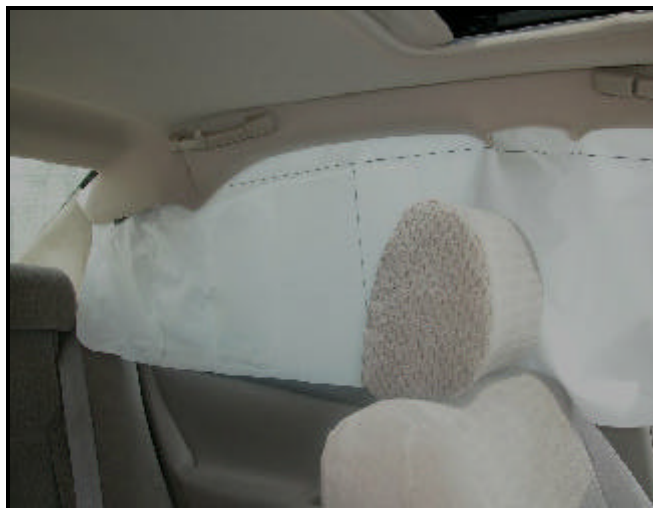
The side curtains were 153 cm (60.2 in) long, 22 cm (8.7 in) tall at the front, and 33 cm (12.9 in) at the back. They are comprised of 11 individual pocket type air pillows contained within the curtain. There was one 33 cm (12.9 in) tether at each A pillar. The tethers separated at 21 cm (8.3 in). This appears to be a designed in separation. The left side curtain was marked by two make-up transfers at the driver location. The two transfers were in the same general location—one measured 12 x 7 cm (4.7 x 2.8 in) and the other measured 6 x 8 cm (2.4 x 3.1 in).

**Figure 9.** Left side curtain

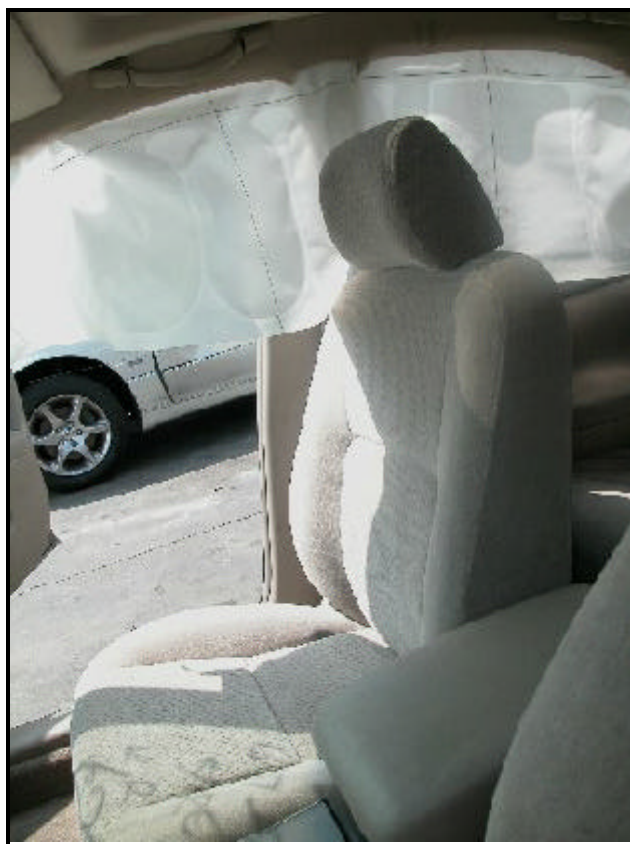
**Figure 10.** Right side curtain

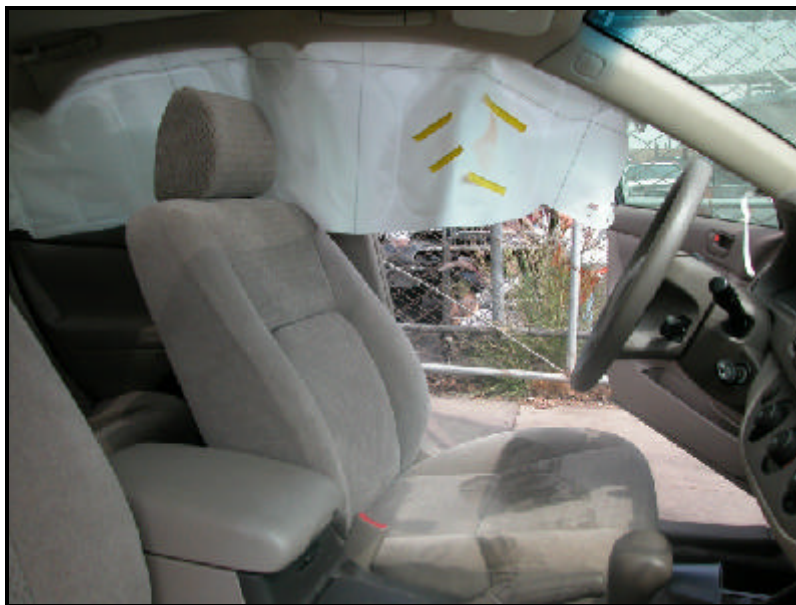
During the initial impact, the driver responded to the 70 degree direction of force by moving forward and to the right. She loaded and was held in place by the seat belt. As the vehicle began its clockwise rotation, the rotational forces forced the driver back to the left. Upon the second impact, the side air curtain deployed. The driver responded to the 280 degree direction of force by moving sharply to the left. The left side of her face and her left shoulder contacted the deployed curtain. The facial contact deposited a make-up transfer to the curtain. The driver did not sustain any facial injuries of any kind. At this same time, the left side of the driver's shoulder, breast and hip engaged the door side panel—resulting in contusions at each of these locations.

Figure 12. Driver's seat-contact to side air curtain

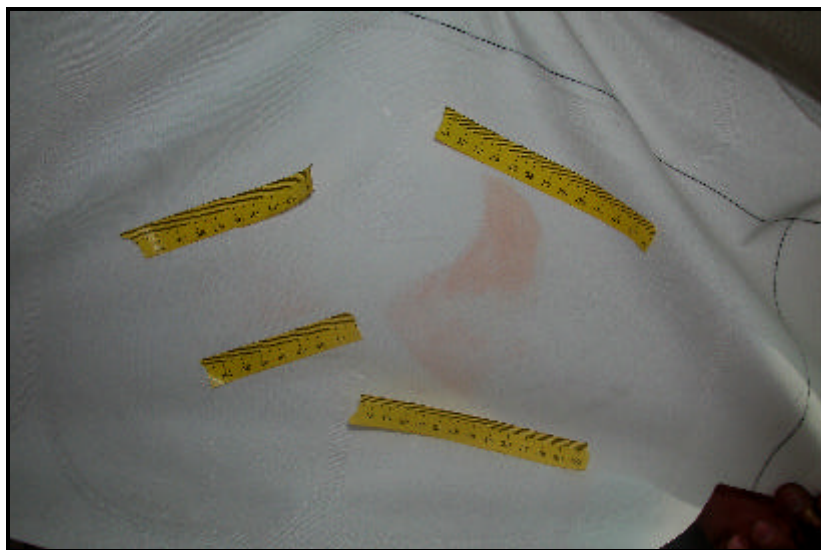
Figure 13. Close up of contact to side curtain
