On Site Side Air Curtain Investigation / Vehicle to Vehicle
Dynamic Science, Inc. / Case Number: DS02018
2002 Lexus GS300
California
June, 2002

1. Report No. DS02018		2. Government Accession No.		3. Recipient Catalog No.	
4. Title and Subtitle On Site Side Air Curtain Investigation				5. Report Date January 28, 2004

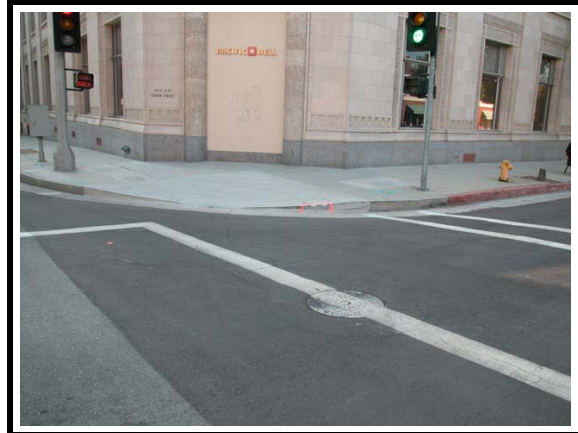
After impact, the case vehicle rotated counterclockwise and traveled in a counterclockwise yaw towards the south-east corner of the intersection. The right rear tire struck (03RBWN1) the concrete curb and damaged the right rear axle.

Figure 2. Case vehicle impact with S/E curb and final rest.

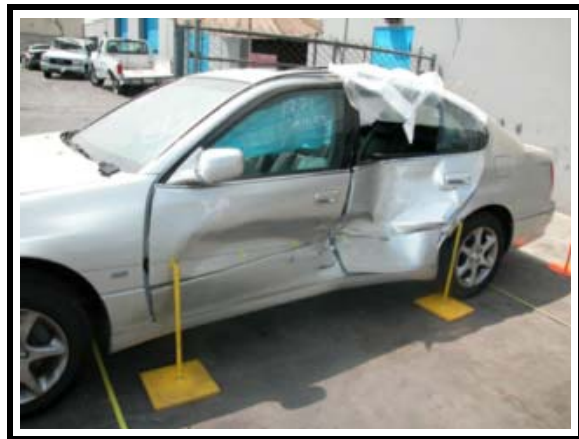
Figure 3. Case vehicle left side damage.

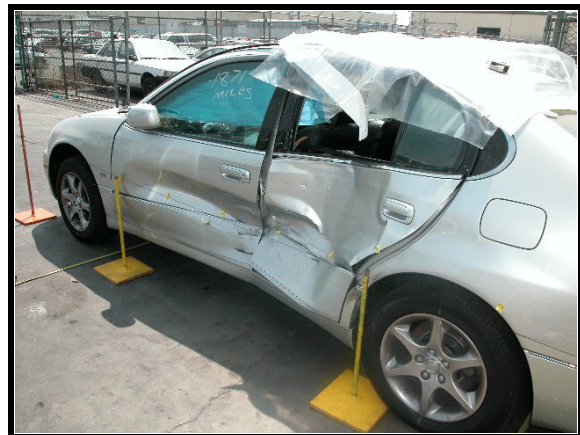
The Lexus GS300 sustained moderate left side damage as a result of the impact with the 2000 Chevrolet Suburban. The direct contact began 54.0 cm (21.2 in) forward of the rear axle and extended 113.0 (65.7 in) cm forward along the left side plane. Both left side doors were involved. Six crush measurements were taken along the mid-door line and were as follows: C1=0 cm (0 in), C2=23.0 cm (9.0 in), C3=28.0 cm (11.0 in), C4=21.0 cm (8.3 in), C5=12.0 cm (4.7 in), C6=0 cm (0 in).

Figure 4. Left side of case vehicle, initial impact

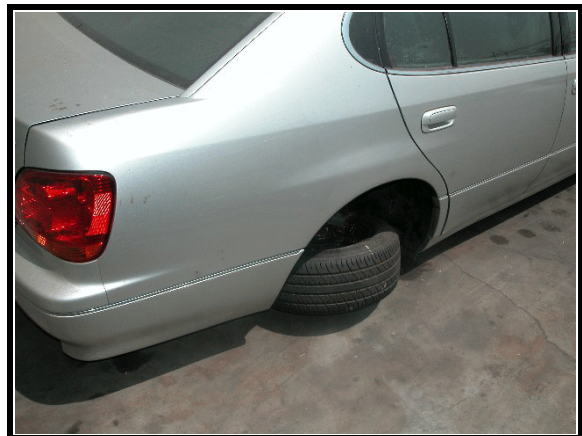
The Lexus GS300 also sustained damage to the right rear tire as a result of the impact with the curb. The wheel and hub were broken away from the axle.

Figure 5. Right rear tire damage from curb impact

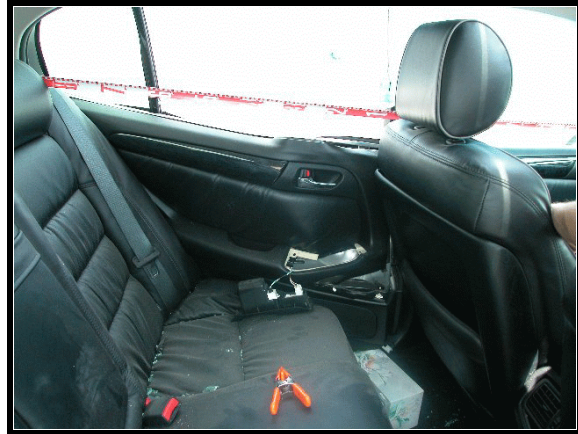
Interior damage to the Lexus GS300 was moderate and attributed to occupant contact and passenger compartment intrusion. A light strand of hair was found on the deployed left side air curtain. There was lateral intrusion of the driver's door panel and the B pillar into the driver's compartment. There was lateral intrusion of the left rear door panel and the window frame into the 2nd left seat area. The left rear window glazing disintegrated.

Figure 6. Left side intrusion

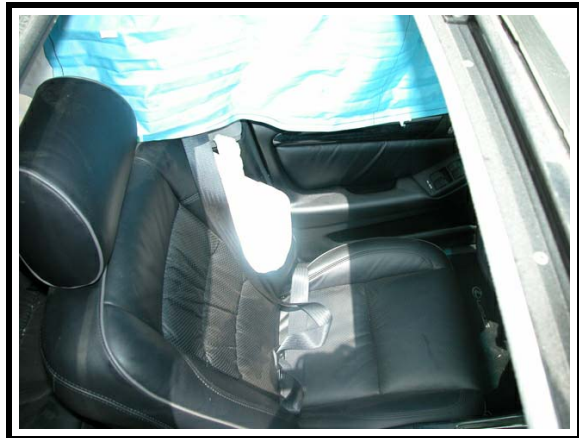
The case vehicle was equipped with three-point safety belts at all five seating positions with switchable retractors (ELR/ALR) at all but the driver's position (ELR only). The retractors for the front safety belts are equipped with pretensioners and force limiters. The driver's pretensioner actuated. The seat belt height adjuster was in the full down position.

Figure 7. Driver's seat belt (pretensioner actuated).

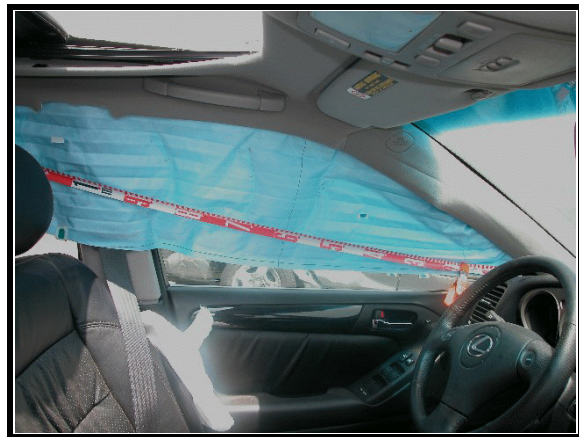
The case vehicle is equipped with six air bags². A driver's steering wheel mounted airbag, a front right passenger's airbag that is top-mounted in the instrument panel. The vehicle is equipped with a driver's and front right seat mounted side airbags, and side curtain airbags mounted above the side windows. The side curtain airbags are located on the right and left sides of the vehicle above the doors and behind the headliner (they extend from the A-pillar rearward to about the middle of the rear windows on both sides.) The side curtain airbag will expand to cover the side windows. The driver's and front right passenger's frontal airbags did not deploy. The driver's seat mounted side airbag did deploy. It measured approximately 24.0 cm (9.4 in.) by 29.0 cm (11.4 in.). It was housed within a plastic module. The side airbag was not tethered or vented. There was no evidence of occupant contact. The driver's side curtain airbag did deploy. It was vaguely rectangular in shape and measured approximately 32.0 cm (12.6 in.) by 142.0 cm (55.9 in.). It contained six individual "pockets" that inflate. The side curtain airbag was not vented. There was no obvious driver contact but a hair strand was found on one of the eight "tabs" that were attached about the side curtain.

Figure 9. Side air curtain

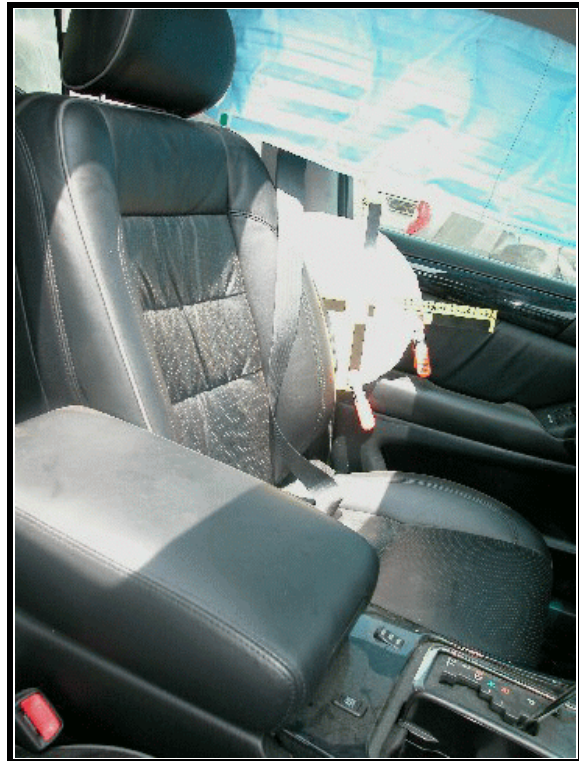
The 31-year-old male driver (173 cm/68 in, 70 kg/155 lbs) of the Lexus GS300 was seated in a normal, upright position on a leather covered bucket seat. The seat was adjusted to approximately the middle track position and the seat back was slightly reclined from vertical. He was wearing the available 3-point lap and shoulder belt in the proper manner. The driver had both hands on the steering wheel. His left foot was on the floorboard; the right was on the accelerator. He was looking straight ahead and was not distracted. He was wearing sunglasses at the time of the crash. He did not see the other vehicle in time to take an evasive actions. At impact, he responded to the 10 o'clock direction of force by moving to the left and slightly forward. The left side air curtain and left side air bag both deployed. The left side of the driver's head contacted the deployed side air curtain. This contact caused a contusion and left a red mark on the left side of the driver's head. The driver's torso likely engaged the seat back mounted side air bag, but there were no indications of contact. The driver sustained a neck and lower back strain. The neck strain was likely related to the head contact to the side air curtain. The lower back strain was likely related to the contact to the left side air bag. He also complained of a sore left shoulder, but there was no associated injury.

Figure 11. Driver's seated position with deployed side curtain and side air bag
