**VERIDIAN ON-SITE AIR BAG RELATED CHILD
FATALITY INVESTIGATION**

VERIDIAN CASE NO. CA02-020

VEHICLE - 1995 CHEVROLET LUMINA

CRASH DATE - MAY, 2002

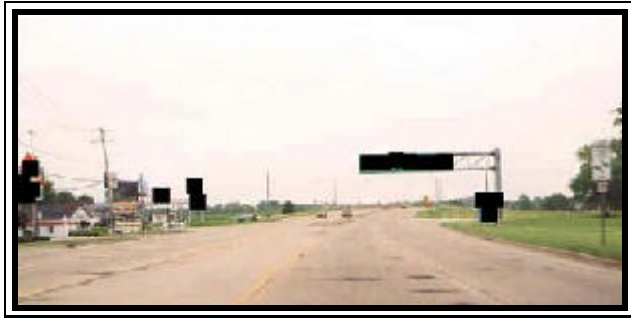
The 49 year old male driver of the 1995 Dodge Ram 2500 pickup truck was operating the vehicle eastbound (**Figure 1**) on the inboard lane of the multi-lane urban roadway at a (police reported) unknown speed when he maneuvered the vehicle into the center turn lane and failed to observe the westbound Chevrolet as he attempted to turn left (north) onto the intersecting roadway.

Figure 1. Eastbound approach for the 1995 Dodge Ram pickup truck.

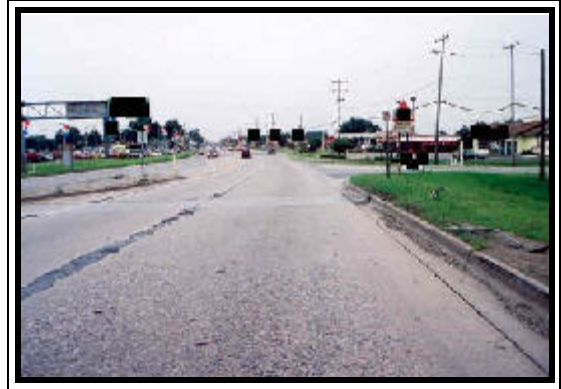
The 49 year old male driver of the 1995 Chevrolet Lumina was delivering newspaper bundles to local carriers, and operating the vehicle westbound (**Figure 2**) in the outboard lane of the multi-lane urban roadway at a (police reported) unknown speed when he observed the 1995 Dodge Ram pickup truck cross his path of travel. Upon recognition of the impending harmful event, he braked in avoidance and remained in the outboard (westbound) lane prior to the collision.

Figure 2. Westbound approach for the 1995 Chevrolet Lumina.

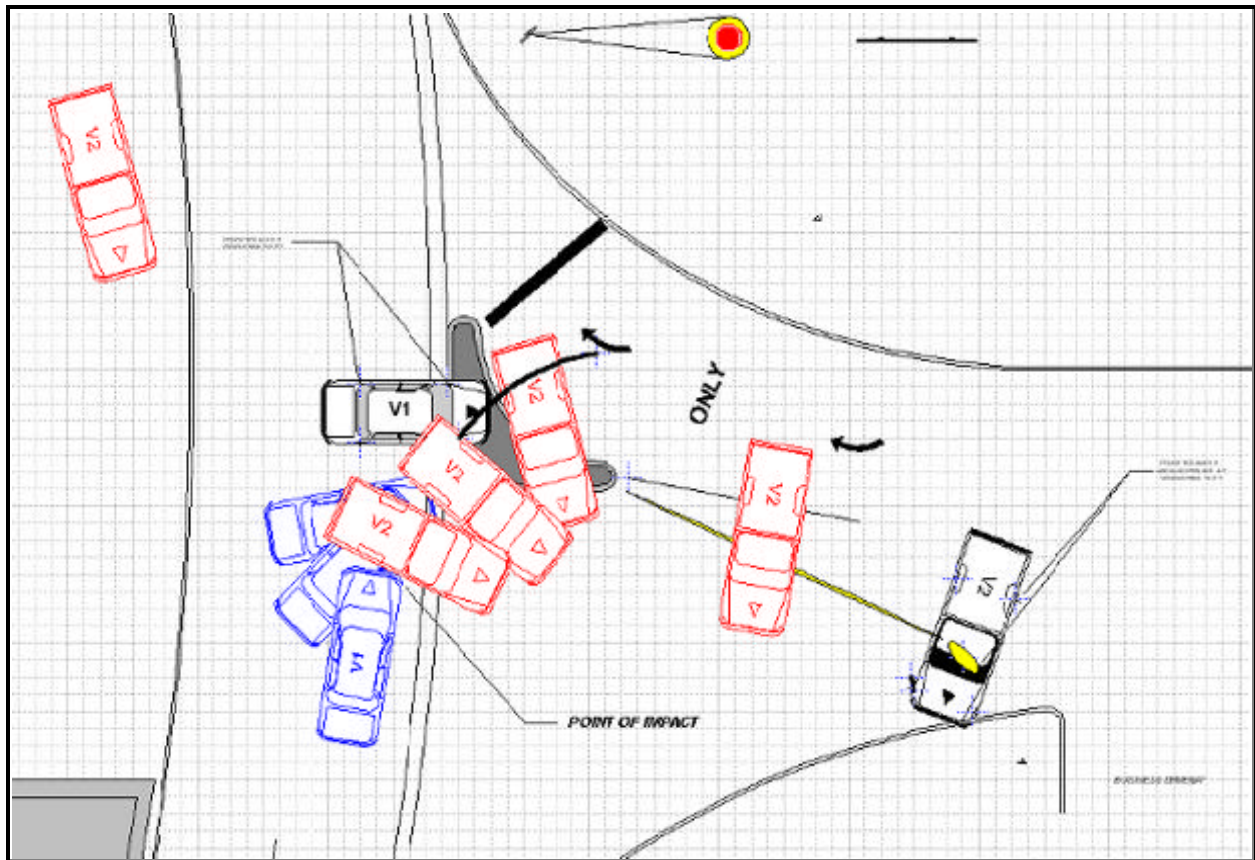
As the Dodge Ram pickup truck crossed the westbound lanes of the multi-lane urban roadway, the right rear side surface was impacted by the frontal area of the Chevrolet Lumina (**Figure 3**) which resulted in moderate damage to both vehicles. The pre-impact braking actions of the Chevrolet driver produced an underride configuration as the bumper and hood structures underrode the bed portion of the Dodge pickup truck. The impact induced deceleration was sufficient to deploy the Chevrolet's frontal air bag system. Impact speeds and velocity changes were calculated utilizing the WinSMASH reconstruction program. The trajectory algorithm computed speeds *at impact* of 50.2 km/h (31.2 mph) for the subject vehicle and 50.3 km/h (31.3 mph) for the struck Dodge. The damage algorithm computed overall velocity changes of 24.4 km/h (15.2 mph) for the subject vehicle and 15.4 km/h (9.6 mph) for the Dodge pickup truck. Respective longitudinal components were -22.9 km/h (-14.2 mph) and -7.7 km/h (-4.8 mph). The Chevrolet's Event Data Recorder (EDR) recorded a deployment event with a longitudinal velocity change of 35.1 km/h (21.8 mph) at the 300 millisecond interval (see **Figures 12 & 13 - pages 13 and 14**).

Figure 3. Crash schematic.

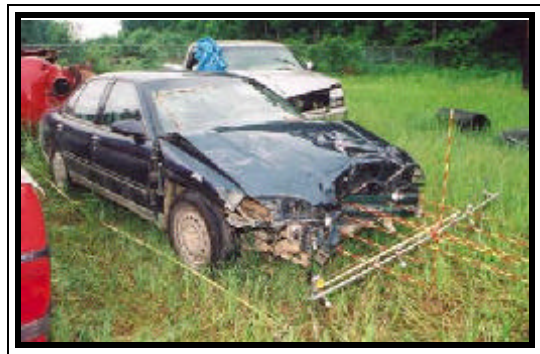
The 1995 Chevrolet Lumina sustained moderate frontal damage as a result of the impact with the 1995 Dodge Ram pickup truck (**Figure 4**). The direct contact damage encompassed the entire front end width resulting in a combined direct and induced damage length (Field L) of 98.0 cm (38.6 in). Six crush measurements were documented at the level of the reinforcement bar (*bumper fascia separation*): C1= 8.0 cm (3.1 in), C2= 32.0 cm (12.6 in), C3= 50.0 cm (19.7 in), C4= 42.0 cm (16.5 in), C5= 22.0 cm (8.7 in), C6= 0. The Collision Deformation Classification (CDC) for this impact to the Chevrolet was 11-FDEW-2 with a principal direction of force of (-)20 degrees. Red paint and black rubber transfers were documented across the direct contact damage, and extended 68.0 cm (26.8 in) rearward on the hood surface; indicative of a side underride configuration. Although the direct contact damage encompassed the entire front end width, a narrow crush pattern or circular indentation was noted to the center section and attributed to the right rear wheel/tire on the opposing Dodge. The windshield was fractured along the lower center section from exterior impact forces and the right mid-windshield from (interior) passenger air bag module cover flap contact. The right fender was deformed rearward which partially restricted the right front door opening. The left rear door was inoperable (“stuck”) and attributed as pre-existing. No wheelbase reduction or induced roof buckle was identified.

Figure 4. Frontal damage to the 1995 Chevrolet Lumina.

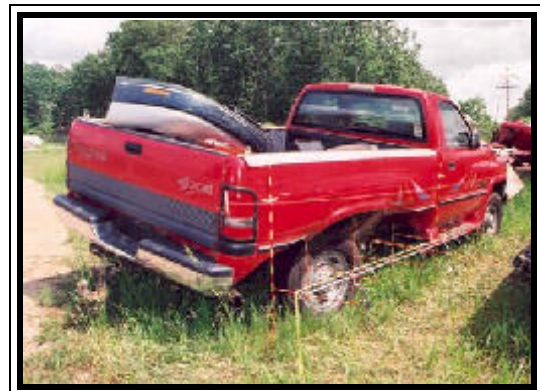
The 1995 Dodge Ram 2500 Laramie SLT 4x4 conventional cab pickup truck sustained moderate right rear side surface damage as a result of the impact with the 1995 Chevrolet Lumina (**Figure 5**). The direct contact damage began 21.0 cm (8.3 in) forward of the right rear bed corner and extended 197.0 cm (77.6 in) forward. The combined direct and induced damage length (Field L) also began 21.0 cm (8.3 in) forward of the right rear bed corner and extended 239.0 cm (94.1 in) forward. Six crush measurements were documented at the level of the mid-body panel: C1= 0 cm, C2= 14.0 cm (5.5 in), C3= 15.0 cm (5.9 in), C4= 21.0 cm (8.3 in), C5= 24.0 cm (9.4 in), C6= 0 cm. A maximum crush value of 30.0 cm (11.8 in) was identified 5.0 cm (2.0 in) forward of the C4 position. Although the crush exhibited a sloped pattern vertically towards the lower edge, crush values were obtained at the level of the mid-body panel to conform to WinSMASH vehicle stiffness coefficients. The CDC for this impact to the Dodge was 02-RBEW-3 with a principal direction of force of (+)60 degrees. The right rear wheel was displaced 27.5 cm (10.8 in) rearward and restricted (not deflated) against the bed. Extensive right wheelbase elongation indicated the heaviest concentration of forces at this area, and may account for the wide variance between the WinSMASH calculated velocity change and the Chevrolet’s EDR summary. Loose cargo stowed in the bed area included a large steel toolbox and table saw. The

Figure 5. Right side surface damage to the 1995 Dodge Ram pickup truck.

combined weight of these items were approximately 317.5 kg (700.0 lb). Pre-existing damage consisted of miscellaneous rust spots and small indentations.

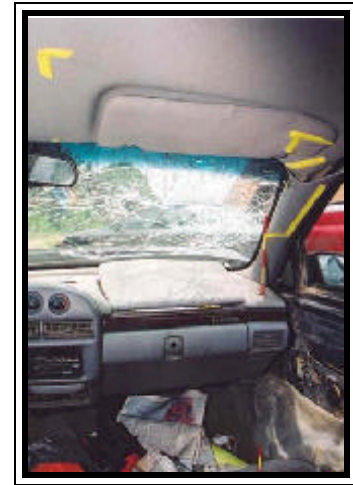
Interior damage to the Chevrolet was moderate and was attributed to occupant contacts (**Figure 6**). A scuff mark was documented on the left knee bolster. Steering wheel rim deformation measured 2.0 cm (0.8 in) at the top section, along with 1.0 cm (0.4 in) of shear capsule movement. Small abrasions and scratches were identified on the forward portion of the right headliner, sunvisor, and roof. Smudge marks and hair strands were also documented on the right sunvisor (vanity mirror undamaged) adjacent to the right A-pillar. This contact pattern extended vertically down the A-pillar into a concentrated area of head interaction. The cover panel was fractured as a deep indentation was noted to the underlying structure with skin tissue and hair strands surrounding the contact site. Blood pooling was found on the front left seat back and cushion, indicative of the child passenger's final rest position. Small areas of abrading and indentations were also documented on the rear aspect of the seat back from loose cargo (newspaper bundles) stowed in the backseat. No intrusions were identified in the vehicle.

Figure 6. Interior view of the front right space.

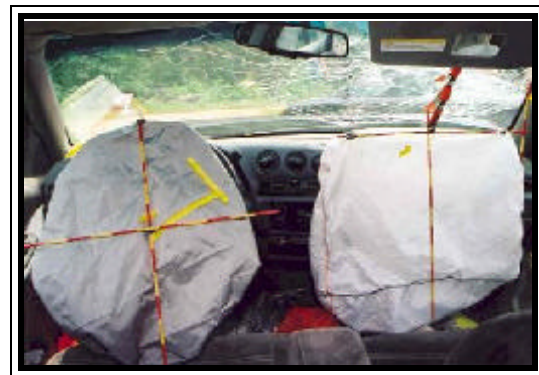
The 1995 Chevrolet Lumina was equipped with frontal air bags for the driver and front right passenger positions which deployed as a result of the crash (**Figure 7**). The driver air bag was identified by the General Motors part number: *P16756616* with a bar coded lot number of: *TTM000369604*, and housed in the center of the steering wheel with a vertically oriented flap tear seam (I-configuration). The flaps were symmetrical in shape and measured 9.0 cm (3.5 in) in width and 11.3 cm (4.4 in) in height. No contact evidence was identified on the exterior surface of the

Figure 7. 1995 Chevrolet Lumina deployed frontal air bags.

module cover flaps. Although the surface of the air bag seemed lightly abraded and discolored from driver interaction, small areas of facial smudging were documented at the right upper and centered sections. The diameter of the driver air bag measured 53.5 cm (21.1 in) in its deflated state. The bag was vented by two 3.0 cm (1.2 in) ports located at the 10 o'clock and 2 o'clock sectors on the rear aspect of the air bag. No internal tether straps were present. Air bag excursion measured 54.0 cm (21.3 in) from the steering wheel hub.

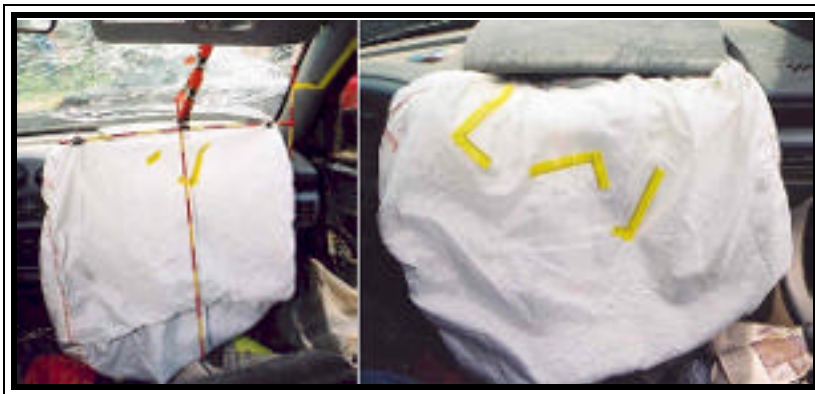
The front right passenger air bag deployed from the right top instrument panel area with a single cover module cover flap design hinged at the forward aspect. The flap was rectangular in shape and measured 40.0 cm (15.7 in) in width and 25.0 cm (9.8 in) in height. No contact evidence was identified on the exterior surface of the cover flap, however, the forward edges were slightly deformed from the noted windshield fractures. Concentrated areas of abrading were identified along the top and upper sections of the membrane along with dark colored fabric transfers to the mid-face. Tissue transfers were identified at the left lower quadrant and right mid-portion of the air bag face. The passenger air bag measured 70.0 cm (27.6 in) in width and 64.0 cm (25.2 in) in height in its deflated state (**Figure 8**). The bag was vented by two 2.3 cm (0.9 in) diameter ports located at the 11 o'clock and 1 o'clock sectors on the side aspect of the air bag. No internal tether straps were present. Air bag excursion measured 41.0 cm (16.1 in) from the aft portion of the mid-instrument panel.

Figure 8. Contact evidence to the 1995 Chevrolet Lumina deployed front right passenger air bag.

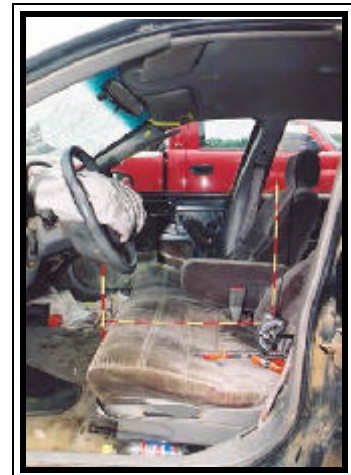
The unrestrained 49 year old male driver of the 1995 Chevrolet Lumina was presumed to be seated in an upright posture with the seat track adjusted to the full rearward position (**Figure 9**). The lack of belt use was determined by the absence of loading evidence on the front left restraint system. Furthermore, the Chevrolet's EDR reflected the driver's belt status switch as "unbuckled".

At impact, the driver initiated a forward and slightly lateral trajectory in response to the 11 o'clock impact force and loaded the knee bolster and deployed driver air bag. Loading of the knee bolster was confirmed by the scuff mark documented on this component, however, no injury was reported as a result. Interaction with the deployed driver frontal air bag was evidenced by the facial smudging documented across the face of the air bag. Possible injury information is unknown as the SCI interview was not obtained. The driver of the Chevrolet Lumina complained to police of unspecified chest soreness, however, he refused subsequent transport to a local medical facility for diagnosis and possible treatment.

Figure 9. Interior view of the driver space.

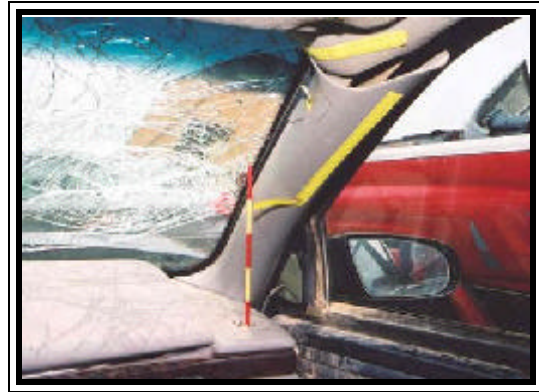
Figure 10. Contact evidence to the right A-pillar.

He was propelled vertically into the right A-pillar, windshield header, and roof side rail areas; evidenced by the indentations, hair strands, and tissue documented on these components (**Figure 10**). This distinct upward trajectory was further evidenced by the abrading and dark colored fabric transfers identified across the top/upper face of the front right air bag. Head contact to the right A-pillar resulted in a linear depressed fracture of the right frontal bone (vault), and a basilar fracture of the right anterior cranial fossa which extended into the sphenoid bone. Associated underlying trauma included focal pontine contusions and a multitude of extensive cerebral trauma. Cerebral trauma involved a deep laceration of the right frontal lobe, subdural/subarachnoid hemorrhages, and multiple cortical contusions. He continued the kinematic pattern into the right roof/side rail area resulting in additional lacerations, abrasions, and contusions to the right and posterior aspects of the scalp. This injury pattern also extended into the posterior regions of the right upper back. These injury mechanisms were evidenced by the abrasions and scratch marks documented on the right roof and side rail areas. A separate abrasion was identified to the left scalp area and attributed to the right sunvisor.

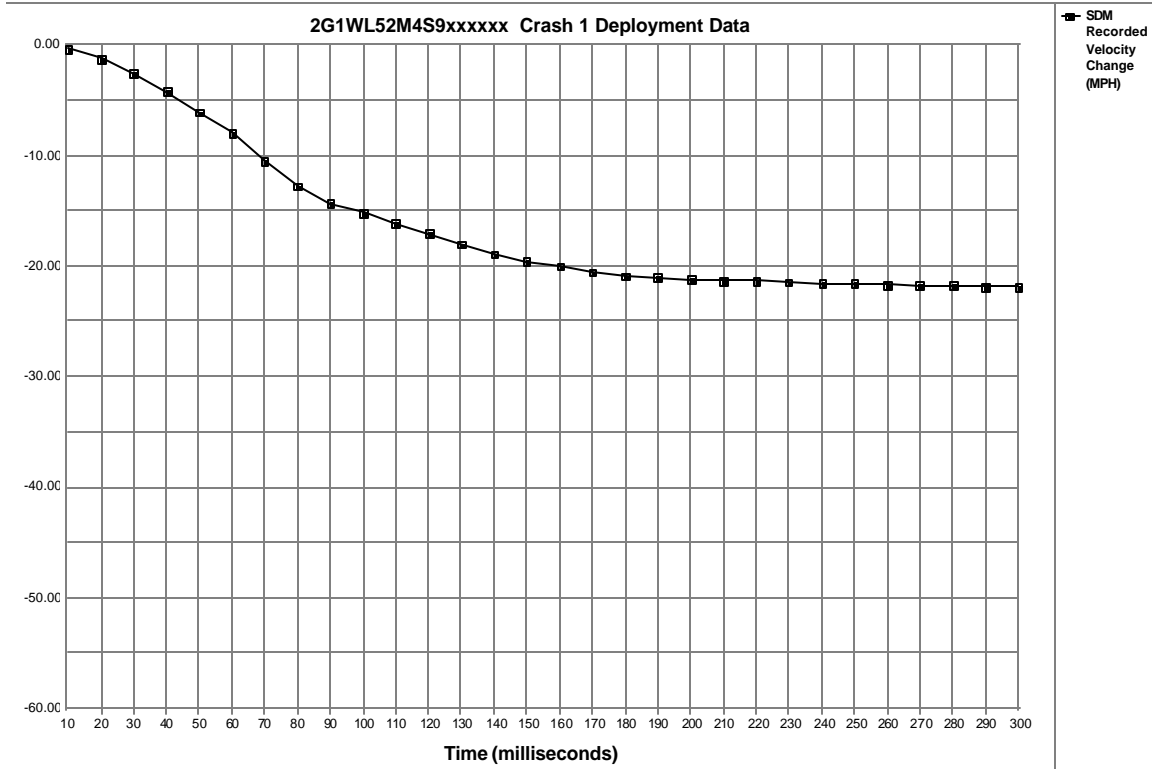
SIR Warning Lamp Status	OFF
Driver's Belt Switch Circuit Status	UNBUCKLED
Ignition Cycles At Deployment	15954
Ignition Cycles At Investigation	15961
Time From Algorithm Enable to Deployment Command Criteria Met (msec)	46.25
Time Between Non-Deployment And Deployment Events (sec)	N/A
