On-scene Investigation / Vehicle to Vehicle
Dynamic Science, Inc. / Case Number: DS02022
2001 Saturn SL2 four door sedan
California
October, 2002

1. Report No. DS02022		2. Government Accession No.		3. Recipient Catalog No.	
4. Title and Subtitle In-Depth Accident Investigation				5. Report Date	
				6. Performing Organization Report No.

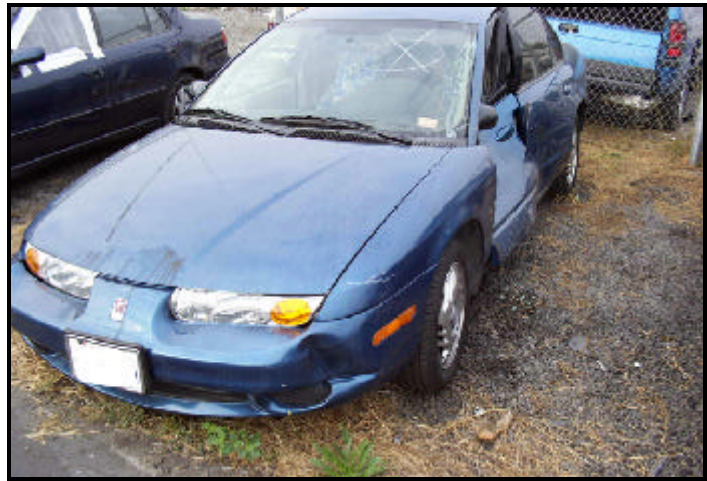
Figure 3. Case vehicle, left side

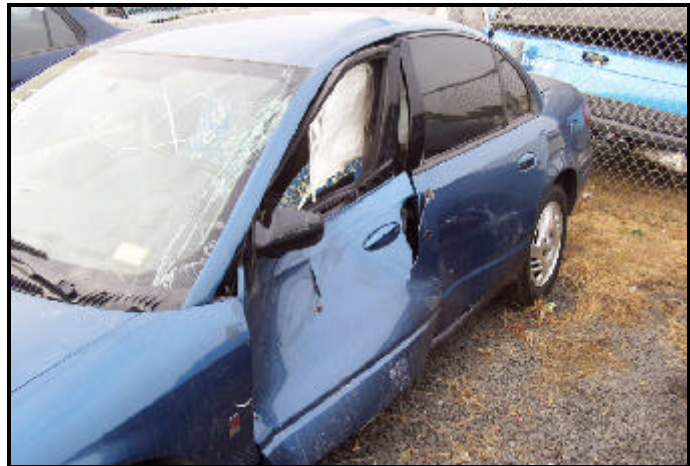
Figure 4. Case vehicle, close up of damage

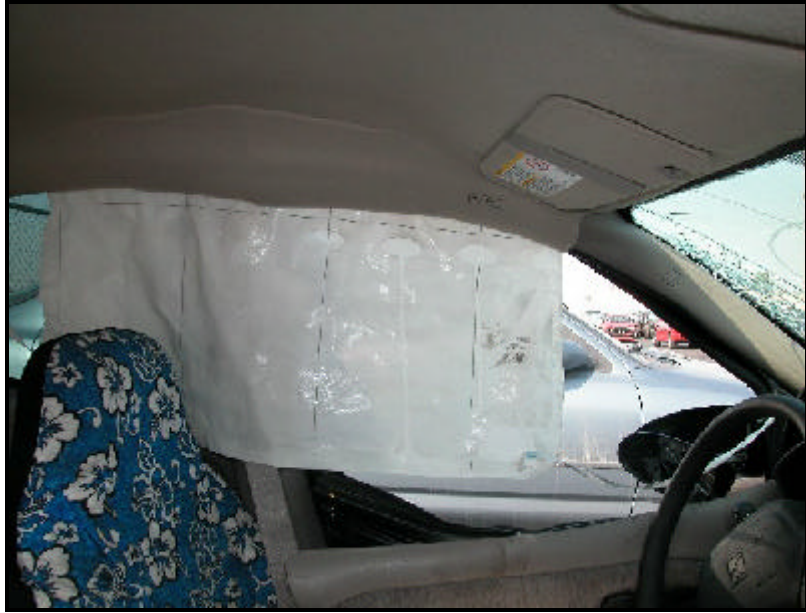
Figure 5. Driver's head curtain side air bag

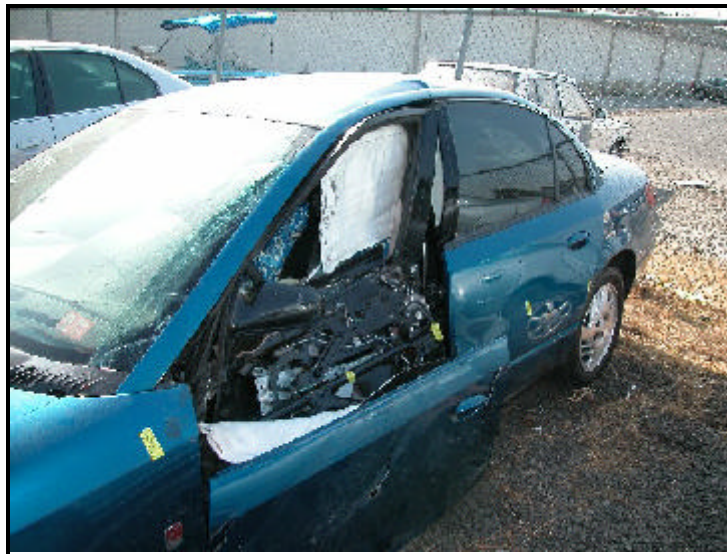
Figure 8. Case vehicle, left side

The case vehicle sustained 184 cm (72 in) of direct contact to the left side of the vehicle. The damage began 35 cm (14 in) forward of the rear axle and extended into the driver's door. The residual crush measured along the sill was as follows: C1=0 cm (0 in), C2=5 cm (2 in), C3=18 cm (7 in), C4=22 cm (9 in), C5=22 cm (9 in), C6=0.5 cm (0.2 in). The maximum crush was between C4 and C5. The principle direction of force was within the 9 o'clock sector and was an estimated 280 degrees. The left front door intruded 30 cm (12 in) into the passenger compartment. The left front window disintegrated upon impact. Both left side doors were jammed shut.

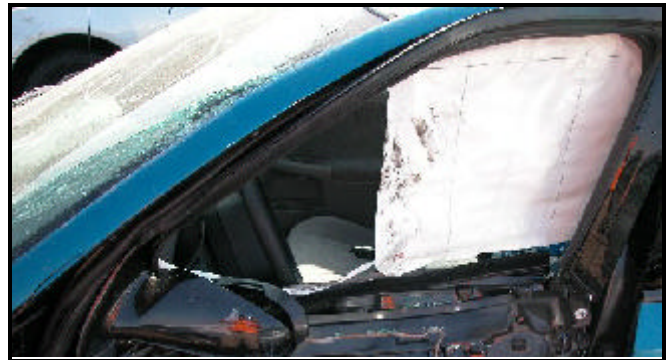
Figure 9. Exterior view, head curtain side air bag

The case vehicle was equipped with redesigned (reduced force) driver and front right passenger air bags, a driver's roof rail mounted head impact air bag, and a front right passenger roof rail mounted head curtain side air bag. The driver's air bag was mounted in the steering wheel hub. The front right passenger air bag was a mid instrument panel mount. The front air bags did not deploy. The side air bags were an option for the S model for 2001. The head curtain side air bag modules were located in the roof rails above the front doors. They were designed to deploy downwards. The inflation cylinders were located in the instrument panel inboard of the A-pillars. The side impact sensors were located in the lower B pillars for sedans. The driver's side head curtain side air bag did deploy during the crash. This air bag was 81 cm (32 in) long and was secured by tethers at either end. The single module cover flap opened at the designed tear point and there was no damage to the cover. There were no indications of any contact or damage to the air bag itself.

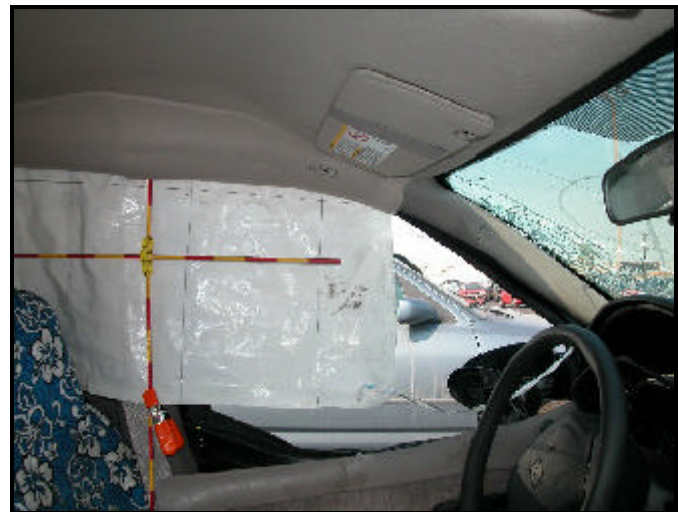
Figure 10. Interior view, head curtain side air bag

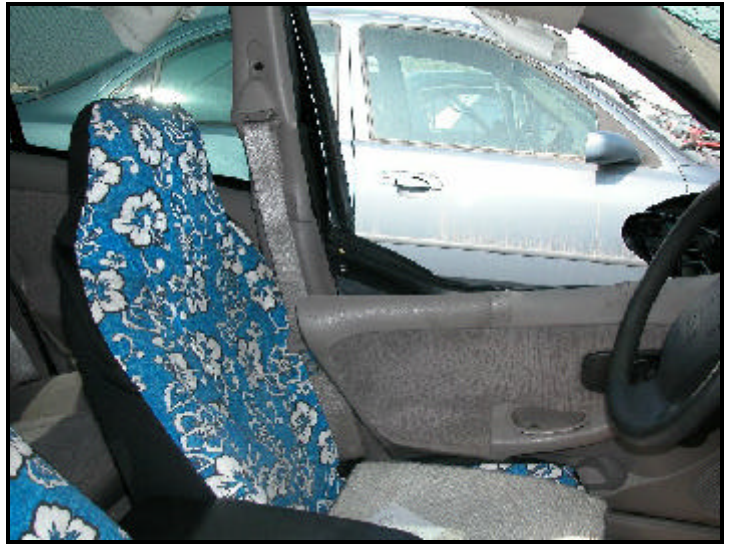
The 18-year old driver of the case vehicle was seated in the fabric covered bucket seat in a normal, upright fashion. The seat was adjusted to the rear most track position. The seat back was slightly reclined. The seat back was covered by flower print seat cover. He was wearing the available lap and shoulder belt. The shoulder belt upper anchorage was in the mid position. Both of his hands were on steering wheel, with the left slightly higher than right. He was wearing all plastic sunglasses and a short sleeve shirt. At impact, the head curtain side air bag deployed. The driver responded to the 280 degree direction of force by moving to his left and slightly forward. His head likely engaged the air bag, but there were no resultant visible contacts to the air bag and the driver stated that he did not have any facial or head injuries. The side glass did disintegrate—most likely due to distortion from the intruding vehicle. The driver did sustain several minor lacerations from the flying glass. His left flank engaged the intruding door panel—causing a contusion.

Figure 11. Left interior, door panel
