**VERIDIAN ON-SITE SIDE IMPACT INFLATABLE OCCUPANT PROTECTION
SYSTEM CRASH INVESTIGATION
SCI TECHNICAL SUMMARY REPORT**

VERIDIAN CASE NO. CA02-024

VEHICLE - 2001 VOLVO V70 T5

CRASH DATE - MAY 2002

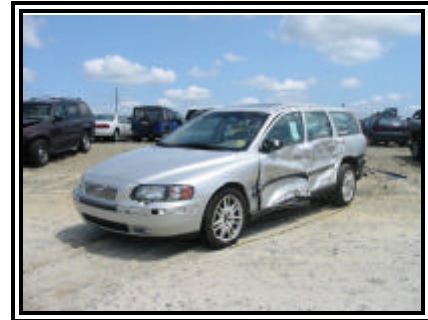
Figure 1. Damaged 2001 Volvo V70

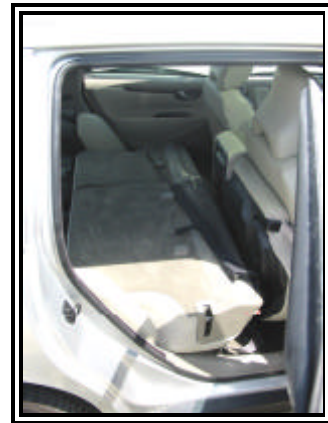
The rear seating positions were configured with a 60/40 bench seat with folding backs. The seat cushions were designed to fold forward against the front seat backs and the rear seat backs folded downward behind the forward-folding cushions (**Figure 4**). At the time of the vehicle inspection, the rear left seat cushion was removed and the rear seats were folded forward. Both the seat cushions and seat backs were equipped with locking mechanisms in the upright and full-down positions. The rear seat was configured with fixed-height head restraints that pivoted fore and aft for the outboard positions. The center position was configured with an adjustable head restraint in the full-down position and a fold down center arm rest. A retractable 60/40 split cargo net was present in the rear seat backs that extended vertically to the roof. The cargo net was fully retracted at the time of the vehicle inspection, however, the driver stated that at the time of the crash the cargo net was extended to the roof.

Figure 4. View of folded rear seats

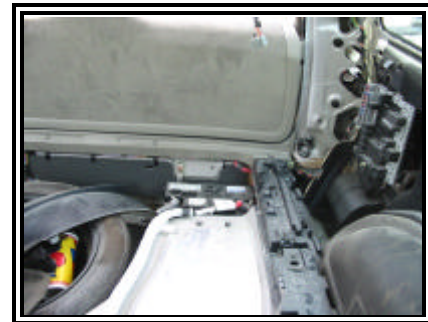
The vehicle's battery was located in the rear cargo area on the left aspect. The fuse panel was also located in the rear cargo area on the rear aspect of the left interior panel. The battery and fuse panel were exposed at the time of the vehicle inspection (**Figure 5**).

Figure 5. View of battery and fuse panel

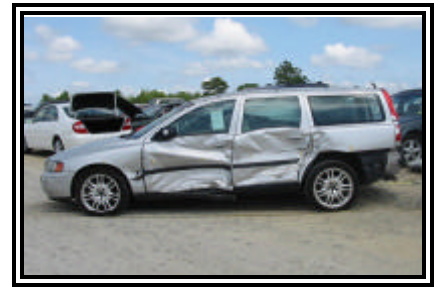
The 2001 Volvo V70 sustained moderate left side damage as a result of the impact with the Ford Mustang (**Figure 6**). The direct contact damage began at the leading edge of the left front door and extended 224.8 cm (88.5") rearward across the left side doors and onto the left rear quarter panel. Direct contact was evidenced by longitudinal abrasions and scuff marks were present above and below the side rub strip on the left side doors. Both doors sustained lateral crush above the sill as a result of the initial impact with the Mustang. The sill trim on the front left aspect was partially separated. A sheet metal tear that measured 6.4 cm (2.5") in width and 1.3 cm (0.5") in height was located below the mid-door rub strip on the lower aspect of the left rear door. The combined direct and induced damage began 44.5 cm (17.5") forward of the leading edge of the left front door and extended 289.6 cm (114.0") rearward across the left side doors and left rear quarter panel. The rear aspect of the left front fender was deformed inward and the forward aspect of the left rear quarter panel was deformed inward as a result of induced damage. The forward deflection point on the left side was located 2.5 cm (1.0") aft of the front axle and the rear deflection point was located 19.1 cm (7.5") aft of the rear axle. The left rear wheel was abraded and scuffed from direct contact with the Mustang as the vehicles disengaged. The top trim which extended longitudinally from the left A-pillar to the left D-pillar along the roof side rail was separated. The Collision Deformation Classification (CDC) for the impact with the Mustang was 10-LZEW-2. Six crush measurements were documented along the bottom aspect of the mid-door rub strip and were as follows: C1 = 0.0 cm, C2 = 5.7 cm (2.3"), C3 = 14.0 cm (5.5"), C4 = 7.6 cm (3.0"), C5 = 8.9 cm (3.5"), C6 = 0.0 cm.

Figure 6. View of left side damage to the VolvoV70

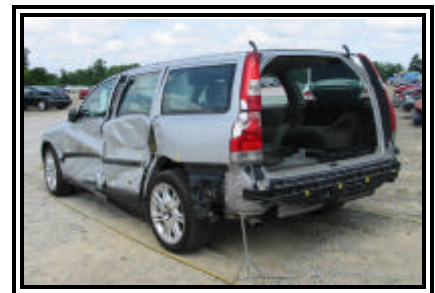
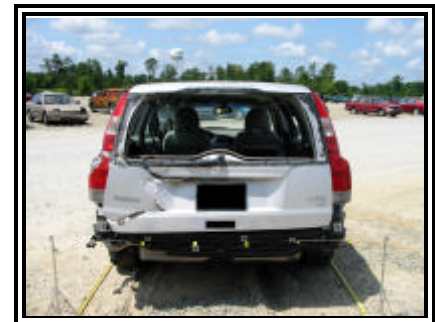
The Volvo V70 sustained moderate rear aspect damage as a result of the secondary impact with the parked Nissan Sentra (**Figures 7 and 8**). The direct contact damage began 11.4 cm (4.5") left of center on the lift gate and extended laterally 68.6 cm (27.0") to the rear left corner. Paint transfers from the Sentra were present on the lift gate. The lift gate was fractured as a result of direct contact 39.4 cm (15.5") left of center. The fracture extended diagonally to the bottom left aspect and upward to the base of the glazing. The rear bumper fascia was separated from the vehicle and not available at the time of the vehicle inspection. The plastic honeycomb filler sustained minor crush and deformation on the rear left corner aspect. The combined direct and induced damaged involved the entire width of the rear plane. Six crush

Figure 7. View of rear left damage to the Volvo V70

Figure 8. View of tailgate and rear damage to the Volvo V70

measurements were documented along the rear bumper and were as follows: C1 = 2.5 cm (1.0"), C2 = 2.5 cm (1.0"), C3 = 0.0 cm, C4 = 0.0 cm, C5 = 0.0 cm, C6 = 0.0 cm. The CDC for the secondary impact with the Nissan Sentra was 06-BYEW-1.

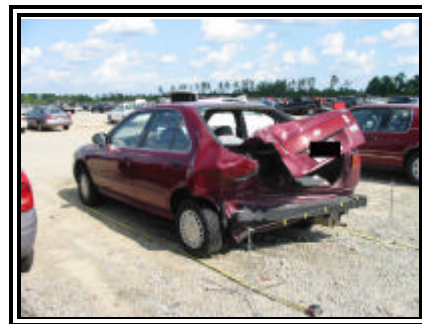
The 1996 Nissan Sentra sustained moderate rear aspect damage as a result of the impact with the Volvo V70 (**Figure 9**). The bumper fascia was separated from the vehicle. The direct contact damage on the bumper fascia began 15.9 cm (6.3") left of center and extended laterally 48.3 cm (19.0") to the rear left corner. The left rear quarter panel and trunk lid were abraded crushed forward from direct contact. The combined direct and induced damage involved the entire width of the Sentra and measured 123.2 cm (48.5"). The entire bumper beam was displaced as a result of the crush on the rear left corner. The backlight was disintegrated as a result of induced damage. The CDC for the impact with the Volvo was 07-BYEW-4. Six crush measurements were documented along the rear bumper beam and were as follows: C1 = 40.6 cm (16.0"), C2 = 31.1 cm (12.3"), C3 = 23.2 cm (9.1"), C4 = 14.0 cm (5.5"), C5 = 4.4 cm (1.8"), C6 = 0.0 cm.

Figure 9. Rear damage to the 1996 Nissan Sentra

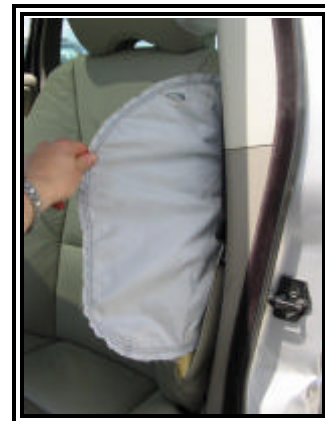
The left SIPS II deployed from the front outboard aspect of the driver's seat back (**Figure 10**). The stitched tear seam along the forward edge of the seat back measured 54.6 cm (21.5") in height. An additional vertical tear in the outboard side aspect of the seat fabric was noted 3.8 cm (1.5") aft of the air bag tear seam and 22.9 cm (9.0") above the bottom aspect that measured 5.1 cm (2.0") long. The laceration was in proximity to the seat belt latch plate stop button in the seat belt's retracted mode. The source of the laceration was not known. In its deflated state, the forward excursion of the SIPS II measured 16.5 cm (6.5) at the center aspect and the air bag measured 40.6 cm (16.0") in height and 34.3 cm (13.5") in length. The SIPS II was vented by a single circular vent port that measured 2.5 cm (1.0") in diameter and was located 2.5 cm (1.0") below

Figure 10. Deployed driver's SIPS II

the top aspect and 15.2 cm (6.0") rear of the forward aspect. The SIPS II air bag was not tethered. There was no contact evidence on the SIPS II at the time of the vehicle inspection.

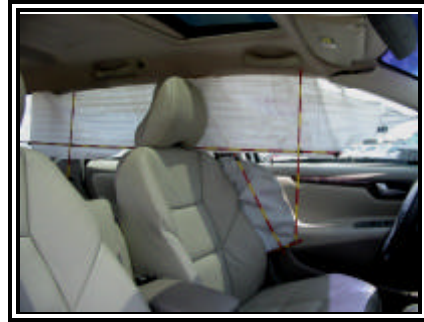
The left IC deployed downward from the left roof side rail as a result of the left side impact with the Ford Mustang (**Figure 11**). The tear seam measured 144.8 cm (57.0") in length and extended from the left A-pillar to 8.9 cm (3.5") aft of the left C-pillar. In its deflated state, the IC measured 143.5 cm (56.5") in length, 30.5 cm (12.0") in height at the forward aspect and 33.0 cm (13.0") in height at the rear aspect. The IC was structured with various chambers with the chamber edges fused together. The configuration of the IC chambers was designed to concentrate the air channels to areas where it was likely for occupants to strike their heads. Volvo information stated that the IC inflates to full volume in approximately twenty-five thousandths of a second and remains inflated for approximately three seconds. The air bag was tethered at the forward aspect. The graduated tether measured 27.9 cm (11.0") in width at the aft aspect and 1.3 cm (0.5") in width at the forward aspect at the left A-pillar. The tether was anchored to the left A-pillar 45.7 cm (18.0") above the bottom aspect of the A-pillar and was cut post crash. There were no identifiable contacts present on the IC.

Figure 11. View of left side IC and SIPS II

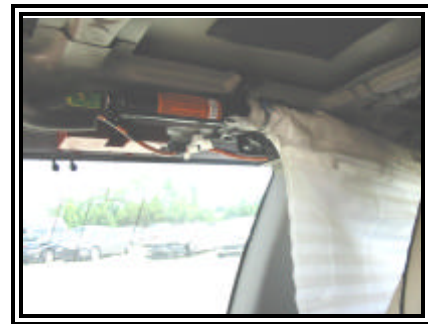
The stored gas inflator for the IC was mounted longitudinally on the left roof side rail between the C- and D-pillars (**Figure 12**). According to Volvo, the gas in the IC was a mixture of argon and helium. The circular inflator canister was located 7.6 cm (3.0") aft of the left C-pillar and measured 30.5 cm (12.0") in length and 3.8 cm (1.5") in diameter. The inflator was manufactured by Autoliv. The inflation tube of the IC was configured in a circular pattern and overlapped the forward aspect of the inflator canister 7.6 cm (3.0") and was secured to the canister by a 1.0 cm (0.4") wide circular clamp.

Figure 12. View of stored gas inflator
